**CONTACT VOLTAGE TEST &
FACILITY INSPECTION
ANNUAL REPORT**

CONSOLIDATED EDISON COMPANY OF NEW YORK, INC.

Report on the results of contact voltage tests & facility inspections for the period
beginning January 1, 2011 and ending on December 31, 2011.

February 15, 2012

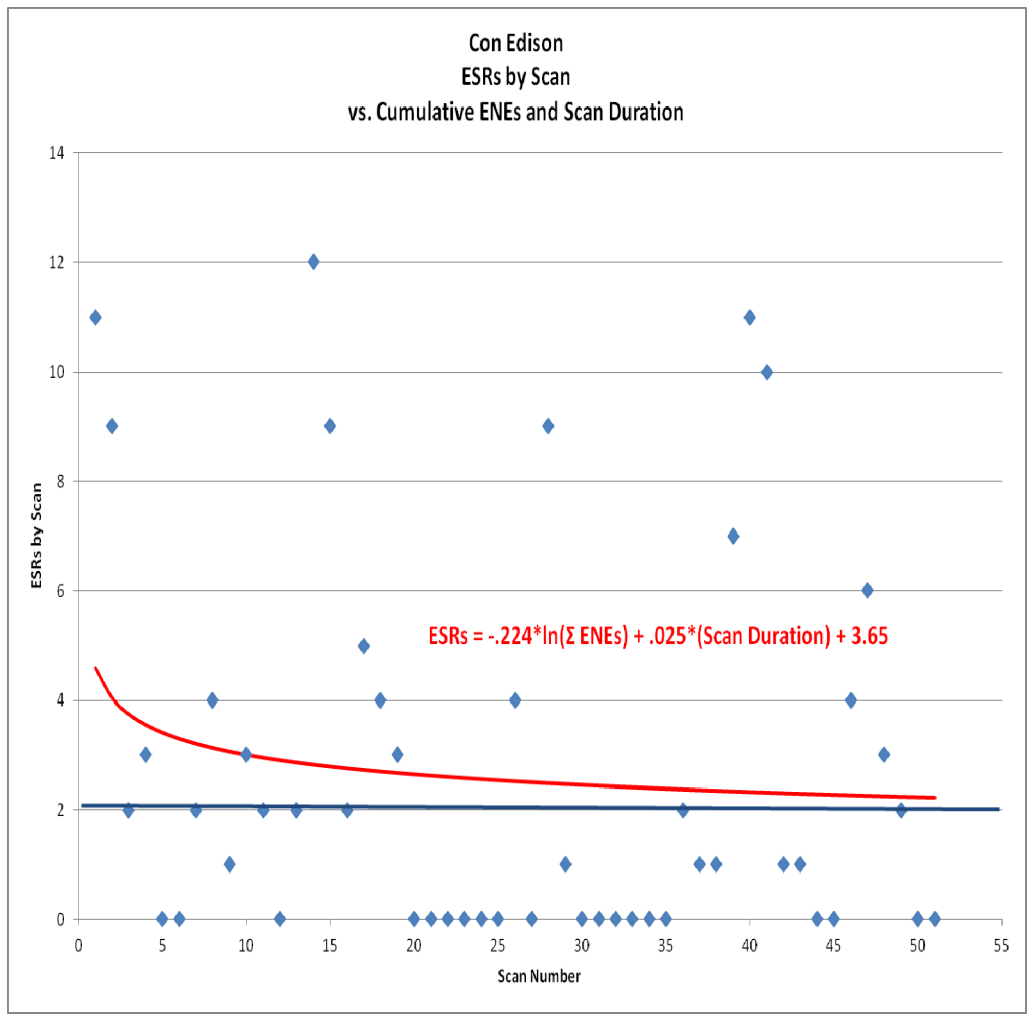
Chart 1

The ESRs associated with Con Edison's equipment appear on Chart 1. As mentioned above, weather also plays a role in ESR generation. The significant precipitation in 2011 increased the generation rate of Con Edison responsible ESRs. This weather variable is accounted for in the underlying models and in both the 2012 and long term predictions. The duration between scans ranges from approximately 20 to 25 days per scan. If we continue with a comparable ENE repair rate and scan interval in 2012, as well as experience similar weather patterns, we can expect ESRs to be approximately 2 per scan. This prediction is consistent with the 2011 actual results of 27 shocks due to Con Edison responsibility.

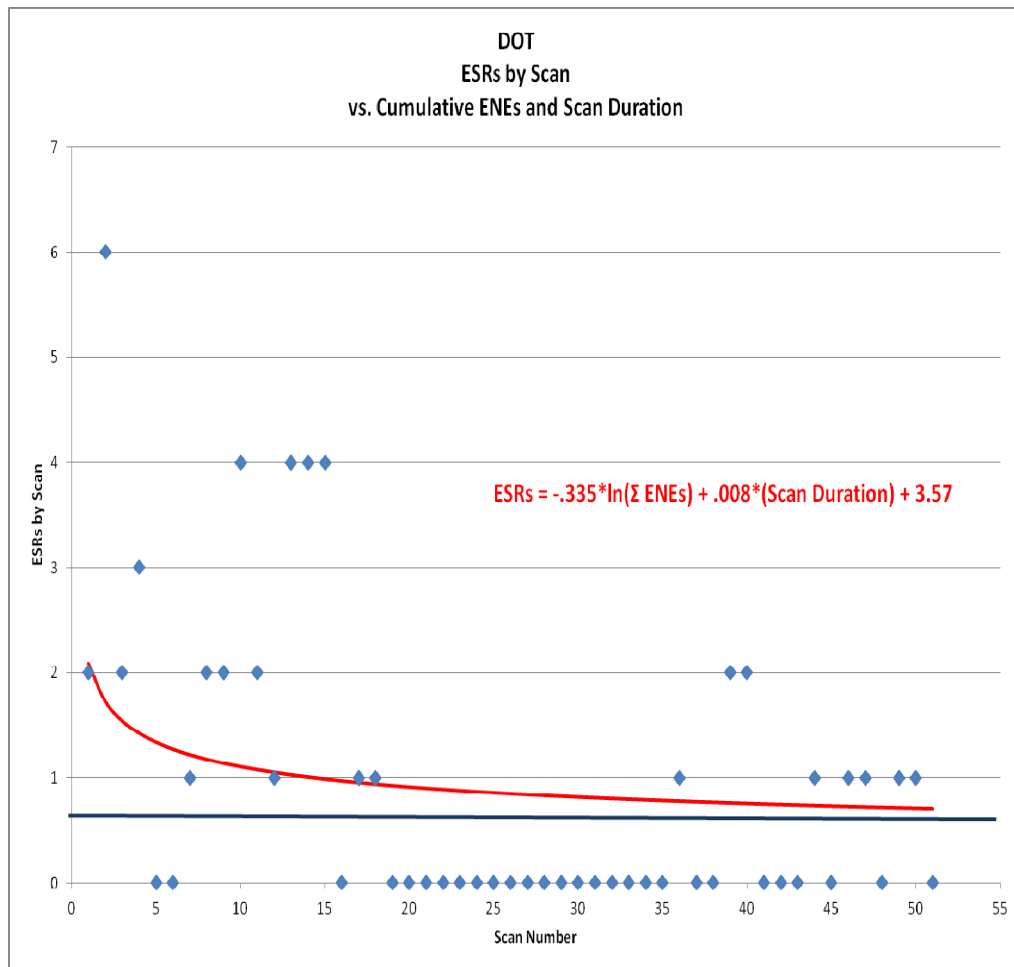
Chart 2

The reduction of ESRs associated with the DOT appears on Chart 2. The duration of scans is 20 to 25 days per scan. If we continue a comparable ENE repair rate and scan duration in 2012, we can expect ESRs at this scan duration level to be approximately 1 every two scans. This demonstrates marginal improvement over current scan durations. In 2011 there were 7 shocks associated with DOT equipment failures. This result is better than predicted, and is likely the result of various programs implemented by both DOT and Con Edison to mitigate shocks.

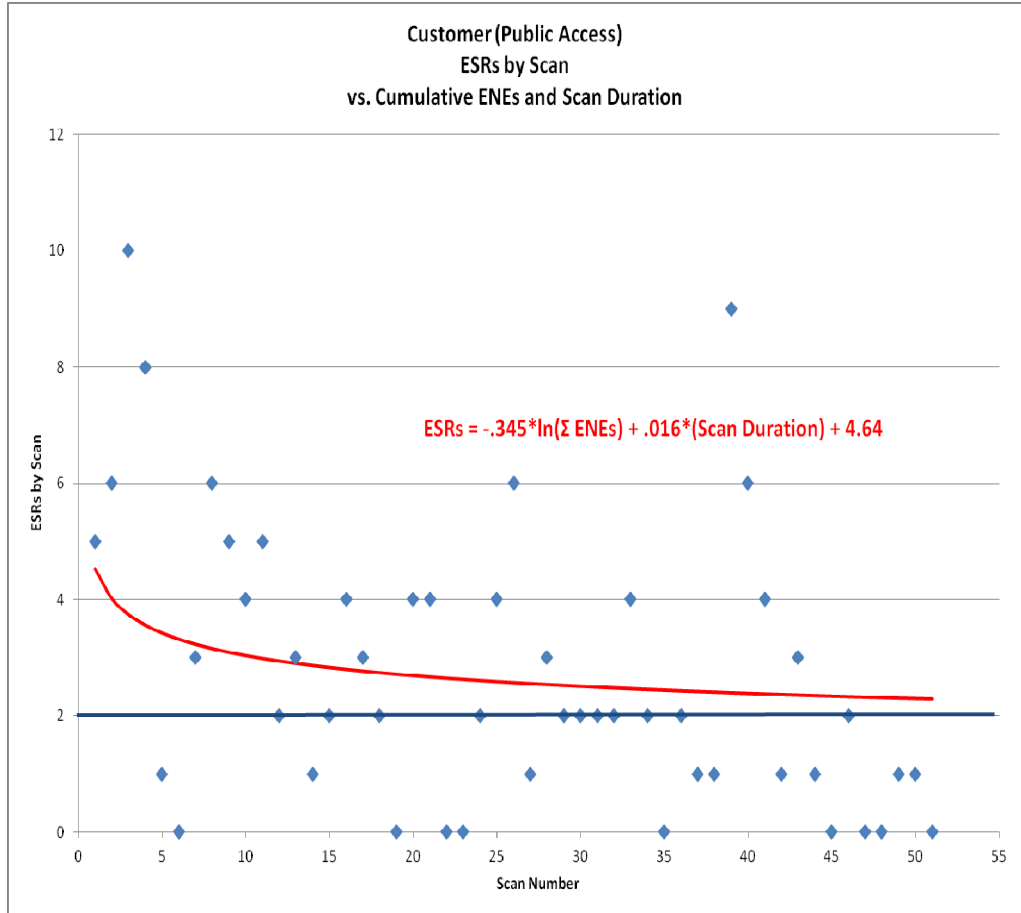
Chart 3

The reduction of ESRs associated with Customer Equipment (Public Access) appears on Chart 3. The duration of scans is 20 to 25 days per scan. If we continue a comparable ENE repair rate and scan duration in 2012, we can expect ESRs to remain at 2 per scan, with no significant reduction anticipated below that level in the near future. The actual performance indicates that these shock events are less sensitive to our mitigation efforts than we initially projected. In 2011, we responded to 21 validated shock reports on publicly accessible customer equipment. This is a 12.5% reduction compared to the number predicted by the model.

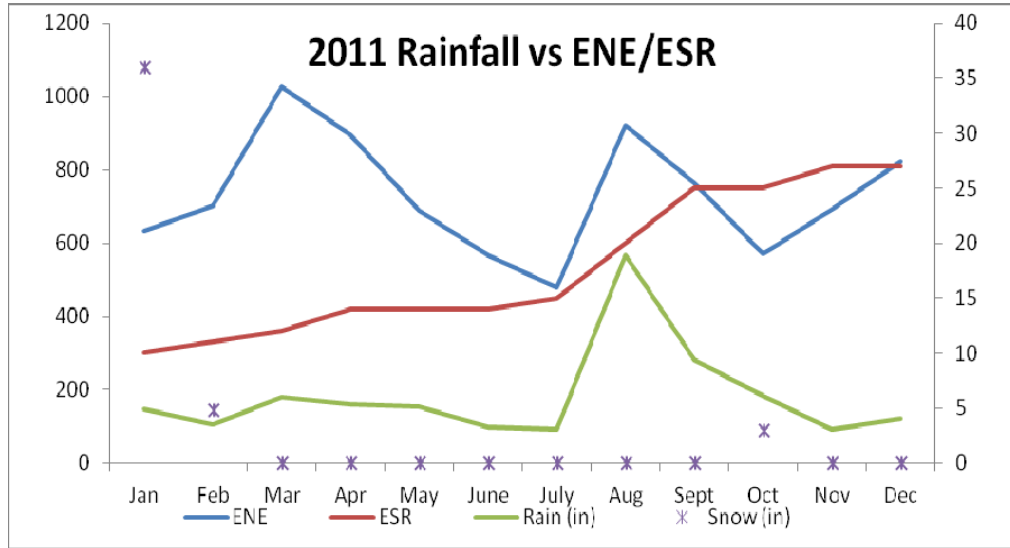
Adverse weather conditions affected Con Edison responsible ESRs the most. A strong correlation was observed between weather and shocks during 2011. Chart 4 shows the impact of rainfall on ESRs during the period of weather from July to October, where we saw a 40% increase in reported electric shocks. During that period, close to 40 inches of rain was recorded in the New York City area.

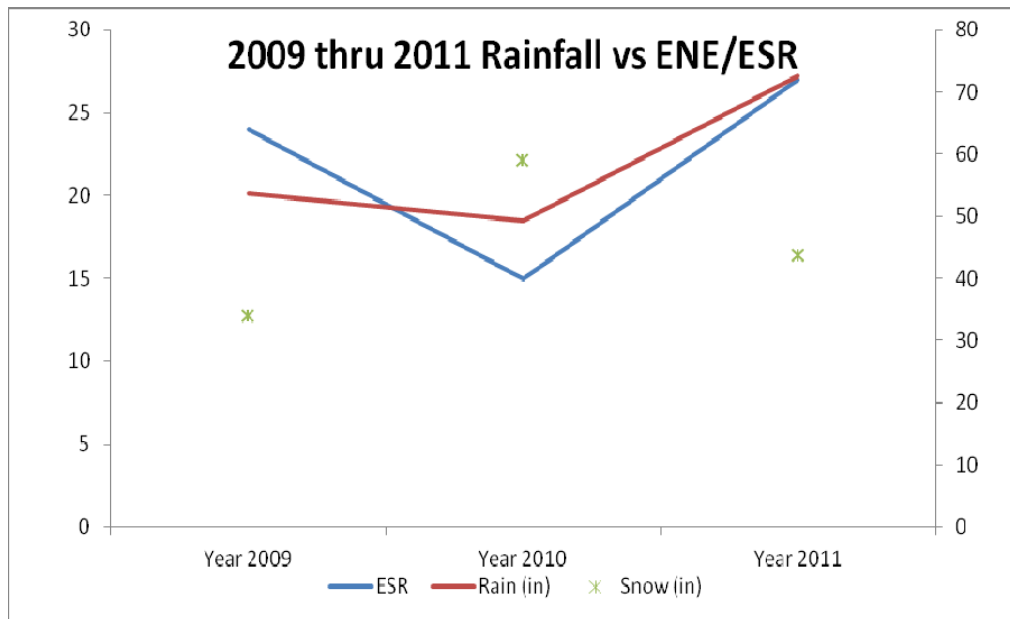
The impact of precipitation is further evident when we look at snow and rainfall year over year. Chart 5 shows system response to ground conditions, as level of precipitation change from 2009 to 2011. As snowfall and rainfall increase from 2009 to 2011, ESRs also increase. We will continue to monitor this correlation in 2012.

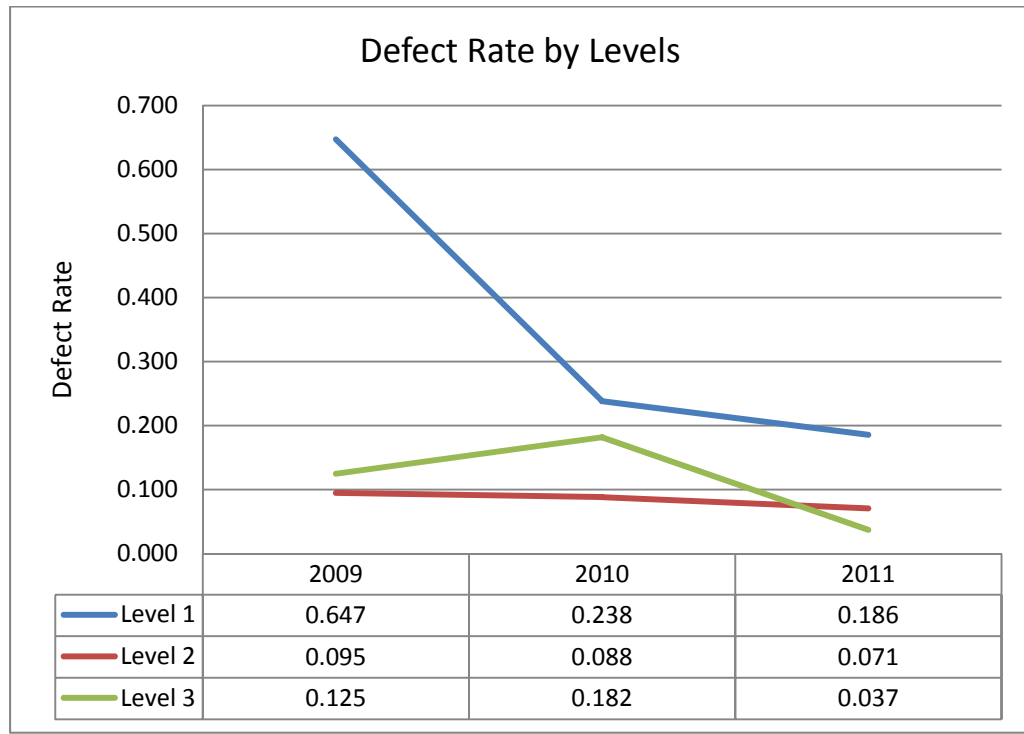
The chart below shows the number of defects found per inspection:

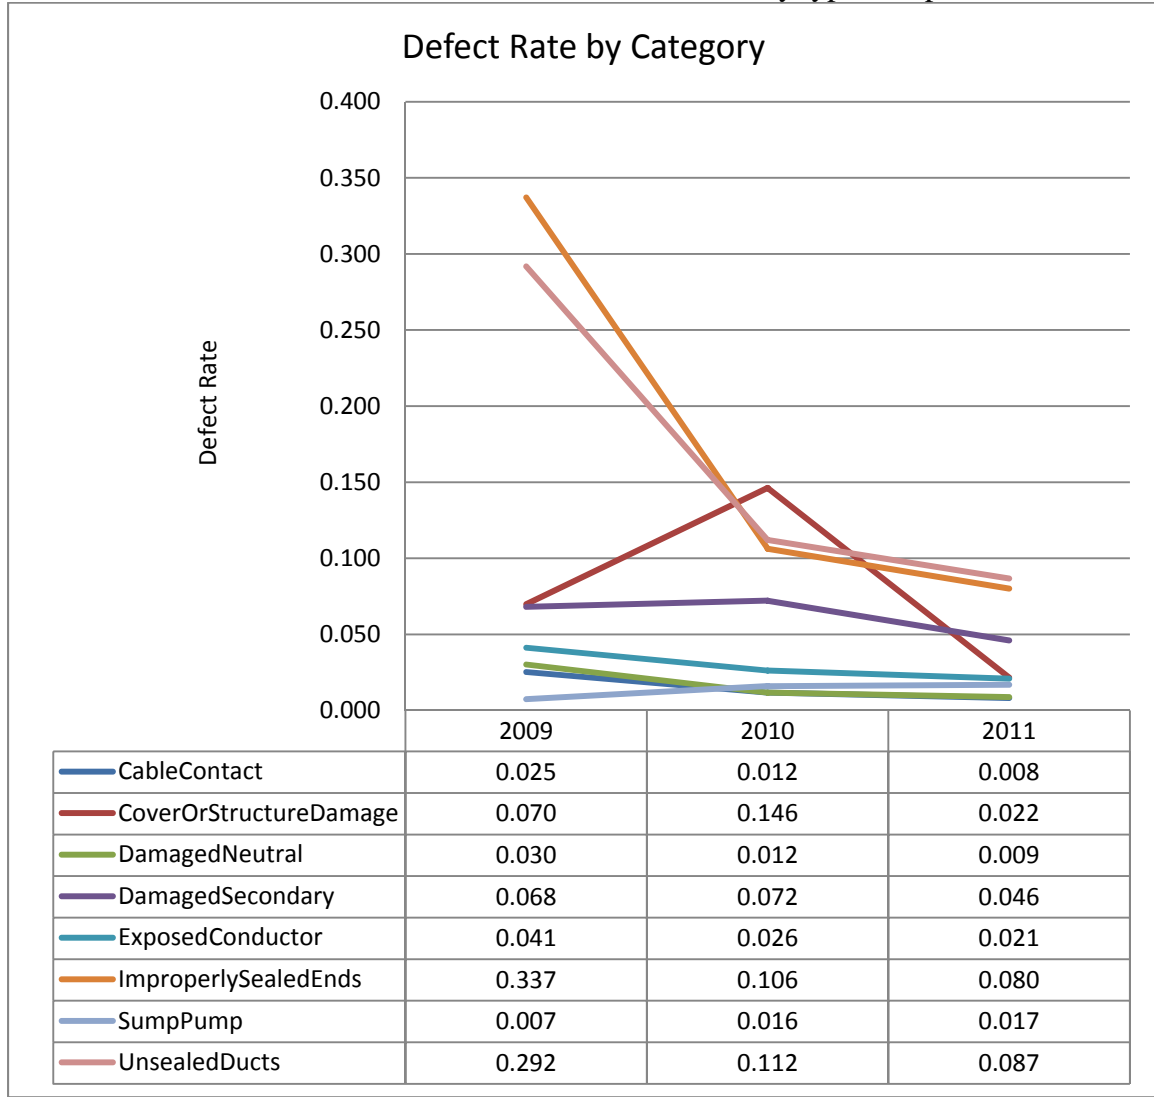
The defect found ratio can be broken down further, by type of repair:

For most categories, we see a minor decrease in defect rate from 2009 thru 2011. Three categories that we see a major decrease in defect rate are unsealed ducts, damaged secondary, and improperly sealed ends. A major part of this decrease may be attributed to the start of Cycle II and better categorizing of defects by the company. We are now re-inspecting structures that were previously inspected within the last 5-year with better understanding of procedures and specifications.

During the first 3 years of the prior inspection cycle (2005-2009), cover damage and structure damage were captured in one category. A specification change was made in late 2009 that enabled the inspector to identify these repairs as two separate repairs. This led to a spike in rate detected during the 2010 program. This also holds true for damaged secondary cable; the rate increase seen in 2010

results from a change in our inspection report form in late 2009 which allows the inspector to report repairs needed to the secondary service, crabs, and removal of split bolt connectors. Also in 2010, we made a change in specification for structure damage. This category was split into one Level I and nine Level 4 categories. Because of this we can distinguish structures that need immediate attention, i.e., Level I, from the Level IV conditions that will be reviewed by engineering.

In 2011, we also saw an increase in sump pump defects (sump pump not working) found. This can be attributed to vaults that currently have an older model sump pump installed. In 2008, the Company changed the specification for purchasing sump pumps to a model which has a more robust seal system which would extend the life of the pump when cycling. The majority of the failed units identified in the 2011 inspection program were sump pumps of the prior vintage. As we find and remove these older pumps, we are replacing them with the new model. Sump pump defects increased from 2009 to 2010 and this increase appears to be leveling off from 2010 to 2011.

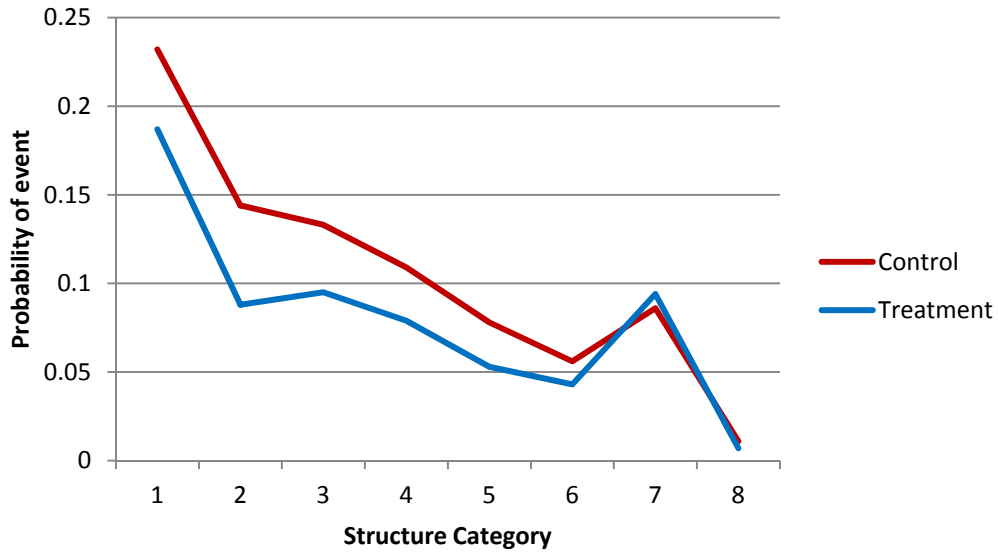
Figure 1: Event probability in CCLS Categories 1 through 8

The benefit derived from the inspection of the 52,000 structures in Manhattan is shown in figure 1. Over a 5 year period there was a reduction in the probability between the treatment group (blue) and the control group (red) of about 5% for categories 1, 2 and 3, with less of an impact on categories 4, 5, and 6. Categories 7 and 8 showed no significant impact. This translates to a reduction of approximately 1,300 secondary events from the inspection of 52,000 structures. The CCLS team concluded that structures in categories 5 and 6 were also most likely to benefit from a onetime reduction in event probability, i.e., a single inspection and would likely not benefit from additional inspections in the near term. The team further concluded that Categories 7 and 8 experienced no measurable benefit as a result of the inspection program.

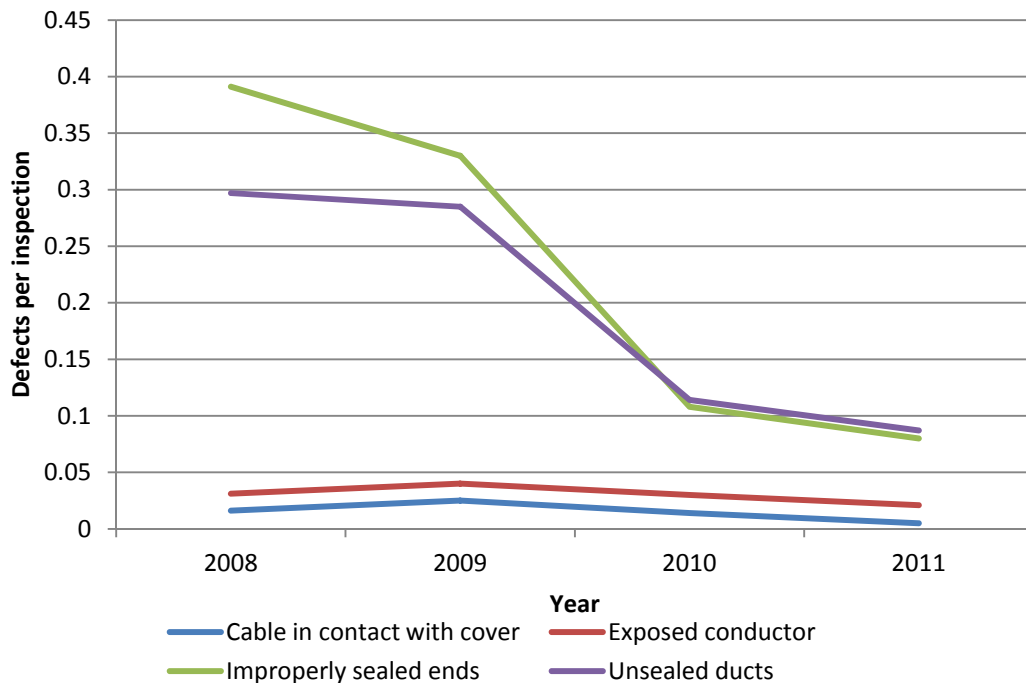
Figure 2: Defect rate of selected defects

Since the study focused largely on the impact of level 1 repairs, the rate of occurrence of these defects will drive the impact of future inspections after the first 5 year cycle, Figure 2 shows the defect rate for those defects likely to cause these events. There has been a dramatic reduction in the number of improperly sealed ends and unsealed ducts. There is a small but noticeable decline in the

number of exposed conductors and cases where cable was in contact with the cover.

The data collected in 2010 and 2011 show more than an 80% decline in the number of level 1 defects from the high in 2009. Since the treatment effect that CCLS was able to detect was directly related to Level 1 repairs, one would expect a commensurate decline in the treatment effect of future inspections. Applying an 80% reduction to the treatment effect of the first cycle of 1,500 annual avoided events would yield a projection of 300 avoided secondary events per year, system wide, in the second cycle of the inspection program.

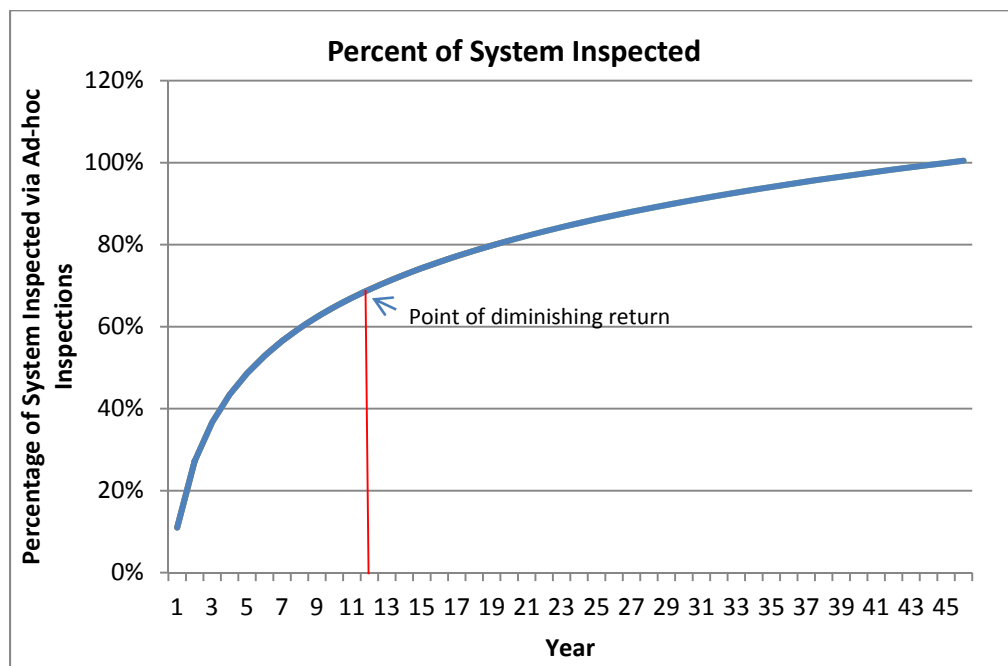
Figure 3: Percent system inspection completed via routine work

The steep slope of the curve in the early years of the inspection program indicates a high generation rate of unique inspections during the early part of the inspection cycle. That return starts to diminish around year twelve. This point is found by determining when the line tangent to the curve is parallel to the secant line of the curve. Therefore, the targeting of inspections prior to year twelve of the inspection cycle does not take optimum advantage of routine work.

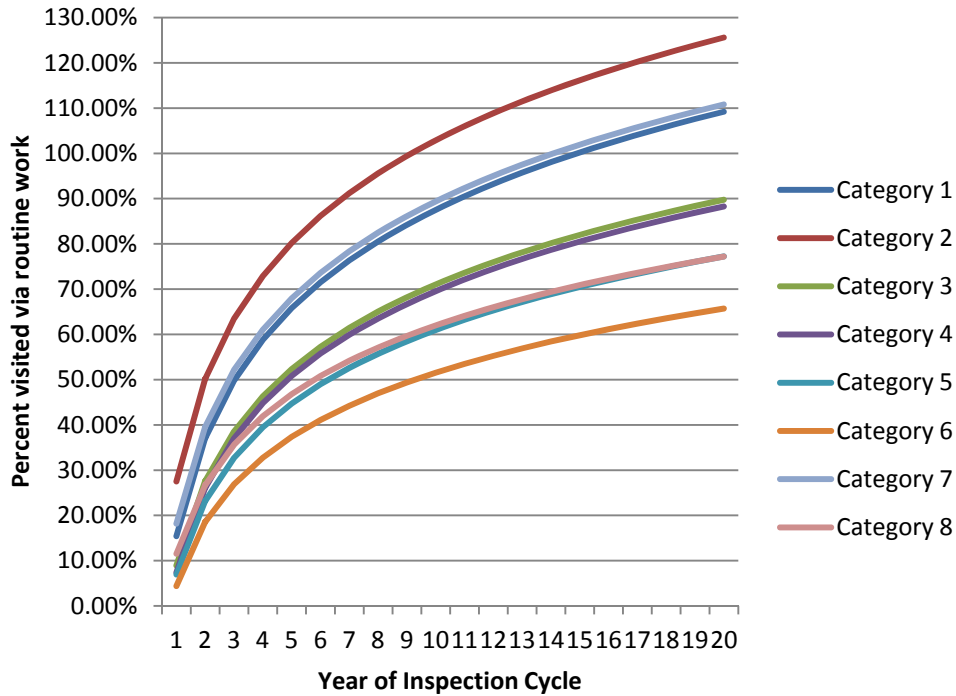
Figure 4: Routine Work inspection model, showing percentage completion by category

The routine work inspection model is based on the actual rate of Con Edison’s unique inspections performed during routine work in the first 5 year cycle projected out to a 20 year period. The model shows that the structures that have the highest frequency of events, i.e. Categories 1 and 2, are visited the most and are inspected more frequently. This is likely because these structures generally contain more secondary cable than other structures so crews visit them more frequently for routine work.

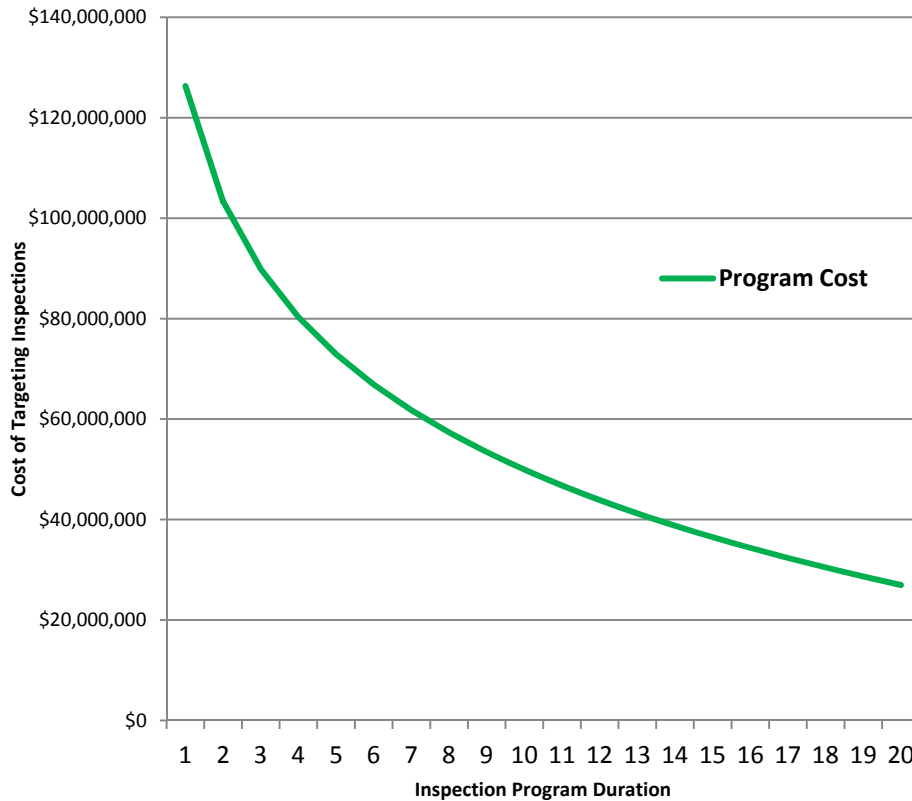
Figure 5: Cost estimates for inspection programs of various durations

Figure 5 shows the avoided cost achieved by delaying the start of targeted inspections. For any given year of the inspection cycle the line projects the cost of targeting the remaining inspections in that year. The difference between the points of two years is the cost savings in delaying the start of targeting to the later year.

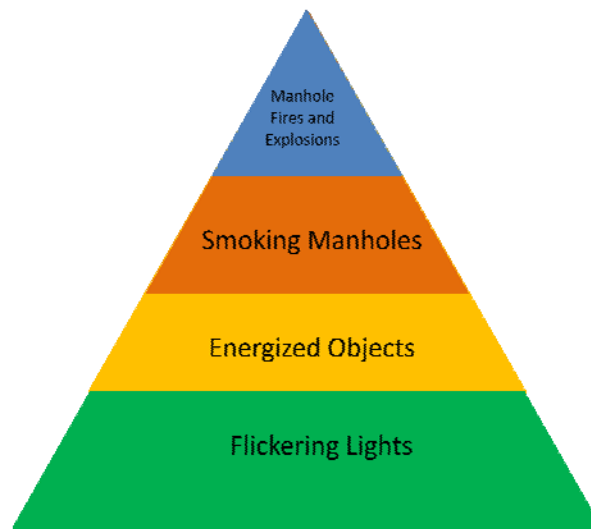
Figure 6: Relative frequency of various secondary events

The most common outcomes of these failures are customer complaints of flickering lights and low voltage, followed by proactively detected energized objects. A smaller number of these defects evolve into smoking manholes and the most serious events, manhole fires, explosions, and shocks are the least likely outcomes of damaged cable insulation. This relationship can be represented as a triangle, shown in figure 6, with the least serious, most common events making up the base and the least common more serious events at the top. The environmental conditions around the failure play a large role in determining if and how the events progresses from a flickering light to an energized object to a smoking manhole or fire.

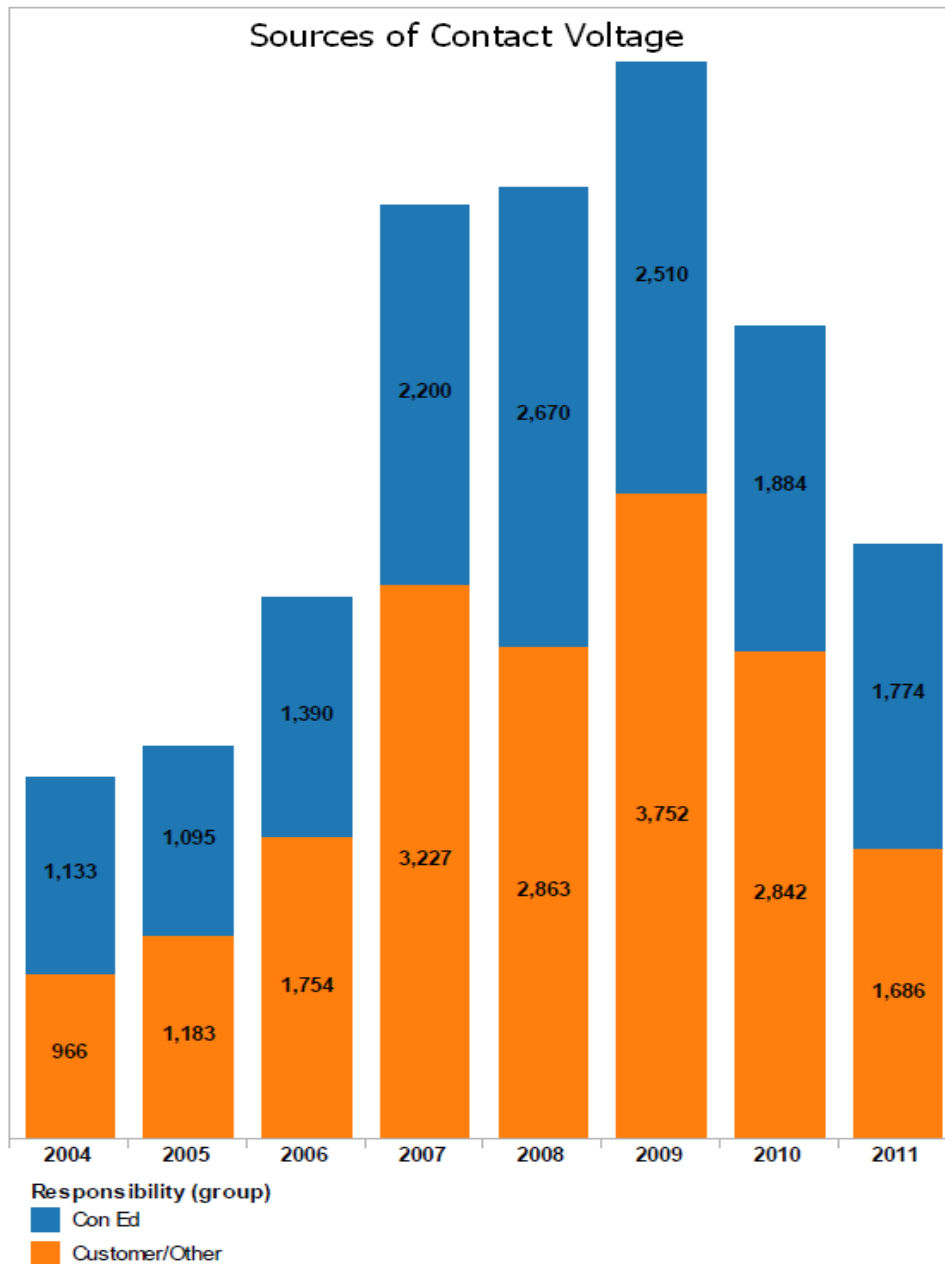
Figure 2: Sources of Contact Voltage, 2004 to 2011

Data collected over the last several years shows a downward decline in the number of sources of contact voltage detected beginning in 2009, as shown in Figure 7. This downward decline demonstrates that the detections are occurring at a rate that is at least equal to that of the generation rate of these defects. It is difficult to measure or predict the exact generation rate because weather plays a significant role in the manifestation of energized objects as well as other secondary events. The number of detections tends to increase when the ground is wet and to a larger extent when salt has been applied.
