STATE OF NEW YORK
DEPARTMENT OF PUBLIC SERVICE

Case 14-G-0201

Investigation of
Natural Gas Explosion and Collapse of the Buildings
1644 and 1646 Park Avenue, New York, NY
March 12, 2014
Consolidated Edison Company of New York, Inc.

Safety Section
Office of Electric, Gas & Water
Final Report November 12, 2015

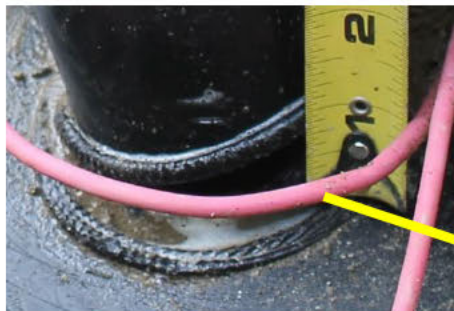
Failed Plastic Fusion joint at the service tee at 1642 Park Avenue

- The primary source of natural gas that caused this incident was the failed plastic fusion joint at the service tee to 1642 Park Avenue building installed in 2011. Among other reasons described below, based on Staff's estimated flow rate calculations and the extent of the natural gas odors sensed the night before the incident (based on personal interviews

- The defective plastic fusion joint in front of 1642 Park Avenue, based on the joint's appearance, failed to conform to the manufacturer's or CECONY guidelines or acceptance criteria. Therefore, it should have been removed and replaced.

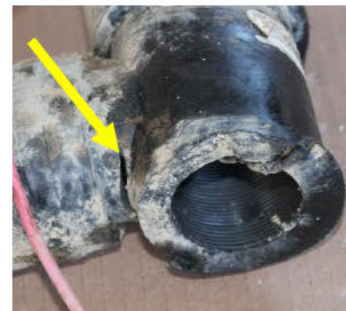
A Crack on the bottom of the molded outlet of the gas service tee at 1642 Park Avenue

DPS conducted), the crack on the bottom of the molded outlet of the same gas service tee could not have released sufficient gas to have caused an explosion of this magnitude.

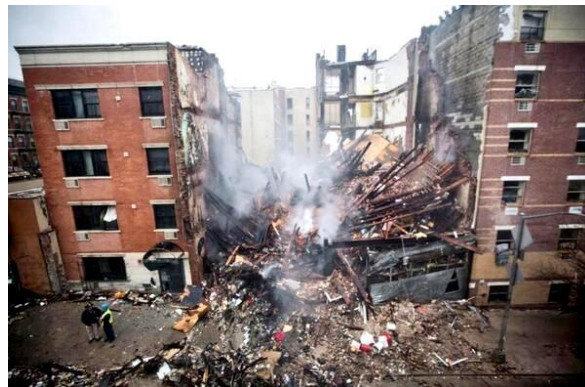
Figure 2 - 1644-1646 Park Avenue after the explosion

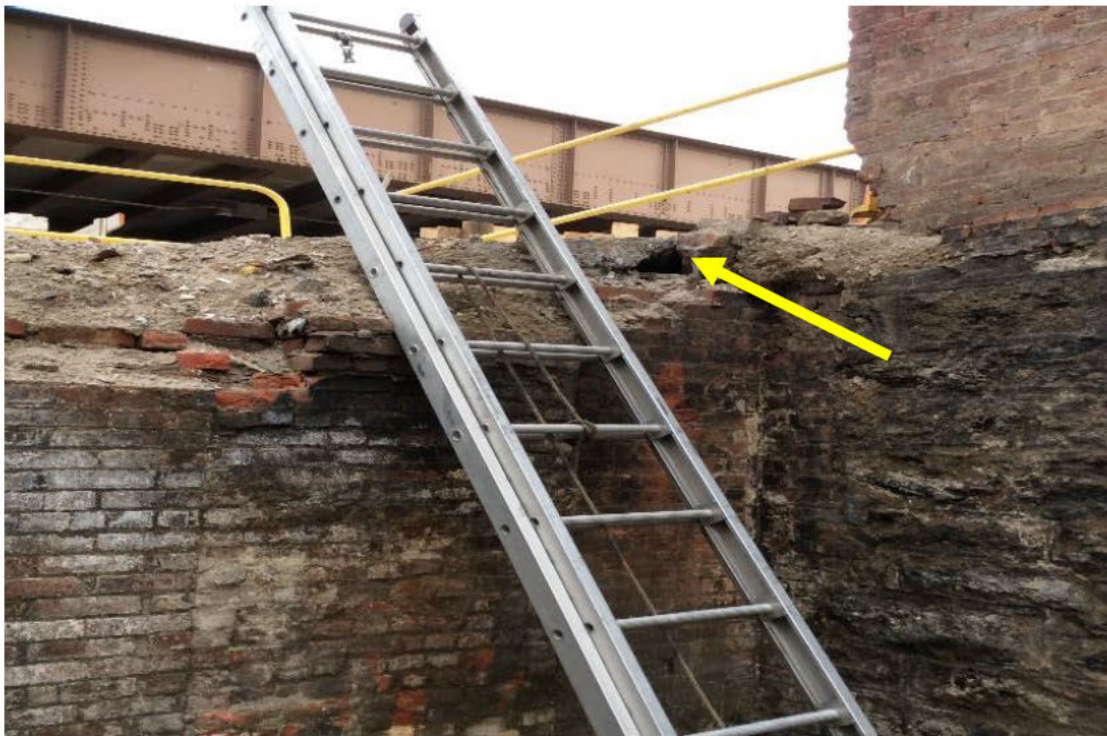
Figure 4 - Soil voids under sidewalk leading to 1644 Park Avenue building (Photo taken from inside basement of 1644 Park Avenue facing South-East direction).

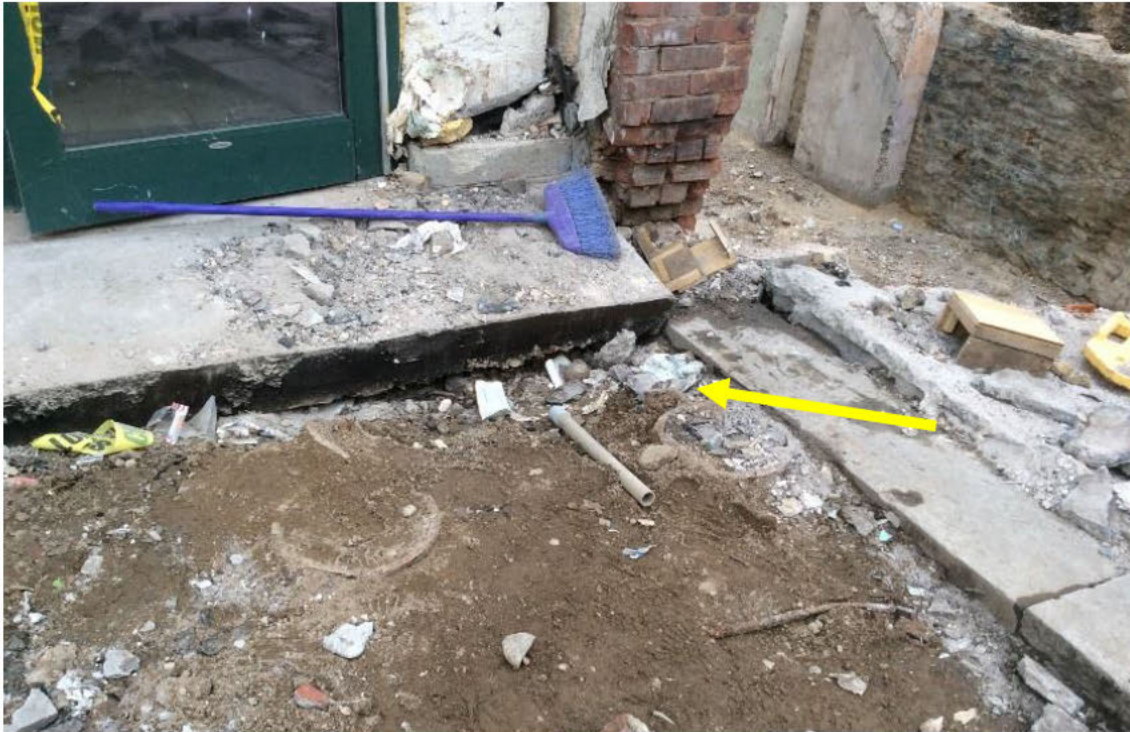
Figure 5 – Charring and voids under sidewalk along the property line between 1642 and 1644 Park Avenue buildings.

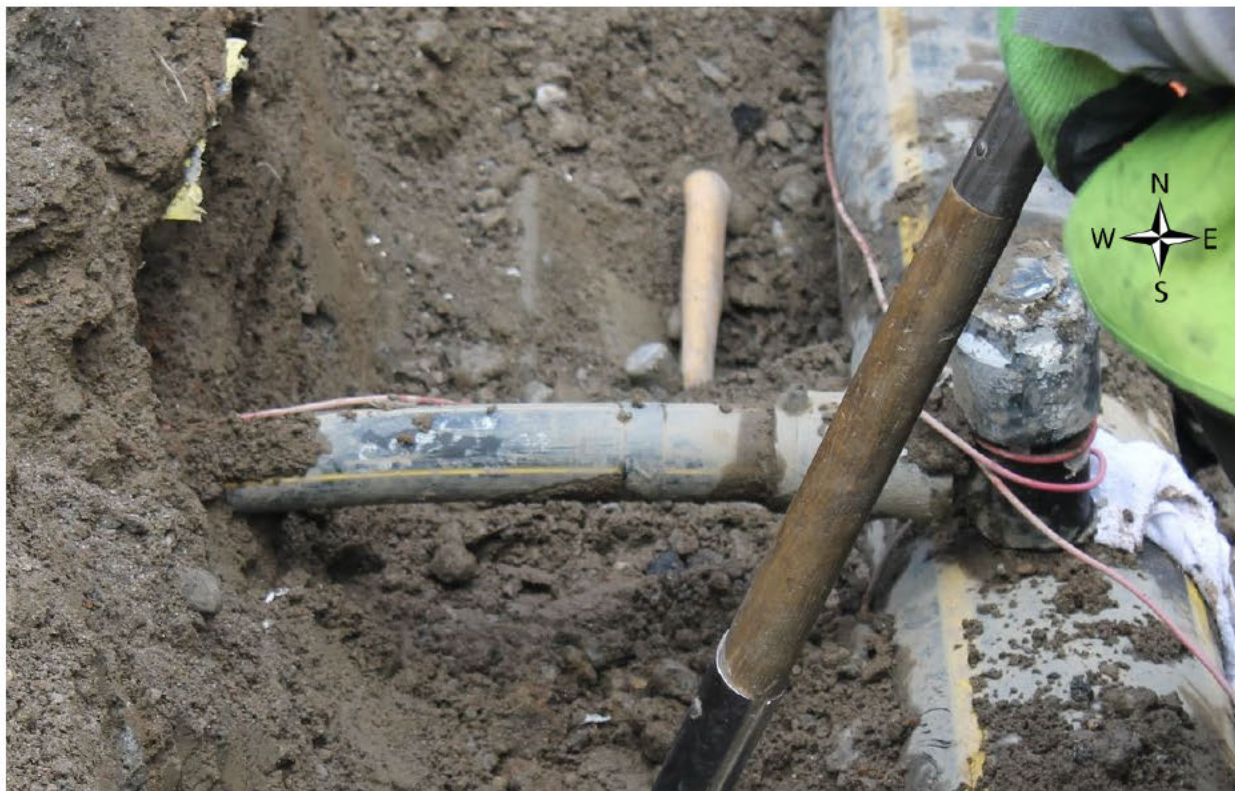
Prior to the NTSB's removal of the service tee to 1642 Park Avenue with sections of main and service, DPS Staff observed tension loading on the service line. The gas main and the service tee were sagging slightly downward in relation to the rest of the service line to 1642 Park Avenue. See Figure 6.

Figure 6 - Plastic gas service line for 1642 Park Avenue bending down with gas main and service tee (Photo taken 3/20/14).

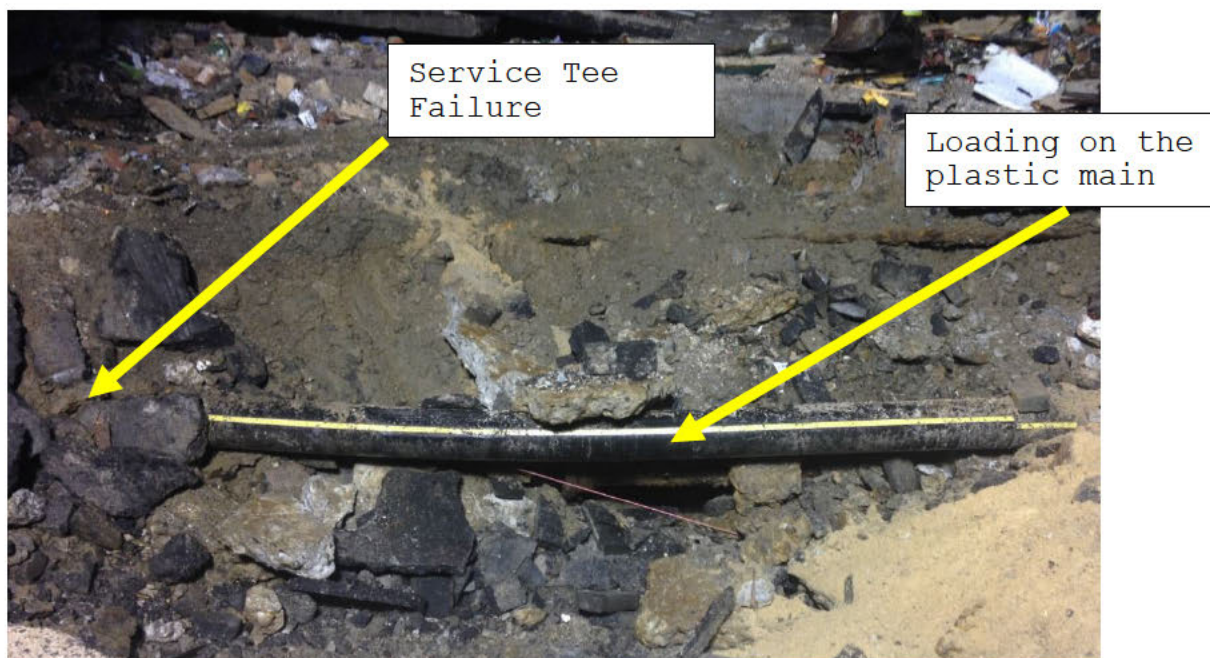
DPS investigators saw that the 8-inch plastic main and the service

tee were under stress loading from lumps of roadway above and was being undermined from below by erosion. The plastic fusion joint itself had partially failed on its northern side due, in part, to the stress loading applied on the plastic gas main (See Figure 7), which is consistent with this DPS conclusion.

Figure 7 – Plastic gas main with stress loading and service tee for 1642 Park Avenue (Photo taken 3/12/14).

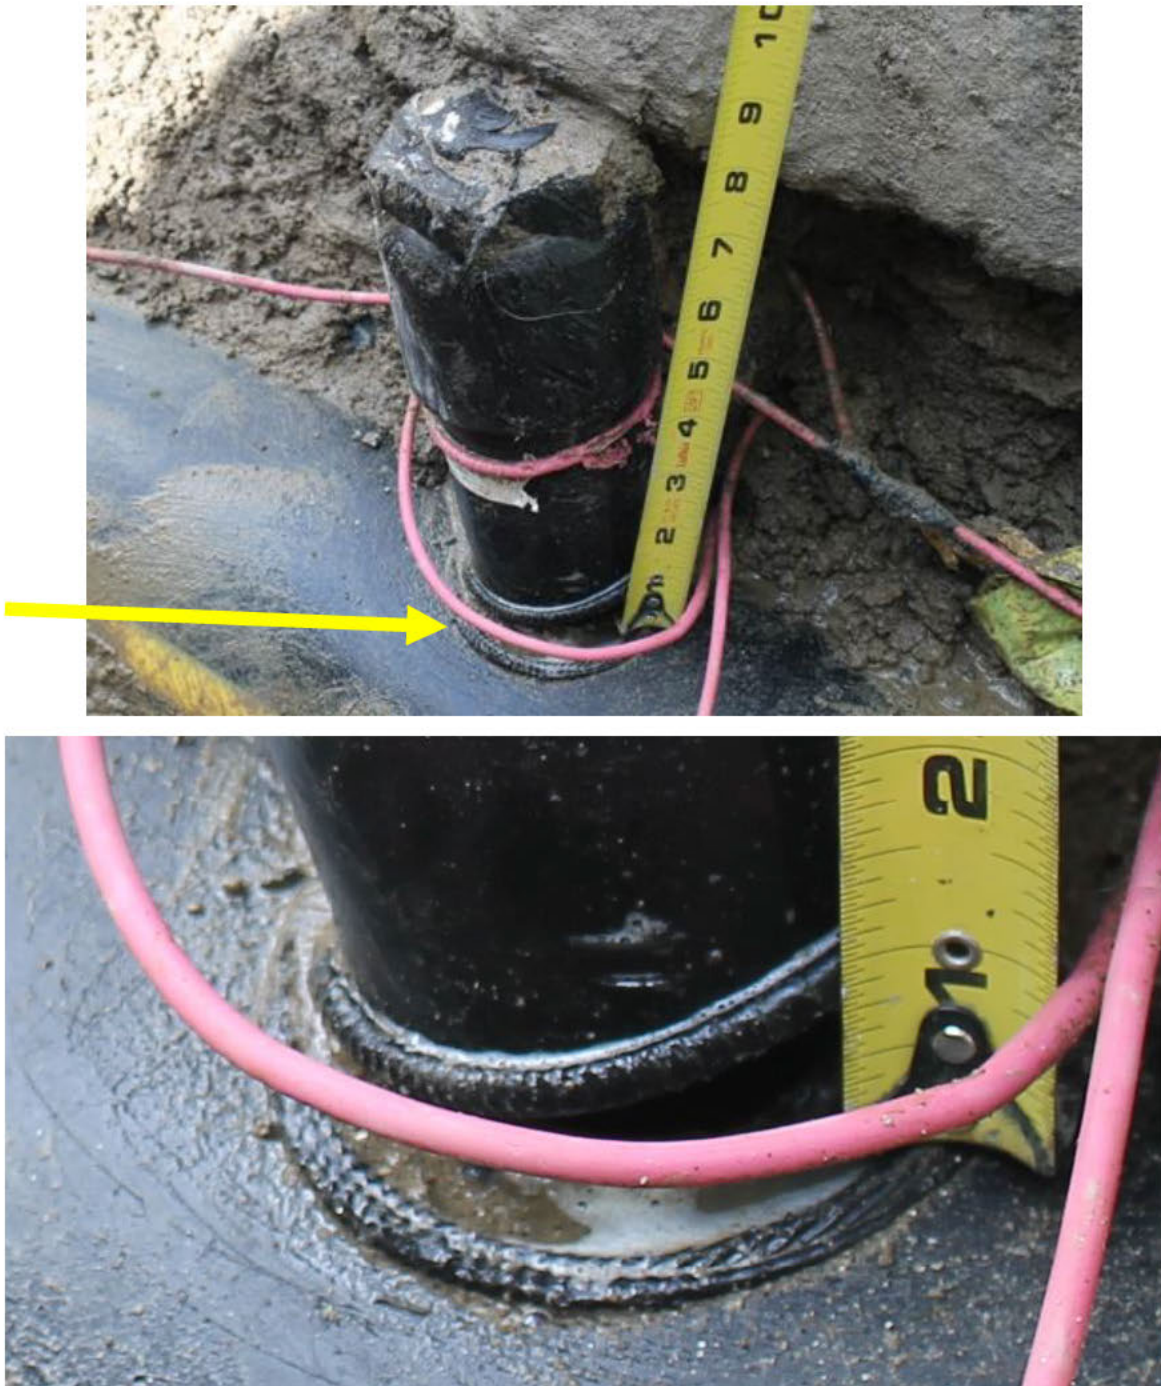
Figure 9 - Failure of the service tee for 1642 Park Avenue at the fusion. (Photo taken 3/20/14). Top Photo, an overview shot. Bottom Photo, a close-up view of the fusion failure.

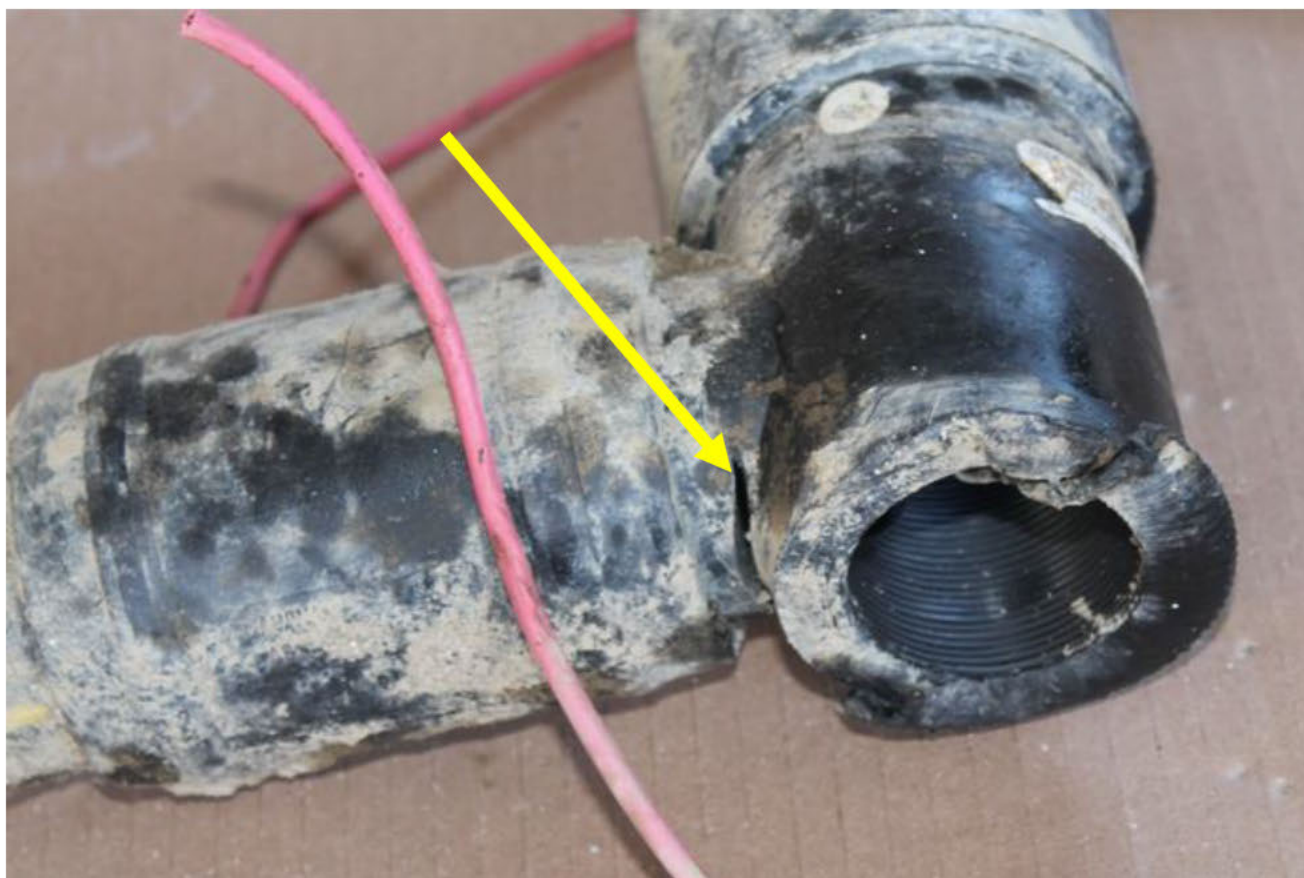
Figure 10 - Crack failure of the service tee for 1642 Park Avenue at the bottom of the molded outlet (Photo taken 3/21/14) .

in the gas main indicate that the plastic fusion joint had failed before the water had been shut off and sinkhole was excavated. Further, the small crack running from north to south on the bottom of the molded outlet on the service tee to 1642 Park Avenue faced downward, unlike the failed plastic fusion joint that was parallel to the water main break; the crack did not have water or mud inside. Considering the law of gravity, the large volume of water in the gas main, and the amount of mud found far inside the service tee and the gas main, the plastic fusion joint failure would have had to have occurred before the sinkhole was excavated.

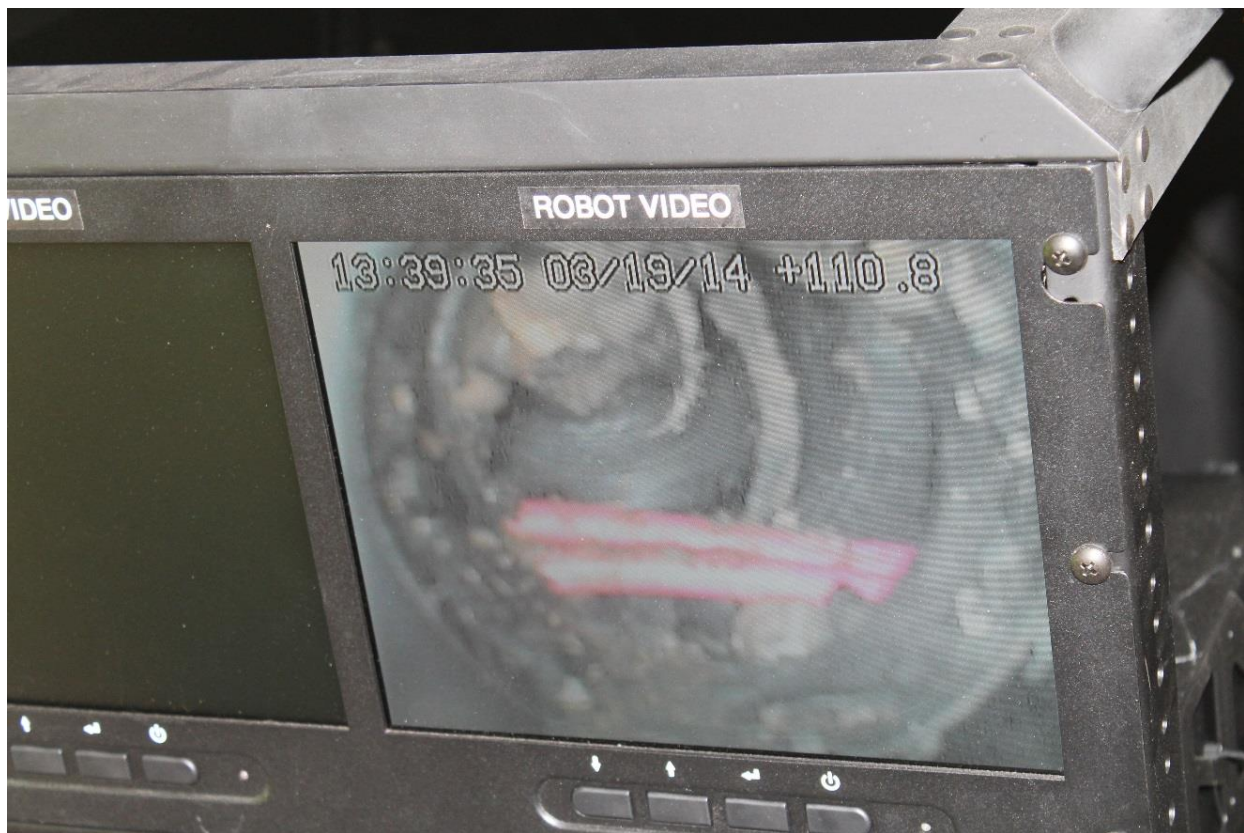
On March 19, 2014 ULC Robotics performed a camera inspection of the still in place 8-inch plastic gas main and identified a failed saddle fusion joint. DPS investigators noted visible mud deposits up inside the service tee (See Figure 11) as well as a pocket of water in the main at the same location. Staff estimates approximately 21 gallons of water was sitting inside the 8 inch plastic gas main on March 19. By 5:30 PM on March 12, 2014, however, the NYCDEP had shut off the water main, which had been operating at approximately 80 psi of water pressure prior to excavating the sinkhole and 8 hours after the explosion. The fusion joint failure was an opening on the north side of the fused joint, directly facing the break in the water main. Therefore, the mud found so far up inside the service tee and the large volume of water found

Figure 11 - Mud in the service tee to 1642 Park Avenue. Photo taken during the camera inspection of the 8 inch plastic gas main on 3/19/14.

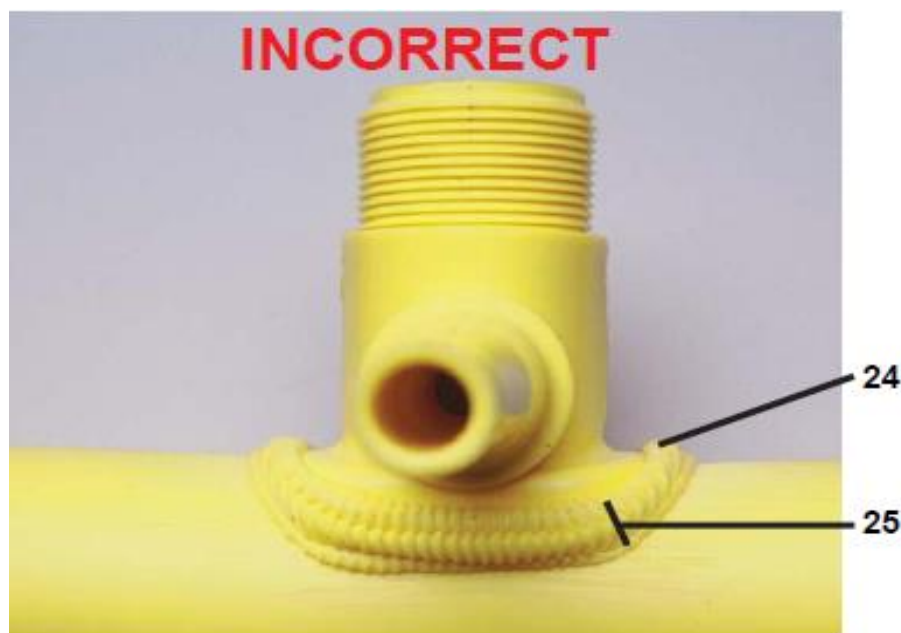
DPS Staff visually inspected and reviewed the digital photographs of the failed joint of the gas service tee to 1642 Park Avenue, which revealed that the fusion of the 2-inch plastic service tee attached to the 8-inch plastic main presents non-uniform fusion beads around the entire joint. The beads appear to overlap and the top bead (the tee fusion bead) is significantly larger than the other two; the middle bead is barely visible (all beads should be uniform). CECONY Procedure G-8123-12 states that the manufacturer's acceptable fusions are shown in "Generic Saddle Fusion Joining Procedure for Polyethylene Gas Piping TR-41/2002" provided by Plastic Pipe Institute. The beading of the failed plastic fusion joint is consistent with an unacceptable fusion joint, one that was produced with excessive melt and/or force (See Figure 13).

24. Bead above base of fitting
25. Excessive melt and force

Figure 13 – Incorrect fusion per Plastics Pipe Institute – TR-41/2002.

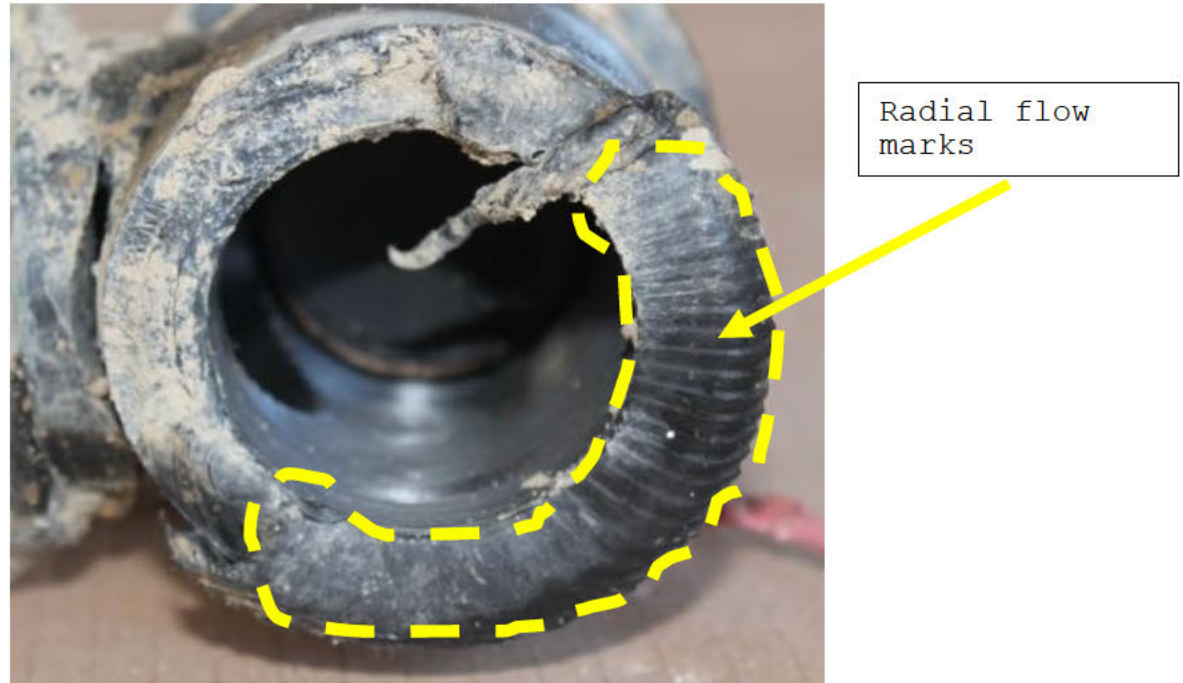
In addition to the unacceptable beading, the surface of the East Harlem failed fusion has radial flow marks on approximately one half of its circumference while the other half reveals a torn plastic surface (see Figure 14 below).

Figure 14 - Failure of the service tee for 1642 Park Avenue at the fuse.

During the NTSB Laboratory analysis, the manufacturer of the plastic service tee made a saddle fusion joint specimen (like the service tee to 1642 Park Avenue) with a plastic pipe and a service tee that had been intentionally sprayed with an organic soy bean oil mold release agent. It was sprayed on the surface of the fusion between the 2-inch service tee and the 8-inch main in order to simulate introduction of a foreign contaminant in the fusion process.²³

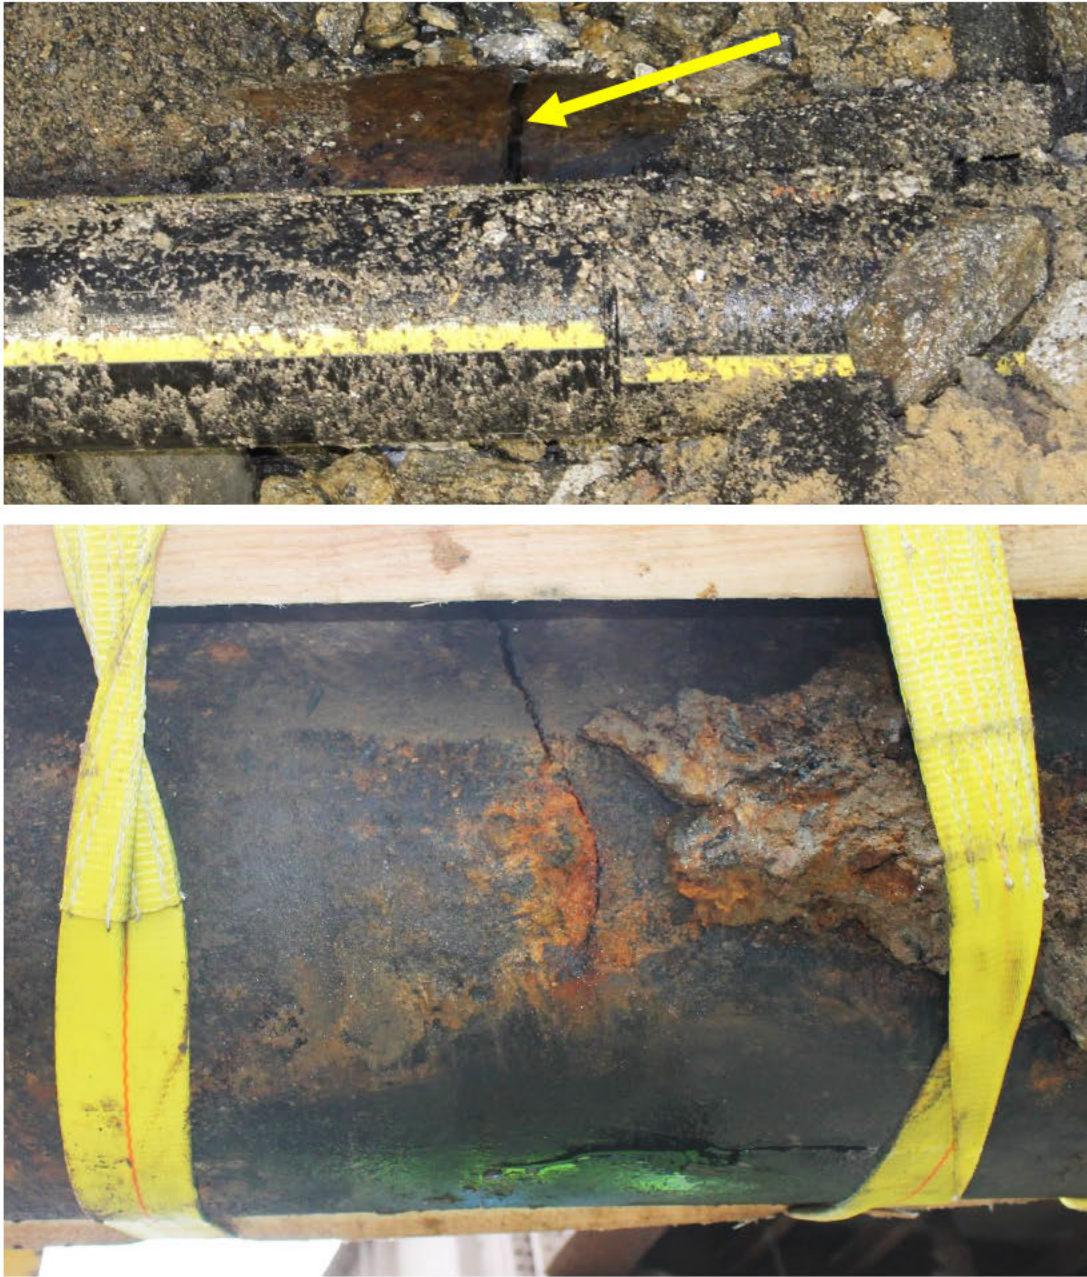
At this time, a circumferential crack on the 12-inch cast iron water main was exposed within the excavated area. This water main runs parallel to the natural gas main serving the buildings along

Figure 15 – A crack on the 12-inch water main running parallel to the 8-inch plastic gas main.

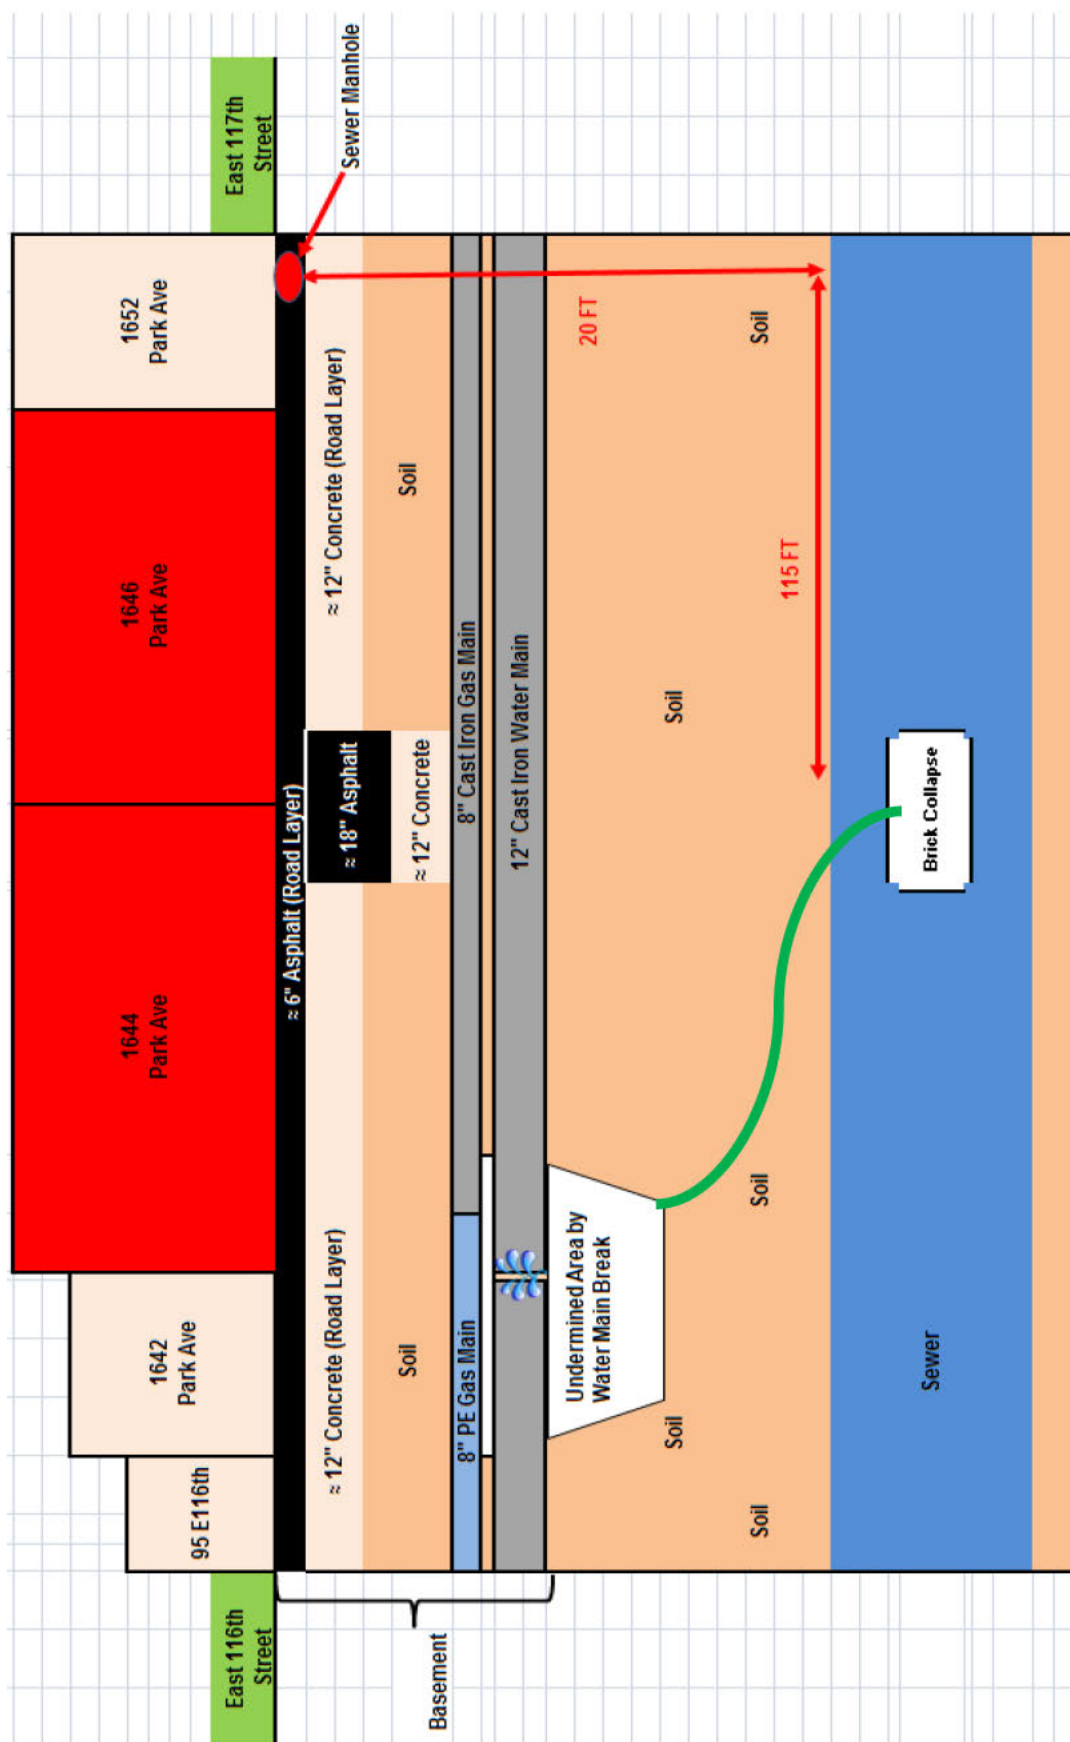
The area of extra thick asphalt investigators had found above the gas service to 1646 Park Avenue is located directly above the brick collapse in the sewer (See Figure 16). Excavation of the gas service tee serving 1642 Park Avenue revealed the gas main, the water main break, and multiple voids in the soil. To verify the depth of the sinkhole, investigators inserted a 5 foot crowbar into the sinkhole, confirming its depth was deeper than 5 feet. On March 28, 2014, once investigators removed the cracked section of water main in front of 1642 Park Avenue, investigators, at NTSB's request, tested the continuity of the sink holes. To do so, NYCDEP poured green colored dye mixed with water into the hole directly below the location of the water main crack (See Figures 17 and 18). Within minutes investigators saw the green dye entering the sewer through the brick collapse area (see Figures 19 and 20). The

Figure 16: Elevation view of the road layers and utilities along Park Avenue between E 116th & E 117th Streets (not to scale).

Based on DPS Staff's visual inspection of the road layer directly above the sewer brick collapse, the thickness of asphalt was 24 inches in comparison to an average of 6 inches on the rest of the block. This location is directly above the road sinkhole at which multiple repairs had been made over an extended period of time. Since as far back as 2006, the soil directly above the collapsed sewer had been gradually escaping as water flowed from either natural groundwater movement, the water main leak or a combination of both. A filled sewer above the height of collapsed brick wall would also contribute to additional washout of adjacent soil.

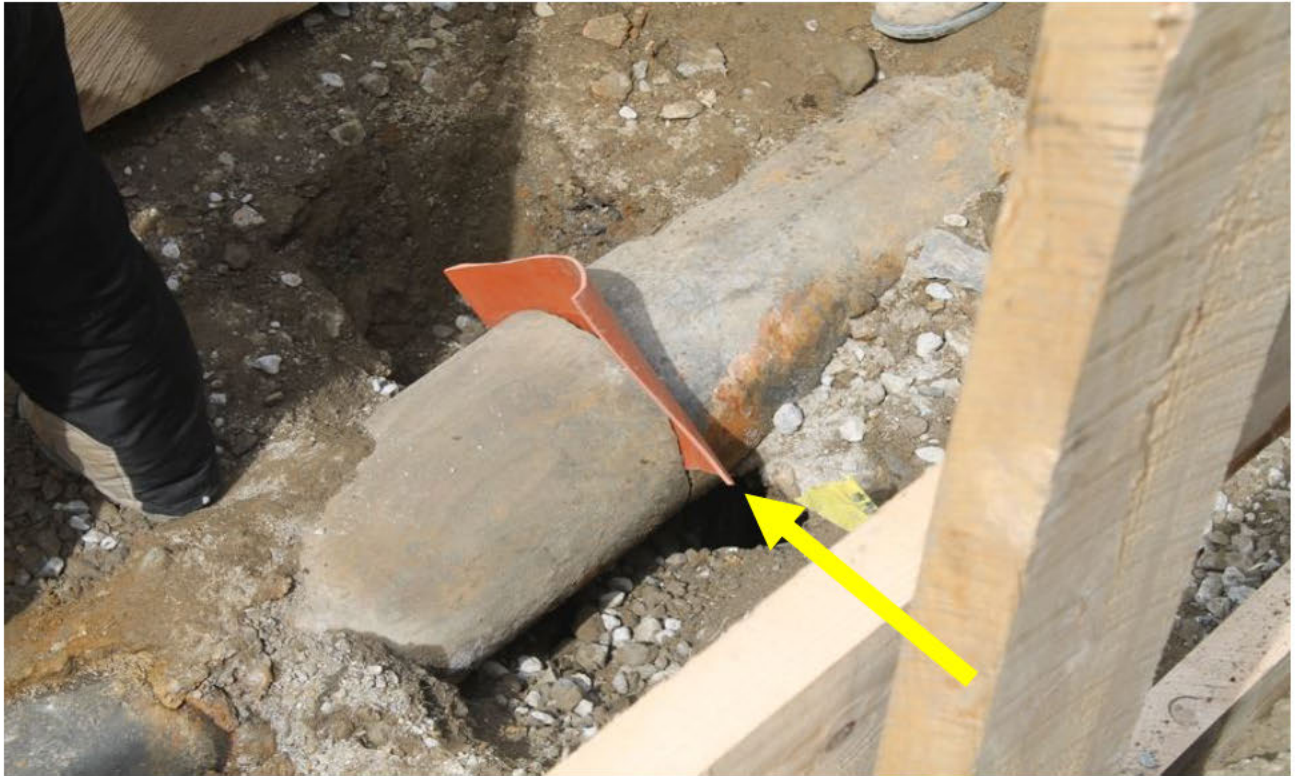
Figure 17 - Prior to removing the section of water main with a crack.

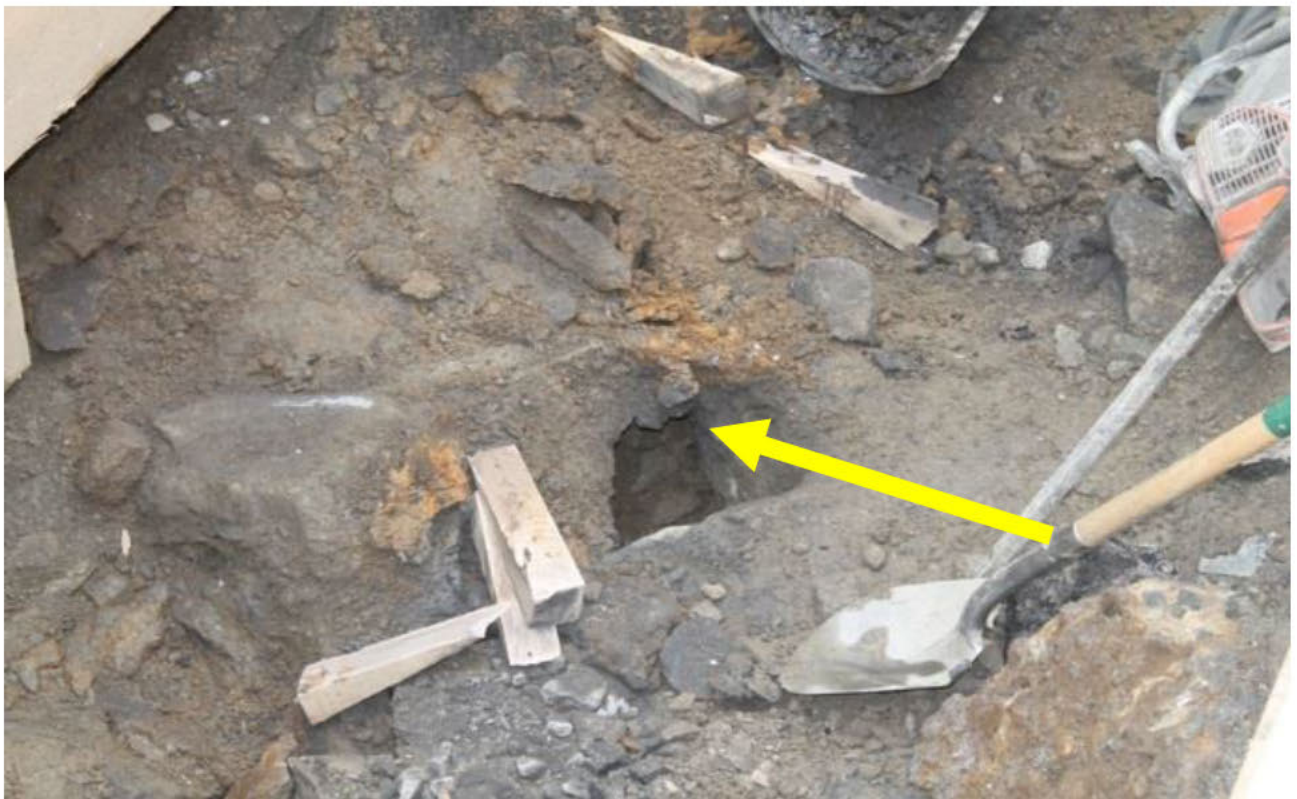
Figure 18 - Sinkhole directly below the water main crack after removal, used for green dye tracing.

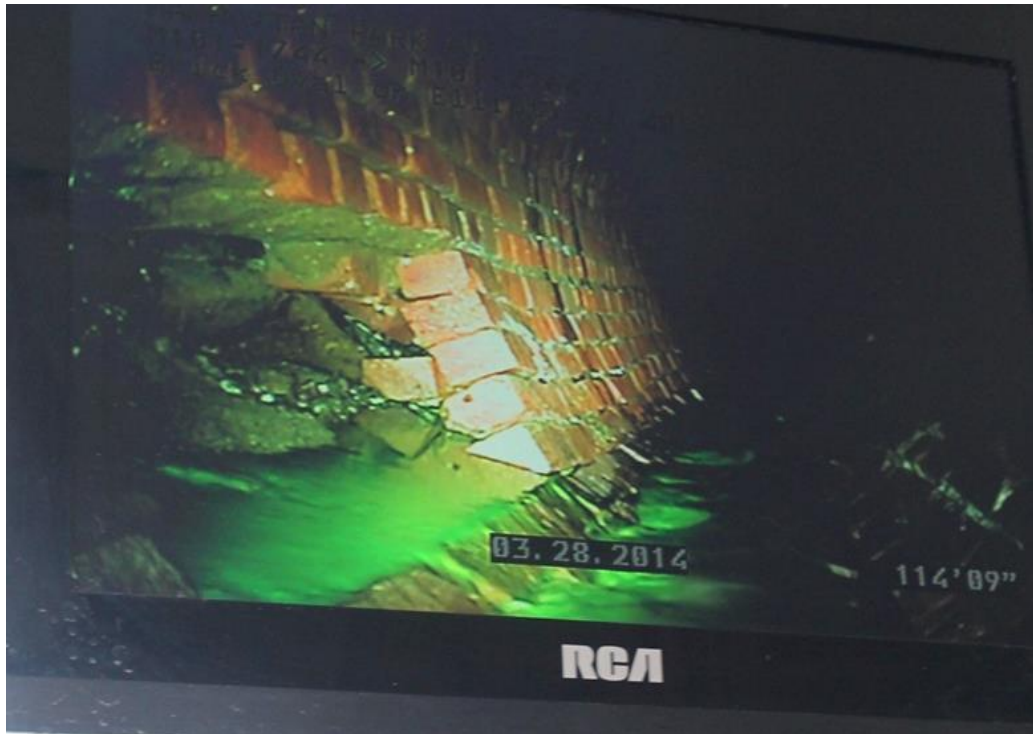
water main break was located approximately 45 feet horizontally south of the brick sewer collapse. The green dye test confirmed a continuous void condition in the soil between the water main break and the sewer collapse.

Figure 19 - Tracer Green dye observed in the sewer after pouring it through sinkhole approx., 45 feet south of the brick collapse.

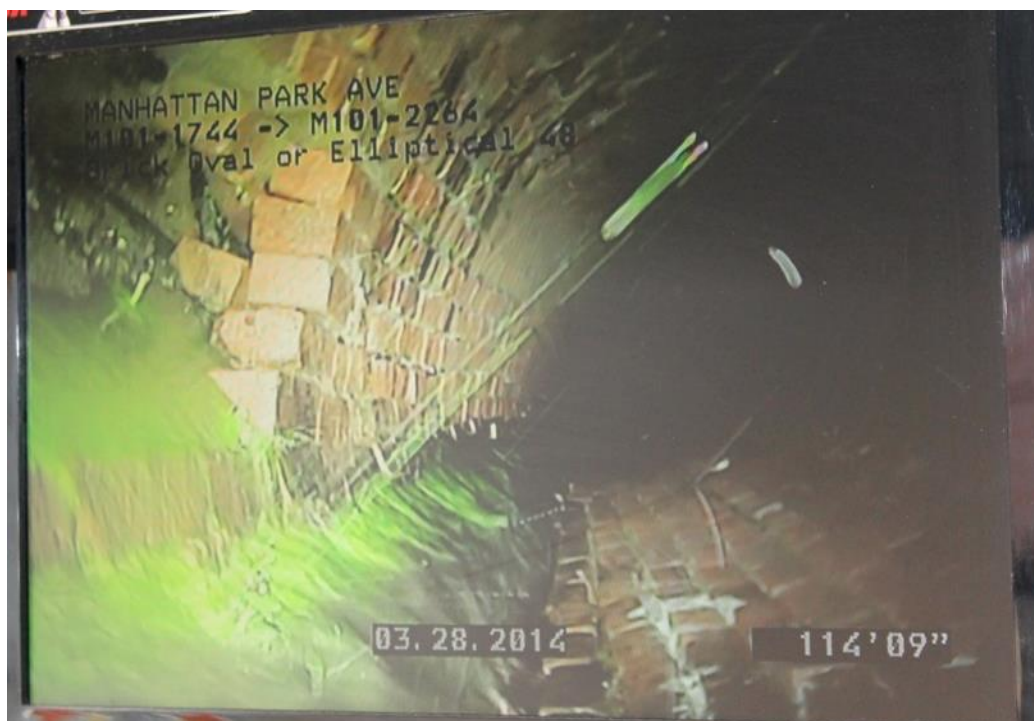
Figure 20 - Tracer Green dye observed in the sewer after pouring it through sinkhole approx., 45 feet south of the brick collapse.

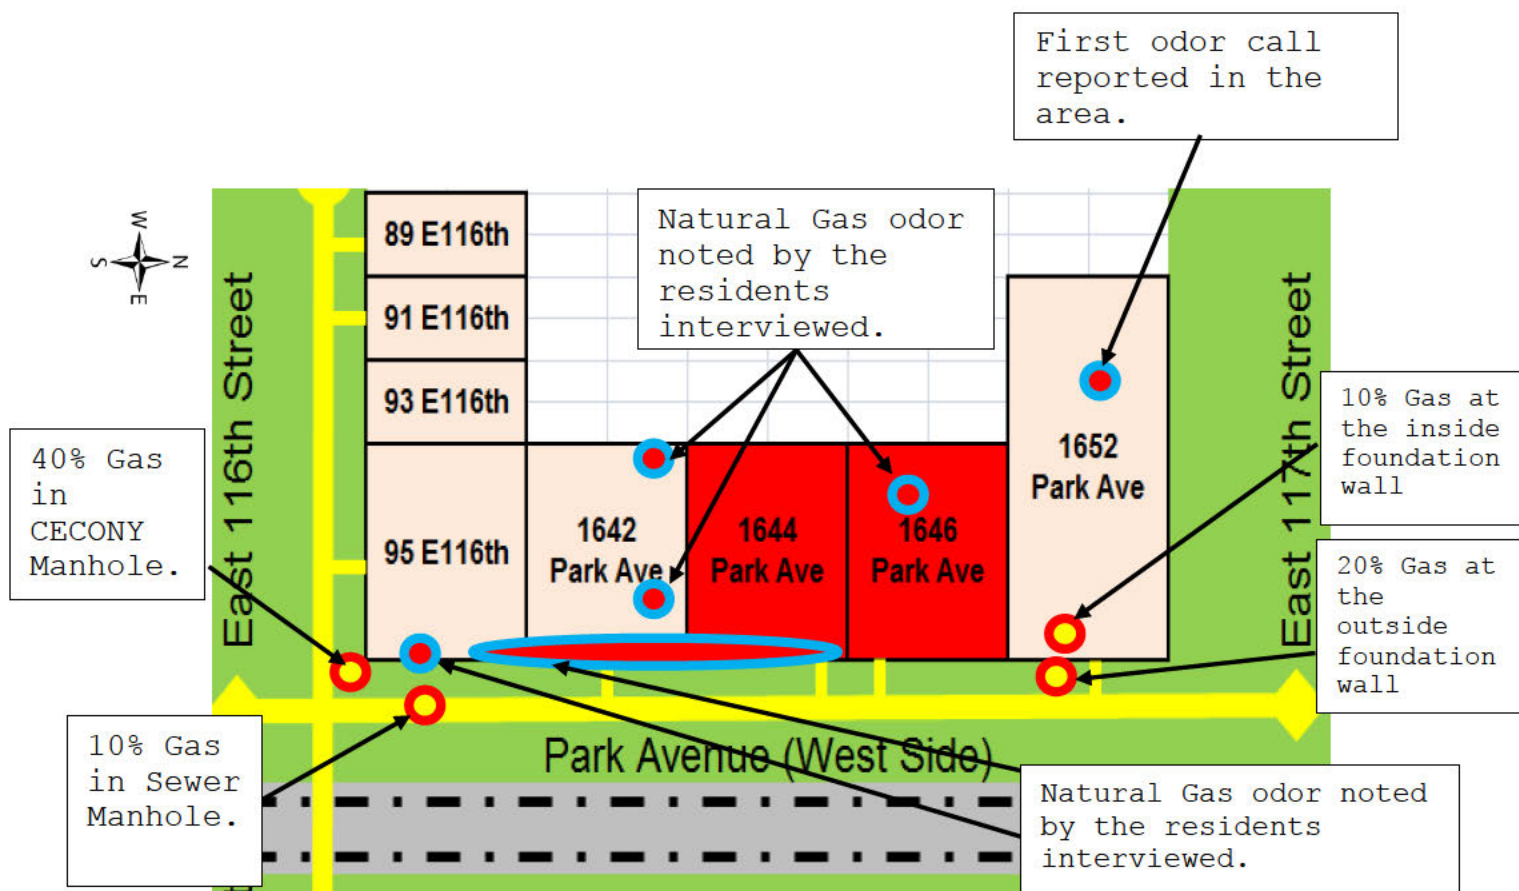
Information from the interviews conducted indicates that natural gas odors were mainly noted outside at the sidewalk from 1644 Park Avenue towards the NW corner of East 116th Street and Park Avenue. In addition, natural gas odor was very prominent in the hallway and basement of 1642 Park Avenue the night before the explosion and became stronger during the morning of the explosion (March 12, 2014). A resident of 1646 Park Avenue smelled gas inside of his apartment at approximately 4:00-5:00 PM on March 11, 2014, but did not notify CECONY because the odor dissipated after he vented it through an open window.

Figure 21 – Diagram with points of natural gas odor noted by the residents based on the interview conducted by NYSDPS (not to scale).
