**CONTACT VOLTAGE TEST &  
FACILITY INSPECTION  
ANNUAL REPORT**

**CONSOLIDATED EDISON COMPANY OF NEW YORK, INC.**

Report on the results of contact voltage tests & facility inspections for the period beginning  
January 1, 2016 and ending on December 31, 2016.

February 15, 2017

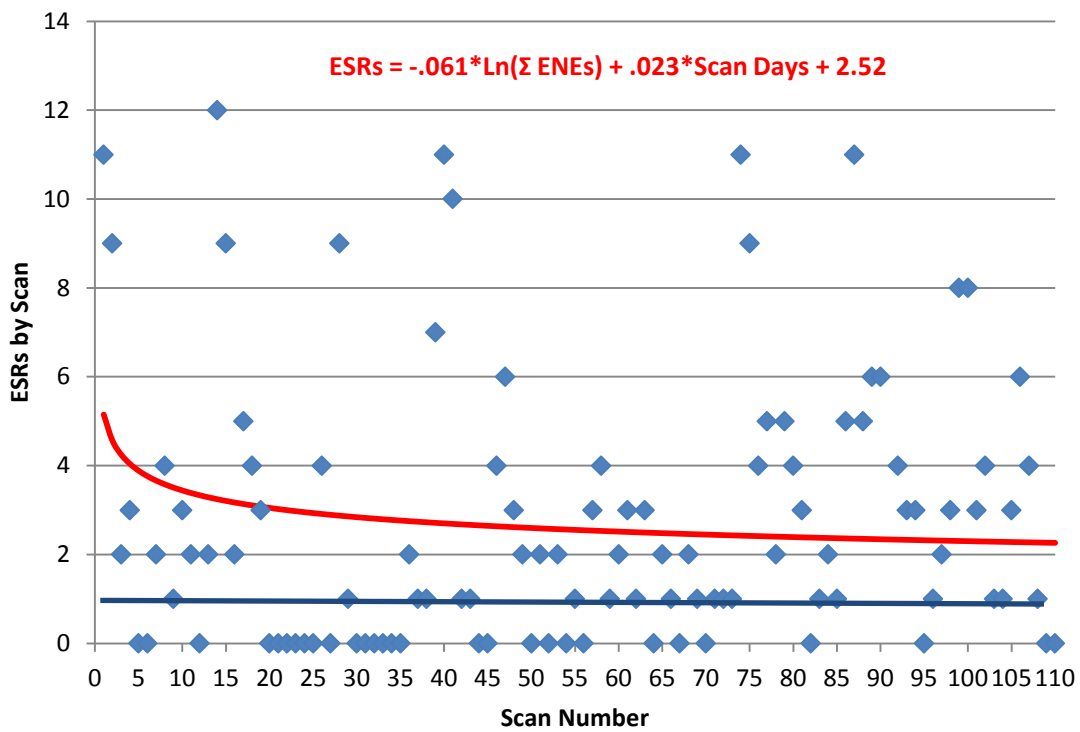
**Chart 1**  
**Con Edison ESR by Scan vs. Cumulative ENEs and Scan Duration**

The ESRs associated with Con Edison’s equipment appear in Chart 1. As mentioned above, weather also plays a role in ESR generation. This weather variable is accounted for in the underlying models and in both the 2016 and long term predictions. The duration between scans ranges from approximately 30 to 35 days per scan. If Con Edison continues with a comparable ENE repair rate and scan interval in 2017 and experiences similar weather patterns, the Company can expect ESRs to be approximately 2 per scan. In 2016, there were 30 shocks associated with the Company’s equipment which is a 25% improvement from last year.

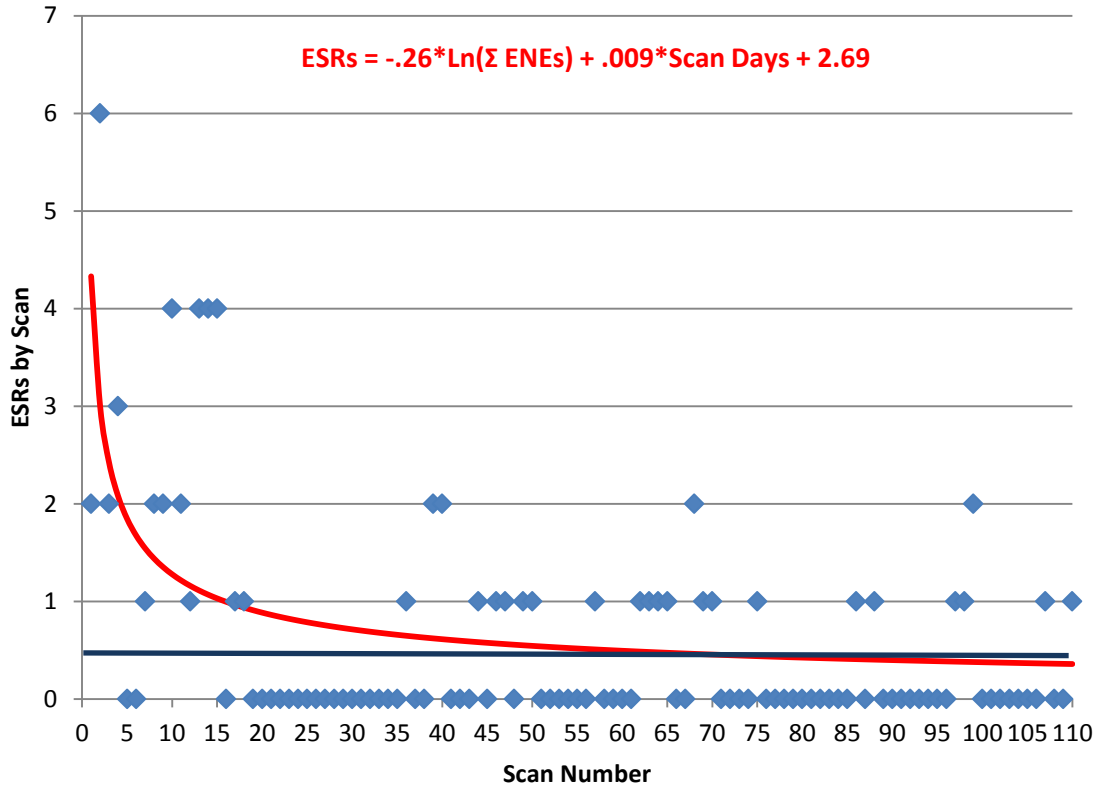
**Chart 2**  
**Other Utility/Government Agency Responsibility ESRs by Scan vs. Cumulative ENEs and Scan Duration**

The ESRs due to “Other Utility/Government Agency Responsibility” equipment appear on Chart 2. The duration of scans is 30 to 35 days per scan. If the Company continues a comparable ENE repair rate and scan duration in 2017, the Company can expect ESRs at this scan duration level to remain at approximately 1 per scan. In 2016, there were 6 shocks associated with “Other Utility/Government Agency Responsibility” equipment which is a 62% improvement from last year.

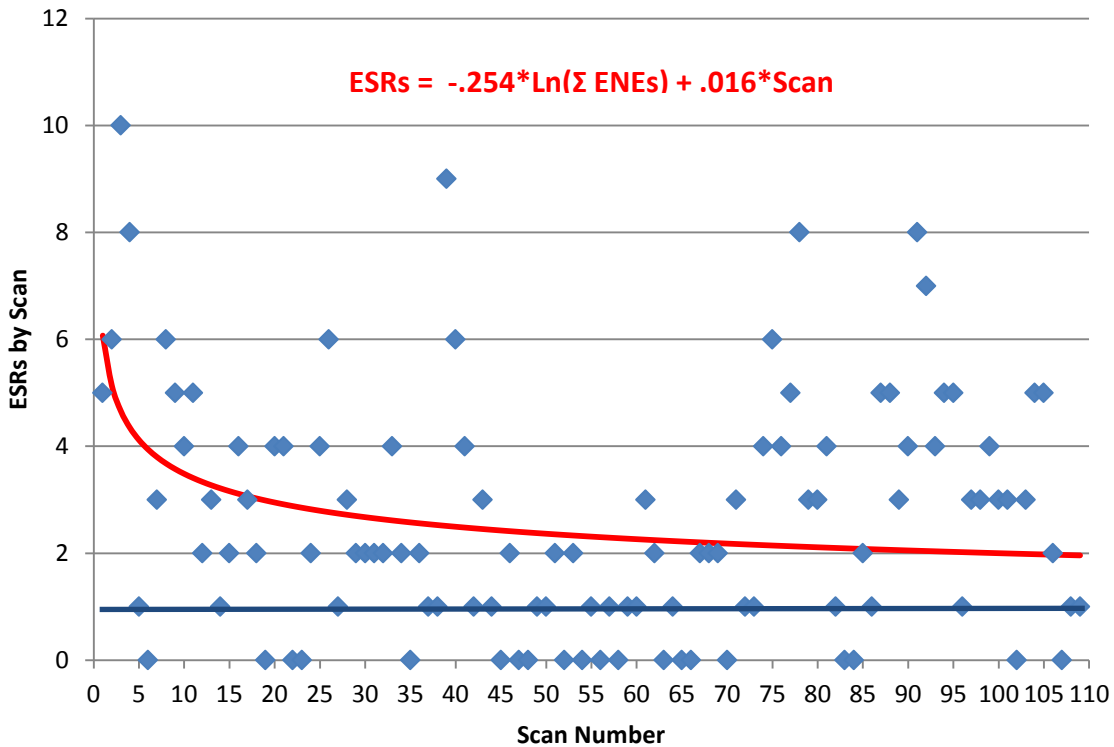
**Chart 3**  
**Customer (Public Access) ESRs by Scan vs. Cumulative ENEs and Scan Duration**

The ESRs associated with Customer’s equipment appear on Chart 3. The duration of scans is 30 to 35 days per scan. If the Company continues a comparable ENE repair rate and scan duration in 2017, the Company can expect ESRs to remain at 2 per scan, with no significant reduction anticipated below that level in the near future. The actual performance indicates that these shock events are less sensitive to our mitigation efforts. However, in 2016, the Company responded to 26 validated shock reports on publicly accessible customer equipment, which is a 26% reduction from last year.

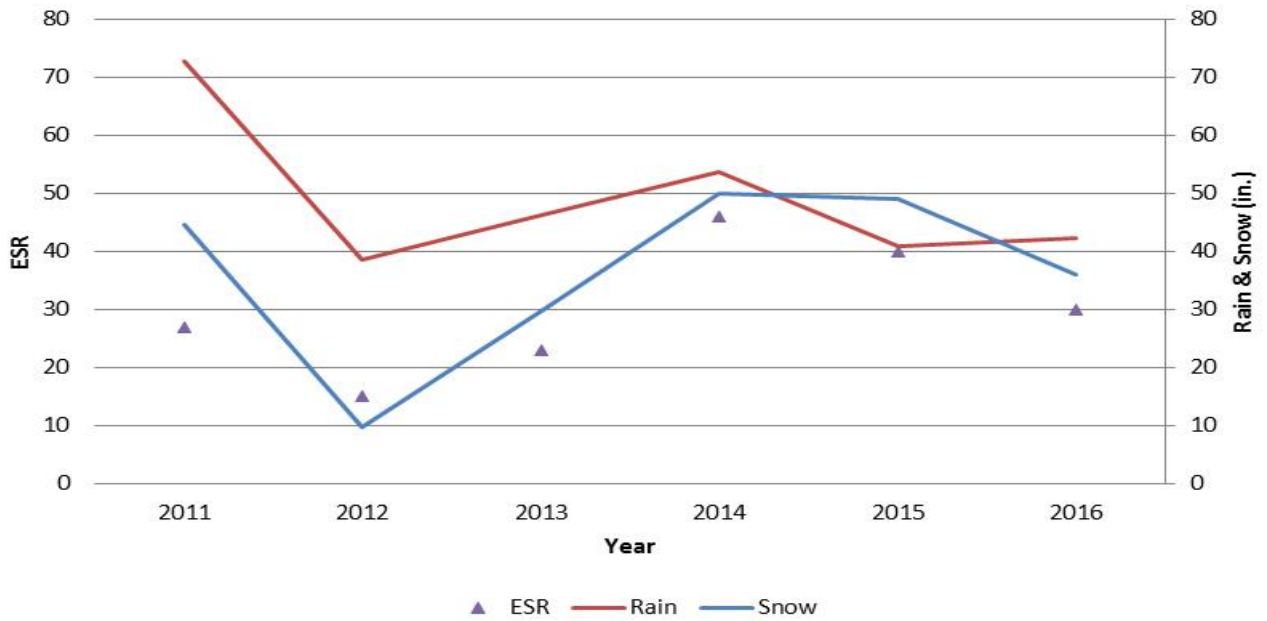
**Chart 4**  
**2010 – 2016 Rainfall, Snow vs. ESR**

Weather continues to have a direct impact on the electrical system. As has been discussed in prior annual reports, the Company continues to observe a strong correlation between weather and shocks (Chart 4). In 2016, the months of January and February accounted for 89% of the snowfall this winter season, second highest in the last five years. The snow precipitation for these two months was 85% higher than the historical average. Approximately 255,300 tons of salt were distributed in these two months, making this the fourth highest salt distribution period in the last five years.

While there have been three consecutive years of harsh winter conditions, the ESRs are showing a downward trend over the same period. Compared to last year, total ESRs improved by 32% (91 vs. 62) and “Utility Responsibility” ESRs decreased by 25% (40 vs. 30). Part of the reduction is attributed to the “Targeted Mobile” pilot program under which additional mobile scans were performed in areas that historically have had high activity of events. This program resulted in the discovery and repair of additional ENEs which could have potentially resulted in ESRs.

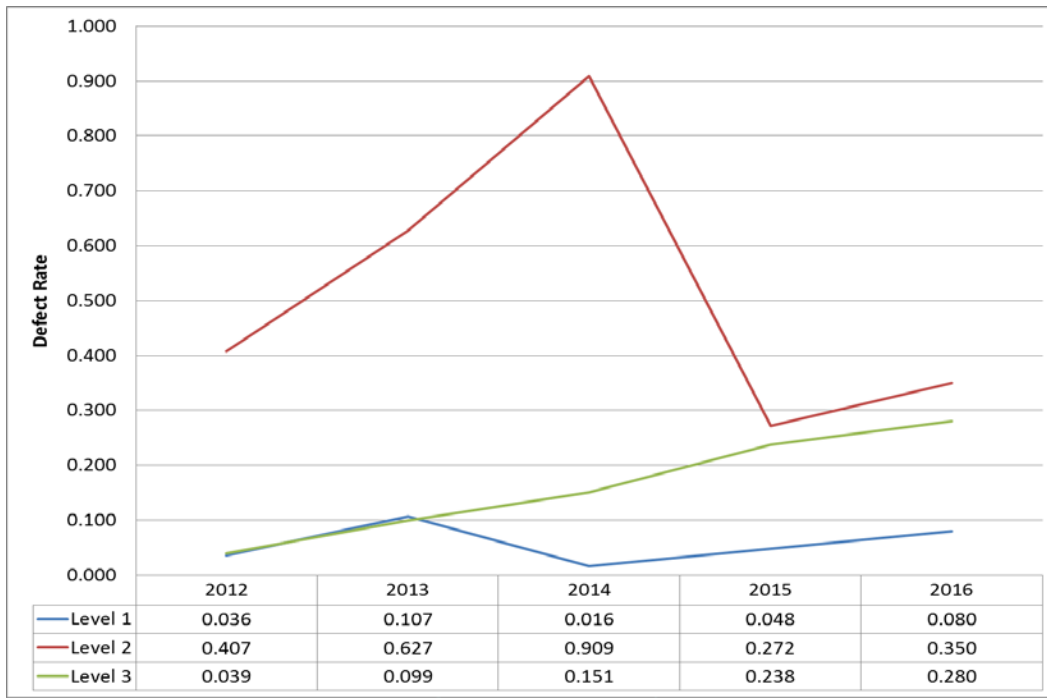
**Chart 5  
Defect Rate by Level**

Chart 5 shows the number of defects found per inspection by classification level. There has been a slight increase across all levels from 2015 to 2016. Part of the contribution to this increase is the introduction of a new category of defect in the OH inspection program like the ‘unprotected riser exposed conductor’ or the ‘grounds on the guy wire’ defect. There has also been an increase in ‘manhole cover damaged’ as well as ‘sump pump not grounded’ and ‘unpacked ducts’. More specifically, the drivers by category are provided in Chart 6.

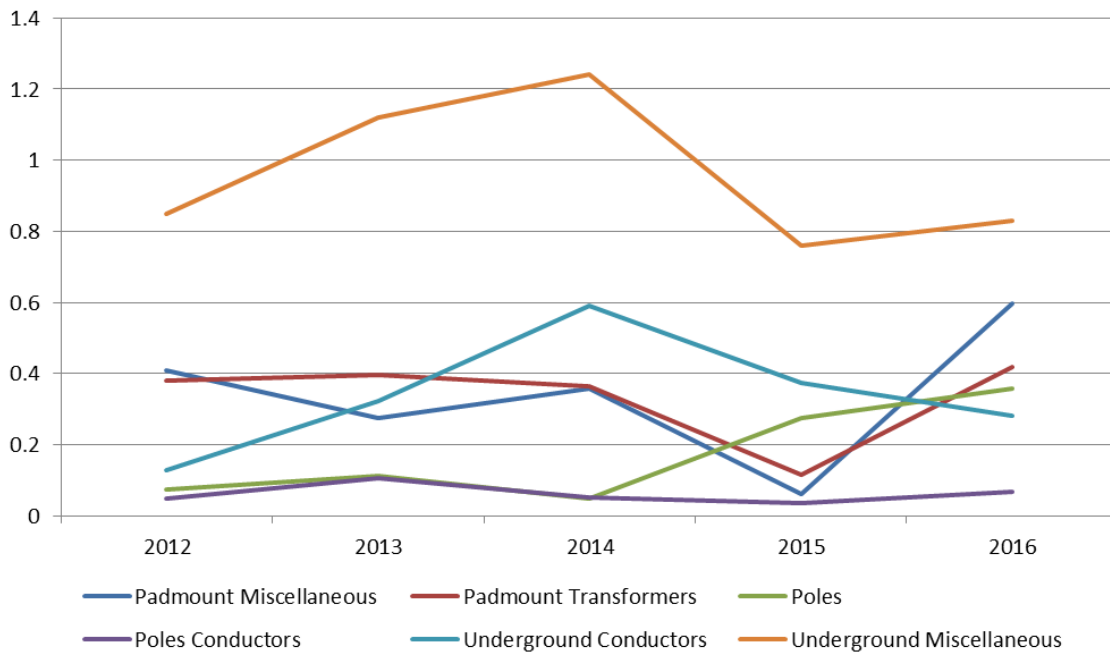
**Chart 6  
Defect Rate by Category**

Chart 6 shows the 2016 Defect Rate by Category. Historically, the distribution of “URD Padmount” annual inspections include both below-grade and above-grade equipment, with the below-grade inspections contributing to the majority of the defects. Last year, the focus was to complete all the above grade padmount equipment inspections, hence the generation rate of defects in 2015 was low. This year, the focus was on all below grade equipment, leading to a higher generation rate of defects.

Underground Miscellaneous defects showed a slight upward trend due to improperly sealed cable endcaps, unsealed ducts, cover damage, and cable or crab in contact with frame or cover.

The main driver of the increase in Overhead Pole defects is due to unprotected risers which is a new defect identified this year and a combination of defective cross arms and equipment.
