# Eight Point Wind Feasibility Assessment

Performed on December 1<sup>st</sup>, 2016 by:

## EIGHT POINT WIND FEASIBILITY ASSESSMENT

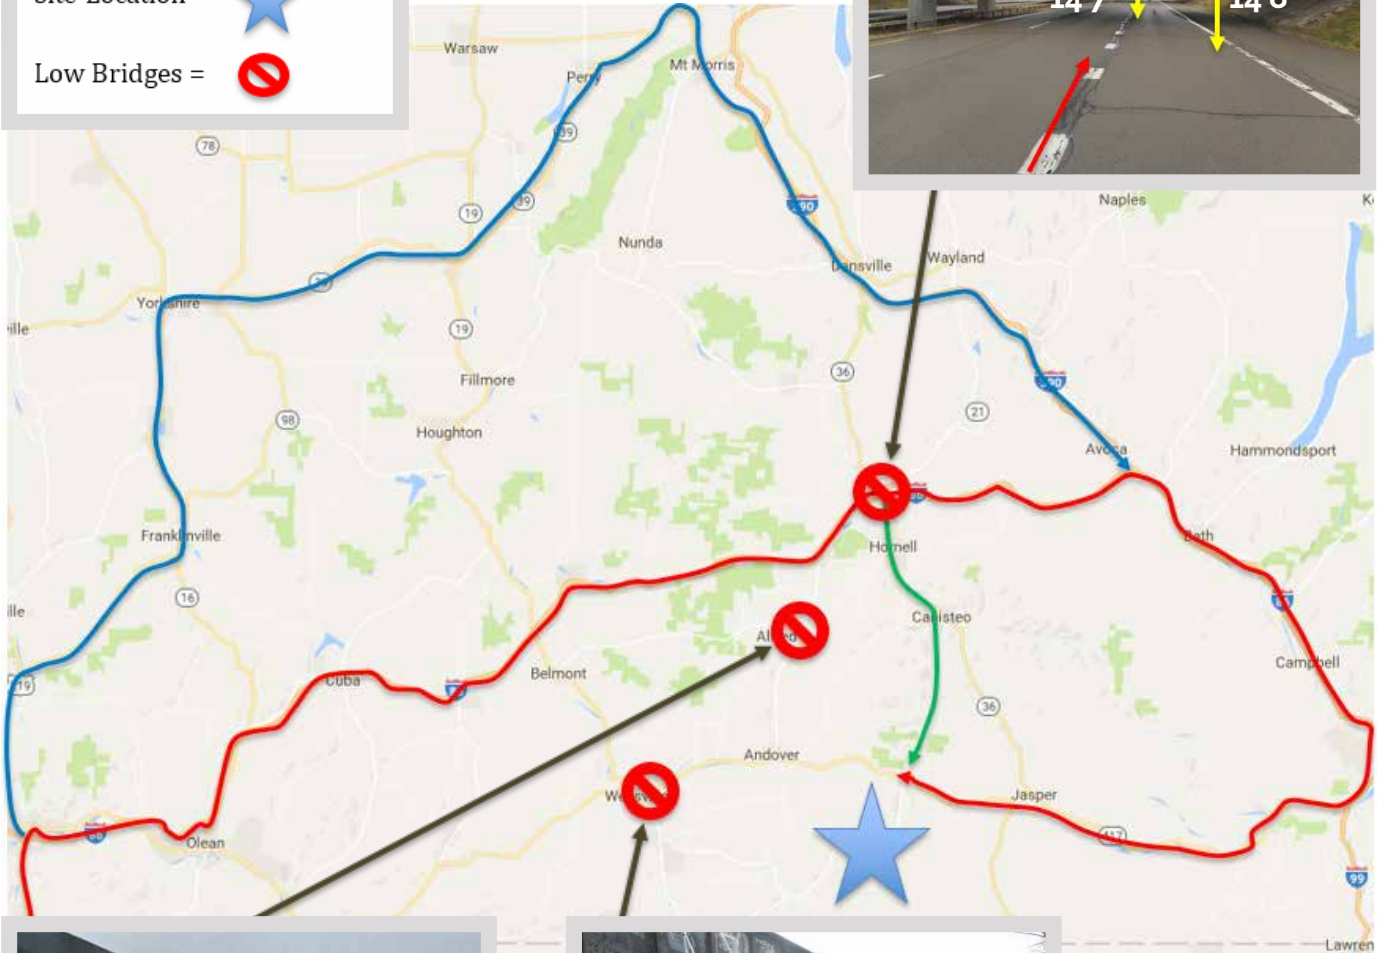
Hwy36 underpass under Int86 in Hornell

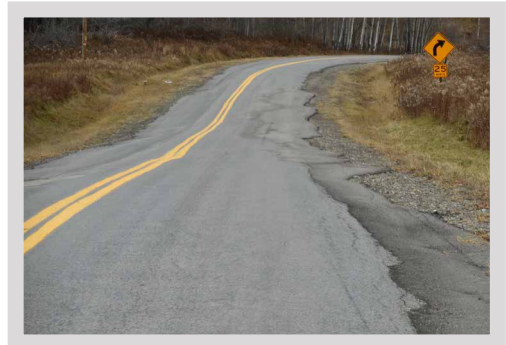
Material – Chip seal, very poor condition

Risk Level – grades up to 8%, poor road surface

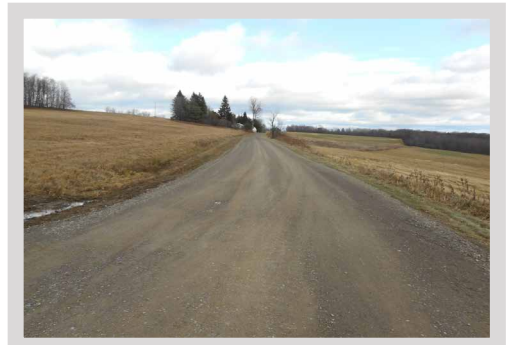
Material – Dirt/Gravel mix

Risk Level – Soft Road and Shoulders

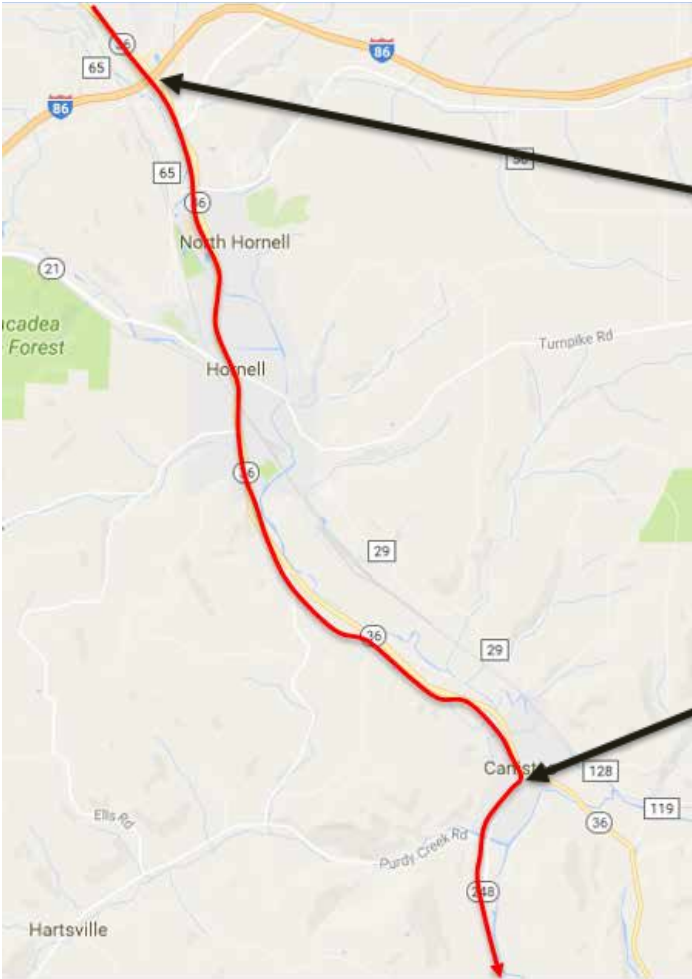
NY36 under Int86, measured 14'7 at the lowest

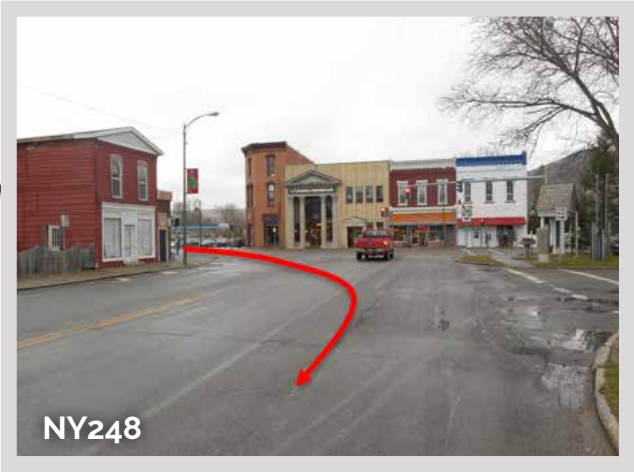
Intersection of NY36 and NY248 in Canisteo measured 135ft, however has limitation. 67.2m Blade CANNOT travel through here.

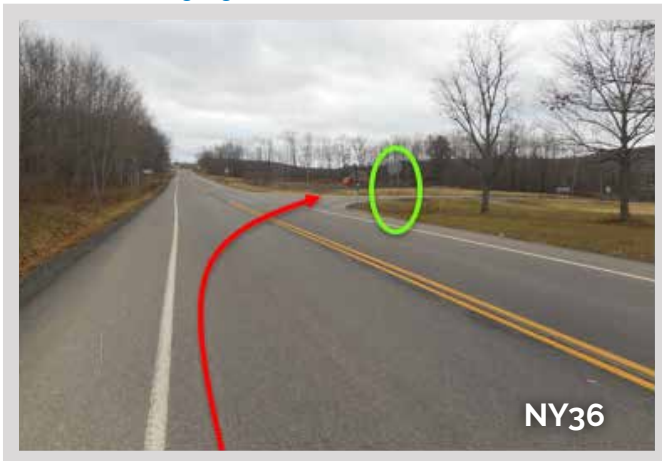
Intersection of NY36 and NY417 in Jasper, measured 130feet. Turn was slightly short and need signage removed in north corner.

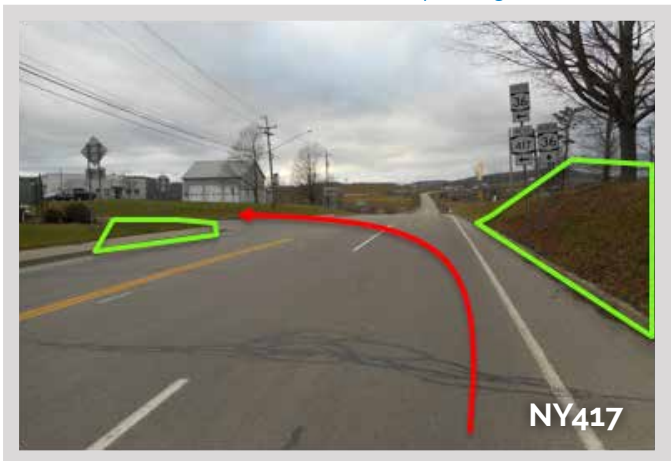
Intersection of NY417 and NY417 in Jasper, measured 115feet. Inside radius need to be widened and outside corner for Tip Swing

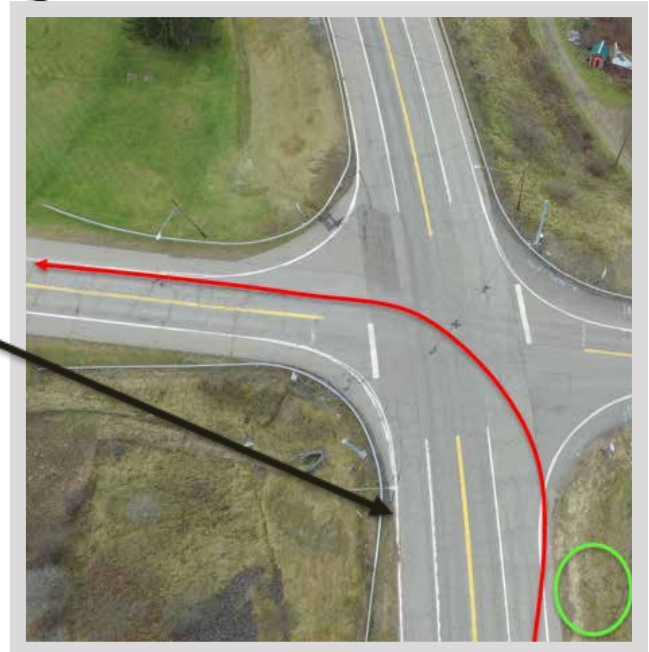
Intersection of NY417 and NY248, measured 135ft  
- signage will need to be removed

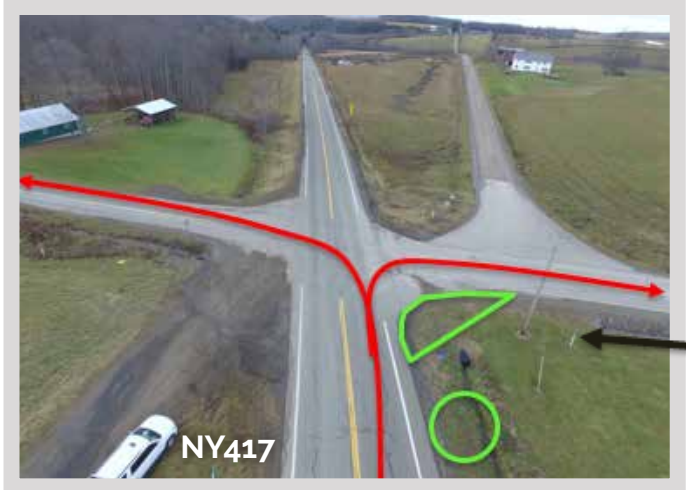
Intersection of NY417 and CR61, measured 135ft to the south and 115ft to the north. Northeast area needs to be modified along with removal of signage. Poor line of sight to the west on NY417 – traffic control needed

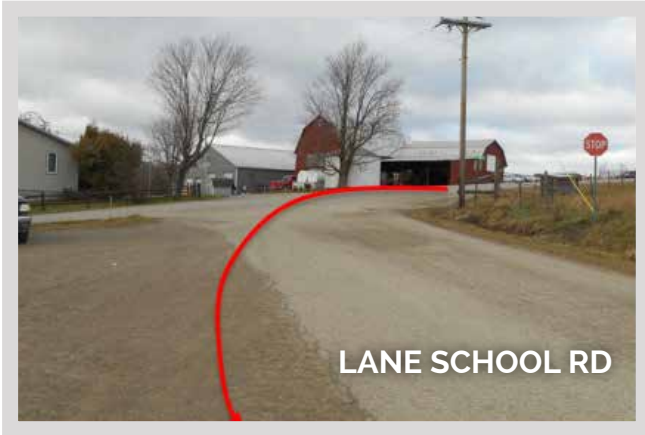
Intersection of CR61 and Lane School Road measured 125ft, use of private property is needed from owner.

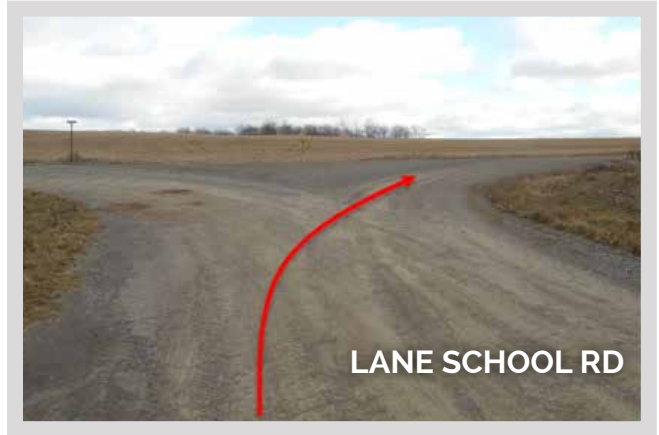
Intersection of Lane School Road and Simmons Road measured 120ft, southwest corner needs to be modified.

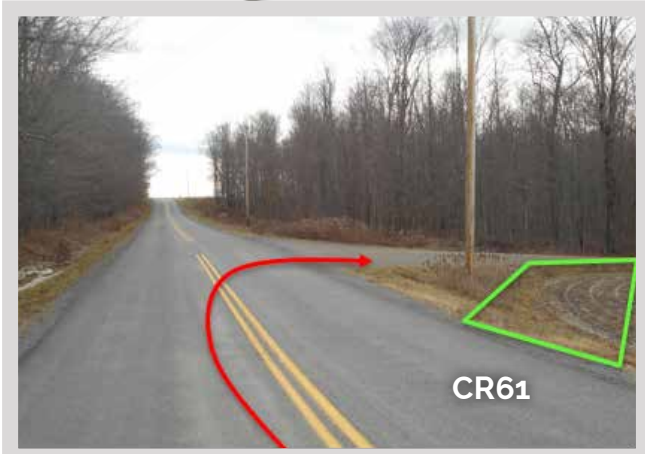
Intersection of CR61 and Pease Rd measured 100ft, Logisticus recommends a cut through to avoid the utility pole.

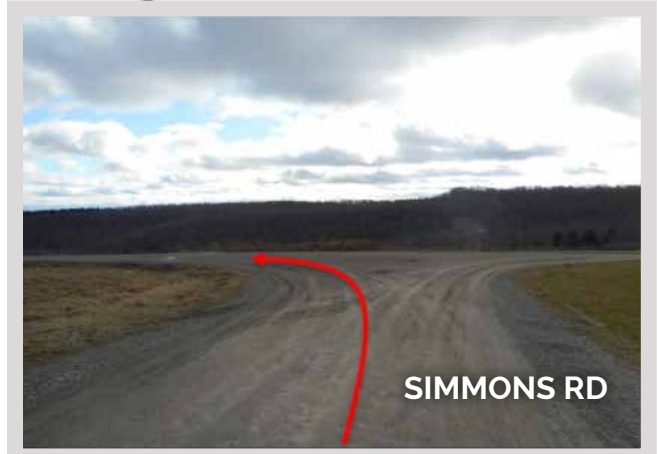
Intersection of Simmons Road and Dryden Hill Road measured 95ft, northeast corner needs to be modified.

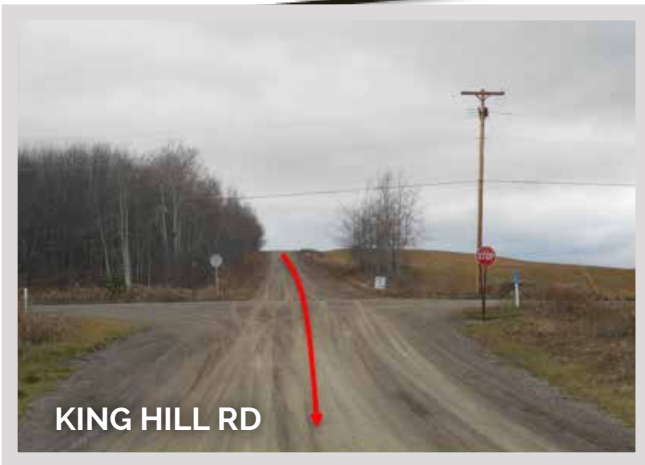
Intersection of King Hill Road and CR60, Logisticus recommends avoiding CR60 at all cost.

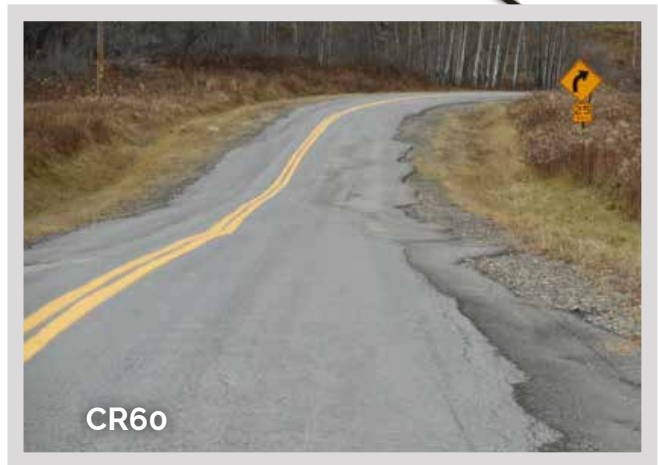
County Road 60, 7% uphill grade and major washout issues. Logisticus does NOT recommend to use this road

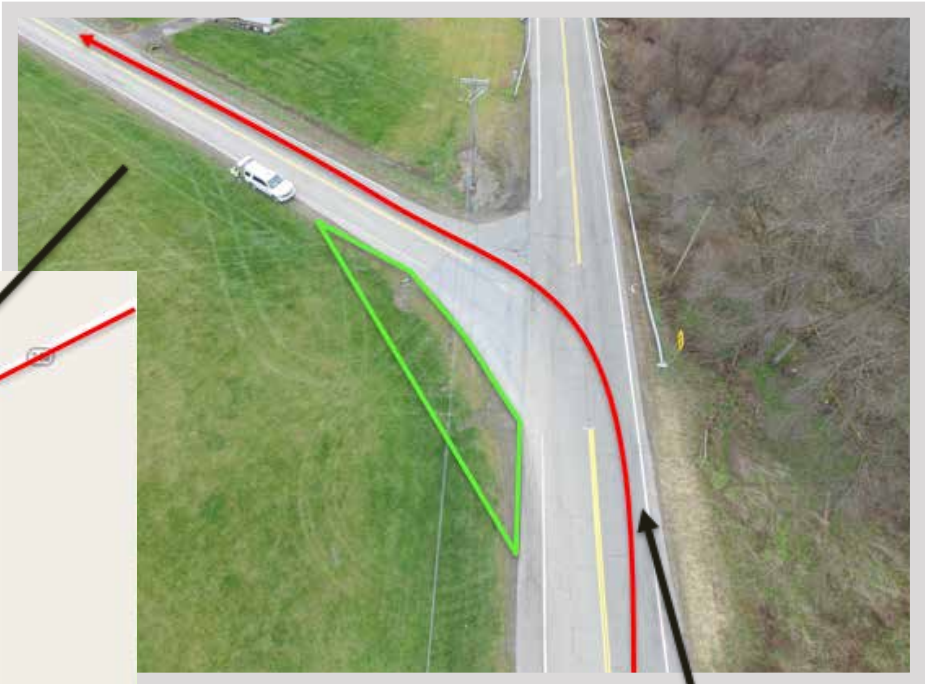
Intersection of NY248 and CR98, measured 120ft – southeast corner needs to be modified with signage removed

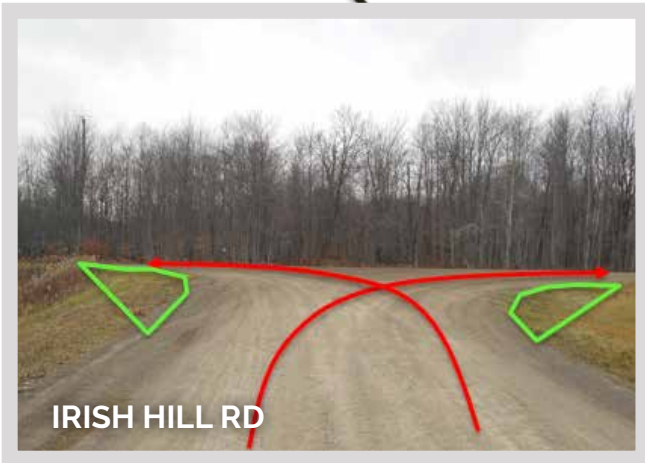
Intersection of Irish Hill Rd and Keenan Rd measured 110ft, both northeast and southeast areas need to be modified

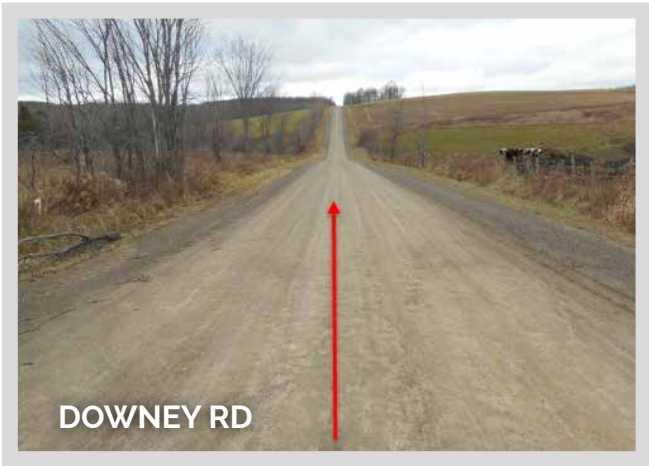
Downey Road, 7% grades

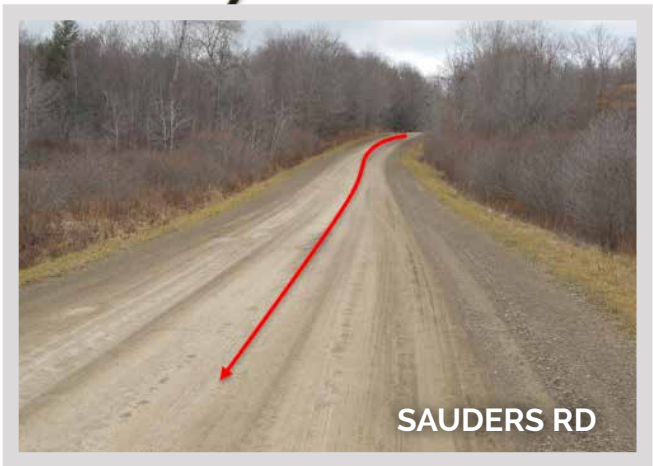
Sauders Road, windy road with some trees which  
will need to be trimmed.
