CONTACT VOLTAGE TEST and
FACILITY INSPECTION

ANNUAL REPORT

CONSOLIDATED EDISON COMPANY OF NEW YORK, INC.

Report on the results of contact voltage tests and facility inspections
for the period beginning January 1, 2010 and ending on December 31, 2010

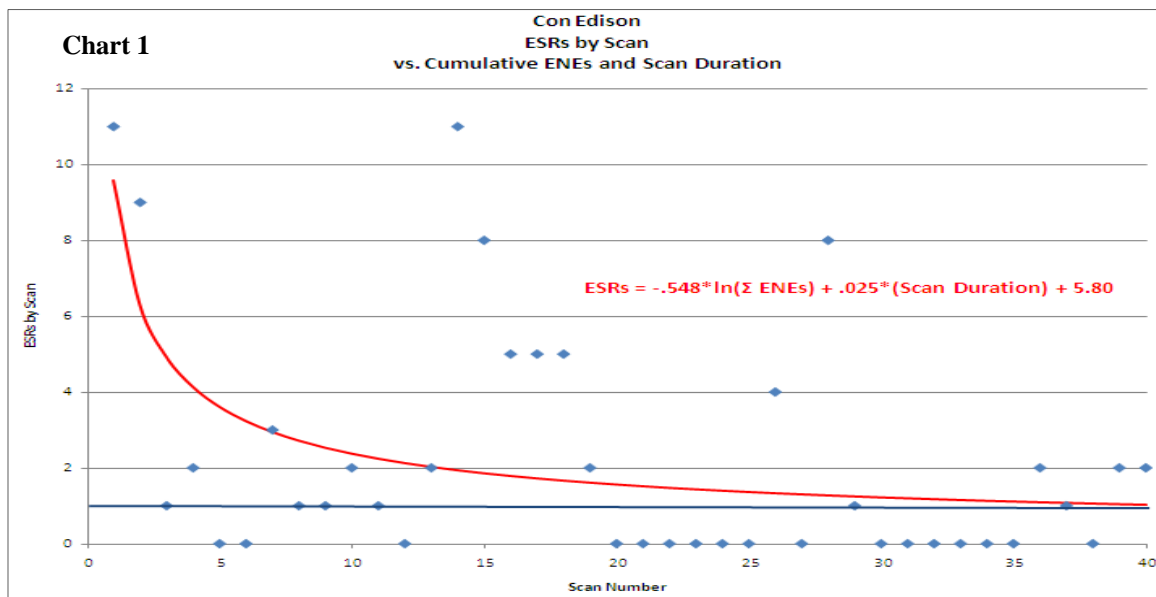
The reduction of ESRs associated with Con Edison's equipment appears on Chart 1. The duration of scans is 30-35 days per scan. If we continue a comparable ENE repair rate and scan duration in 2011, we can expect ESRs at this scan duration level to fall to approximately 1 per scan. This prediction is consistent with the 2010 actual results of 15 shocks due to Con Edison responsibility.

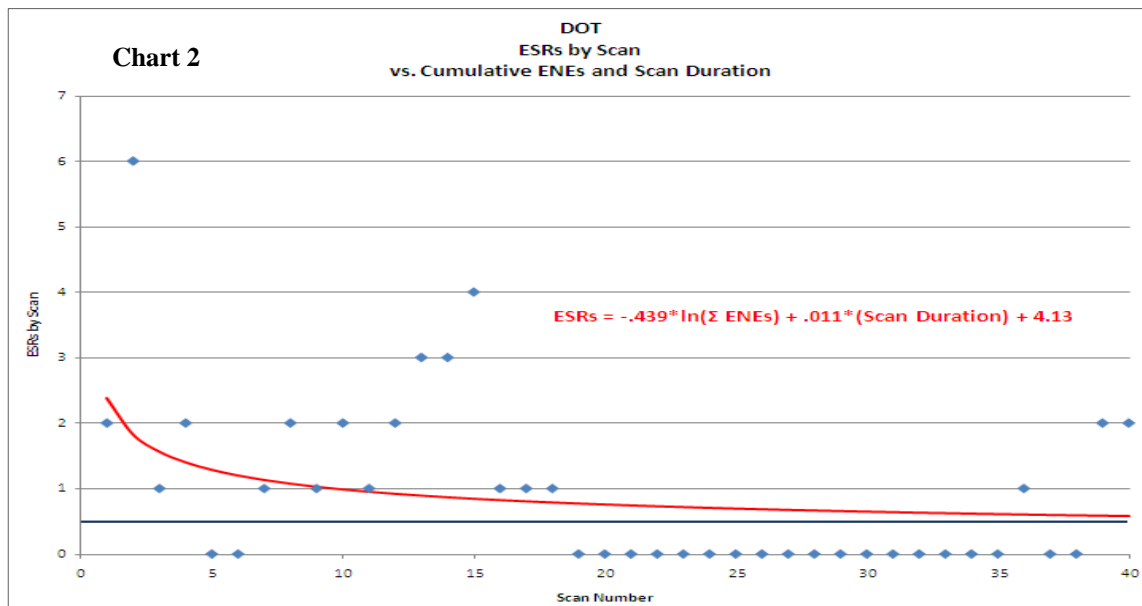
The reduction of ESRs associated with the DOT appears on Chart 2. The duration of scans is 30-35 days per scan. If we continue a comparable ENE repair rate and scan duration in 2011, we can expect ESRs at this scan duration level to be approximately 1 every two scans. This demonstrates marginal improvement over current scan durations. In 2010 there was 1 shock associated with DOT equipment failures. This result is better than predicted, and is likely the result of various programs implemented by both DOT and Con Edison to mitigate shocks.

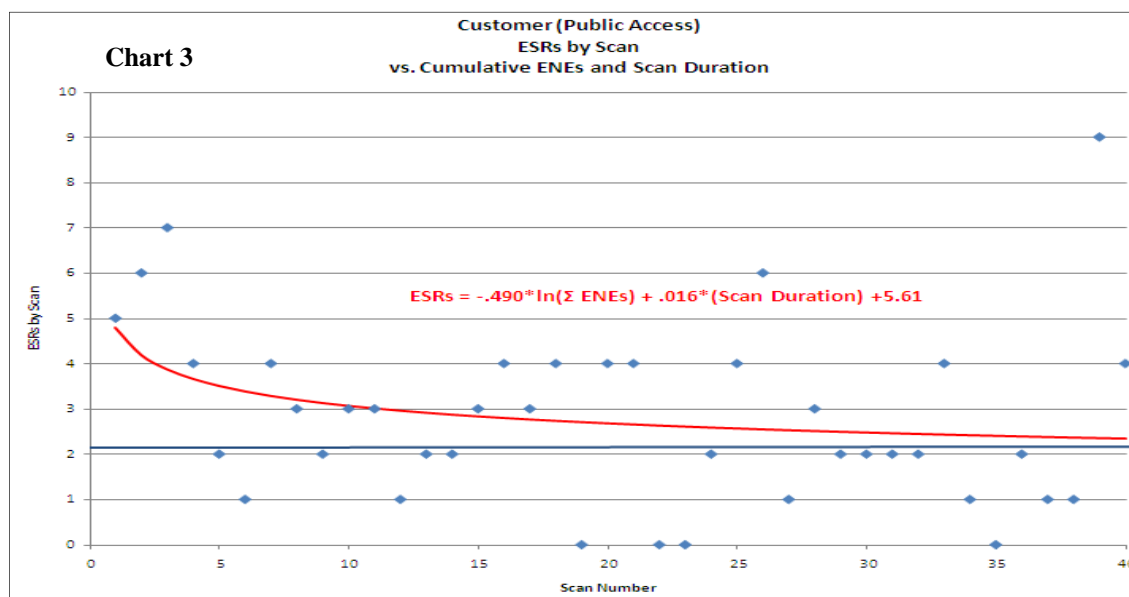
The reduction of ESRs associated with Customer Equipment (Public Access) appears on Chart 3. The duration of scans is 30-35 days per scan. If we continue

a comparable ENE repair rate and scan duration in 2011, we can expect ESRs to remain at 2 per scan with no significant reduction anticipated below that level in the near future. These ESRs appear essentially insensitive to changes in scan duration at this point in time. The actual performance indicates that these shock events are less sensitive to our mitigation efforts than we initially projected. In 2010, we responded to 43 validated shock reports on publicly accessible customer equipment, this is 32 % higher than predicted by the model.

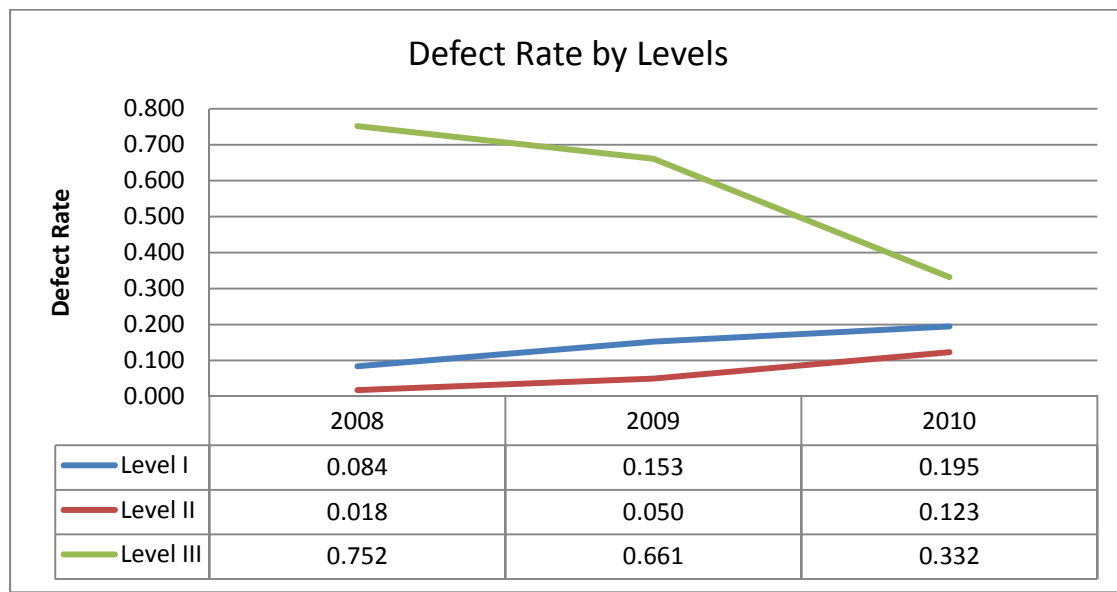
The chart below shows the number of defects found per inspection:

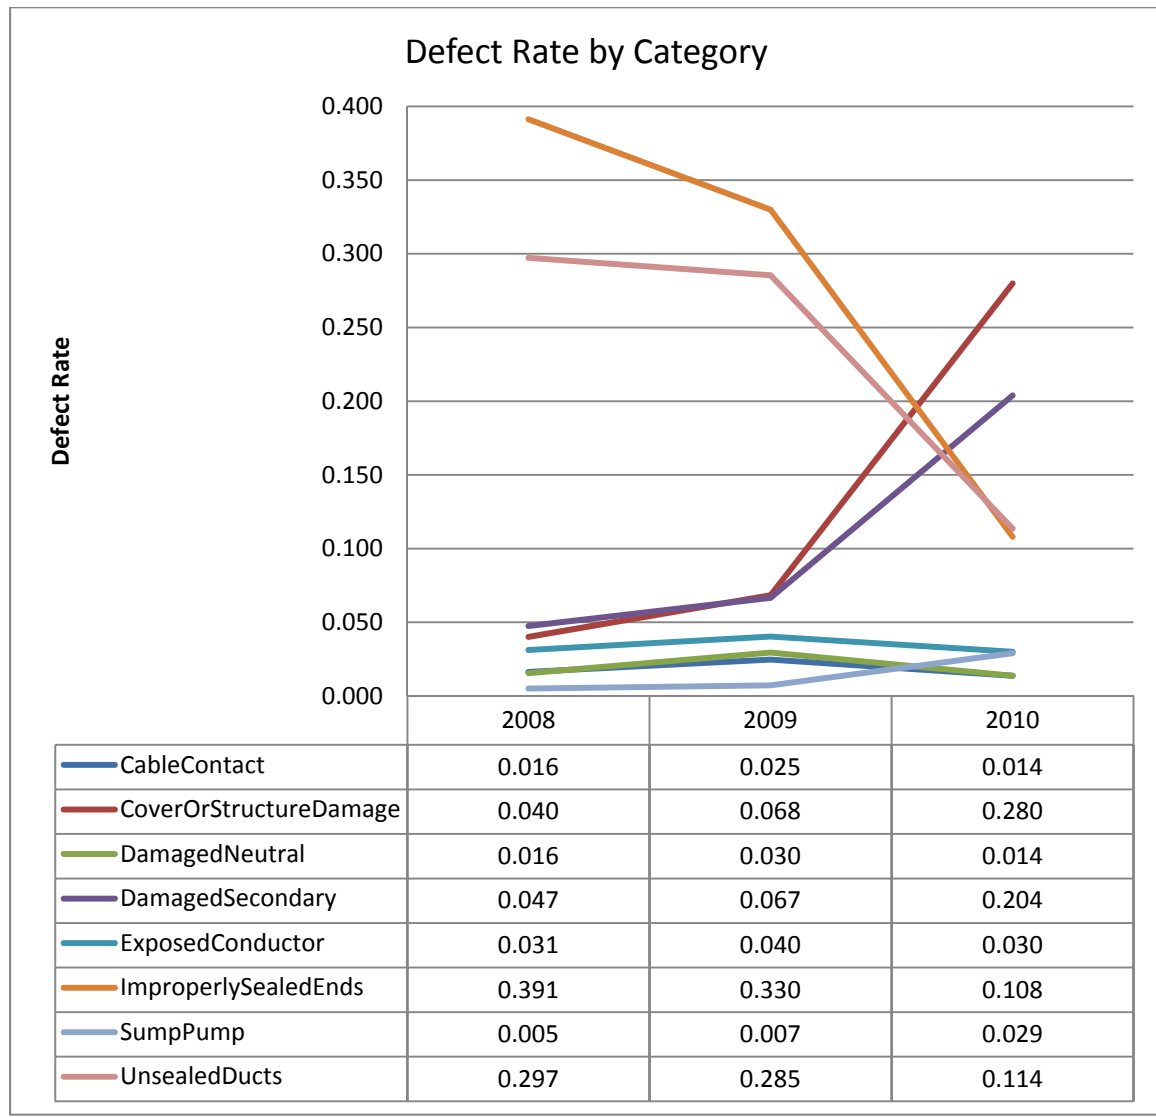
The defect found ratio can be broken down further, by type of repair:

For most categories, we see a minor decrease in defect rate from 2009 to 2010. Two categories that we see a major decrease in defect rate are unsealed ducts and improperly sealed ends. In 2009, we included the sealing of ducts and improperly sealed ends as a Level 1 repair. This resulted in a significant reduction of these types of defects being found in 2010 (as shown in the graph above). We also saw an upward spike in a few categories.

During the first 3 years of the prior cycle; cover damage and structure damage was captured in one category. A specification change was made in late 2009 that enabled the inspector to identify these repairs as two separate repairs. This led to a spike in rate detected during the 2010 program. This also holds true for damaged secondary cable; the rate increase seen in 2010 results from a change in our inspection report form in late 2009 which allows the inspector to report repairs needed to the secondary service, crabs, and removal of split bolt connectors.

In 2010, we also saw an increase in sump pump defects (sump pump not working) found. This can be attributed to vaults that currently have an older model sump pump installed. In 2008, the Company changed the specification when purchasing sump pumps to a model which has a more robust seal system which would extend the life of the pump when cycling. The majority of the failed units identified in the 2010 inspection program were sump pumps of the prior vintage. As we find and remove these older pumps, we are replacing them with the new model.

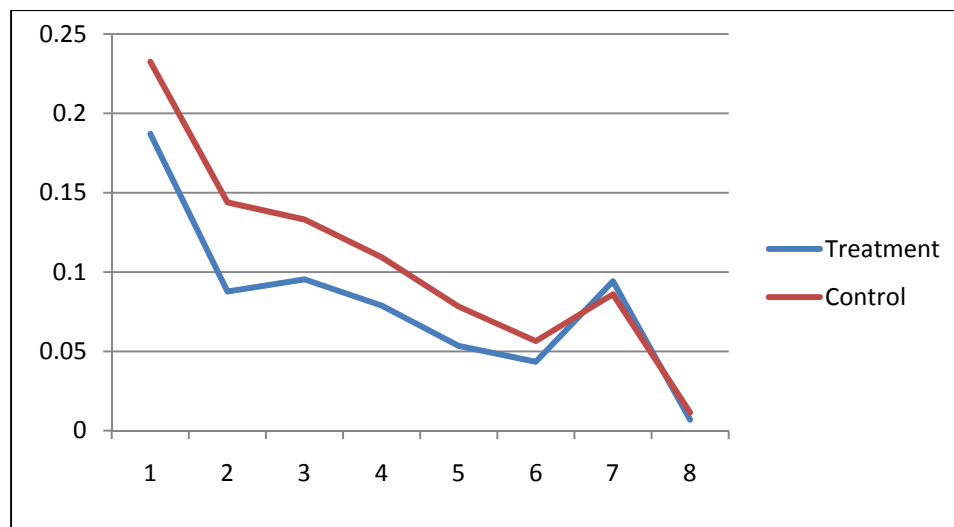
The conclusion of the study was that, as a result of the inspection program approximately 1,300 events across all 8 categories were avoided over a 5 year period. Of the 1,300 events approximately 200 were smoking manholes. The remaining 1,100 events were other secondary conditions such as flickering lights, energized objects, etc. The study did not detect a reduction in manhole fires and explosions as a result of the inspection program.

The benefit derived from the inspection of the 52,000 structures studied was a reduction in probability between the treatment group (blue) and the control group (red) of about 5% for categories 1, 2 and 3 with less of an impact on categories 4,5, and 6. Categories 7 and 8 showed no significant impact. This translates to a reduction of approximately 1300 secondary events from the inspection of 52,000 structures.
