STATE OF NEW YORK  
DEPARTMENT OF PUBLIC SERVICE

147-25 Sanford Avenue, Queens  
Natural Gas Explosion  
July 25, 2008  
Consolidated Edison Company of New York. Inc.

Safety Section  
Office of Electric, Gas & Water  
April 2009

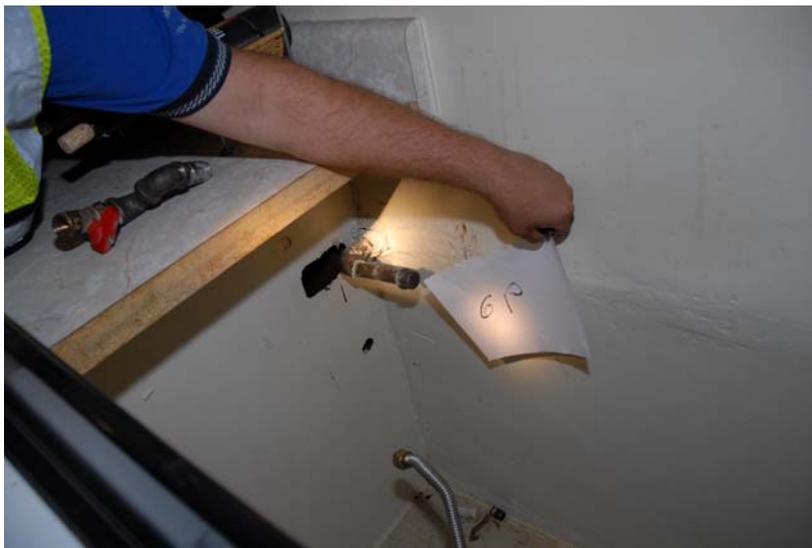
uncapped, with the understanding that the plumber or plumber's assistant would install the appliance valve when the Con Edison mechanics left the unit. Photographs taken immediately following the incident indicates that the open end of the riser in apartment 6P had been restored to its pre-integrity test condition, i.e. nipple and cap (See Photo 2). During a subsequent interview, the plumber's assistant attested to replacing the nipple and cap.

Photo 2 - Nipple and cap in Apt. 6P

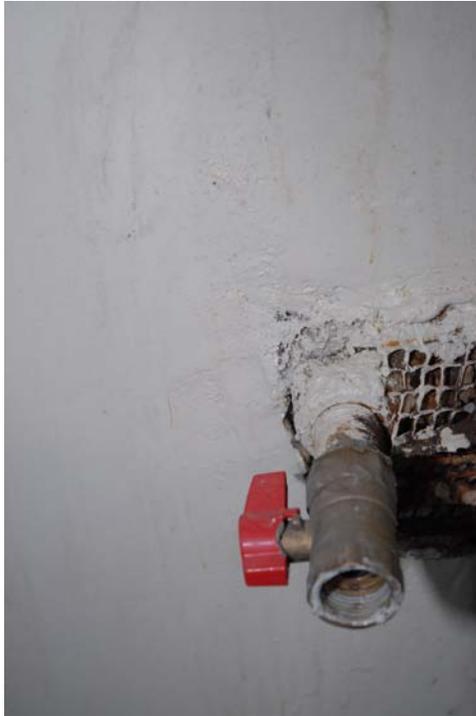
Staff received notification of the explosion at approximately 5:15 PM. Staff was dispatched to the location and arrived at approximately 8:40 PM. Upon arrival, Staff found that the scene was being controlled by FDNY marshals and the company had not been allowed entry. Staff was made aware that Con Edison personnel had been on location that day performing gas turn-ons. Later in the evening, the FDNY granted Staff and Con Edison personnel access to apartment 2P, where the explosion was centered. The area was photographed. The stove was found pulled away from the wall and leaning on the opposite counter (done so by the FDNY prior to Staff's arrival). An appliance valve was found installed and in the open position with no plug at the opening. The stove and associated flex connector was not secured to the end of the gas riser. Based on the condition of the flex hose and valve connection, the stove appeared to have been disconnected prior to the incident (See Photo 3 below).

Photo 3  
Appliance valve in Apt 2P

The appliance valve in apartment 2P was found open following the incident. However, it would have had to be closed

during the integrity test of riser P, or the test would not have passed. This indicates that someone entered apartment 2P sometime after completion of the integrity test but before the gassing-in of the riser (which took 15 - 20 minutes due to difficulty accessing the riser valve in the boiler room) and opened the appliance valve. This most likely was one of the plumbers or the building superintendent. If the P riser had been gassed in at the time they opened the appliance valve, they would have smelled and/or heard the escaping gas logically leading to reclosure. However, if the appliance valve was opened before gas was introduced to the riser, and inadvertently left that way, then when gas was introduced it would flow out of the open-ended appliance valve into apartment 2P.
