***NYS Dept. Of Public Service  
Office of Electric, Gas & Water Division  
Safety Section  
Incident Investigation Report***

<b>Pipeline System:</b> <u>Williams ABA Windsor Pipeline</u>	<b>Operator:</b> <u>Williams Field Services Company, LLC</u>
<b>Location:</b> <u>Dunbar Compressor Station – Windsor NY</u>	<b>Date of Incident:</b> <u>1/6/2014</u>
<b>Material Released:</b> <u>Natural Gas</u>	<b>Quantity:</b> <u>Approximately 535 MCF</u>
<b>Staff Arrival Time &amp; Date:</b> <u>9:15 1/7/2014</u>	<b>Total Damages \$</b> <u>3,000,000</u>
<b>Report Date (Final):</b> <u>October 23, 2014</u>	<b>Matter Number</b> <u>14-00083</u>

<i>Narrative Summary</i>
<p>Short summary of the Incident/Accident scenario</p> <p>At 20:40 on January 6, 2014, Williams Field Services (Williams) notified DPS Staff (Michael McCutcheon) that there had been a fire on the number four unit at the Dunbar Station in the town of Windsor. DPS Staff (McCutcheon) responded to the site the following morning. The initial investigation indicated that the fire was on the engine and damage to the engine from the fire exacerbated the situation by releasing engine oil and ethylene glycol onto the skid causing a longer lastin

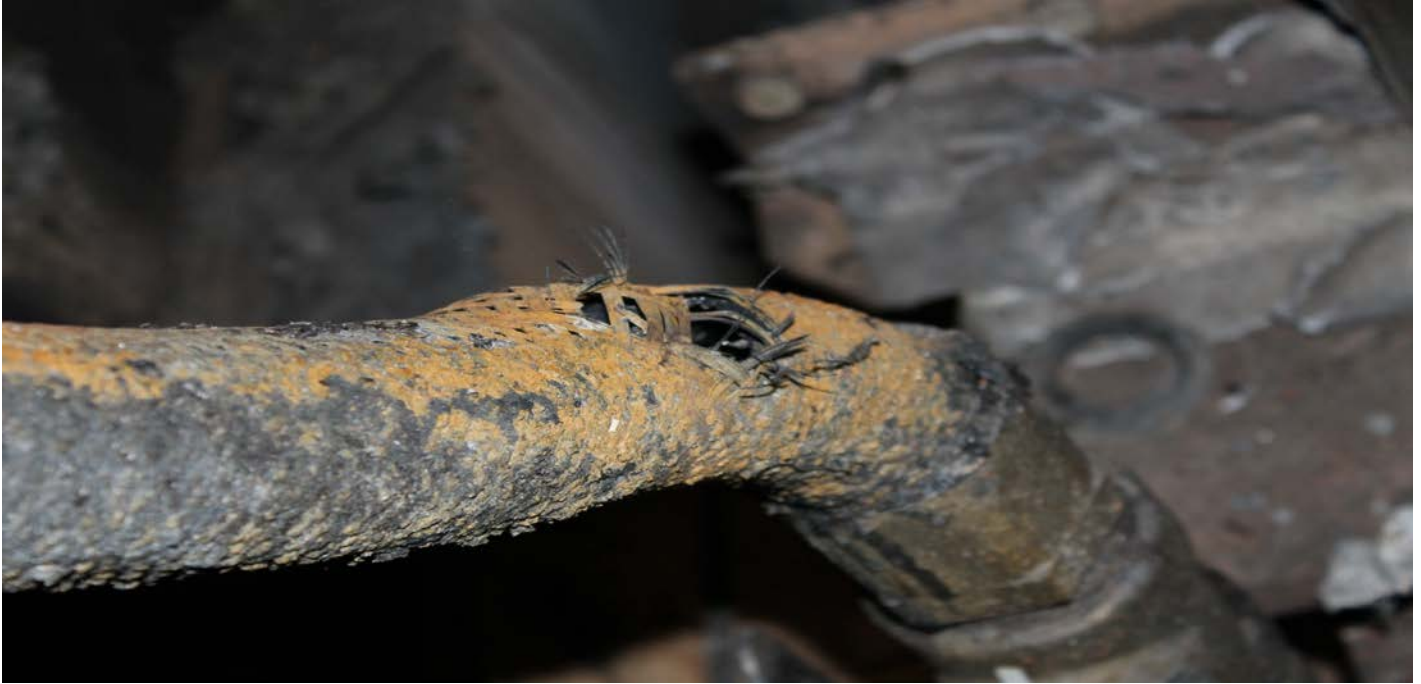
Photo 5

The fuel line entered the engine area at or near the floor of the skid. Approximately 40 inches of flexible metal braided supply line was used to correct a misalignment of the two pieces of pipe. The failure occurred in the area of a tight bend in the metal braided fuel pipe (see Photo 5). This situation was remedied by utilizing hard pipe, cut and treaded to facilitate a 'straight' pipe alignment that also reduced the 30-40 inch pipe to a 7 to 8 inch piece of flexible pipe with no bending stresses due to poor alignment.

<b>External Pipe or Component Examination</b>	
External Corrosion?    ___ Yes <u>X</u> No <sup>(1)</sup>	Coating Condition (Disbonded, Non-existent):    Paint <sup>(1)</sup>
Description of Corrosion: None	
Description of Failure Surface (Gouges, Arc Burns, Wrinkle Bends, Cracks, Stress Cracks, Chevrons, Fracture Mode, Point of Origin): There was a stress crack in a 1 inch nipple that likely resulted from the rapid stop of the engine during the emergency shutdown of the station, the braid-reinforced fuel line ruptured likely as a result of stress to the line in a tight bend and a brazed oil return line failed as a result of a natural gas fire impinging directly onto the joint.	
Above Ground: <u>X</u> Yes    ___ No <sup>(1)</sup>	Buried:    ___ Yes <u>X</u> No <sup>(1)</sup>
Stress Inducing Factors: <sup>(1)</sup> The length and configuration of the fuel supply line experienced undue stress.	Depth of Cover: <sup>(1)</sup> N/A

The investigation noted that the fuel supply system was poorly designed and was redesigned and the new design was implemented.
