Niagara Mohawk Power Corporation
d/b/a National Grid

Report on the Condition of Physical Elements of Transmission and Distribution Systems
Submitted September 30, 2011

REPORT ON THE CONDITION OF PHYSICAL ELEMENTS OF TRANSMISSION AND DISTRIBUTION SYSTEMS

OCTOBER 1, 2011

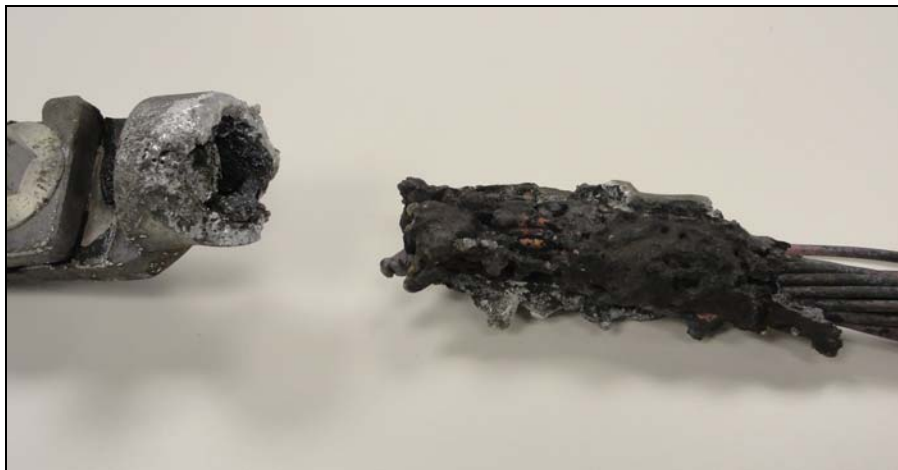
**Photo II-1
T1660 Failed Loop Splice**

- July 2011 – A splice failed on the T1860 Pannell – Geneva 4 115kV transmission line near structure #356. During an infrared patrol on 6/22/2010, this splice was detected as an 11.6°C delta temperature rise. This fell into the range of “monitor” status during 2010.
- April 2011 - The T5390 Mecro – Rotterdam 10 line was taken out of service to repair an open jumper loop at Structure 401. Lineman performing the repair noted that the failed jumper loop and the other two jumper loops at the structure were in poor condition, so all three jumper loops were replaced. The jumper loop was an unusual

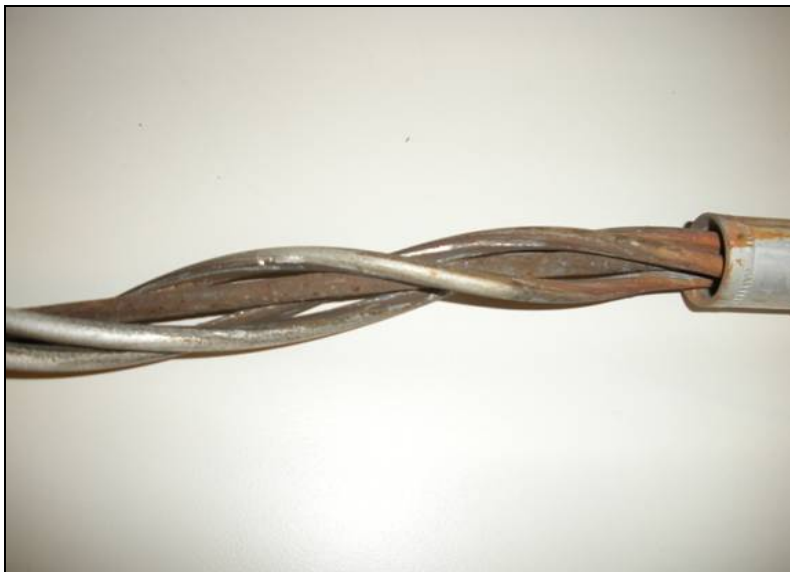
Photo II-2
Early onset of Corrosion

- January 2010 - T1340 Homer Hill–Bennett Road #157 tripped and locked out due to a splice failure between structure #168 and #169. The splice failed at one end where the conductor and splice meet. At one end, 3 of the 6 outer aluminum strands were missing and the single steel core wire showed signs of galvanic protection loss and early onset of corrosion (Photo II-2). Since the line was operating below its thermal rating at the time of failure, the cause of the failure was due to a splice that could no longer perform to its design thermal capacity. Given the age of the conductor at 43 years, it would be expected that the steel core wire would have sufficient galvanization. The fact that the conductor leading from the failed splice was missing 3 outer aluminum strands and displayed signs of corrosion on the steel core wire may be indicative of prior damage that went unnoticed.

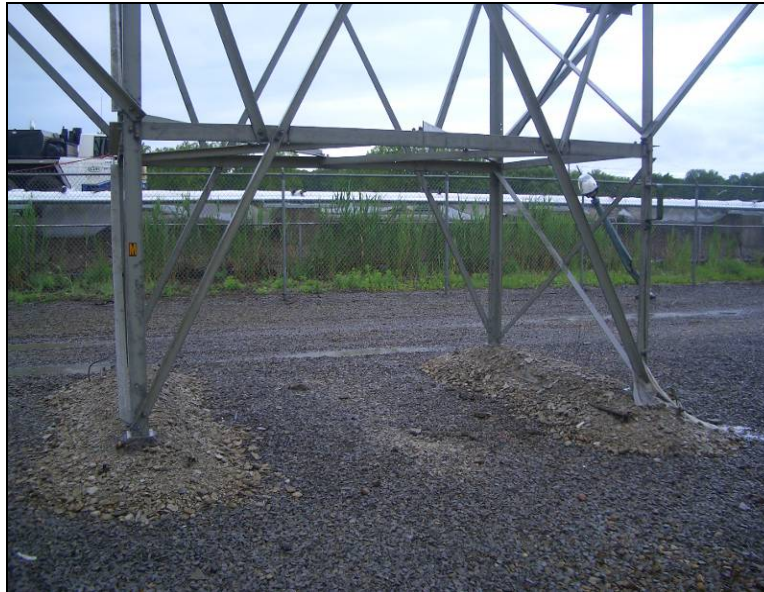
**Photo II-4
230kV Structure Foundation at Dunkirk**

Some circuit breaker foundations are in very poor condition raising the possibility that an oil circuit breaker (OCB) could move during a severe fault leading to more damage and/or cause safety issues.

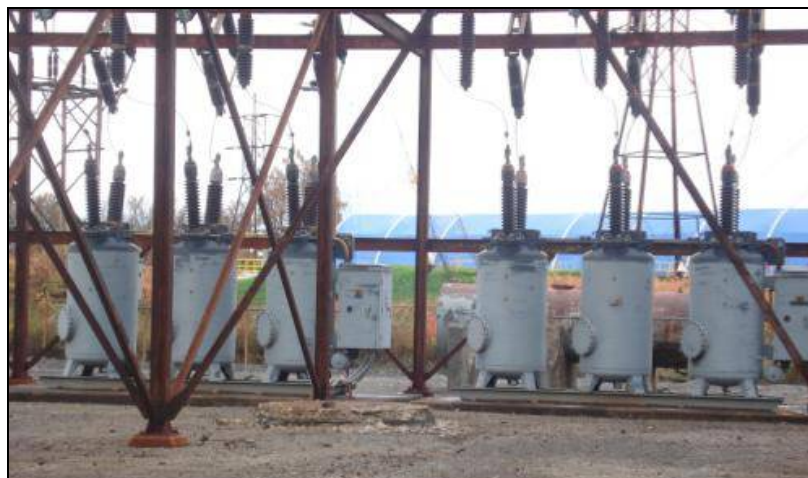
**Photo II-5
Deteriorated Rome Station Structures and Foundations**

The 115kV radial Levitt-Rome #8 line feeds approximately 100MW of load in the surrounding area and has had several outages resulting in lost customer minutes due to

slow closing breakers which in prior condition assessments have been noted to have rusting and compressor oil leaks.

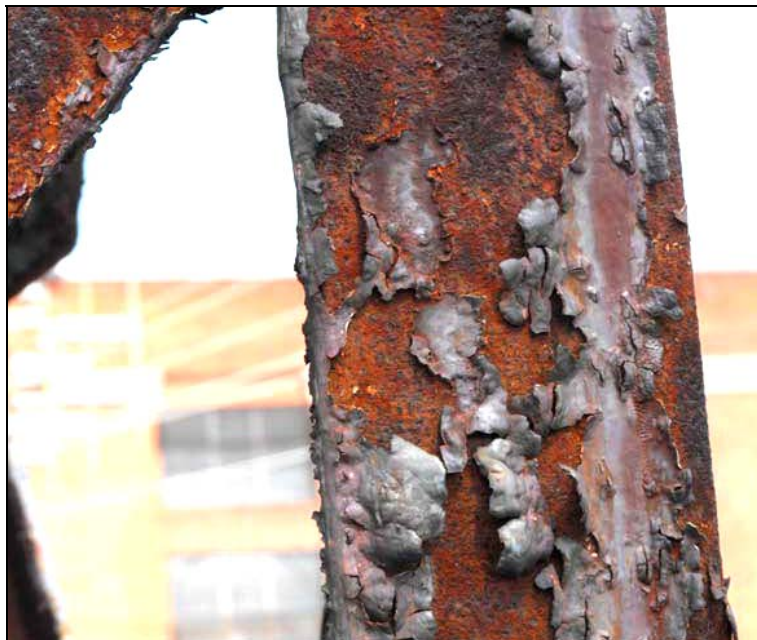
**Photo II-7
Deteriorated Steel Structures at Lockport**

The original manhole and duct system for control cables is in degraded condition which have caused control wire shorts, battery grounds and unwanted circuit breaker operations. Station maintenance crews are restricted in performing repairs due to the overall condition of the duct bank because single control cables cannot be replaced without adversely affecting adjacent control cables in the same ducts.
