STATE OF NEW YORK  
DEPARTMENT OF PUBLIC SERVICE

Case 09-G-0380

80-50 260<sup>th</sup> Street, Queens  
Natural Gas Explosion  
April 24, 2009

Consolidated Edison Company of New York, Inc.

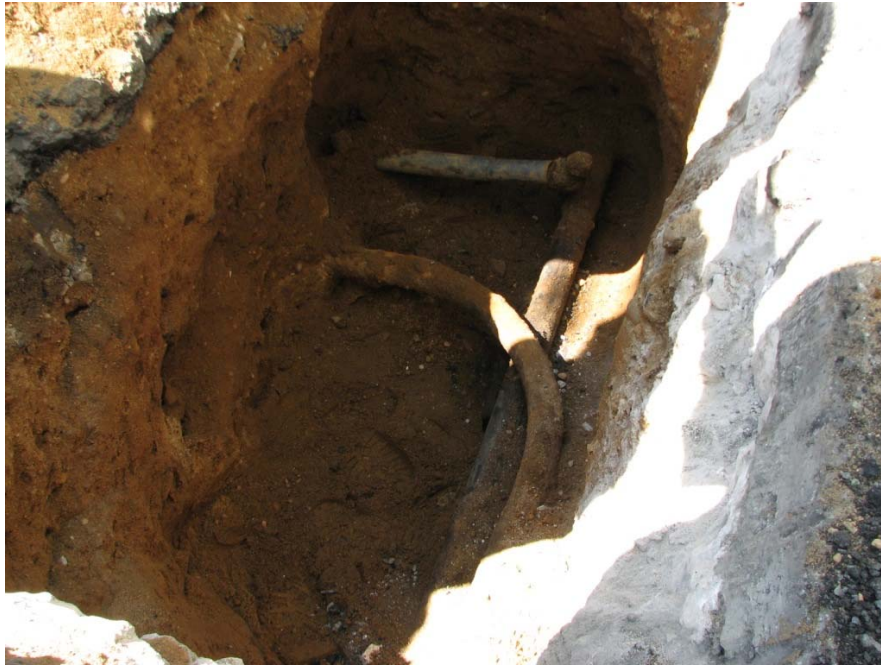
An excavation over the gas main revealed that the conduit containing the electric service to house 80-50 was in close proximity to, and in contact with, the gas main (see Photo 1).

Photo 1 - Electric conduit in contact w/gas main

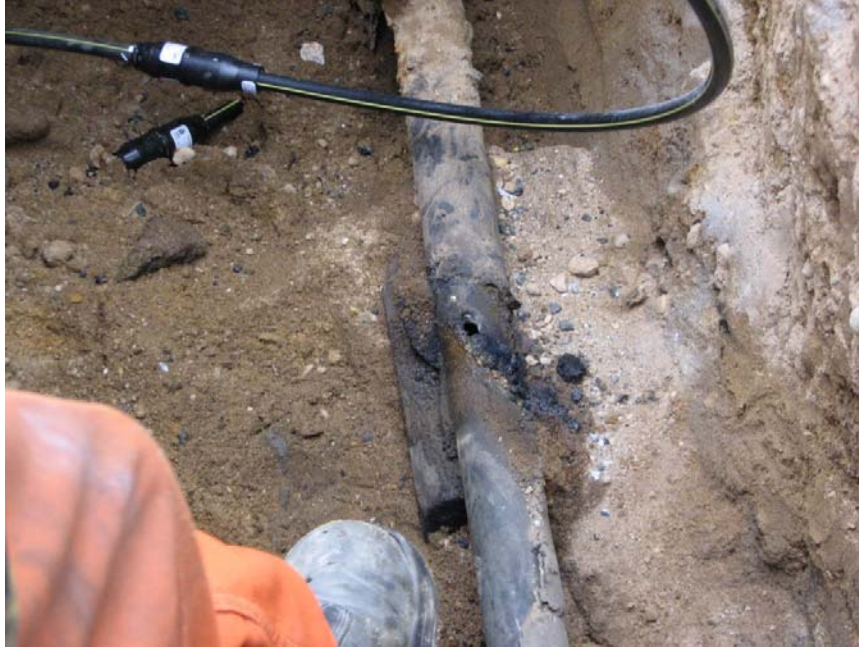
A dime-sized hole was found at the 12 o'clock position on the two-inch gas main, at a point where it passed directly under the two-inch steel electric conduit (see Photo 2).

Photo 2 - Hole in the gas main

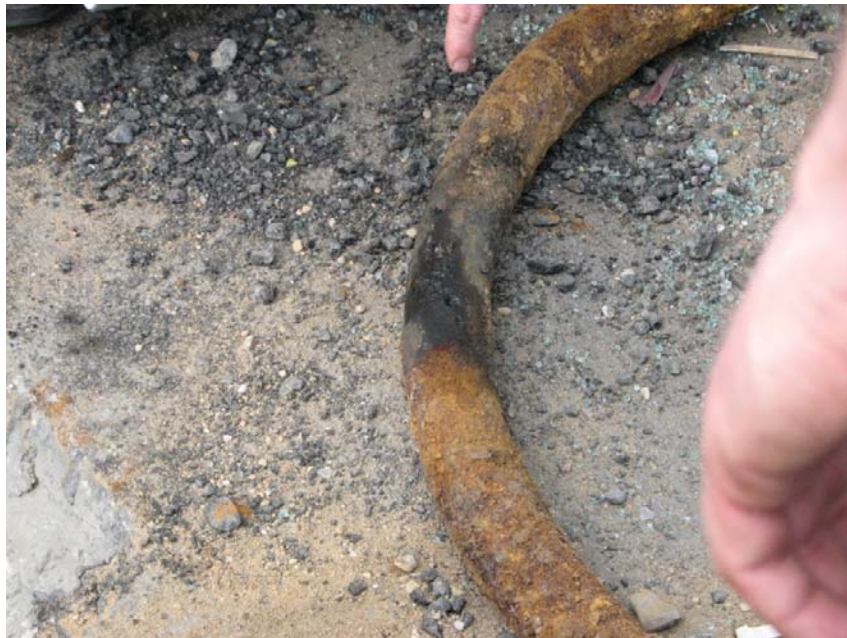
The electric conduit had a corresponding hole in the 6 o'clock position where it crossed over the steel gas main (see Photo 3).

Photo 3 - Hole in electric conduit

Examination of the electric conduit and cable, in the area where it contacted the gas main, revealed indications of failure, with the cable melted in spots, and some of the insulation also completely melted off. Another area of damage to the electric conduit was found approximately 19 feet west (towards 80-50 260th Street) of the crossing of the electric conduit and gas main. The damage appeared consistent with contact during past excavation activities. The steel conduit was bent upward, and a coupling connecting two sections of conduit had been compromised by corrosion and conduit deformation.

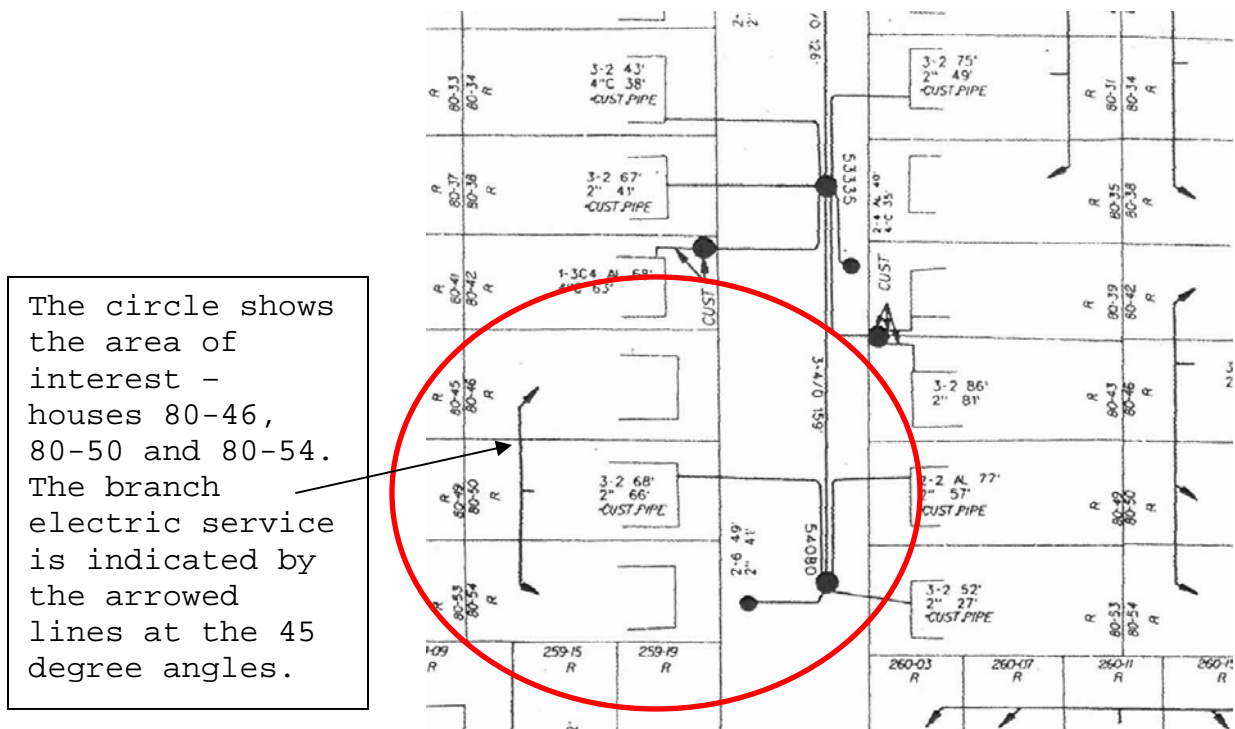
Figure 2 - Byers Image of Electric Facilities on 260<sup>th</sup> Street

Had he done so, he would have determined that the electric service to house 80-46 branched from house 80-50, as did the service to house 80-54. As shown in Figure 2, information on the service boxes and connections to buildings are shown on the same screen in Byers. Since these three buildings shared a common electric conduit, and since a positive gas reading had been found in the electric pull box in house 80-46, this would have prompted the mechanic to check the interior of those homes

Staff also believes that Con Edison's leak investigation procedures should be enhanced to provide better clarity and direction regarding which and how many buildings on both sides of the street adjacent to a manhole in an urban setting will be checked in the event of positive gas readings found within a subsurface structure.

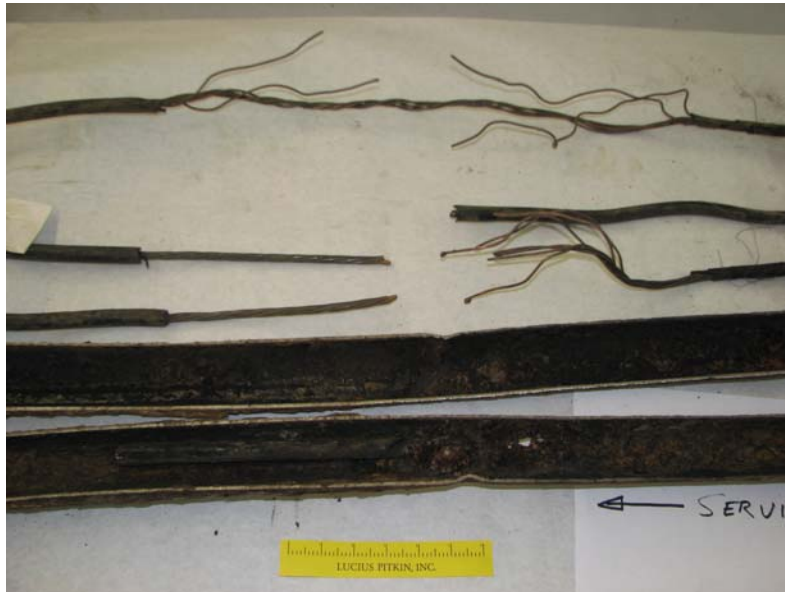
Damage to the electric conduit was found approximately 19 feet west (towards 80-50 260th Street) of the crossing of the electric conduit and gas main (see Photo 4).

Photo 4 - Electric conduit and cables 19 feet from gas main crossing

LPI's preliminary<sup>20</sup> determination is that a fault in the electric service cables most likely originated in the area where the conduit was damaged (near the west curb line), causing fault current to flow into the steel electric conduit and arc onto the two-inch gas main at the point where they crossed. The arcing created holes in both the electric conduit and the gas main. The arcing also caused localized damage to the insulation and one conductor of the electric service cables. Once the arc created the hole in the gas main, the escaping gas migrated through routes in the soil and subsurface facilities, ultimately accumulating in the house at 80-50 260th Street.

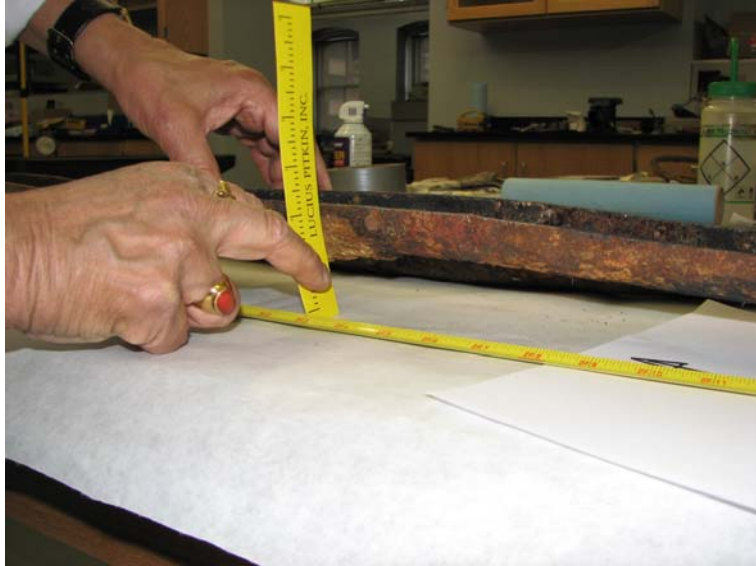
The damage appeared consistent with contact during past excavation activities. The steel conduit was bent upward (see Photo 5), and a coupling connecting two sections of conduit had been compromised by corrosion and conduit deformation (see Photo 6).

Photo 5 - Bend in Electric Conduit  
Note: taken at LPI Facility

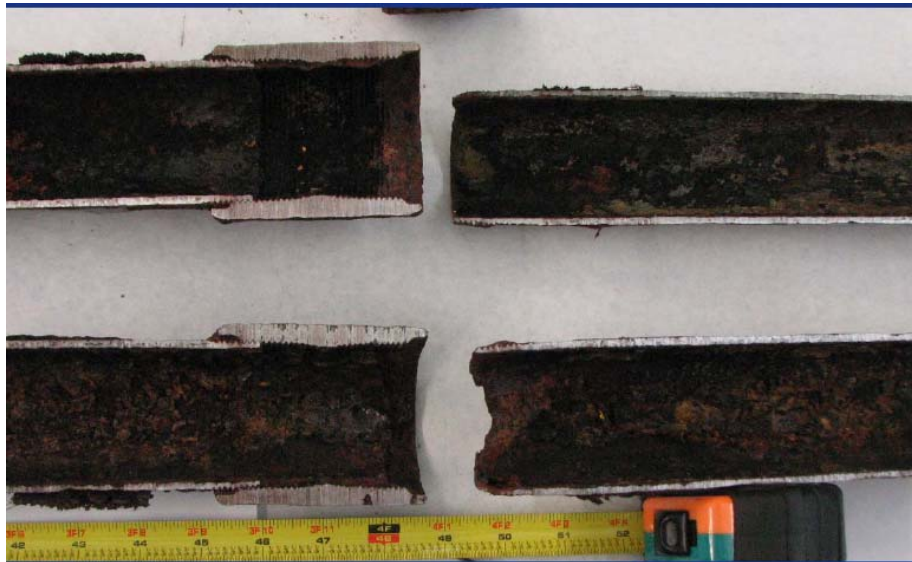
Photo 6 - Damaged conduit and coupling 19 feet from gas main crossing  
Note: taken at LPI facility
