STATE OF NEW YORK
DEPARTMENT OF PUBLIC SERVICE

198 Joseph Street, Horseheads
Natural Gas Explosion
January 26, 2011
New York State Electric and Gas Corporation

Safety Section
Office of Electric, Gas & Water
Final Report January 2014

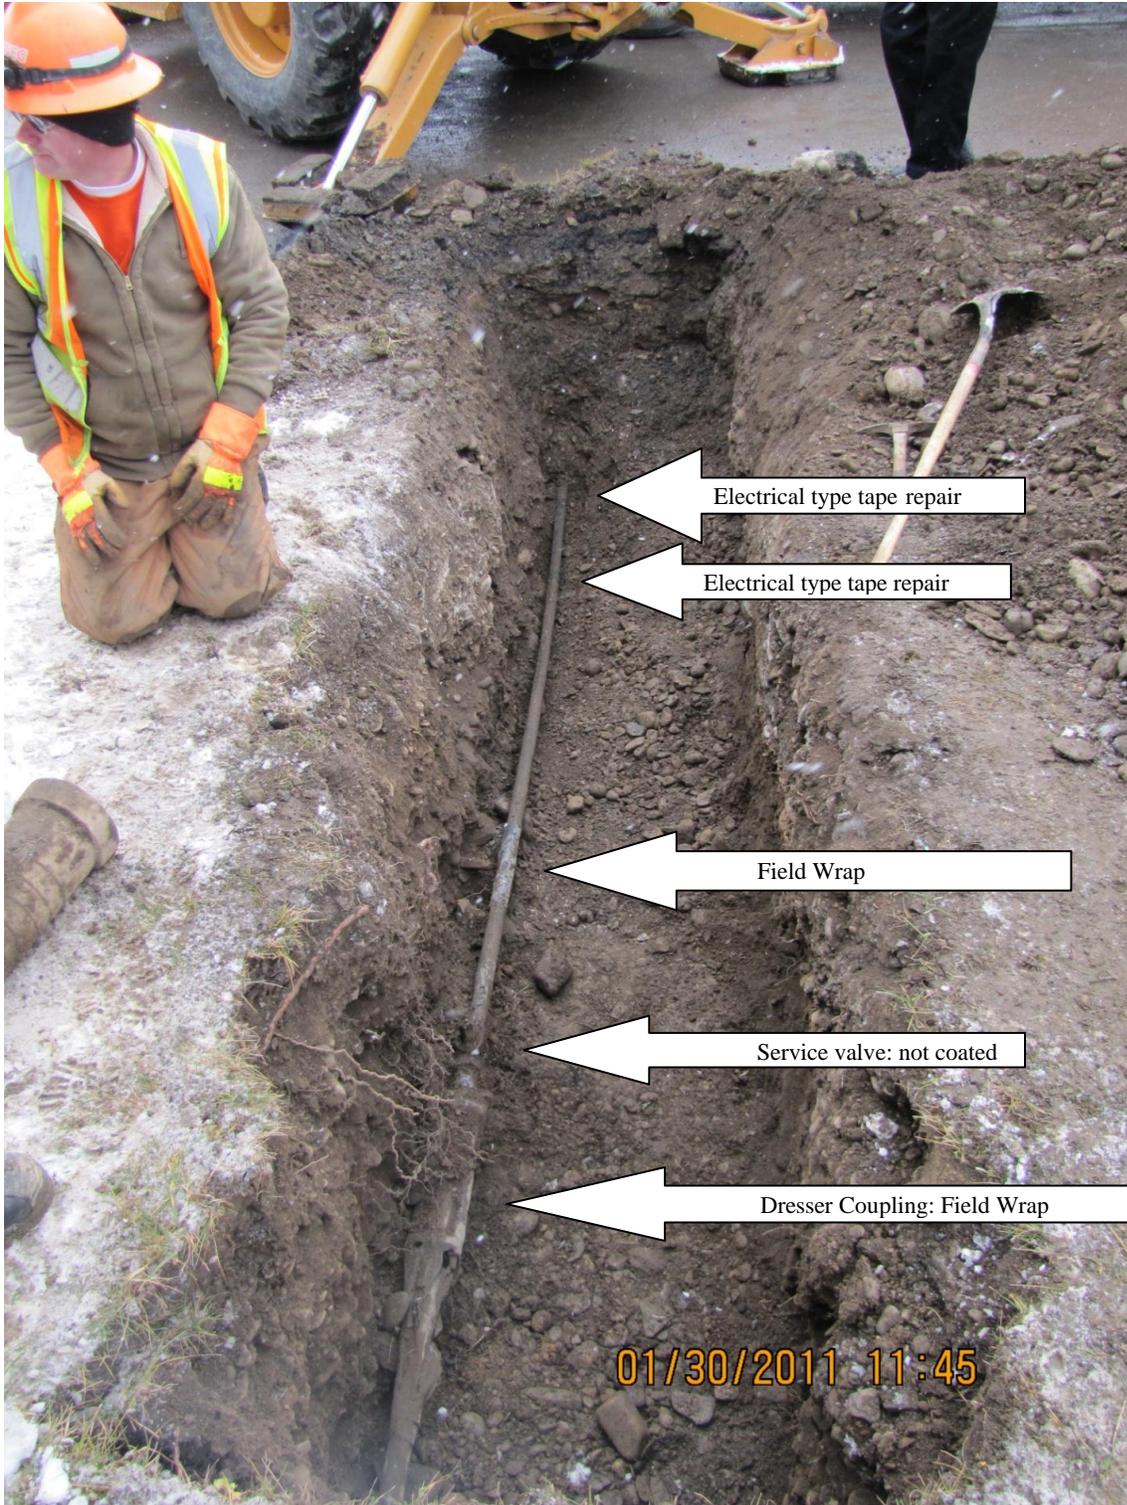
. . . is also 2 inches wide (nominal) with a 8-9 mil thick black polyethylene backing and a butyl rubber adhesive. It is the same type of tape product as (the fracture tape). Because other tapes exist that are comparable in physical characteristics and chemical composition to (these specimens), it cannot be inferred that they originated from the same roll, or were manufactured by the same company.

At least two types of black tapes were present in Q2.1 and Q3.1 and they differ from Q1.2 in thickness and/or width. Both are a different tape product from Q1.2. No chemical examinations were conducted on the Q2.1 and Q3.1 tapes.

Photo 7 from the May 2012 report is shown on the following page. Correlating the descriptions of the pieces of evidence by the Chemung County Sheriff (CCS) and the laboratory analysis by the FBI, it appears that (1) FBI specimen Q4.1 is CCS "194 service tape B" and is one of the two arrows labeled "Electrical type tape repair" and (2) FBI specimen Q3.1 is CCS "194 service tape A" and is either the "Field Wrap" arrow or the "Dresser Coupling Field Wrap" arrow.
