**NYS Dept. Of Public Service
Office of Electric, Gas & Water Division
Safety Section
Incident Investigation Report**

Pipeline System: 80 PSIG MAOP Distribution System,
Operating at 65 PSIG **Operator:** Orange and Rockland Utilities, Inc. (ORU)

Location: 52 Zarriello Lane, West Haverstraw, New York **Date of Incident:** January 16, 2012

Report Date (Final): 3/20/15 **Matter Number** 12-00189

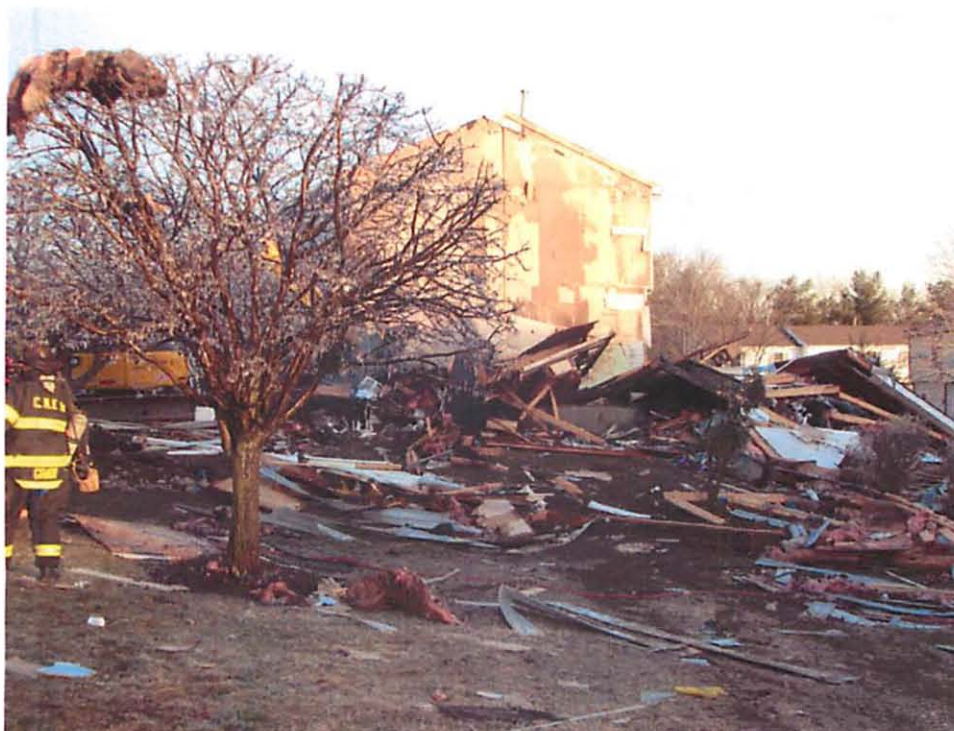
Damages	
Product/Gas Loss or Spill ⁽³⁾	Estimated Property Damage \$ \$1,000,000
Amount Recovered	Associated Damages ⁽⁴⁾ \$382,000
Estimated Amount \$ 576	
Description of Property Damage: 52 Zariello Lane was completely destroyed. Adjacent building 54 Zariello Lane was heavily damaged by the explosion.	
Customers out of Service: <input checked="" type="checkbox"/> Yes <input type="checkbox"/> No Number: 94	
Suppliers out of Service: <input type="checkbox"/> Yes <input checked="" type="checkbox"/> No Number:

Image #1: Damage to 52 Zarriello Lane – Taken by Arpit Mehta

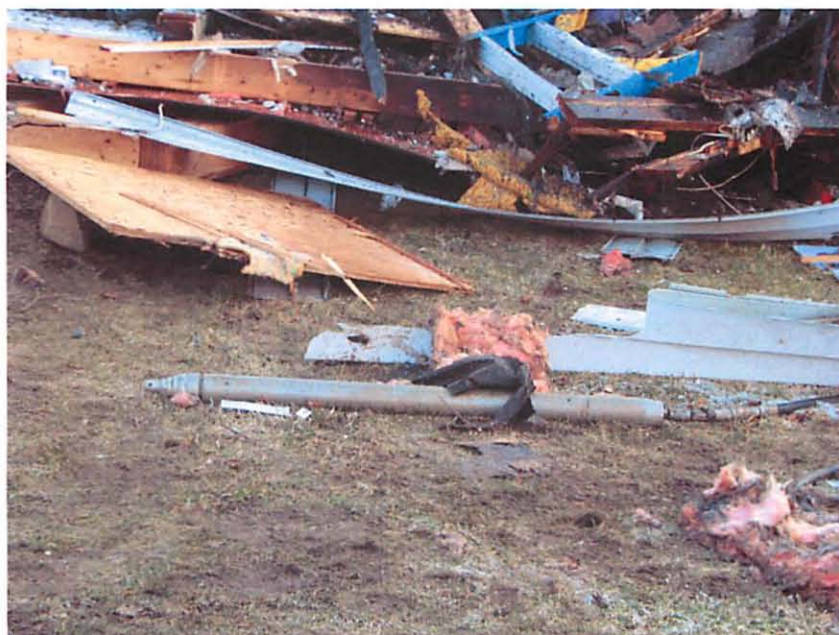
Using a pneumatic device commonly referred to as a "bullet", FGC was boring across the street in front of 52 Zarriello Lane. It was approximately 28 feet to the east of where the dots had been placed by the ORU locator. According to FGC, this was towards the end of their work in the complex. During a subsequent interview, MasTec confirmed that FGC excavated where it instructed them to dig. MasTec also claimed that they instructed FGC to dig test holes to verify the gas main location. FGC denies this in interviews with Staff.

Image #2 – Pneumatic Bullet Used by Contractor – Taken by Arpit Mehta

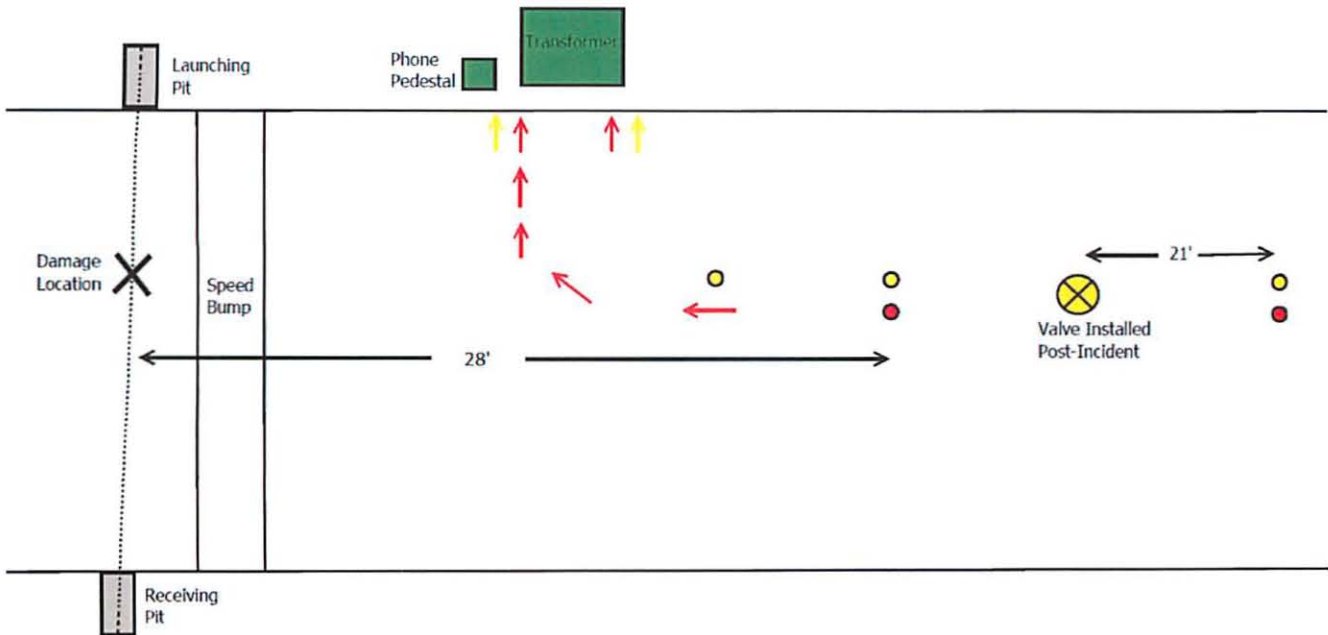
According to the ORU locator, after discussion with FGC, he placed two sets of two dots on the ground within the area that the locator stated they would be crossing the road. A red dot in each set indicated the primary electric, while the yellow dot indicated the gas main. Measured from an electric transformer in front of 52 Zarriello, the first set of dots is approximately 12 feet away from the transformer. The second set of dots is approximately 40 feet away from the transformer. The two sets of dots are 28 feet apart. Closer to the transformer, the locator placed another yellow dot for the gas main along with a red arrow mark-out for the electric. There is an arc of electric arrow mark-outs leading to the service line mark-outs (see Image #3 and Image #7).

Image #3: Location of Pre-Incident Mark-Outs

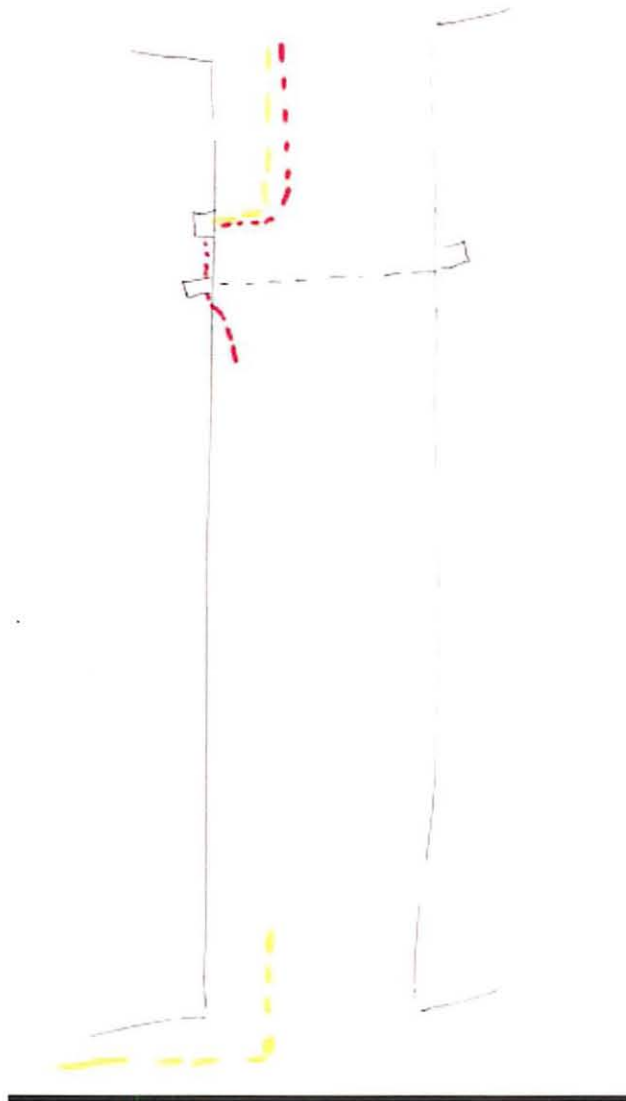
During interviews on 2/22/12 & 3/6/13, FGC denies that ORU told them this. FGC claimed that due to the placement of the dots and the service line arrows leading to the transformer, it believed that rather than continuing east under Zariello Lane, both the electric line and gas main turned away from the roadway and into the field by 52 Zarriello Lane.

Image #4: – Drawing by Fidel Padilla of FGC Communications Inc of Mark-Outs Observed by the Contractor on Location During Excavation, Drawn During Staff's Interview with FGC on February 22, 2012

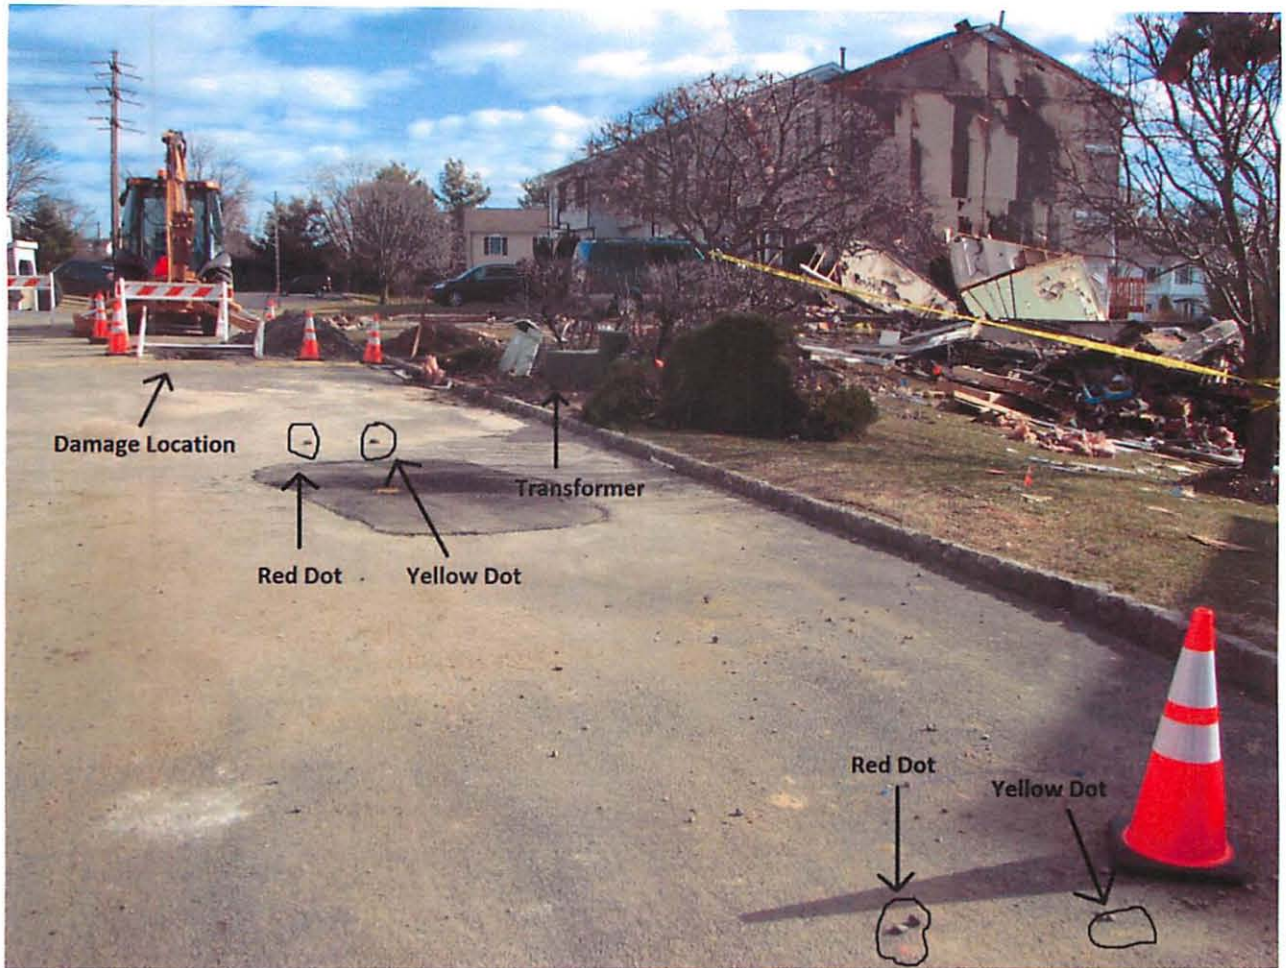
Image #5: Mark-Out Dots Placed by ORU – Taken by Arpit Mehta

Image shows the four dots placed by ORU to mark the location of the natural gas main and electric facilities. The red dots indicate electric facilities, while the yellow dots indicate the location of the natural gas main in the street. The damage location can be seen in the background, approximately 28 feet away from the easternmost dots.

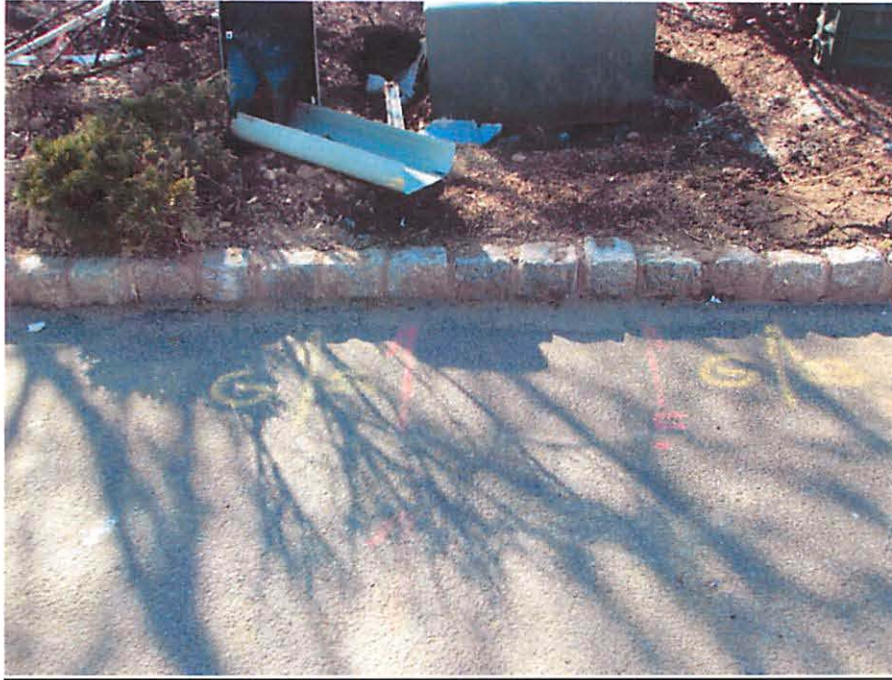
Image #6 – Service Line Mark-Outs at Transformer Placed by ORU – Taken by Arpit Mehta

Image shows the four service line mark-outs at the transformer and curb of the street. There are two gas service line mark-outs (yellow) and two electric service line mark-outs (red).

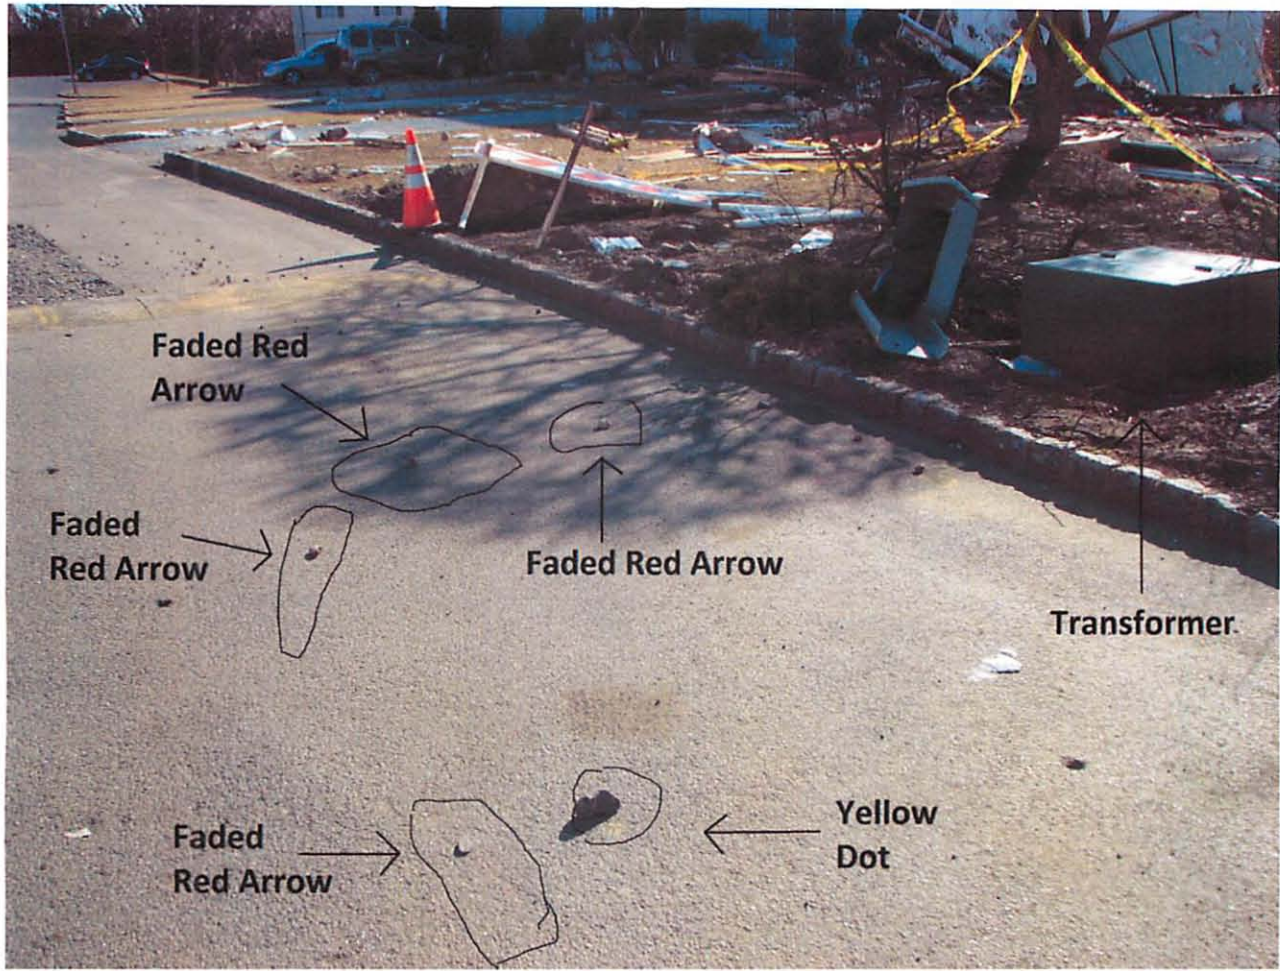
Image #7: Mark-Outs Leading to Transformer Placed by ORU – Taken by Arpit Mehta

Image shows mark-outs leading to the transformer. There are four red arrows signifying electric facilities. The first red arrow runs parallel to the curb. The next arrow is angled, bending into the curb. The next two red marks are perpendicular to the curb and are intended to show the electric service going into the transformer. There is only one natural gas mark-out, a yellow dot in the street by the first red arrow. At the transformer, there are four mark-outs for electric and natural gas service lines, as shown in Image #6.
