**CONTACT VOLTAGE TEST &
FACILITY INSPECTION
ANNUAL REPORT**

CONSOLIDATED EDISON COMPANY OF NEW YORK, INC.

Report on the results of contact voltage tests & facility inspections for the period
beginning January 1, **2014** and ending on December 31, **2014**.

February 15, **2015**

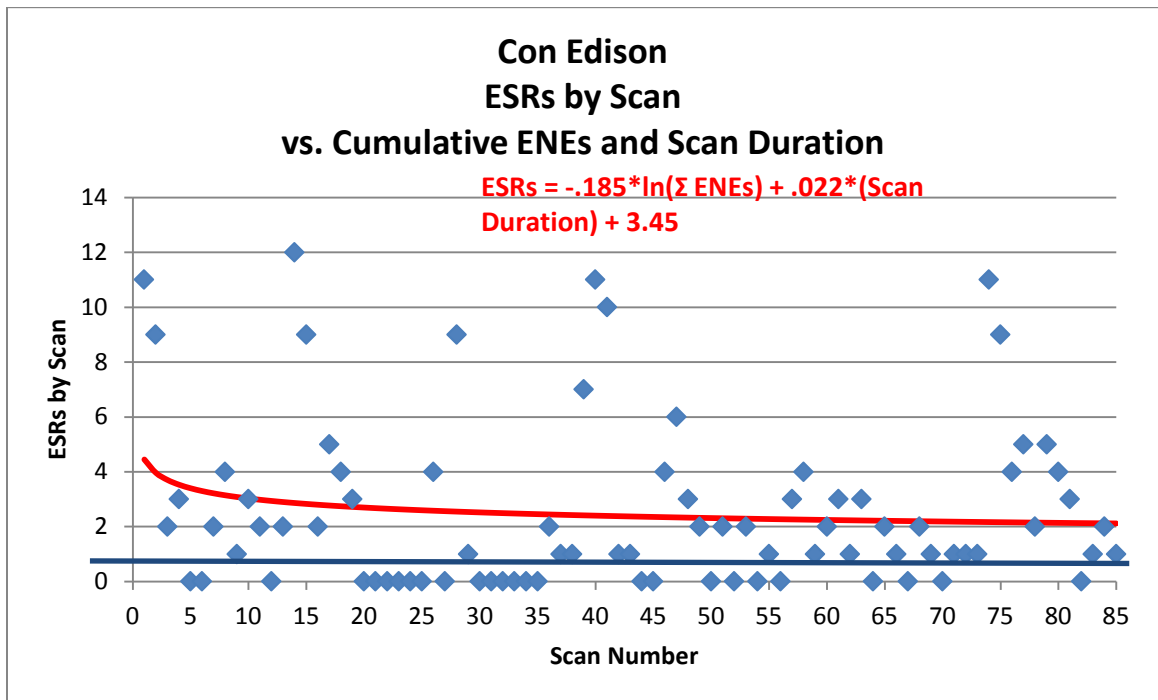
Chart 1

The ESRs associated with Con Edison’s equipment appear on Chart 1. As mentioned above, weather also plays a role in ESR generation. Higher precipitation in 2014 increased the generation rate of ESRs associated with Con Edison’s equipment. This weather variable is accounted for in the underlying models and in both the 2014 and long term predictions. The duration between scans ranges from approximately 30 to 35 days per scan. If Con Edison continues with a comparable ENE repair rate and scan interval in 2015 and experiences similar weather patterns, the Company can expect ESRs to be approximately 2 per

scan. In 2014 there were 46 shocks associated with the Company's equipment. This result is above the projection but well below pre-safety program performance and more consistent with weather related influences.

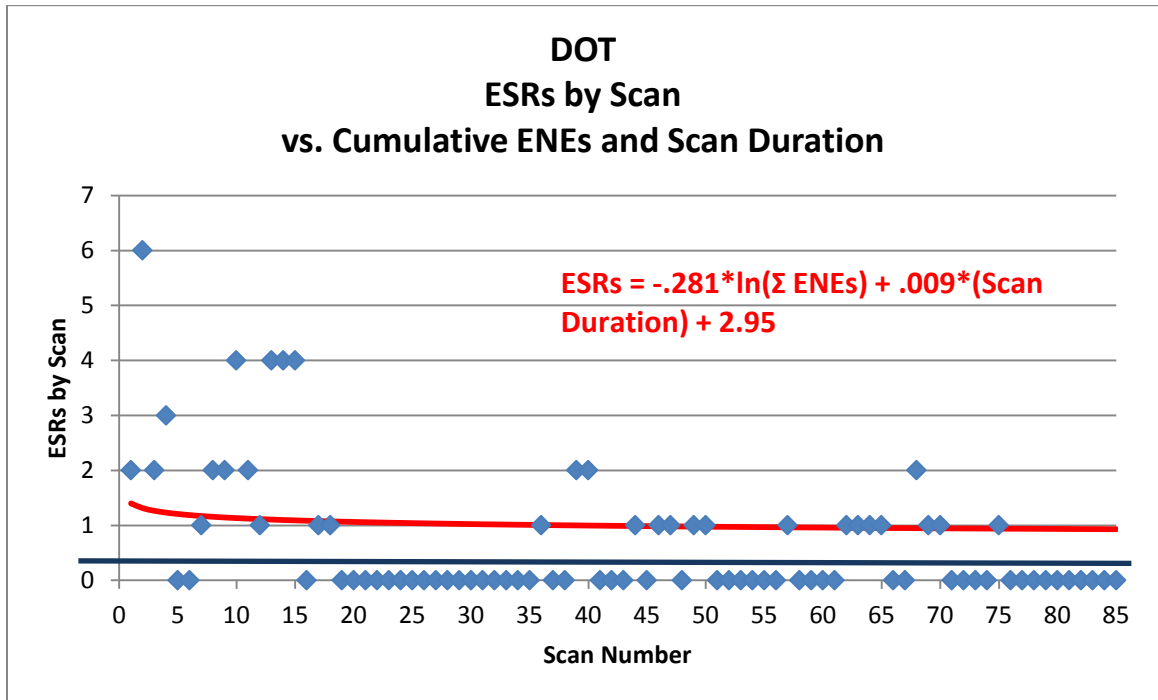
Chart 2

The ESRs associated with DOT equipment appear on Chart 2. The duration of scans is 30 to 35 days per scan. If the Company continues a comparable ENE repair rate and scan duration in 2015, the Company can expect ESRs at this scan duration level to be approximately 1 per scan. The expected ESR per scan rate has decreased from 2 ESR every 1 scan to 1 ESR per scan. In 2014 there were 4 shocks associated with DOT equipment failures. This result is below the company's projections and shows performance continues to improve from the various programs implemented by both DOT and Con Edison to mitigate shocks.

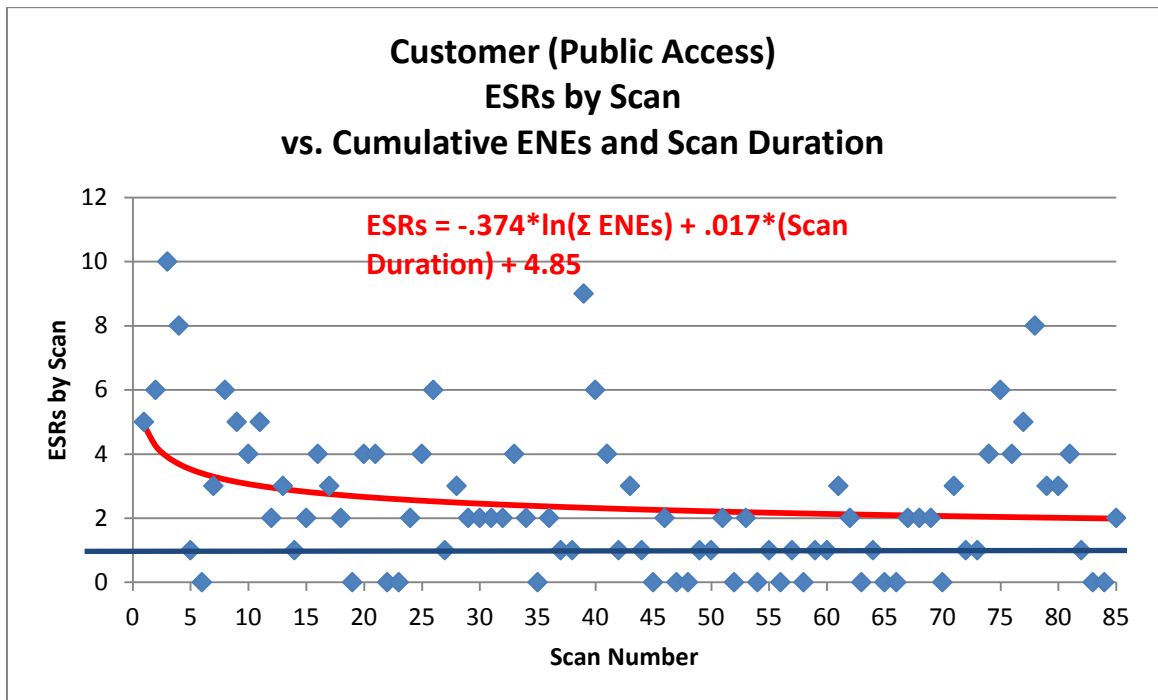
Chart 3

The ESRs associated with Customer’s equipment appear on Chart 3. The duration of scans is 30 to 35 days per scan. If the Company continues a comparable ENE repair rate and scan duration in 2015, the Company can expect ESRs to remain at 2 per scan, with no significant reduction anticipated below that level in the near future. The actual performance indicates that these shock events are less sensitive to our mitigation efforts than we initially projected. In 2014, the Company responded to 34 validated shock reports on publicly accessible customer equipment.

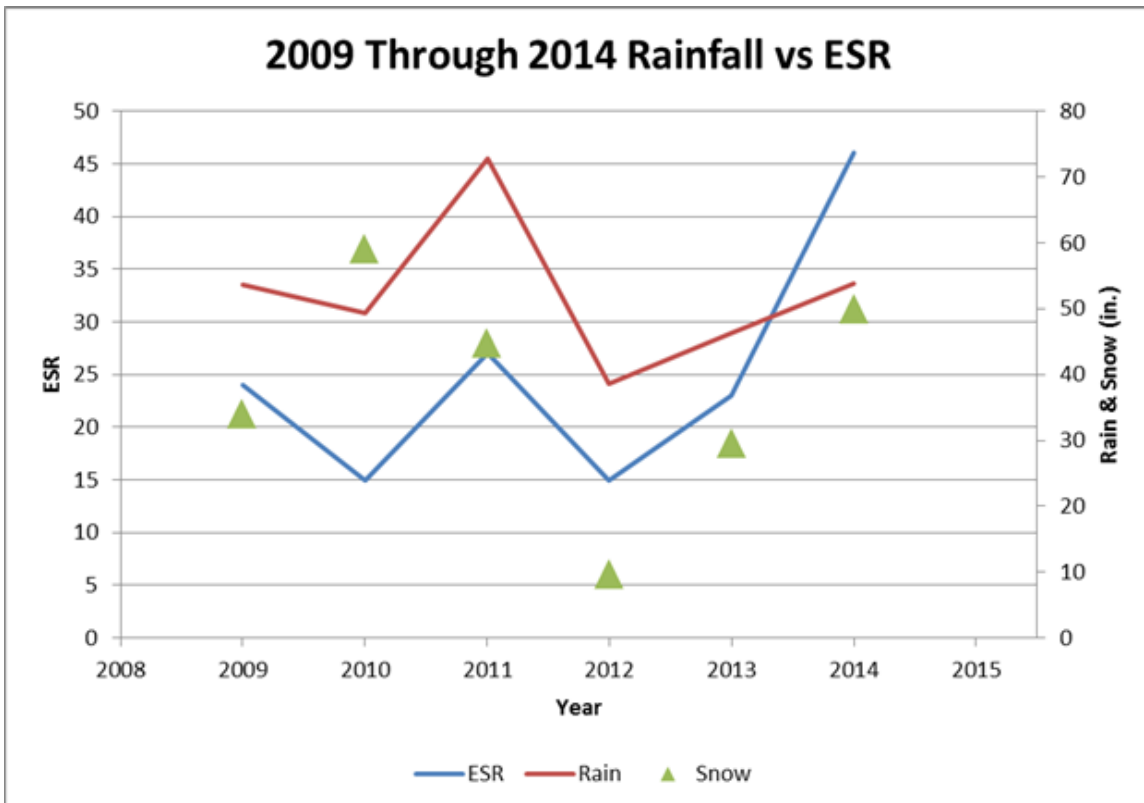
Chart 4

In evaluating snow and rainfall in successive years (chart 4), the system response to ground conditions, such as the level of precipitation, changes from 2009 to 2014. As snowfall and rainfall increase from 2009 to 2014, ESRs also increase, and as snow and rainfall increased there is an increase in number of ENE/ESR in 2014. The Company will continue to monitor this correlation in 2015.

In 2014 energized objects (ENEs) detected and electric shock reports (ESRs) increased from 2013. This increase is primarily due to a harsh winter in 2014 - including approximately 149k tons more salt and 20 inches more snow than 2013, and a five year high of days when the temperature did not exceed the freezing point. ESRs remain well below their pre-program historical values, e.g., in 2004 there were 285 ESRs.. These weather-driven fluctuations demonstrate that the Con Edison Public Safety Programs continue to control risk. In addition, the ESR generation rate per scan appears to be stable.

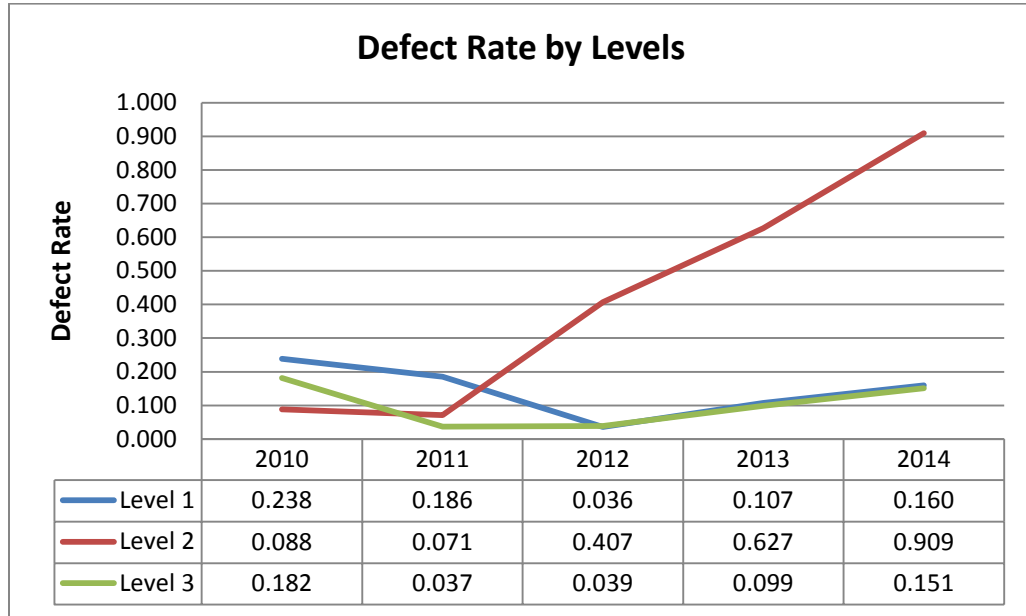
The chart below shows the number of defects found per inspection:

Beginning in 2012, the Company reclassified Unsealed Ducts and Improperly Sealed Ends from Level I to Level II defects. This was done to account for defects generated by a change in specification and not a true defect condition. Repairs will continue to follow level 1 criteria. This reclassification has led to an overall increase in Level II defects.

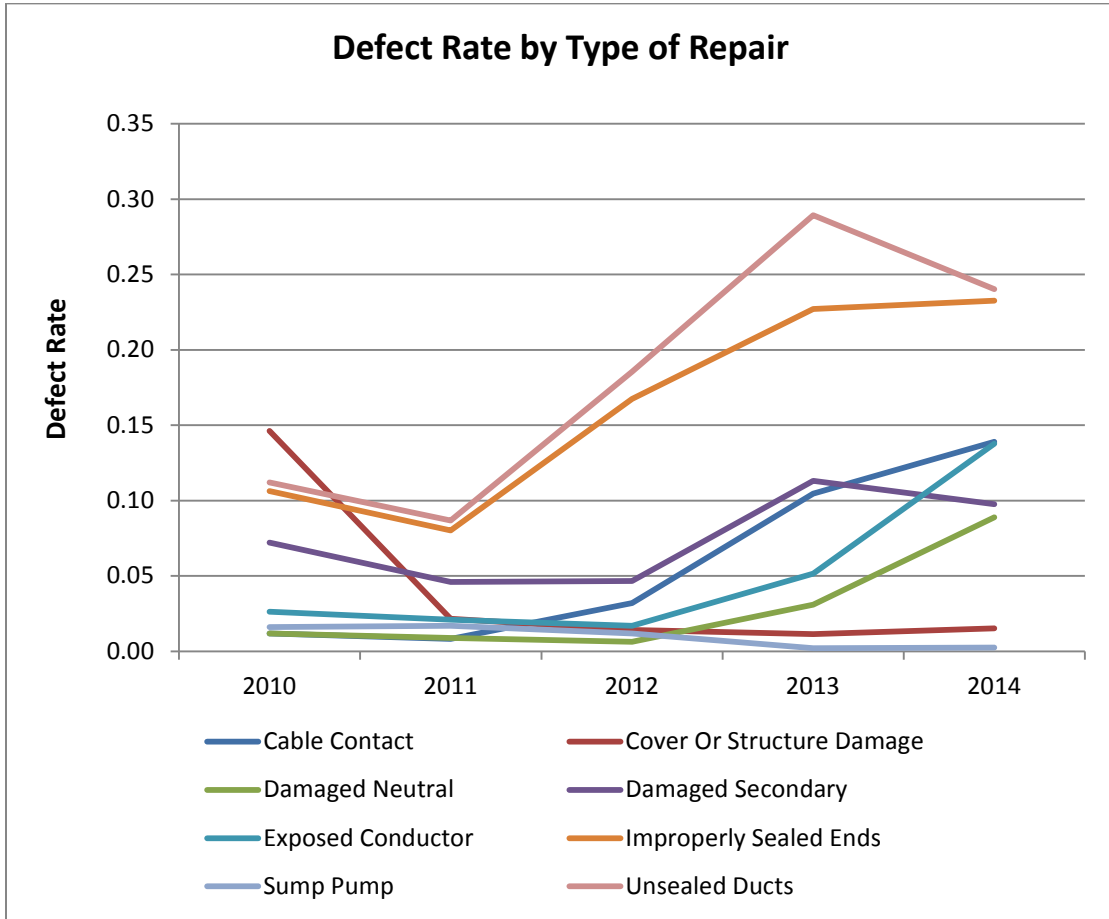
The defect found ratio can be broken down further, by type of repair:

In most categories, there are increases in the defect rate from 2013 to 2014; however, there has been a decrease in the level of unsealed ducts and damaged secondary, along with a leveling in the rate of improperly sealed ends. Years 2013 and 2014 were challenging years in terms of weather with 30 inches and 50 inches of snow and 232 k tons and 382 k tons of salt distributed, respectively. The weather contributed to a significant increase in the number of manhole events from the prior years; 196 and 257 manhole events, respectively. Manhole events represent stresses to the system and associated components that contribute to increasing inspection program defect rates in some categories.

The weather directly contributed to the increase in damaged secondary, exposed conductor and damaged neutrals. Additionally, 2014 saw an increase in reported cable contact by contractors due to a misinterpretation of the required cable clearance, which has been addressed through training.
