Re: Case 04-M-0159, Proceeding on the Motion of the Commission to Examine
the Safety of Electric Transmission and Distribution Systems

**CONTACT VOLTAGE TEST &
FACILITY INSPECTION
ANNUAL REPORT**

CONSOLIDATED EDISON COMPANY OF NEW YORK, INC.

Report on the results of contact voltage tests & facility inspections for the period
beginning January 1, 2012 and ending on December 31, 2012.

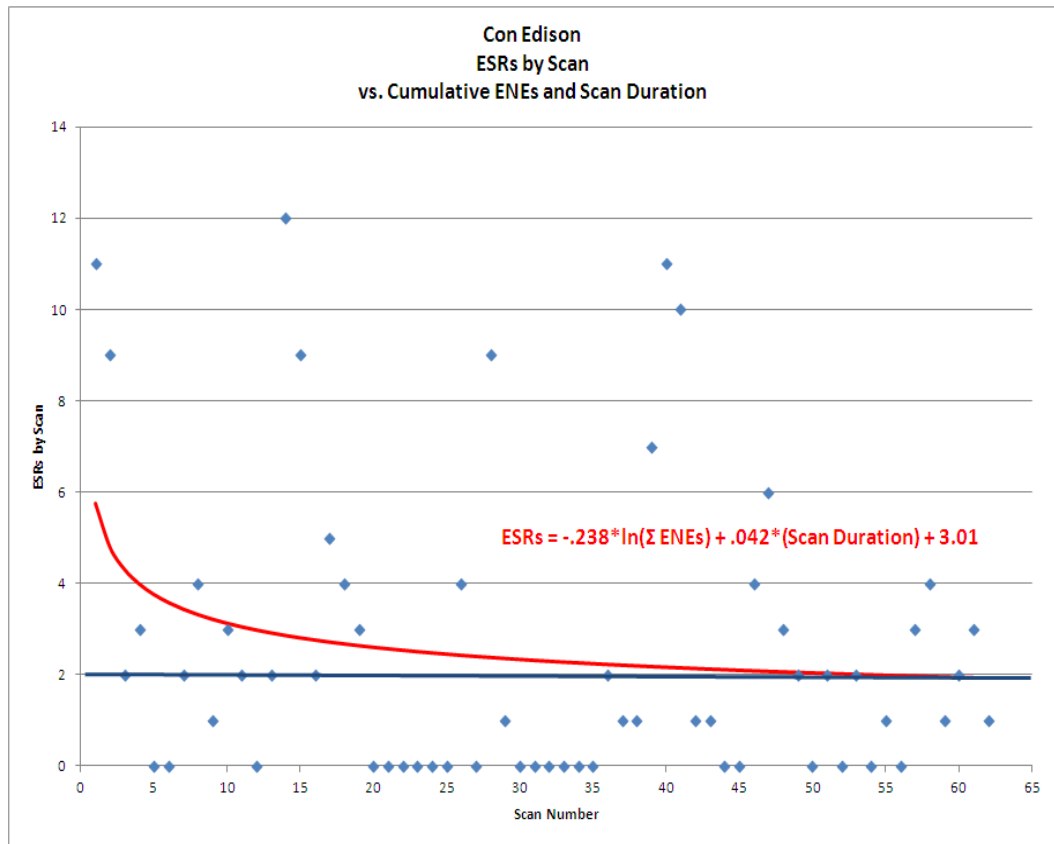
Chart 1

The ESRs associated with Con Edison’s equipment appear on Chart 1. As mentioned above, weather also plays a role in ESR generation. The lower precipitation in 2012 decreased the generation rate of Con Edison responsible ESRs. This weather variable is accounted for in the underlying models and in both the 2012 and long term predictions. The duration between scans ranges from approximately 30 to 35 days per scan. If we continue with a comparable ENE repair rate and scan interval in 2013, as well as experience similar weather

patterns, we can expect ESRs to be approximately 2 per scan. This prediction is consistent with the 2012 actual results of 15shocks due to Con Edison responsibility.

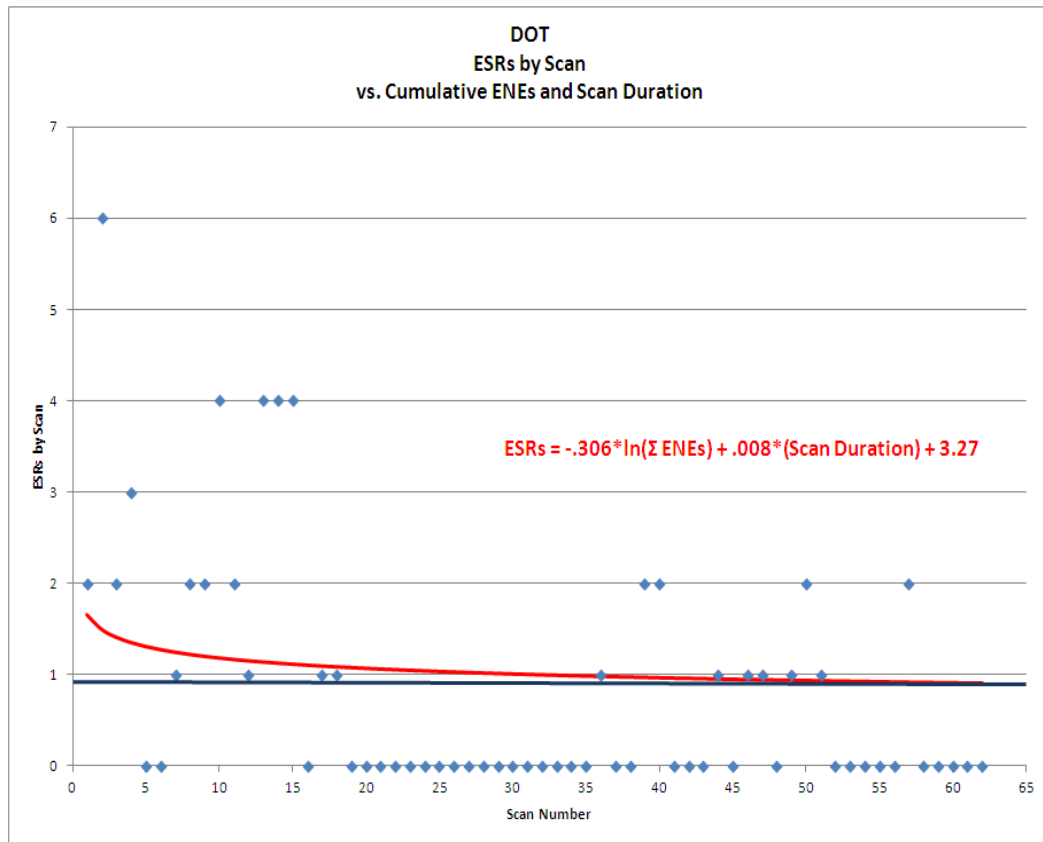
Chart 2

The reduction of ESRs associated with the DOT appears on Chart 2. The duration of scans is 30 to 35 days per scan. If we continue a comparable ENE repair rate and scan duration in 2013, we can expect ESRs at this scan duration level to be approximately 1 per scan. The expected ESR per scan rate has increased from 1 ESR every 2 scans to 1 ESR per scan. In 2012 there were 2 shocks associated with DOT equipment failures. This result is better than predicted, and is likely the result of various programs implemented by both DOT and Con Edison to mitigate shocks.

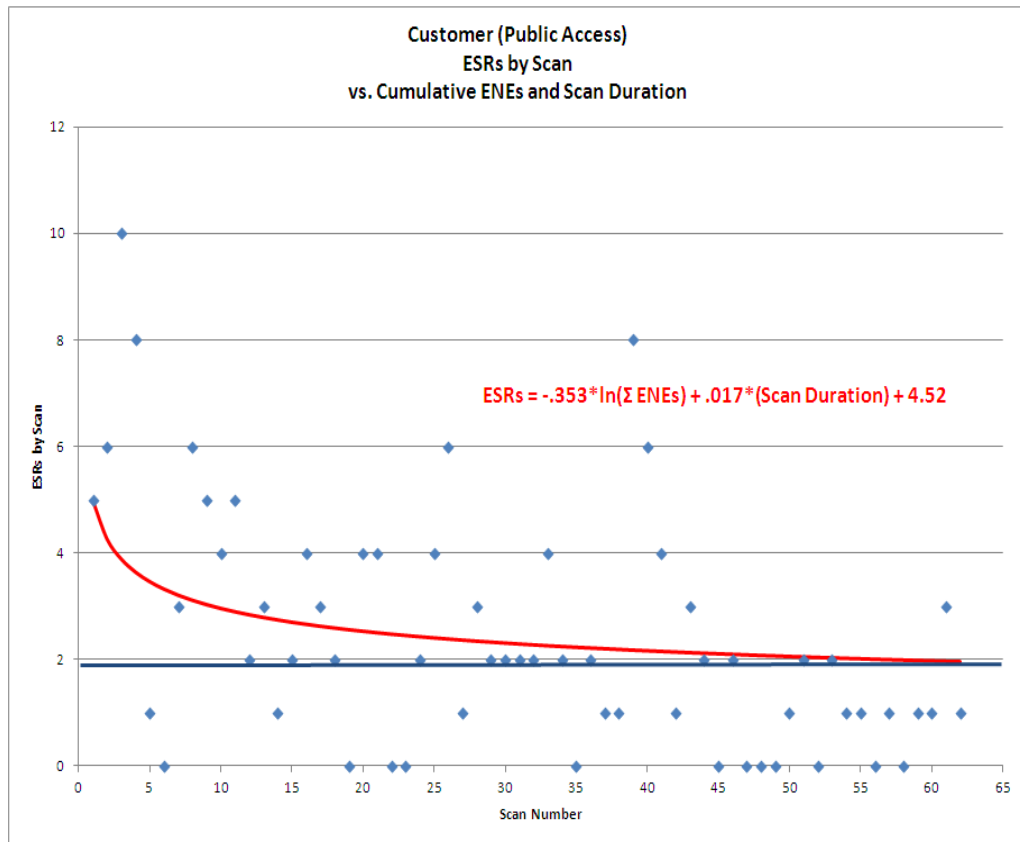
Chart 3

The reduction of ESRs associated with Customer Equipment (Public Access) appears on Chart 3. The duration of scans is 30 to 35 days per scan. If we continue a comparable ENE repair rate and scan duration in 2013, we can expect ESRs to remain at 2 per scan, with no significant reduction anticipated below that level in the near future. The actual performance indicates that these shock events are less sensitive to our mitigation efforts than we initially projected. In 2012, we responded to 37 validated shock reports on publicly accessible customer equipment.

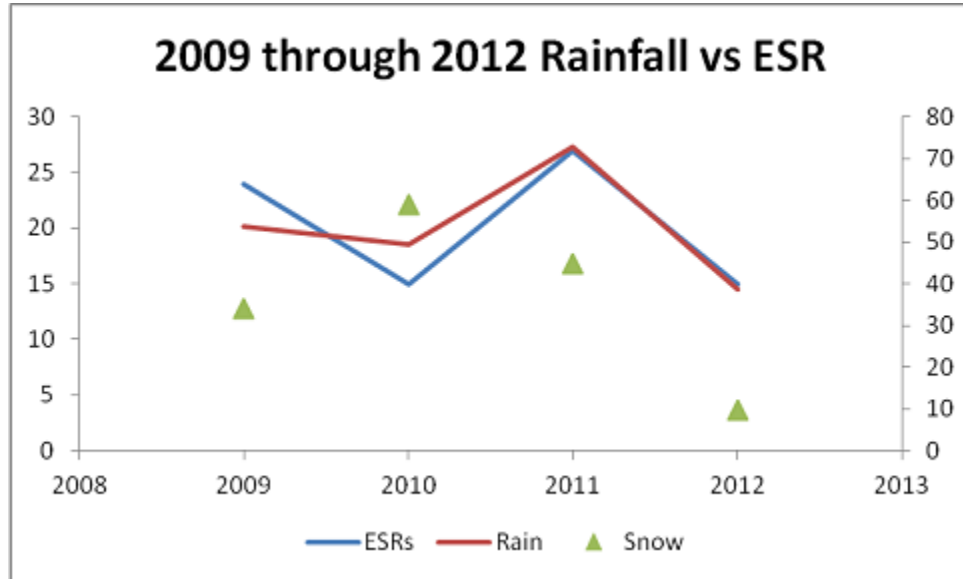
Chart 4

As mentioned in previous year's report a strong correlation was observed between weather and shocks during 2012.

When we look at snow and rainfall year over year (chart 4), we see the system response to ground conditions, as level of precipitation change from 2009 to 2012. As snowfall and rainfall increase from 2009 to 2011, ESRs also increase and as snow and rainfall decreased there is a decrease in number of ENE/ESR in 2012. We will continue to monitor this correlation in 2013.

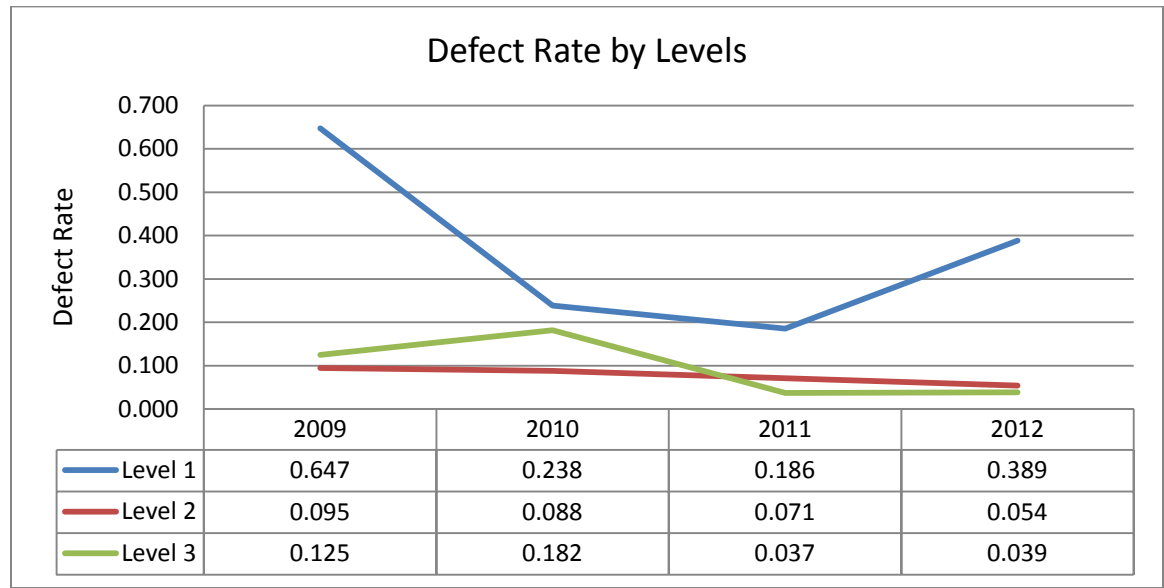
The chart below shows the number of defects found per inspection:

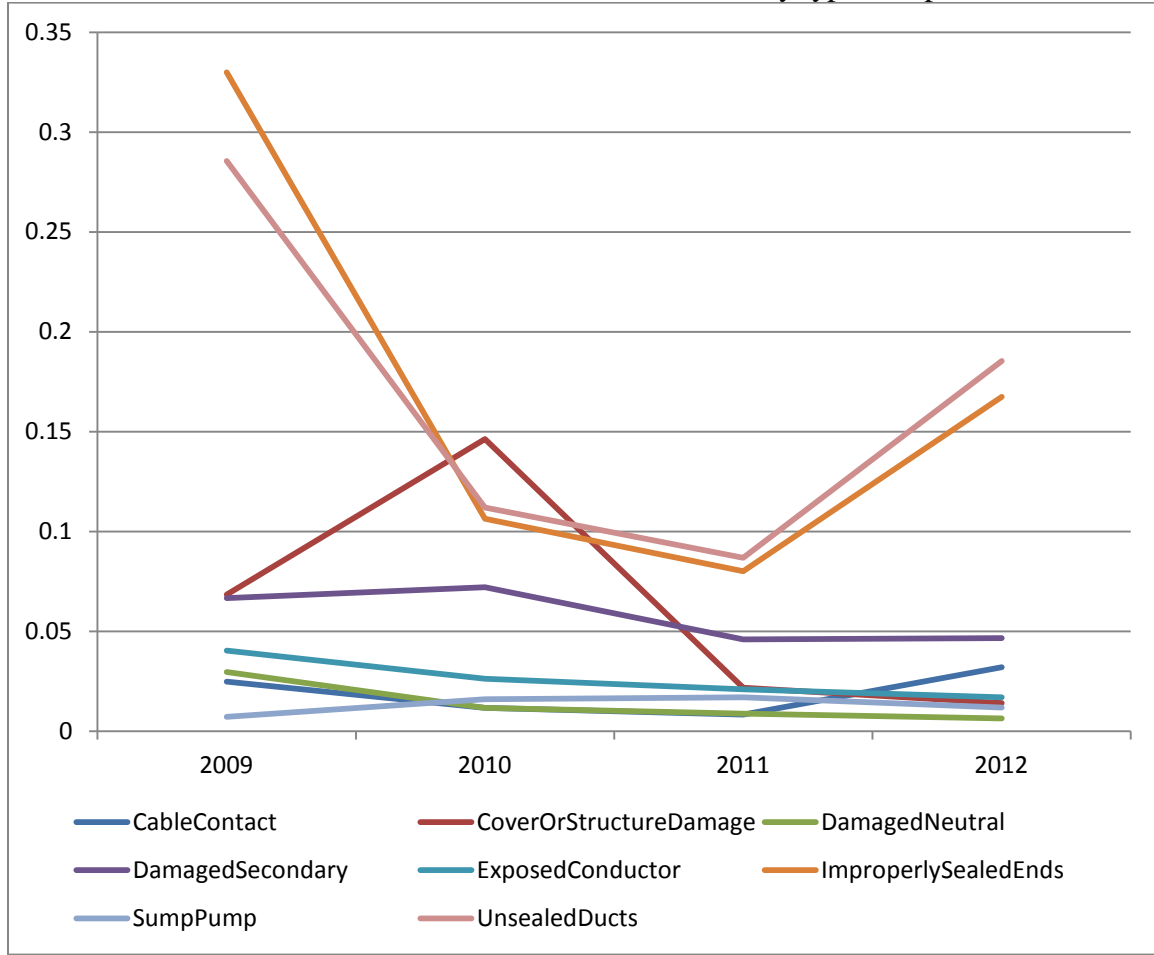
The defect found ratio can be broken down further, by type of repair:

For most categories, we see a minor decrease in defect rate from 2009 thru 2012. There are three categories where we see an increase in the defect rate: unsealed ducts, cable in contact and improperly sealed ends. We are currently investigating this increase, but we believe there may be multiple factors contributing to the increases. For example: 1) An increase in the flushing of structures (more vented covers on the system), 2) Our current tracking system (EDIS), in some cases, does not allow us to differentiate between defects found due to field conditions versus defects created during a new installation process (i.e. new crab installations), 3) Natural wear and tear from the elements.
