***NYS Dept. Of Public Service
Office of Electric, Gas & Water Division
Safety Section
Incident Investigation Report***

Pipeline System: <u>Natural Gas Distribution</u>	Operator: <u>National Grid Corporation</u>
Location: <u>310 Paige Street, Schenectady, NY</u>	Date of Incident: <u>August 10, 2014</u>
Material Released: <u>Natural Gas</u>	Quantity: <u>Unknown</u>
Staff Arrival Time & Date: <u>4:05 PM August 10, 2014</u>	Total Damages \$ <u>140,000 (estimated per National Grid 30-Day Report No. 20140078-15927, dated 9/10/2014, Form PHMSA F 7100.1 (Rev. 06-2011))</u>
Report Date (Final): <u>4/1/15</u>	Matter Number <u>14-01638</u>

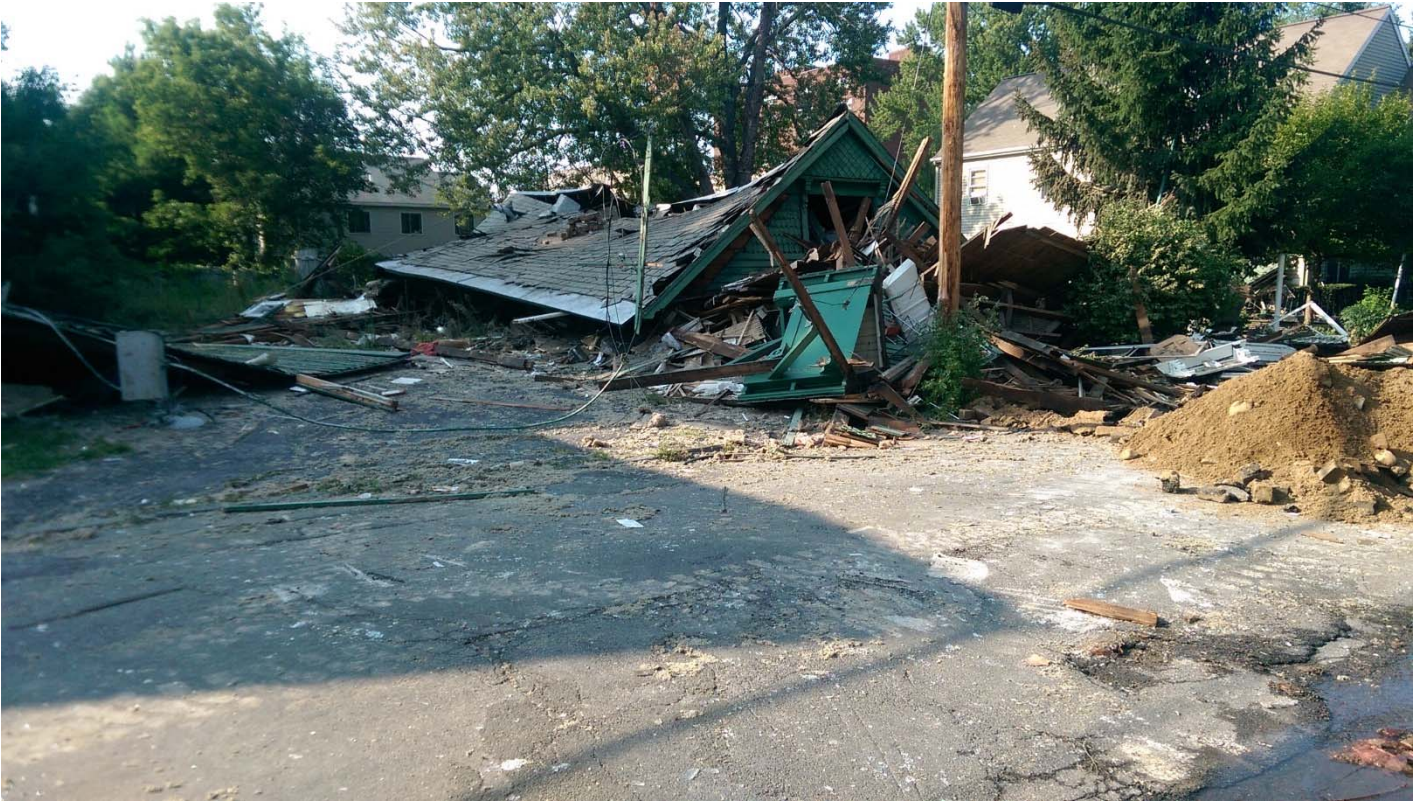
Photo 1 (8/10/2014) - 310 Paige Street after the explosion (Facing North).

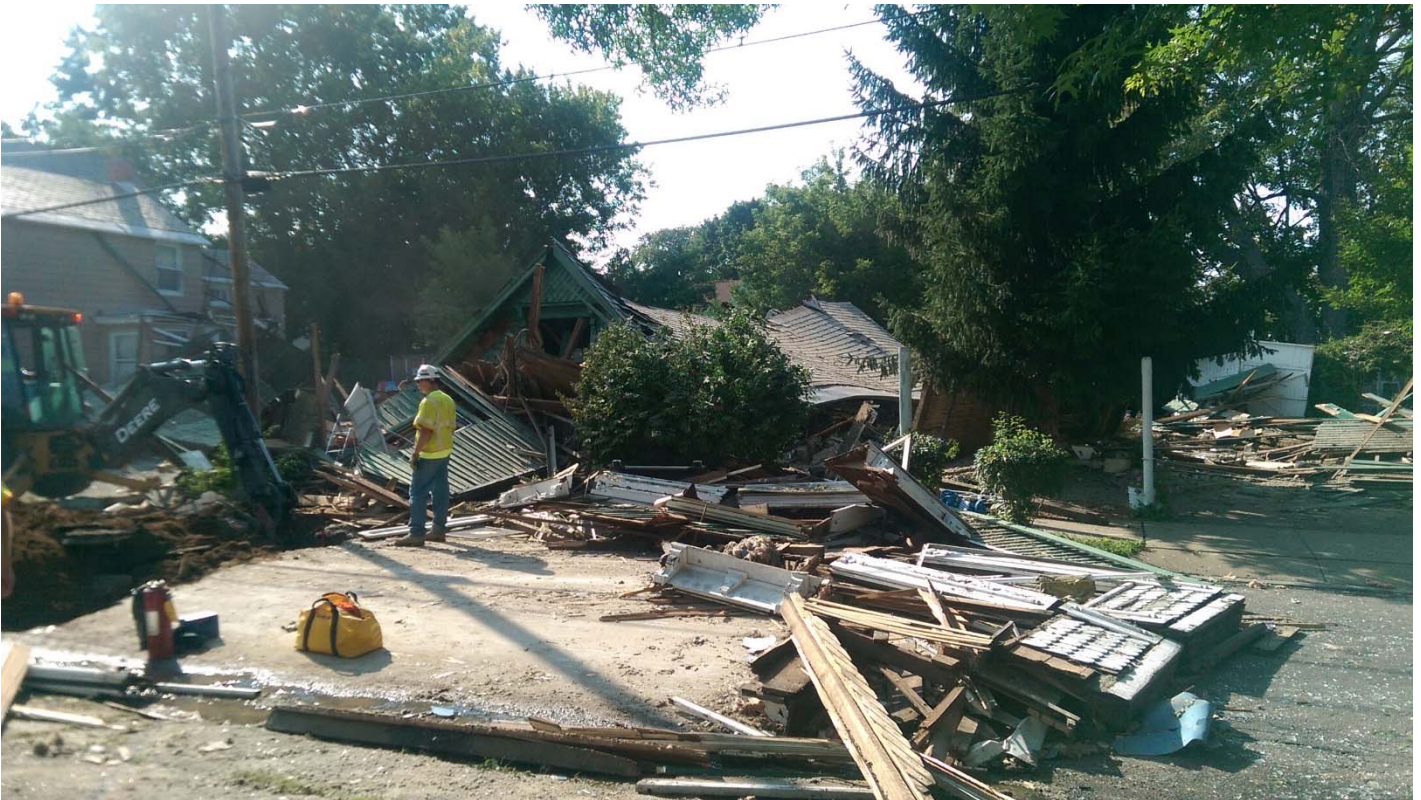
Photo 2 (8/10/2014) - 310 Paige Street after the explosion (Facing West).

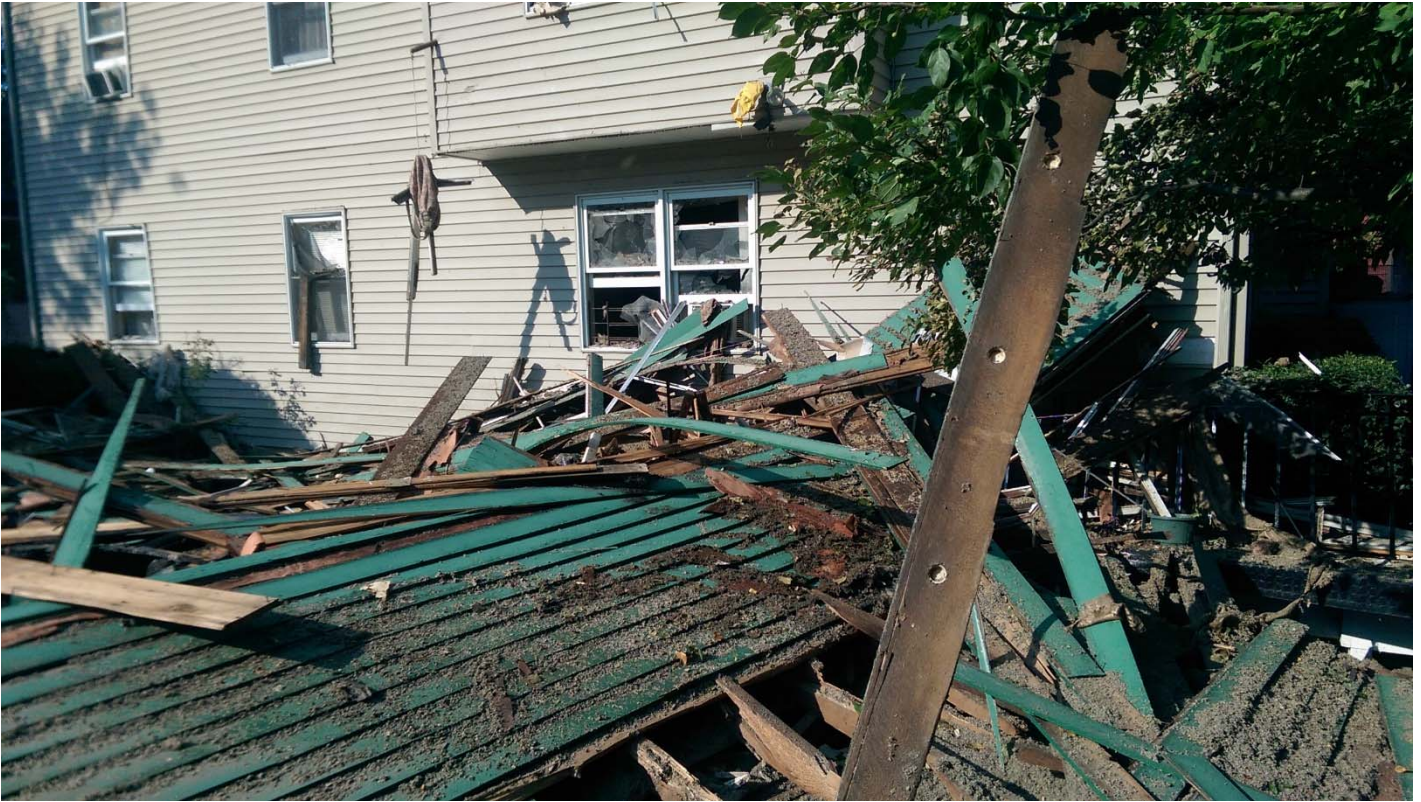
Based upon the evidence, the root cause of this incident was escaping gas from a leaking fuel line inside the house, beyond the meter. The leak was a result of trespassers cutting piping in the basement two days prior to the explosion. A contributing factor to this incident was the utility company’s failure to physically lock the gas service line valves and/or physically disconnect the customer piping from the gas supply, when the service was discontinued. Staff believes that the gas service piping up to the meters was intact prior to the incident. The service piping most likely sheared off during the explosion or when the search and rescue mission was underway. Although Staff could not confirm definitively, ignition appears to have initiated at the water heater. The explosion completely destroyed the two-family residential structure at 310 Paige Street and substantially damaged the neighboring residential structures, 304 and 314 Paige.

Photo 3 (8/10/2014) - 304 Paige Street exterior damage.

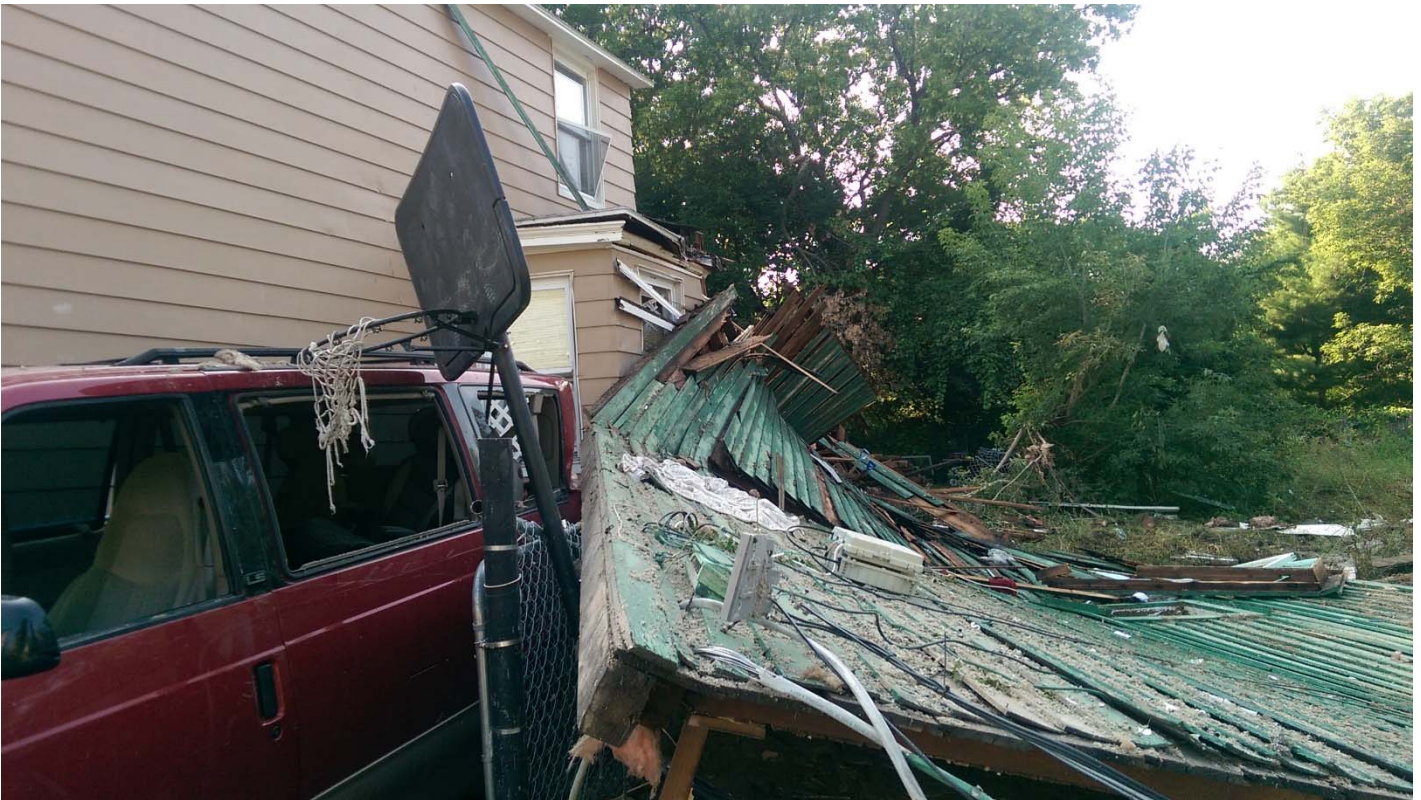
Photo 4 (8/10/2014) - 314 Paige Street exterior damage.

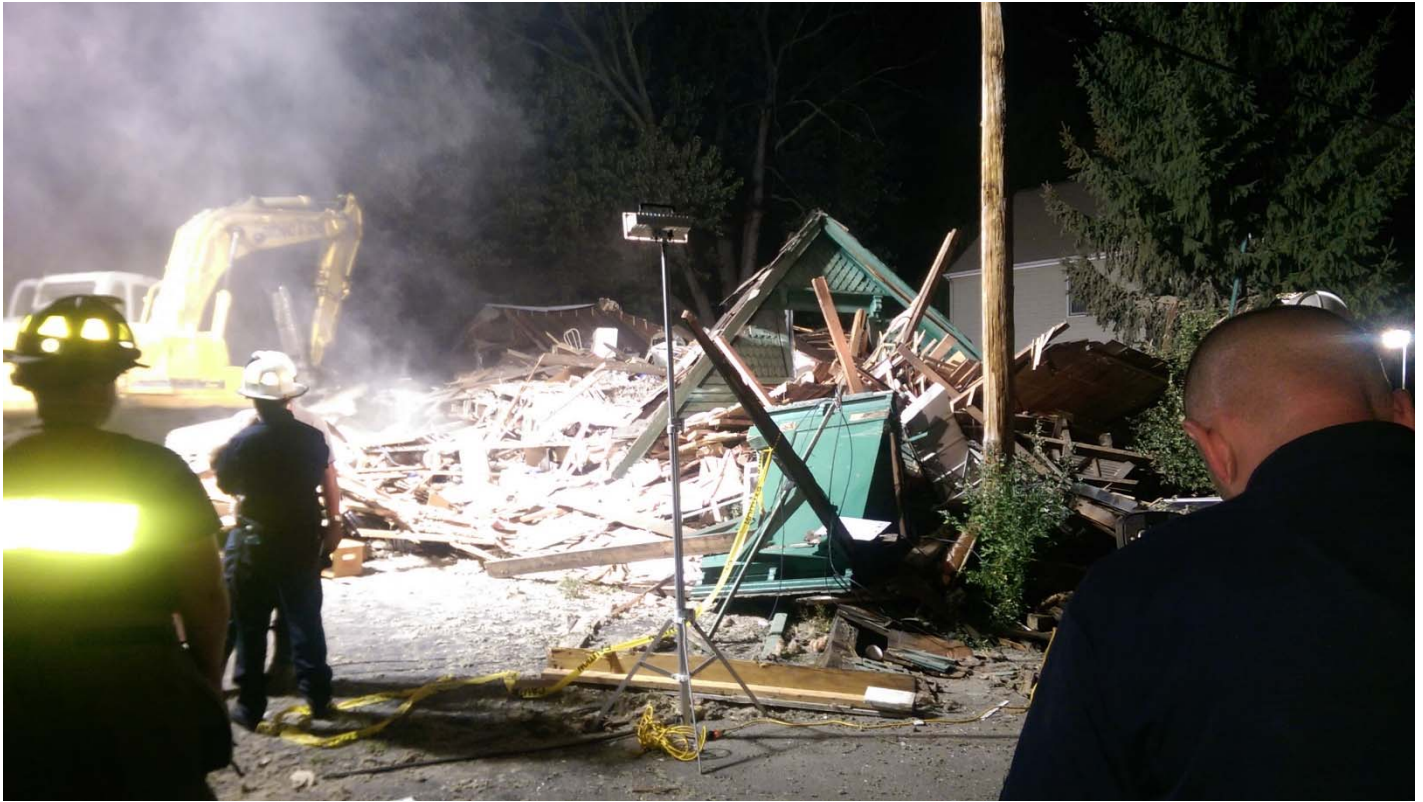
Photo 5 (8/10/2014) - Search and rescue mission after the explosion.

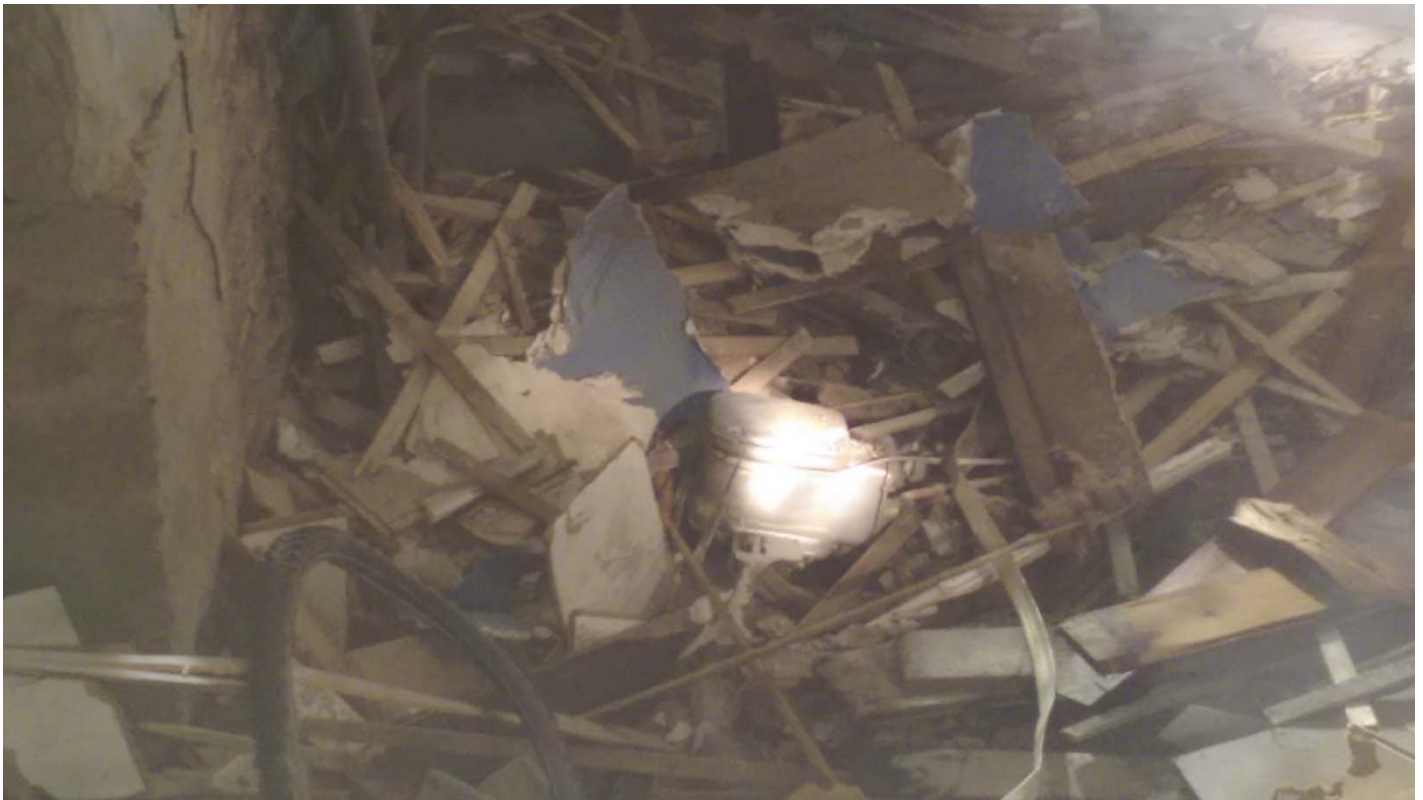
debris to expose what was left of the gas facility. Two gas meters, a section of 1-1/4-inch steel meter piping, and two service valves were recovered from the basement (See Photos 6, 7 and 8). The meters and associated piping were discovered lying on the basement floor, several feet from where the service line came through the foundation wall. Staff examined the meter piping and found that it had sheared at the wall (See Photo 9). Staff also found both service valves unlocked in the “on” position (See Photos 10 and 11). A hot water heater, which still contained hot water several hours after the incident was also recovered. This indicated that gas was being supplied to the customer’s piping prior to the incident.

Photo 6 (8/11/14) - A gas meter on the floor of the basement, before it was moved for observation.

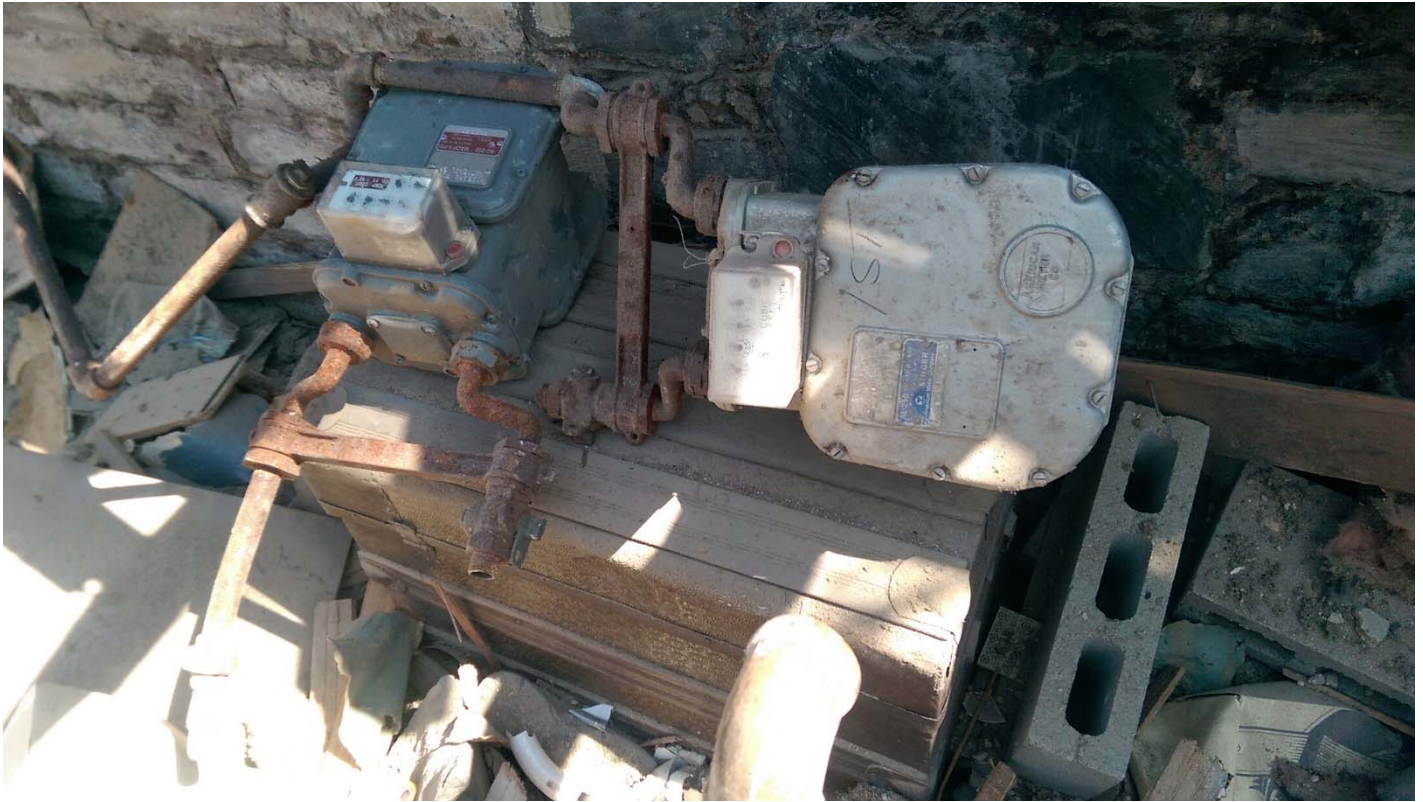
Photo 7 (8/11/2014) - Inside meters and service valves, after they were moved for observation.

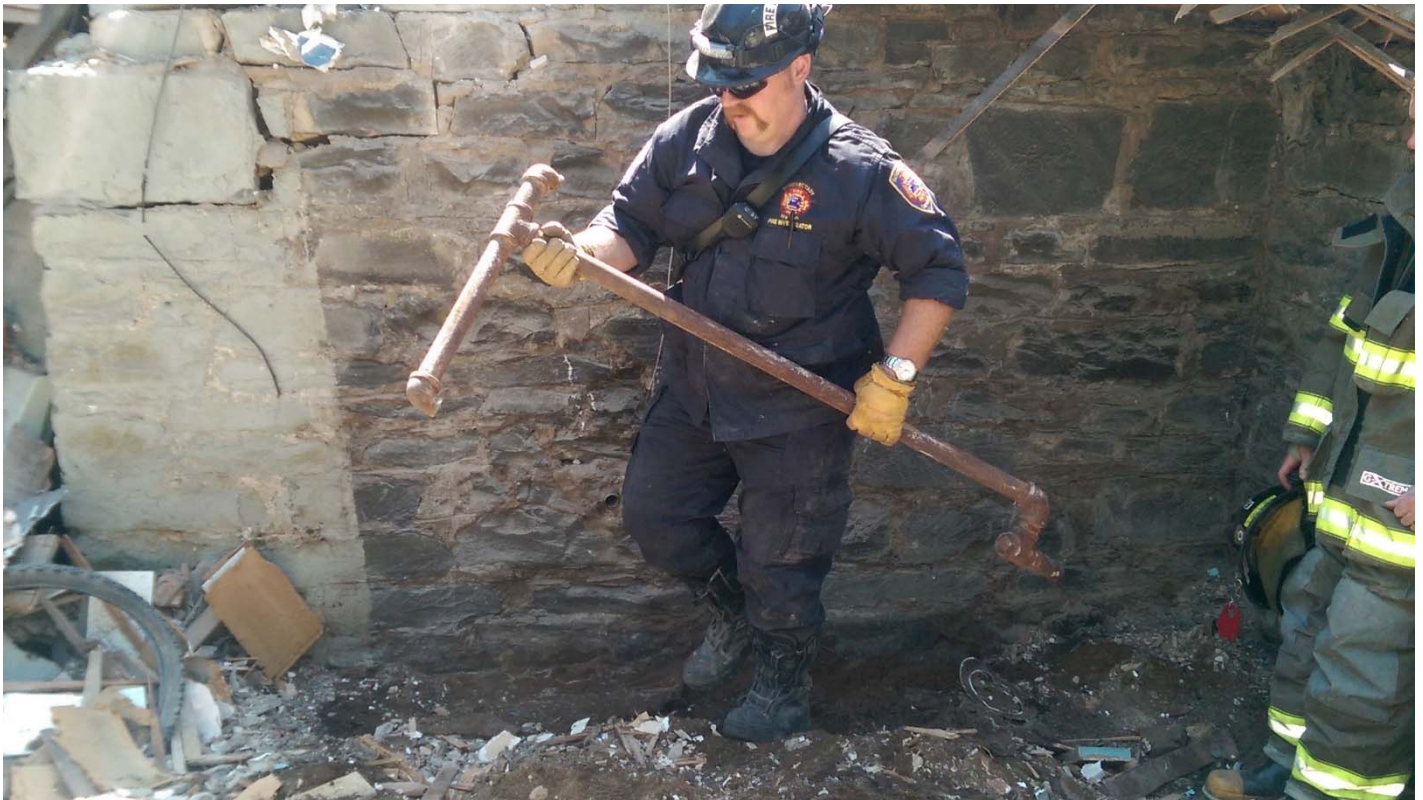
Photo 8 (8/11/2014) - 1 1/4 inch steel service pipe (inside).

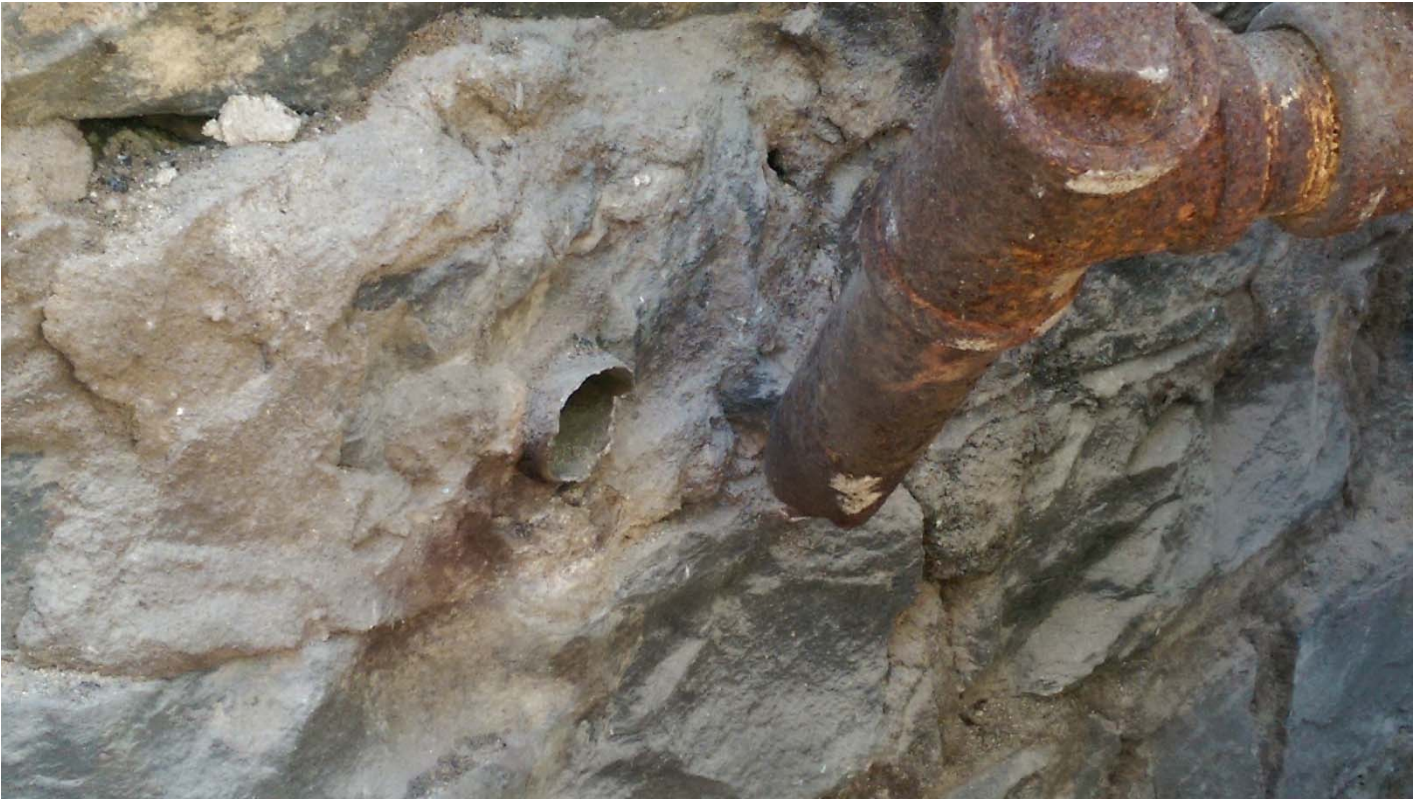
The following day (8/11/14), Staff discovered that the inside piping had sheared at the foundation wall, leaving the service line open ended, which prevented an effective test the previous day. A second test was performed from inside the foundation wall to the main. The service line was capped at the main. Pressure was applied from inside the foundation wall, where the service piping has sheared (See Photo 14). This test was also unsuccessful.

Photo 9 (8/11/2014) - 1 ¼ inch steel service pipe where it was sheared off at the foundation wall.

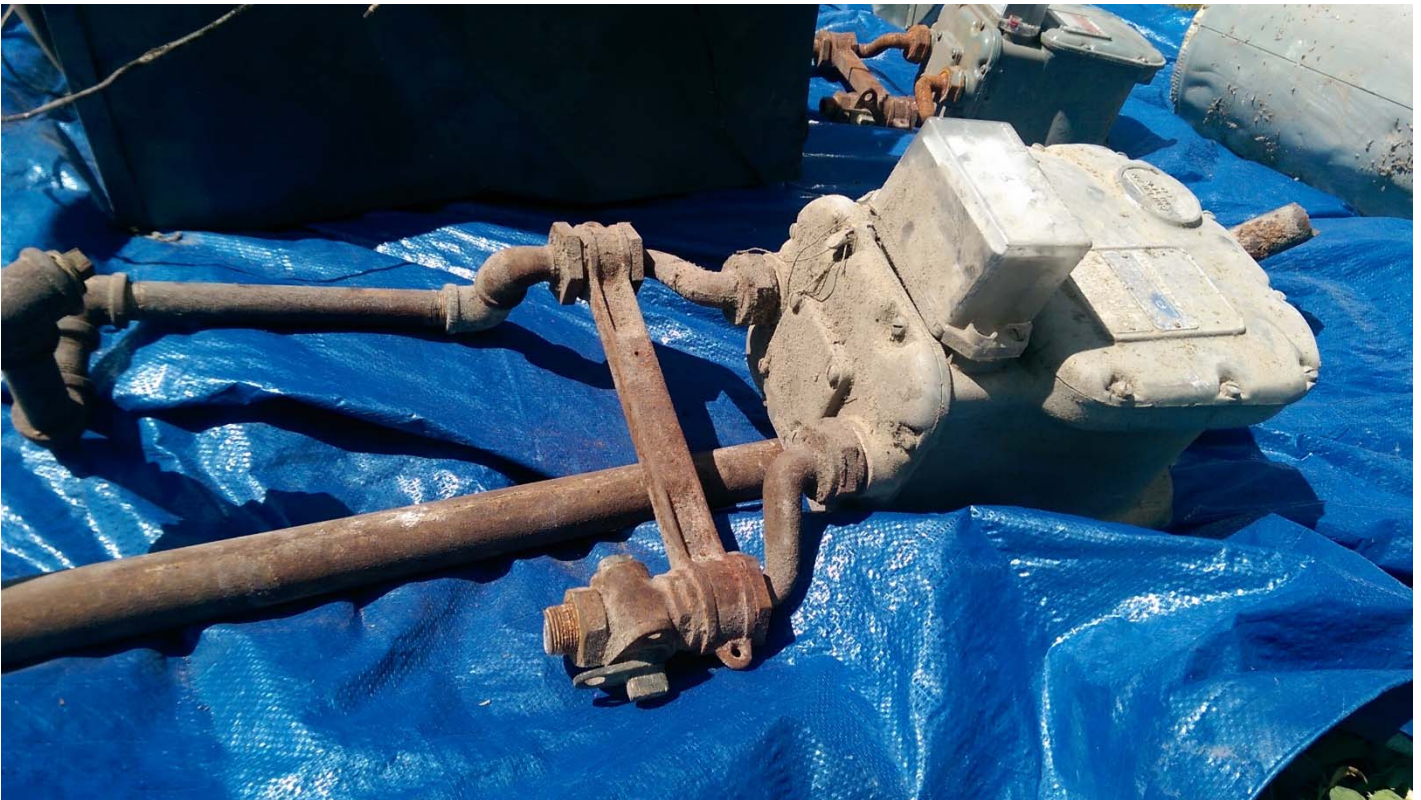
Photo 10 (8/11/2014) – First floor inside meter and service valve in “on” position.

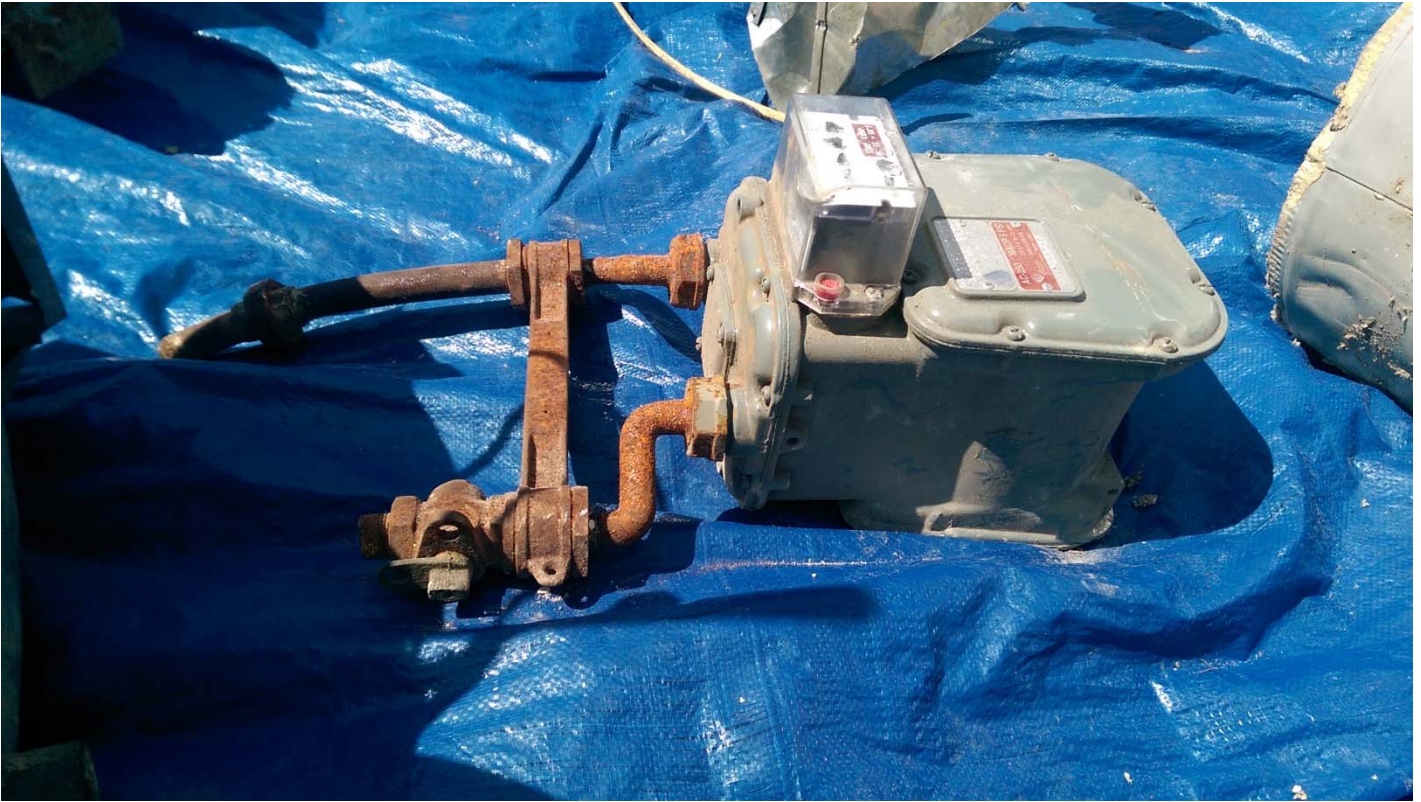
Photo 11 (8/11/2014) – Second floor inside meter and service valve in “on” position.

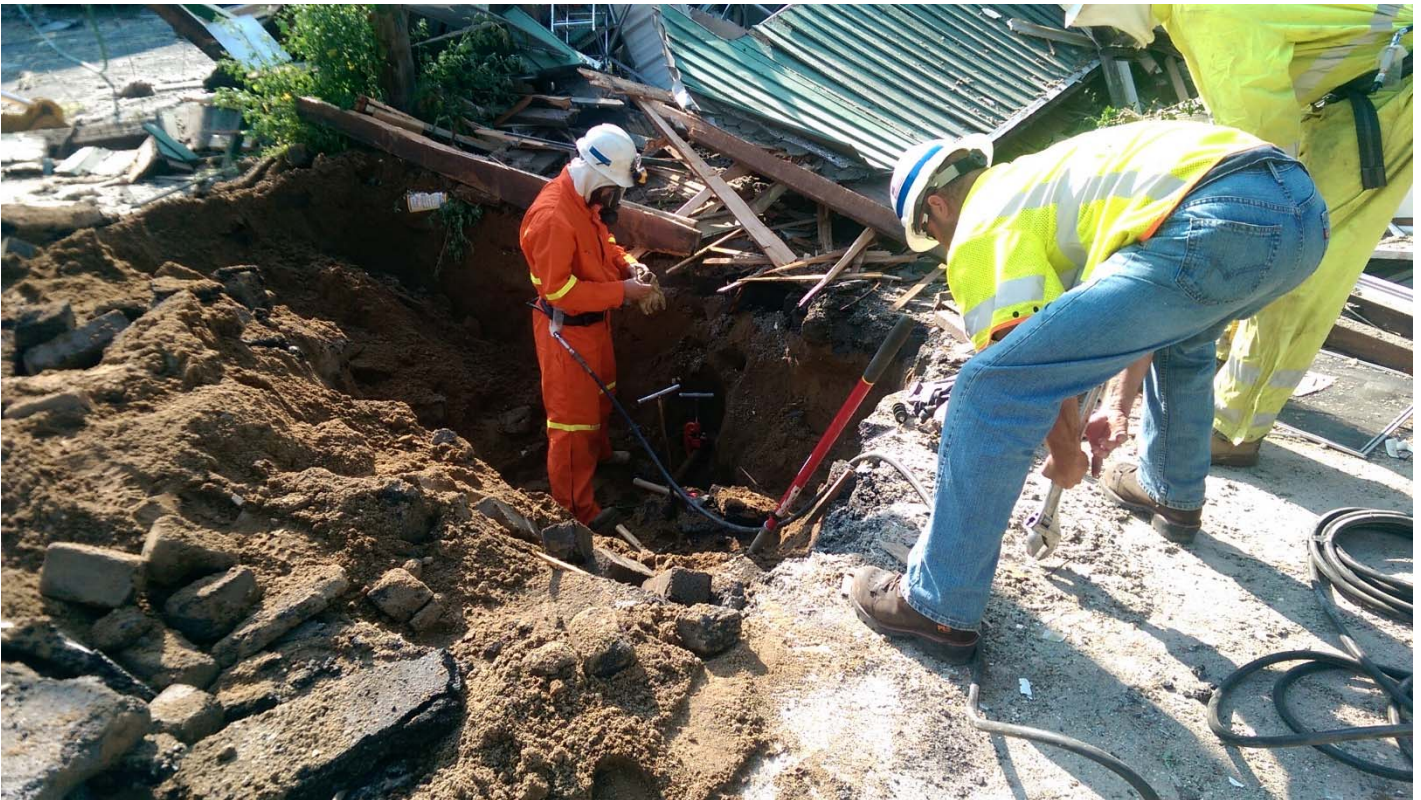
Photo 12 (8/10/14) – National Grid crews cutting the service at the main.

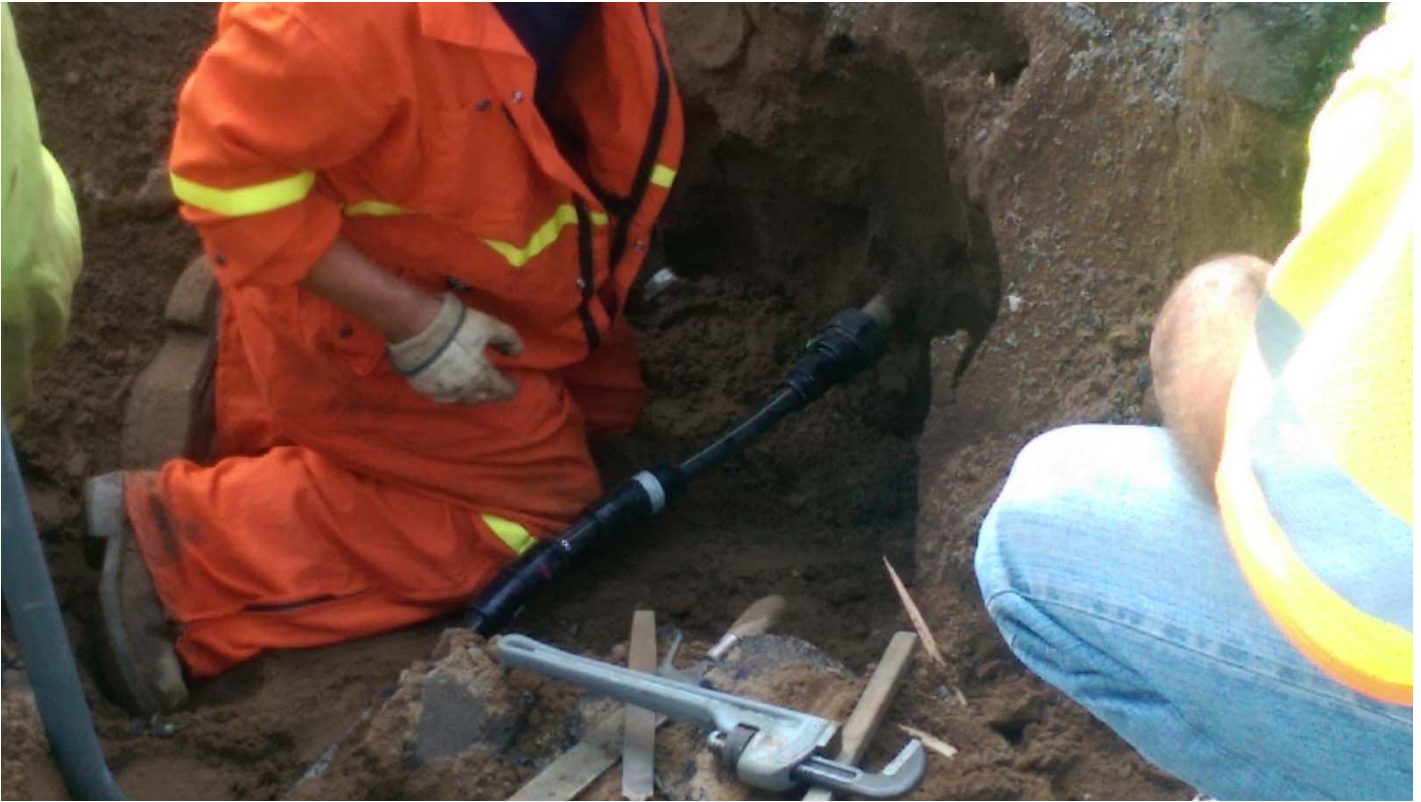
Photo 13 (8/10/14) – National Grid crews pressure testing the service pipe (near the main).

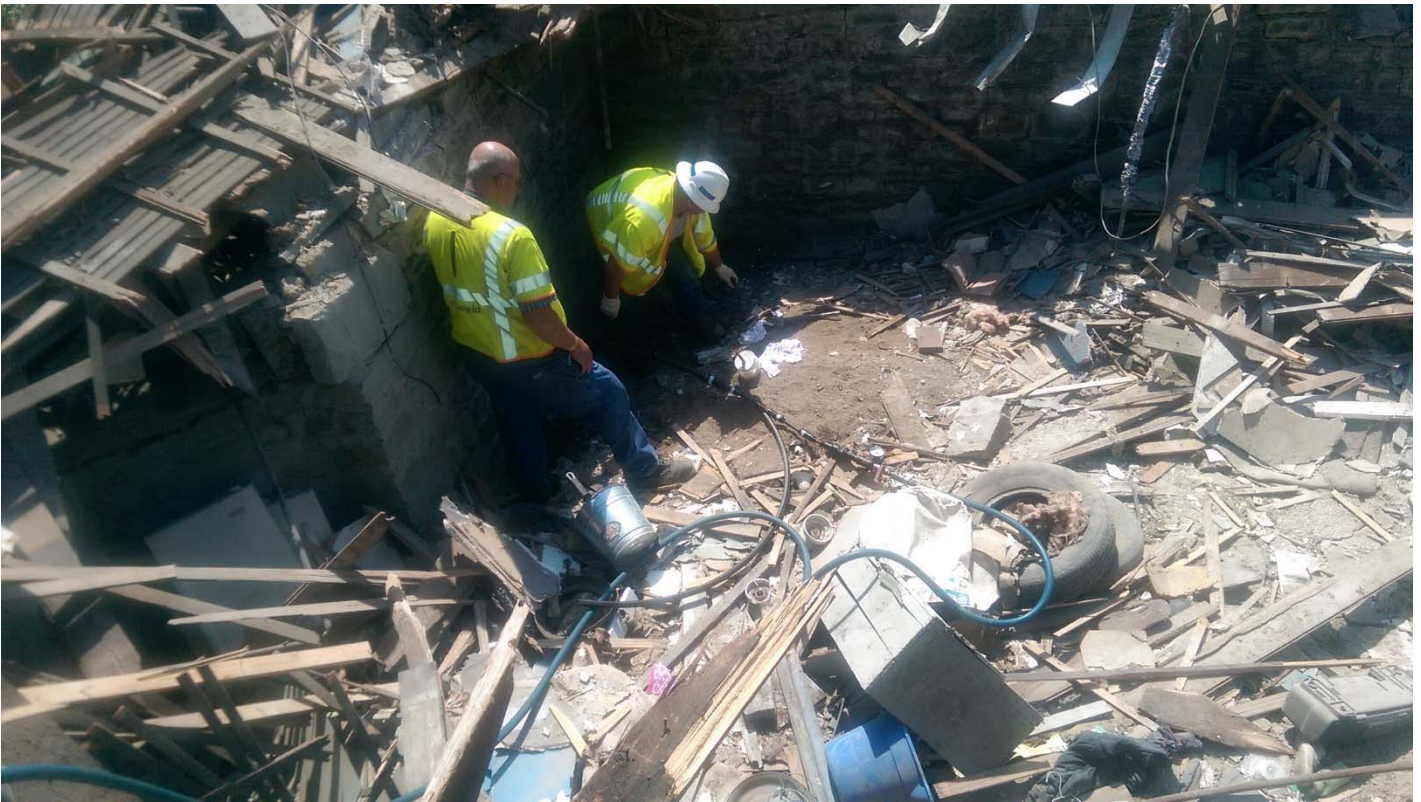
Photo 14 (8/11/14) – National Grid crews pressure testing the service pipe at the foundation wall to the capped end of the service (near the main).

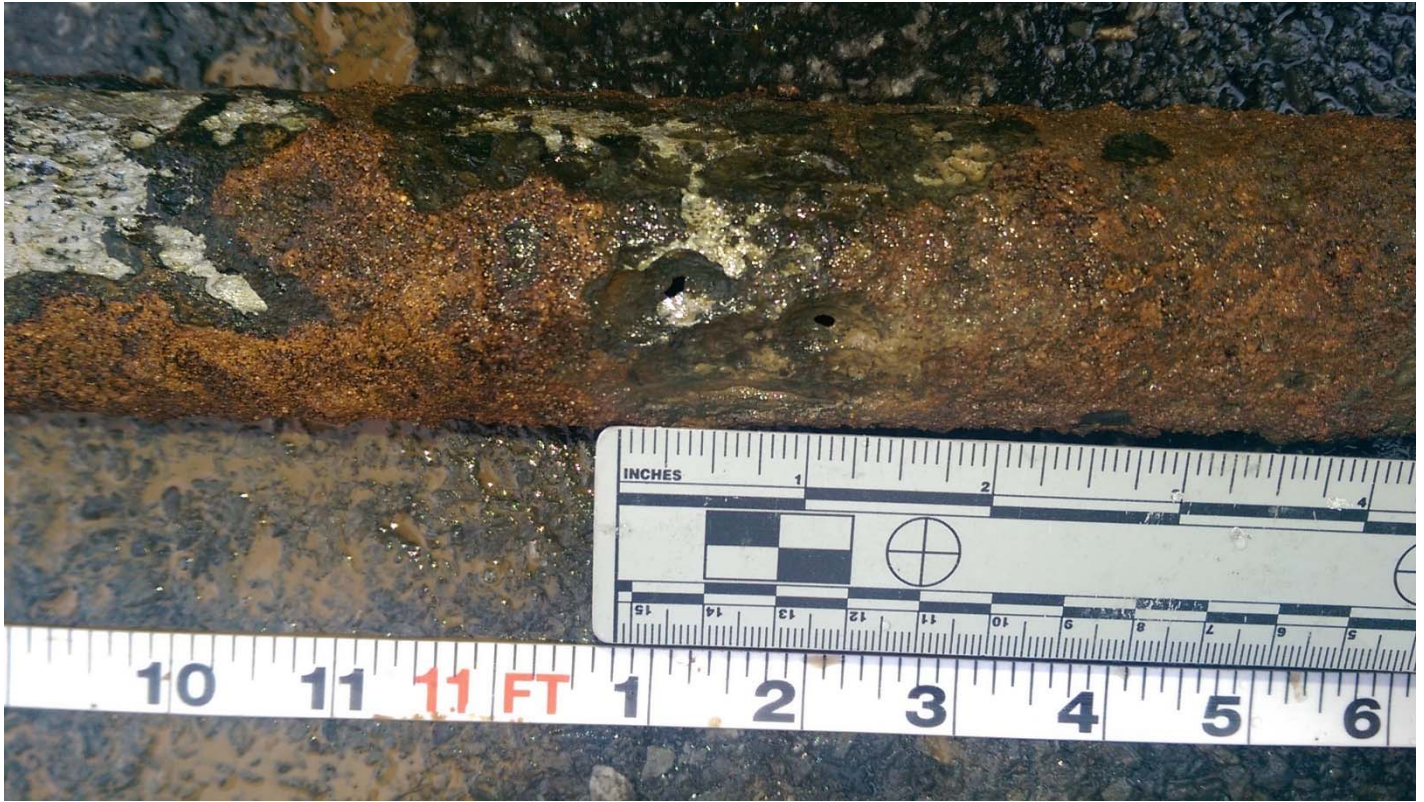
On the next day (8/12/14), the company uncovered the service with a high pressure water lance and vacuum excavator. A few pinholes were discovered in the service line, approximately 11 feet from the foundation wall (See Photo 15).

Staff is unsure whether these pinholes had formed due to corrosion, or were created during the excavation and/or pressure testing process. Due to the following factors, it is not likely that these pinholes were the primary source of gas migration into the house: the size of the pinholes, their relative location to the foundation wall, the low pressure distribution system, sandy soil conditions, and areas of unpaved cover above the service line. The service line was not believed to be a contributing factor in the explosion.

External Corrosion? <u>X</u> Yes <u> </u> No ⁽¹⁾	Coating Condition (Disbonded, Non-existent): ⁽¹⁾ Non-existent
<p>Description of Corrosion: The unprotected steel service showed surface corrosion throughout its length. There were a few visible pinholes along the external surface, approximately 11 feet from the foundation wall. An additional microscopic leak was discovered approximately 4 feet from the building wall.</p> <p>Staff is unsure whether these pinholes had previously formed due to corrosion, or were created during the excavation and/or pressure testing process on the service line. Due to the size of the pinholes, their relative location to the foundation wall, the low pressure distribution system, sandy soil conditions, and areas of unpaved cover above the service line, it is not likely that these pinholes were the primary source of gas migration into the house. The service line was not believed to be a contributing factor in the explosion.</p>

Photo 15 (8/12/14) - The pinholes found in the 1 ¼ inch service line.
