Case 18-S-0448: In the Matter of the Investigation of a Rupture at Fifth Avenue and 21st Street on July 19, 2018 in the Service Territory of Consolidated Edison Company of New York, Inc.

NEW YORK STATE DEPARTMENT OF PUBLIC SERVICE

CASE 18-S-0448

TECHNICAL REPORT

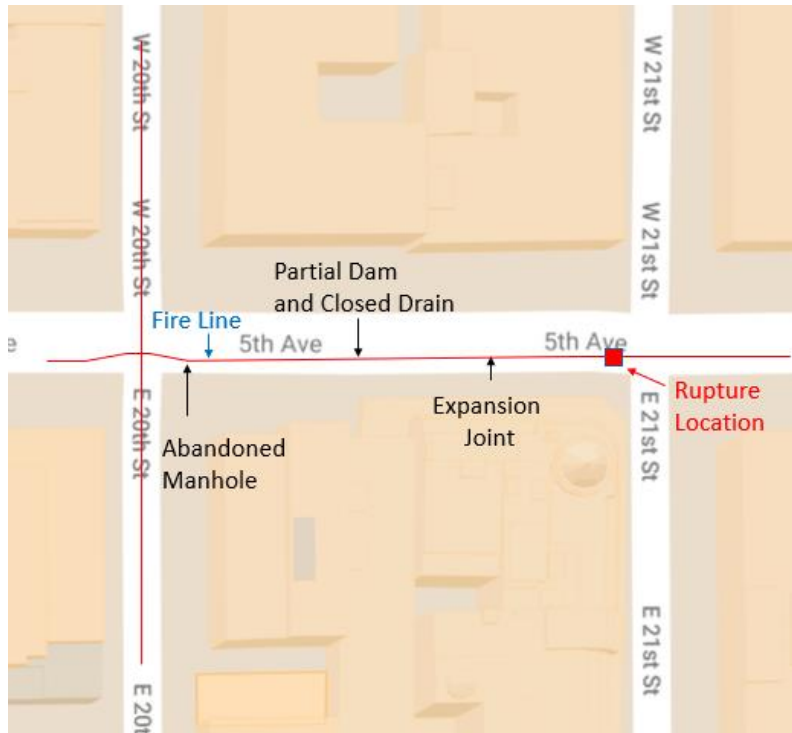
Figure 4 - Layout of Steam Main near Rupture Site

The layout of the steam distribution mains at the intersection of 21st Street and Fifth Avenue, as they existed on July 19, 2018, is shown in Figure 4. The 20-inch main that ruptured ran in a north-south direction along Fifth Avenue, crossing 20th Street, 21st Street, and 22nd Street. The steam main at the intersection of Fifth Avenue and 21st Street, near the rupture location, is approximately 9 feet deep. The section of steam main from 20th Street to 21st Street contains a base anchor and an expansion joint. In addition, within the block between 20th Street to 21st Street is a steam service connection for Building 141 Fifth Avenue. At the intersection of 20th Street and Fifth Avenue, the pipe depth is approximately 14 feet, where it connects to an east-west run of another 20-inch steam main running along 20th Street.

Steam mains are designed such that the pipe is sloped downward, so that condensate within the pipe can flow towards steam traps and be removed from the system. In this rupture location area, steam traps were located approximately one block in each direction from the rupture location. The steam traps are located at the intersection of 20th Street and Fifth Avenue and at the intersection of 22nd Street and Fifth Avenue (not shown in Figure 4). The intersection of 21st Street and Fifth Avenue, near where the incident occurred, was a relative high point on the steam system.

Most of the steam main between 20th Street and 21st Street was installed in 1932. However, small sections of main had been replaced during past operations and maintenance work. For example, adjacent to the rupture location was an anchor that was installed in 1991. Similarly, the expansion joint in this section of main was installed in 2005.

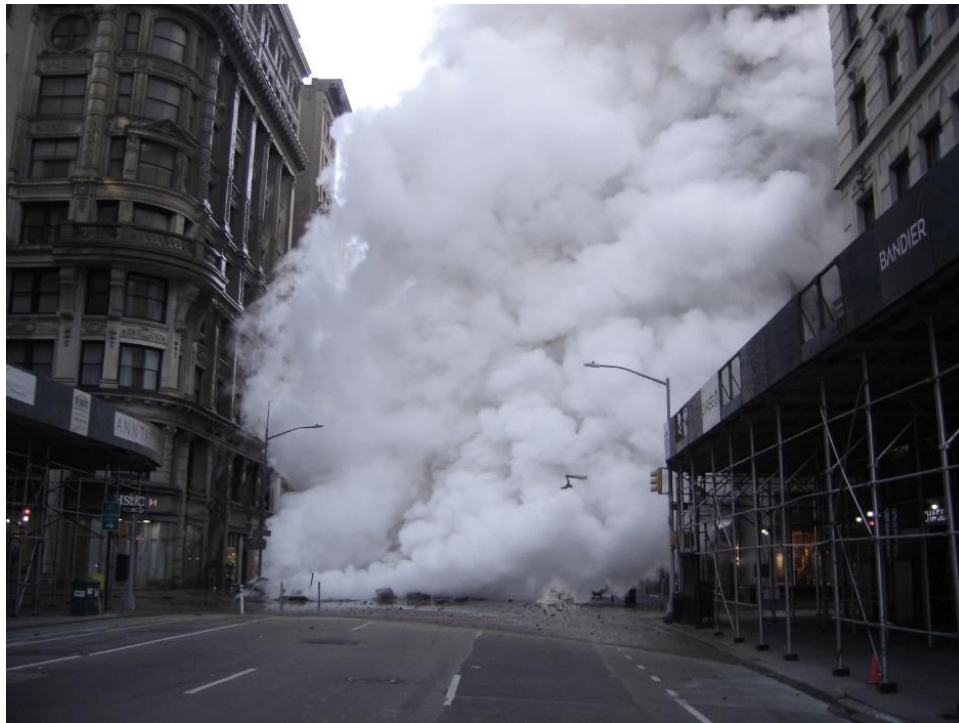
Figure 5 - Photo of Intersection of 21st Street and Fifth Avenue, Post Rupture. Taken by Con Edison

ruptured in the Flatiron district of Manhattan near the intersection of 21st Street and Fifth Avenue. The rupture caused debris and escaping steam to break through the pavement, resulting in a crater that was approximately 34 feet (North to South) by 15 feet (East to West). At 6:40 AM, Con Edison steam dispatch noticed a drop in system pressures in the area. CECONY was notified of a possible steam main rupture by the NYC Fire Department also at 6:40 AM. The rupture resulted in a large plume of steam emanating from the incident site.

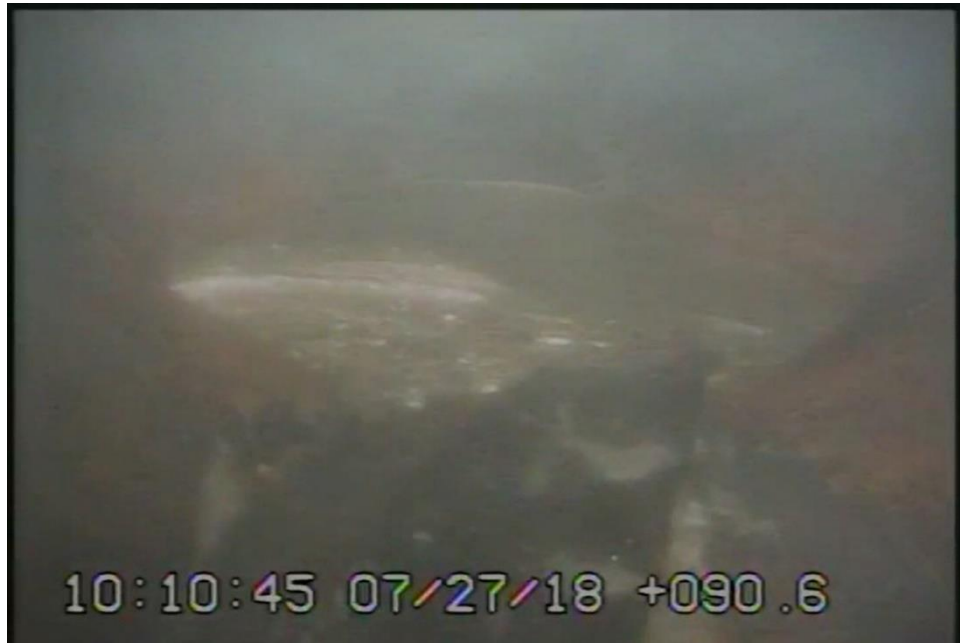
Figure 7 - Screen capture of rupture site from inside main from ULC Robotics Video

On July 27th, a mobile robotic video camera was inserted into the pipe at an opening near 139 Fifth Avenue, approximately 90 feet south of the rupture. The camera traveled northward towards the intersection of Fifth Avenue and East 21st Street, and encountered the fish-mouth rupture at the 6-o'clock

position on the pipe. The rupture was submerged in water, but evidence of an opening in the pipe was clearly visible.

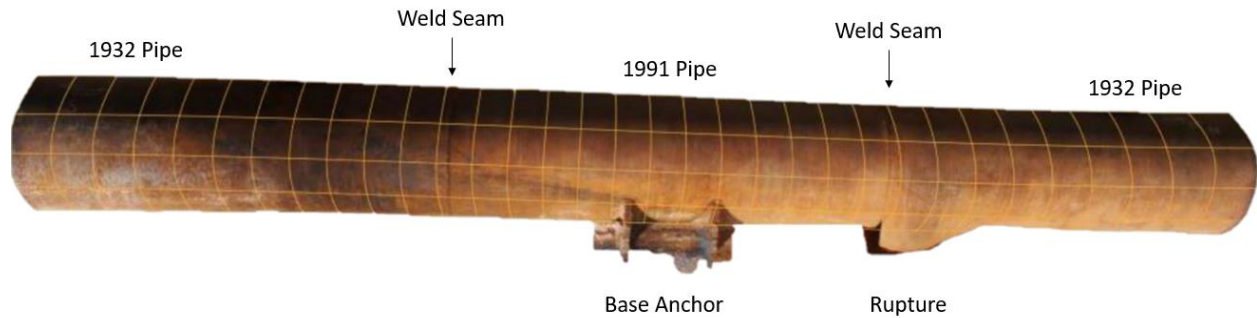
Figure 8 - Photo of Steam Pipe, from Affiliated (Rotated to Show Pipe in Same Orientation as Found in Ground)

Figure 8 shows the removed section of ruptured steam main. The majority of the 20-inch steam main along Fifth Avenue, between 20th and 21st Street, was installed in 1932. Since then, small sections of the steam main within this block had been replaced due to prior Con Edison operations and maintenance work. In the removed section containing the rupture, a 64.5-inch piece of pipe had been installed in 1991 between two sections of pipe installed in 1932. The 1991 pipe was installed to accommodate the installation of an anchor (shown in Figure 8) at this location. Anchors are used in tandem with expansion joints to allow for controlled linear expansion of the steam main due to thermal expansion.

As shown in Figure 8, the area where the steam main ruptured is located on the 1932 pipe, abutting where the pipe is joined to 1991 pipe. The rupture is confined to the 1932 pipe and extends along the weld joining the 1932 pipe to the 1991 pipe. See Figure 9.

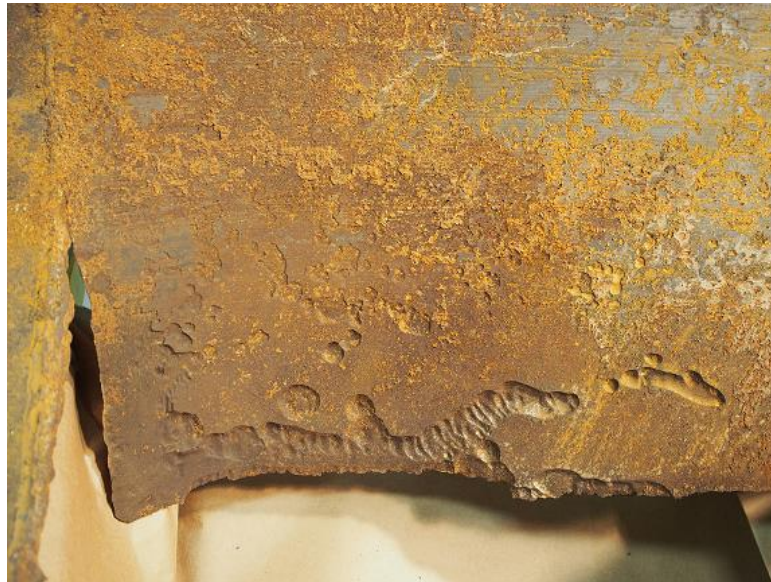
Figure 10 - Flow-Accelerated Corrosion on Bottom of Pipe, Taken by Affiliated

- There was severe metal loss on the pipe around the rupture area. The wall loss did not cause the pipe to rupture, but it did contribute to the failure by increasing the likelihood of the pipe rupturing during an overpressure event (such as over-pressurization caused by water hammer).

Affiliated's report notes that there was significant wall loss at the bottom (6 o'clock position) of the steam main. Affiliated characterizes the corrosion as being consistent with "corrosion-erosion". Affiliated states that such damage was consistent with condensate sitting at the bottom of the pipe and churning with steam flow as a result of turbulent steam flow. This process would have occurred over time during normal steam operations. LPI, in its report, states that the damage was consistent with flow-accelerated corrosion (FAC), due to the smooth and scalloped appearance of the corrosion on the pipe surface. FAC is a mechanism by which a metal's protective oxide layer is removed by a fast-moving fluid. The metal corrodes to recreate its oxide layer but loses material in the process. In this case, both terms ("corrosion-erosion" and "flow-accelerated corrosion) describe a similar cause for the corrosion observed at the bottom of the pipe - steam condensate was able to puddle near the pipe weld and movement from the steam flow caused the material loss observed at the bottom of the bottom. The condensate accumulation was made more likely because this area of the pipe has a flat slope and the weld bead on the inside of the pipe provided an area for the condensate to collect.

The lowest remaining wall thickness measurement in the corrosion area was 0.06-inches, significantly thinner than the pipe's nominal wall thickness of 0.375-inches. Although the lowest remaining wall thickness reading was 0.06-inches, this

reading was 4 inches away from where the pipe ruptured. Wall thicknesses along the rupture were around 0.134 inches. Therefore, although Affiliated's report states that the corroded wall section was near the initiation site of the rupture; the wall loss was not the cause of the rupture.

11. Con Edison will contract with a third-party to study the causes of steam main corrosion and identify mitigation methods. The study will examine the corrosion susceptibility of pipes of varying vintages and include a fracture mechanics evaluation to determine the effect various sized corrosion related flaws have on the structural stability of steam mains. Con Edison will submit the study to the Commission's Secretary or Records Access Officer, as appropriate, by November 30, 2021.
12. Con Edison Steam will evaluate the adoption of American Petroleum Institute Recommended Practice (API RP) 1173 "Pipeline Safety Management Systems." The evaluation will include a baseline assessment/gap analysis of the steam system by a third-party vendor. Con Edison will submit the evaluation results to the Commission's Secretary or Records Access Officer, as appropriate, by March 31, 2022.

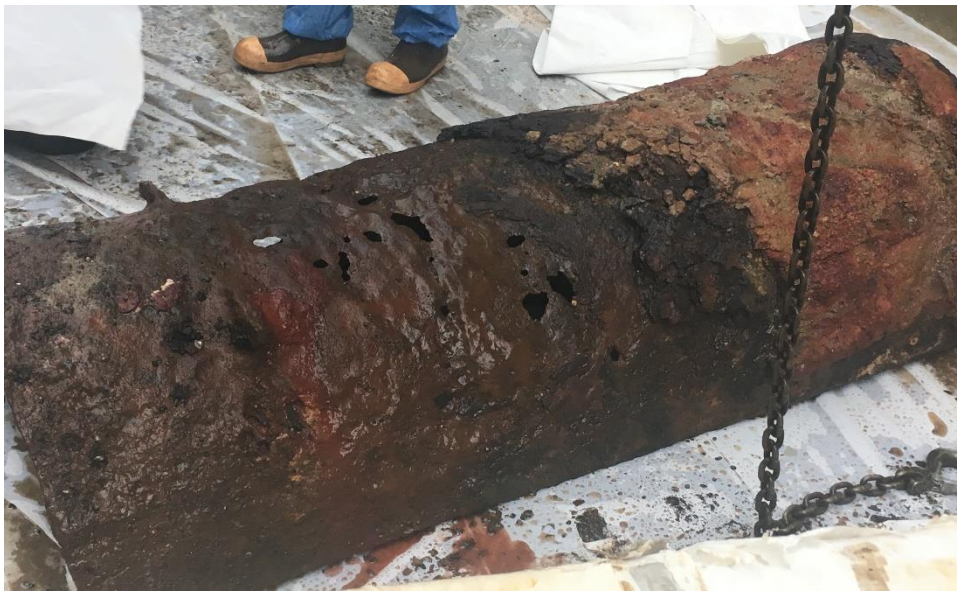
Figure 11 - Cast Iron Housing Removed from Rupture Site, Image Taken by Staff

- Con Edison's steam housing in the area of the rupture did not have adequate drainage to allow water flow out of the housing. Drainage through this housing had either not been maintained or had been compromised by Con Edison's construction over the years. Specifically, an abandoned Con Edison Steam manhole located near the intersection of 20th Street and Fifth Avenue was found to have significantly impeded the drainage of water from the housing to manhole vault, where it could have been removed from the system and avoided contributing to this incident. This lack of drainage allowed water to remain in the housing, which facilitated the generation of condensate and, therefore, the subcooling of the steam main necessary for condensation-induced water hammer. Although no safety

As explained previously, an external source of water that infiltrated into the steam main housing and the configuration of the steam main housing allowed water to build up around the steam main. The housing directly underneath the water service was a newer style concrete housing, installed in 2005. However, approximately 10 feet north of the fire line are older cast iron housings (circa 1932). The cast iron domes for the older housing were found corroded to the point that there were holes in the top of the housings (see Figure 11). It appears that water could have entered the steam housing through holes in these cast iron housings.

4. By September 30, 2021, Con Edison will submit to the Commission's Secretary or Records Access Officer, as appropriate, revised design specifications that include the requirement of drainage continuity through steam main housings for new construction, repairs, and retirement projects.

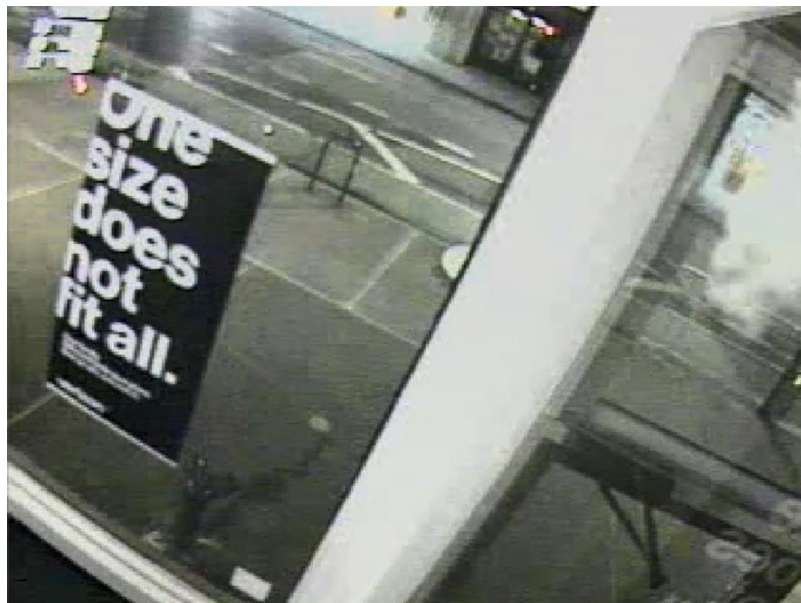
Figure 12 - Screen capture of steam leaking from valve access cover at 4:56 AM

A video obtained from the Verizon store at 139 Fifth Avenue shows a plume of steam vapor from a valve access cover in

front of the store (see Figure 12 below). The steam vapor starts at 4:17 AM and ends at approximately 5:44 AM. The video provides strong evidence that water had infiltrated the steam housing, began boiling off and cooling the main, and then stopped once the main had subcooled and the condensate stratified to the point where the outer surface of the main was no longer hot enough to boil off the water. This cooling resulted in the condensate necessary to cause the water hammer condition.

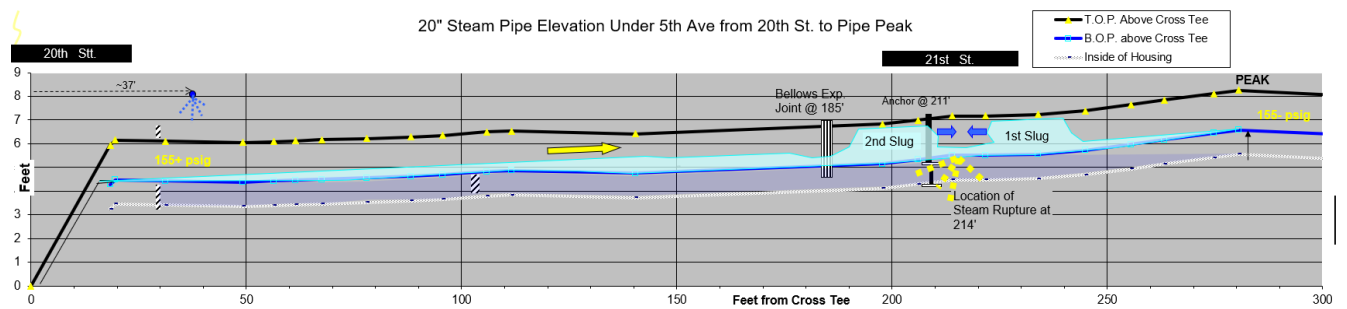
Figure 13 - Diagram of Two-Opposing Slug Water Hammer Mechanism (From Kirsner Report)

Based on the known facts, the water hammer formed was a less conventional type of water hammer, what Kirsner terms "The Two-Opposing Slug CIWH." In the conventional water hammer scenario, one end of the pipe is completely filled with subcooled condensate. A single slug, which is a mass of water that blocks or impairs steam flow in the pipe, entraps a steam bubble within the subcooled condensate. The bubble then rapidly collapses, resulting in a water hammer.

In the Flatiron Steam Incident, the most likely cause of the water hammer was two opposing slugs colliding into each other. As shown in Figure 13, two slugs entrap a bubble of steam. The trapped steam suddenly condenses and collapses, causing the two slugs to collide into each other causing water hammer. Kirsner concludes that this is the most likely cause of the CIWH at 21st and Fifth Avenue for two reasons.
