Report 1000635.401
Project No. 1000635.00
20th August 2010

**Level One HRSG Assessment
Consolidated Edison's East River Units 10 and 20**

Structural Integrity Associates, Inc.
Charlotte, North Carolina

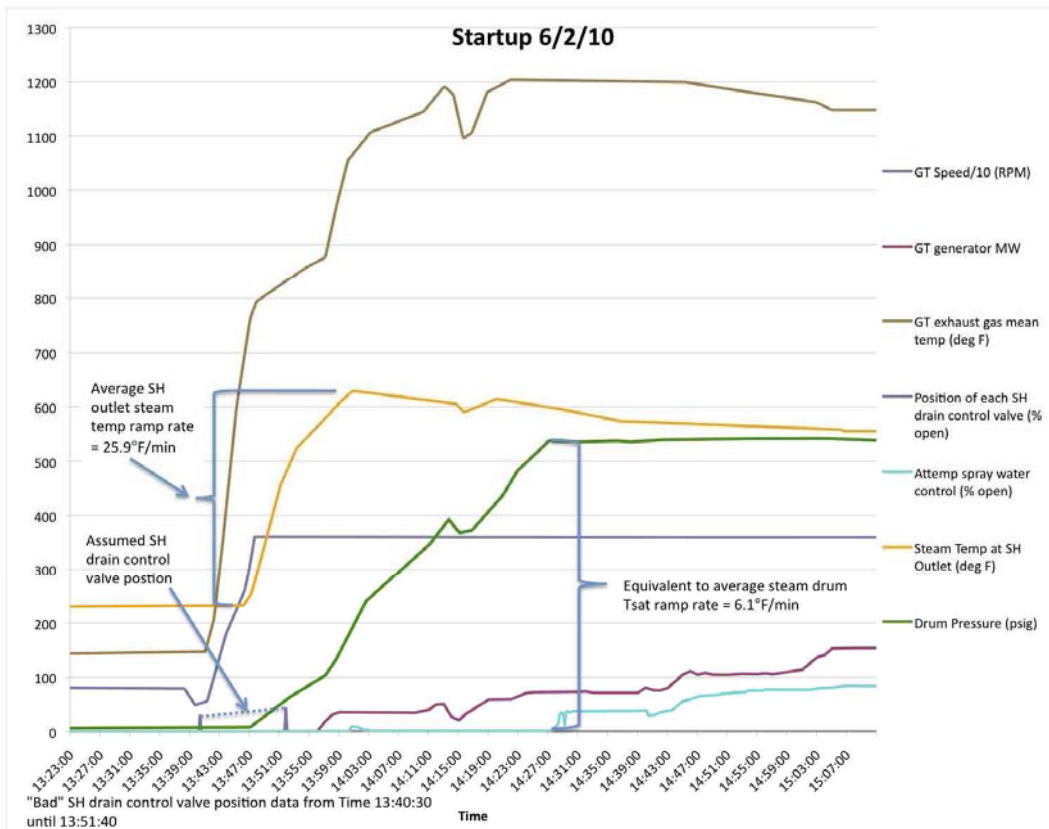
Figure 1 – Plots of DCS historical data for startup on 6/2/10

SH drain operation is reported to be fully automatic with no need for operator intervention. The reported current drain control logic opens the SH drain MOV during startup when GT ignition is detected. The MOV remains open for a minimum of one minute if drum pressure is in excess of 50 psig. Otherwise, it closes when drum pressure reaches 50 psig. Actual SH drain valve action observed via historical DCS data for the startup on 6/2/10 (Figure 1) indicates that the MOV opened quickly to 29% stroke when the GT ignited with drum pressure at zero. When drum pressure increased to 50 psig the MOV rapidly closed from a position of 43% stroke. It is uncertain what drain valve MOV action may have been between opening and closing since this data point indicates a "bad" signal during this period. It is assumed that the MOV remained open at some position between 29% and 43% stroke, but this cannot be verified via the data provided.

It was reported that after audible evidence of water hammer associated with SH drain operation the 1-inch SH drain piping was replaced with 2-inch pipe, substantial drainpipe elevation increases in the direction of drain flow were eliminated, and that the original 1-inch SH drain MOV and block valve were retained. The new 2-inch pipe size was chosen based upon condensate formation rate and two-phase drain flow capacity calculations performed by ConEd personnel. The automatic logic controlling the SH drain MOV was also modified to eliminate water hammer.

The plot of Drum Pressure during the startup on 6/2/10 in Figure 1 indicates that drum saturation temperature increased at an average rate of 6.1°F per minute. The plant's operating procedures list the maximum permissible drum saturation temperature ramp rate as 20°F per minute. Assuming that the maximum drum saturation temperature ramp rate listed in the operating procedures is consistent with those calculated by the HRSG OEM, the actual ramp rate of 6.1°F per minute observed during the 6/2/10 startup provides substantial margin against thermal fatigue damage to the drum.

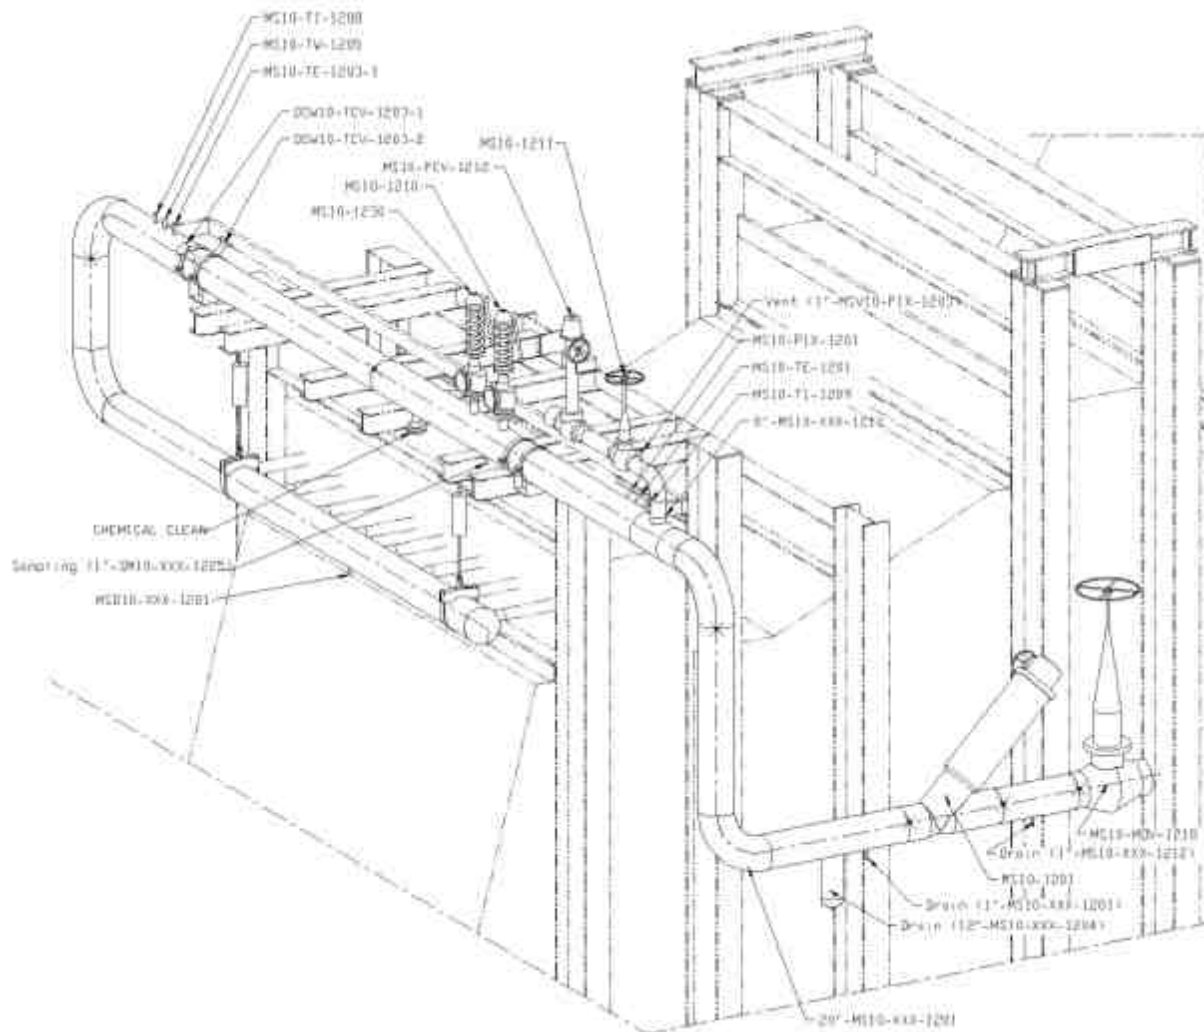
Figure 2 – Main steam pipe arrangement with SH outlets, attemperators and existing drains.

Steam flows from the eight 6-inch SH outlet nozzles into the side of a horizontal 20-inch main steam pipe. A single 1-inch drainpipe with manual valve is located on this pipe at the HRSG centerline. The steam travels up a vertical U-shaped section of 20-inch pipe into another horizontal 20-inch pipe in which the two attemperator nozzles are located at an elevation approximately 10 feet above the SH outlet. A 12-inch drip leg with a 1-inch drainpipe is located on the main steam pipe downstream of the attemperators at an elevation about 14 feet below the attemperators. See Figure 2. Any spray water introduced by the attemperator via valve leakage or inappropriate operation during low, or zero, steam flow conditions is likely to flow back into the SH. Since attemperator leakage and inappropriate operation are not planned events, the single 1-inch manual drain upstream of the attemperator is of no value in preventing backflow of water into the SH. A number of ductile overload and tube fracture events have occurred in other units that lack adequate attemperator piping drains.

To minimize the risk of such failures it is suggested that a 12-inch drip leg be installed in the main steam piping just upstream of the attemperators. Sizing of the drainpipe attached to this drip leg should take into account the maximum attemperator spray water flow anticipated during a worst-case leak or inappropriate operation event. While ConEd is under no obligation to retroactively comply, it is worth noting that the ASME Boiler and Pressure Vessel Code was amended in 2007 to require on new units a low point drain between the attemperator and SH where the risk of back-flow exists.

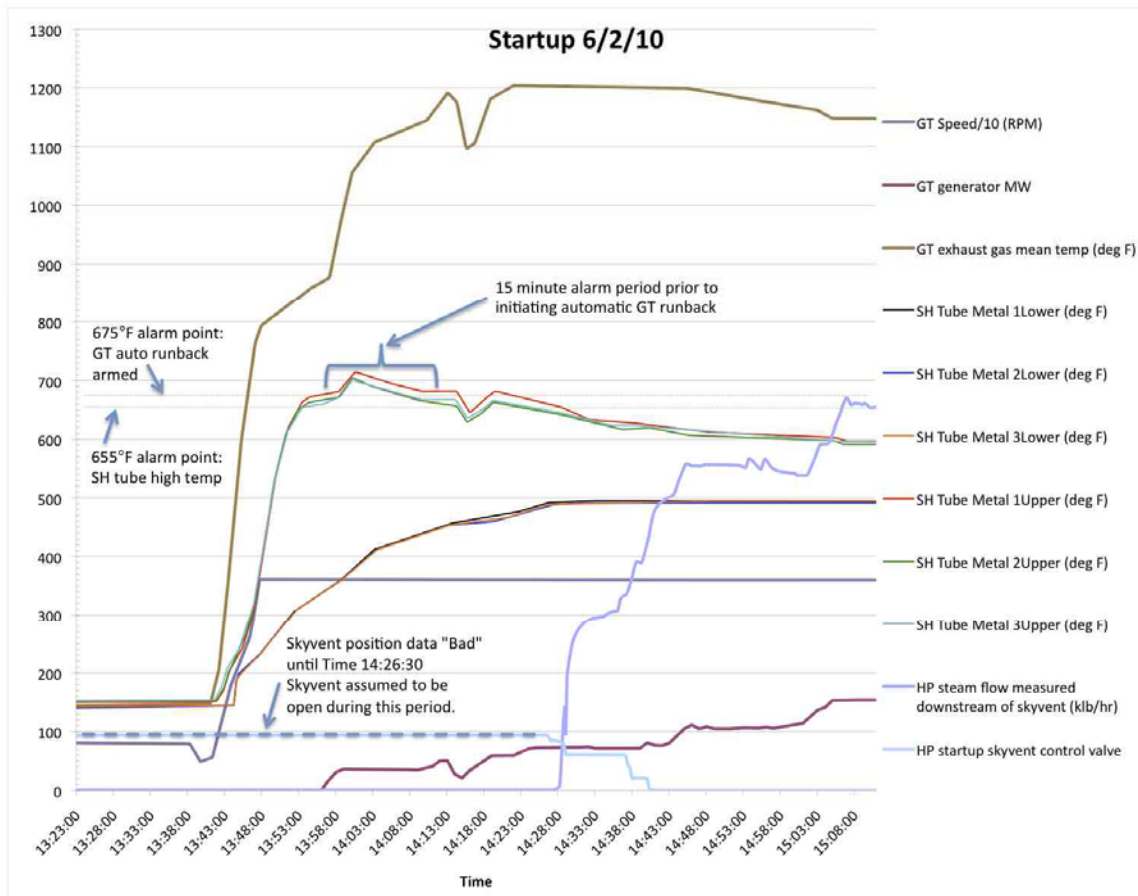
Figure 3 – Plots of DCS historical data for startup on 6/2/10

The plots of upper tube temperatures during the startup on 6/2/10 in Figure 3 indicate that during this startup event both the 655°F High temperature and the 675°F High-High temperature alarm points were exceeded and that the High-High tube temperature condition persisted beyond the 15-minute time delay required to initiate a GT load runback. The hottest instrumented SH tube reached a peak temperature of 714°F.

It has been demonstrated in other HRSGs via data from temporary tube metal temperature thermocouples distributed across the SH that during early startup SH tube metal temperatures vary greatly. This variation is due to non-uniform distribution of GT exhaust gas flow, higher velocity of exhaust gas through gaps at sidewalls and between modules, and non-uniform steam flow distribution through SH tubes at lower volumetric steam flow rates. While the three permanent upper SH tube temperature thermocouples appear to be located adjacent to the side wall and center module gaps where temperatures are typically higher, it may not be safe to assume that these three instrumented tubes actually represent worst case SH tube outlet temperatures during all startup conditions. In addition, a feature of the GE7FA GT is that its exhaust temperature is highest when passing through loads below the normal operation load range during startups and shutdowns. When operating in this load range, GT load runback can actually increase tube temperatures for a period of time rather than decreasing them. The carbon steel SH tubes, headers and piping are vulnerable to significant irreversible material properties degradation via decarburization when operated above about 800°F for periods of time that cumulatively exceed a few thousand hours. It is important to minimize the duration of excursions above the prescribed limit temperatures. The 655°F High temperature and the 675°F High-High temperature alarm points may seem significantly lower than temperatures that will cause material degradation, but this may be to provide adequate margin to accommodate those parts of components that may operate at temperatures significantly higher than those measured by the monitoring thermocouples.

It was reported during the site visit that the runback is triggered if the operator increases GT load too rapidly during startup. While it is apparent from Figure 3 that this protective feature worked as designed during this startup, it would be prudent to determine the optimum GT loading rates, GT load hold points, GT load hold durations, and SH steam flows required during startup to avoid triggering high SH temperature alarms and GT load runback. Once established, these parameters should be incorporated into the plant's written startup procedures and consistently observed. Consideration might also be given to automating these aspects of startup via their incorporation into the plant's DCS logic.

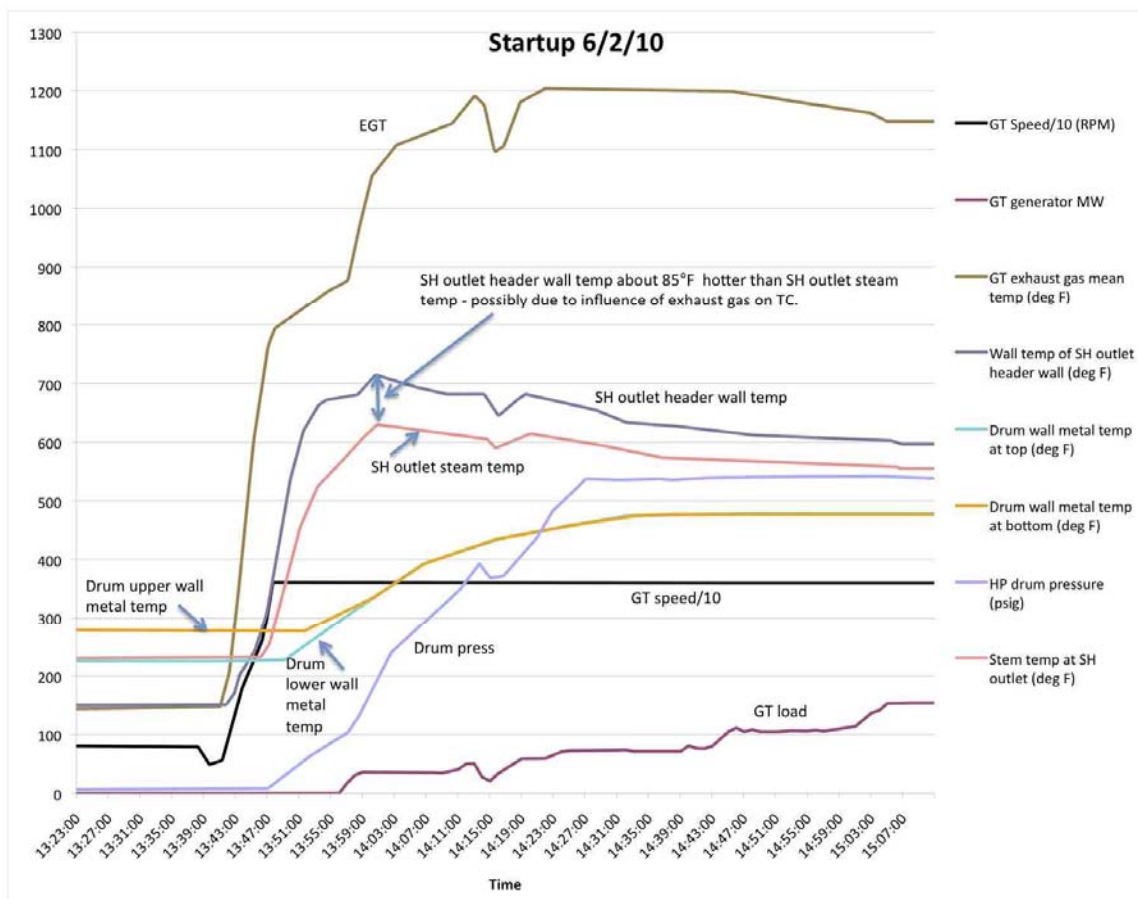
Figure 4 – Plots of DCS historical data for startup on 6/2/10

The East River HRSG is equipped with a permanent SH outlet header wall temperature thermocouple. It is assumed that this thermocouple is welded to the outer header surface. The plot of *SH Outlet Header Wall Temperature* during the startup on 6/2/10 in

Figure 4 illustrates that the SH outlet header wall temperature is consistently close to that measured at the upper outer surface of the three SH tubes plotted in Figure 3. The header wall temperature plotted in Figure 4 and the SH upper tube temperatures in Figure 3 are consistently hotter than measured SH outlet steam temperature also plotted in Figure 4. The header wall temperature peaks at 714°F, as do the instrumented SH tubes discussed above. While at this peak temperature the header wall is approximately 85°F hotter than SH outlet steam temperature.

It is suggested that the SH header wall thermocouple should be inspected for any of the following conditions that may cause erroneously high readings:

- Insecure attachment to the SH header wall
- Insufficient and/or incomplete covering of thermal insulation
- Additional thermal junctions introduced by defective thermocouple wiring
- Erroneous SH header wall thermocouple calibration.

Consider performing replication of the SH outlet headers' outer surface to determine if any metallurgical degradation associated with high temperatures has occurred, particularly if the foregoing thermocouple and gas baffle inspections indicate that the header surface temperatures presented in Figures 4 and 5 are accurate.

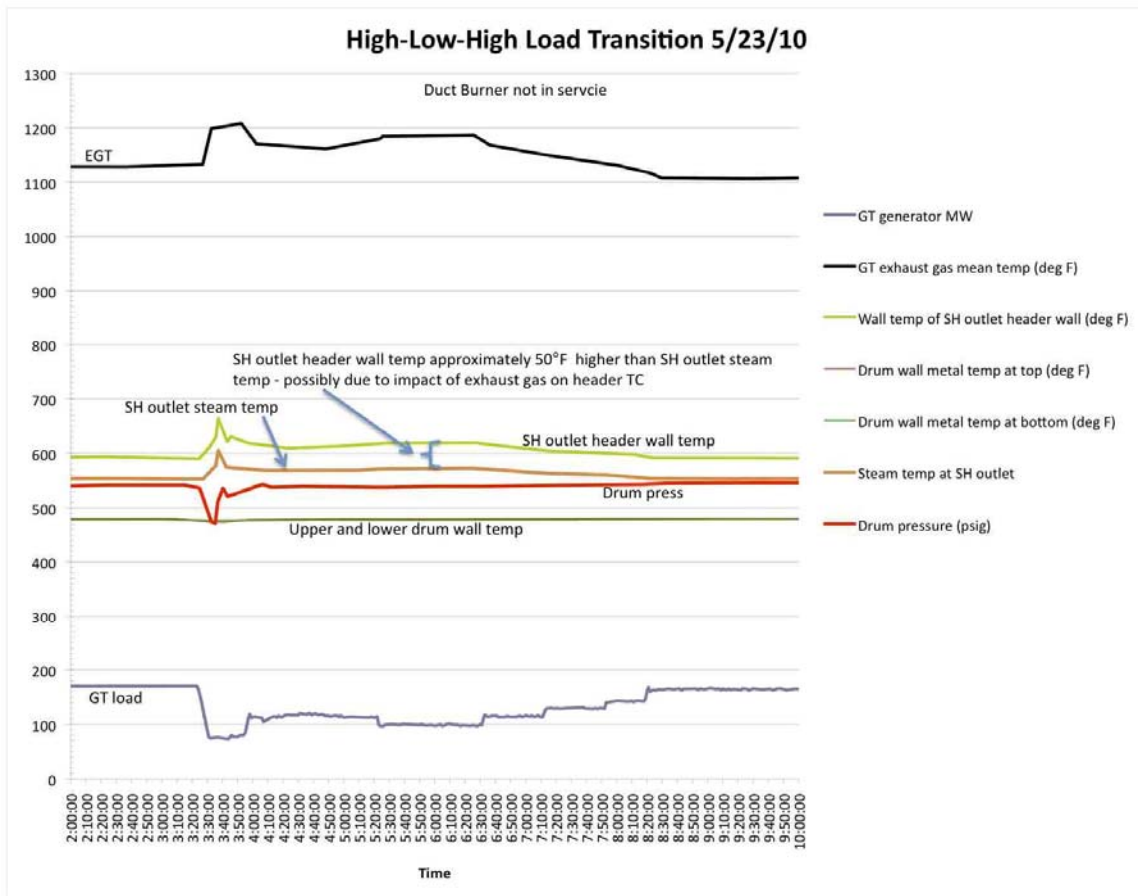
Figure 5 – Plots of DCS historical data during high-low-high GT load transition on 5/23/10

The plot of *SH Outlet Header Wall Temperature* during operation at higher GT load on 5/23/10 in Figure 5 indicates that the header wall temperature is consistently about 50°F hotter than SH outlet steam temperature during stable operation at GT loads above about 80MW. However, during the load reduction transient in Figure 5 the header wall temperature peaks briefly at 664°F, which is above the 655°F High SH tube temperature alarm point.

HRSG headers are typically partially shielded from direct exhaust gas impingement and are therefore primarily heated and cooled from the inner surfaces by the steam flowing through them. During startup when steam flow is very low a moderate mismatch between header outer surface temperature and the remotely located bulk outlet steam temperature thermocouple is not unusual. However, during stable periods of high steam flow significant difference between header wall and bulk steam temperatures, such as those in Figure 5, are not anticipated when the thermocouple attached to the outer surface of the header wall has been covered with thermal insulation such that it is not influenced by the temperature of the hotter gas flow across the back of the header.

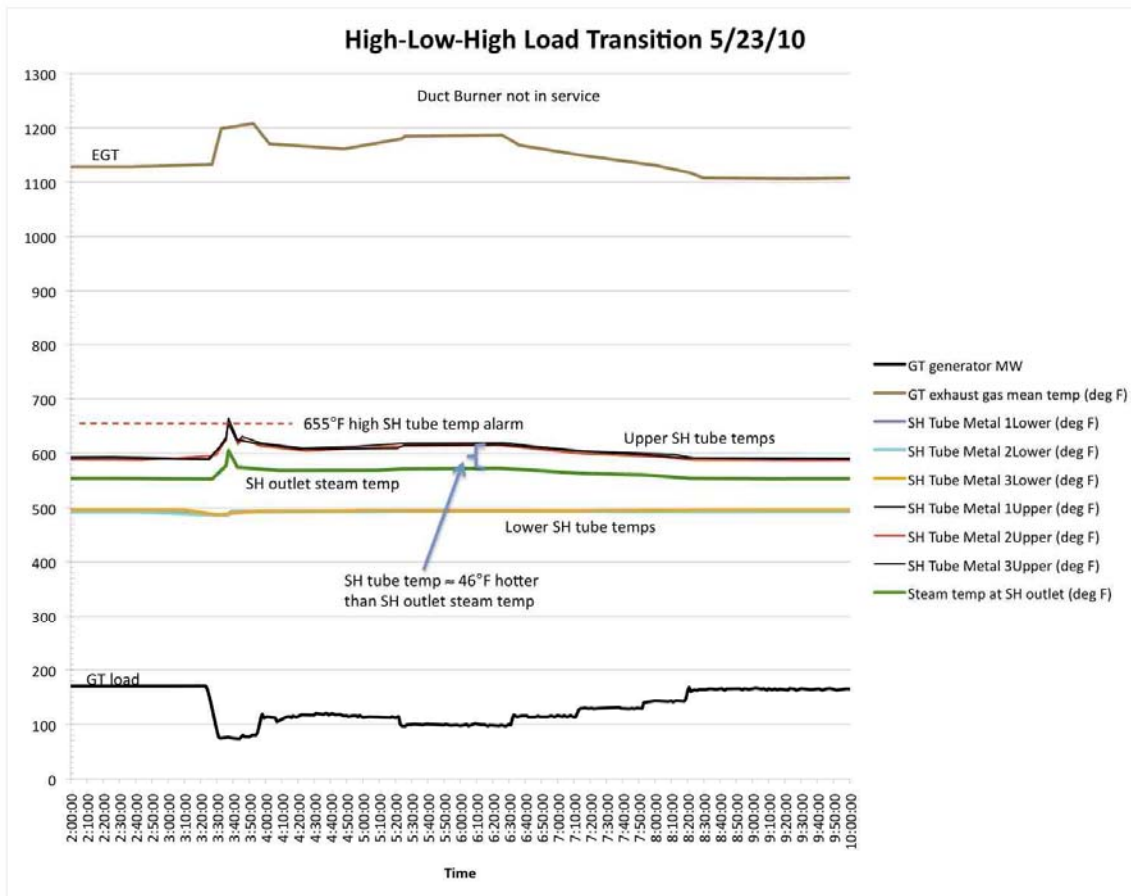
Figure 6 – Plots of DCS historical data during high-low-high GT load transition on 5/23/10

The plots of *SH Tube Metal Temperature* during the GT load transitions on 5/23/10 in Figure 6 indicate that upper tube metal temperatures are consistently about 46°F hotter than SH outlet steam temperature during both high and low GT loads. The hottest tube temperature peaks at 664°F during the load reduction transient, which is above the 655°F High SH tube temperature alarm point. If tube thermocouples are properly insulated to protect them from exhaust gas impingement, during periods of high steam flow rates they should perhaps indicate tube temperatures closer to the temperature of the steam flowing through the tube.

During the GT load reduction in Figure 6 GT load was lowered rapidly to about 73 MW. This load is the GE7FA GT’s “hot zone” and results in exhaust temperature near the maximum (called the isotherm) in excess of 1200°F. When GT load was later increased slightly above 100 MW (presumably to clear the SH tube high temperature alarm) exhaust gas temperature and SH tube temperatures returned to values acceptable for longterm operation.

It is suggested that the SH tube temperature thermocouples are inspected for any of the following conditions that may cause erroneously high readings:

- Insecure attachment to the SH tube
- Insufficient and/or incomplete covering of thermal insulation
- Additional thermal junctions introduced by defective thermocouple wiring

Since the permanent SH tube thermocouples are installed on tubes located near the side walls and center module gap it is possible that the quantity of exhaust gas bypassing the SH through these gaps results in individual tube temperatures 46°F higher than the bulk steam outlet temperature as indicated in Figure 6. It is suggested that the gap seals along the SH sidewalls and center module gaps be inspected for damage and to ensure that the clearance between tubes and baffles is consistent with the OEM's recommendations.

Consider performing replication of the outer surface near the top end of the hottest running SH tube instrumented with a permanent metal temperature thermocouple to determine if any material property degradation associated with high temperatures has occurred, particularly if the foregoing inspections indicate that the tube metal temperatures presented in Figures 3 and 6 are accurate.

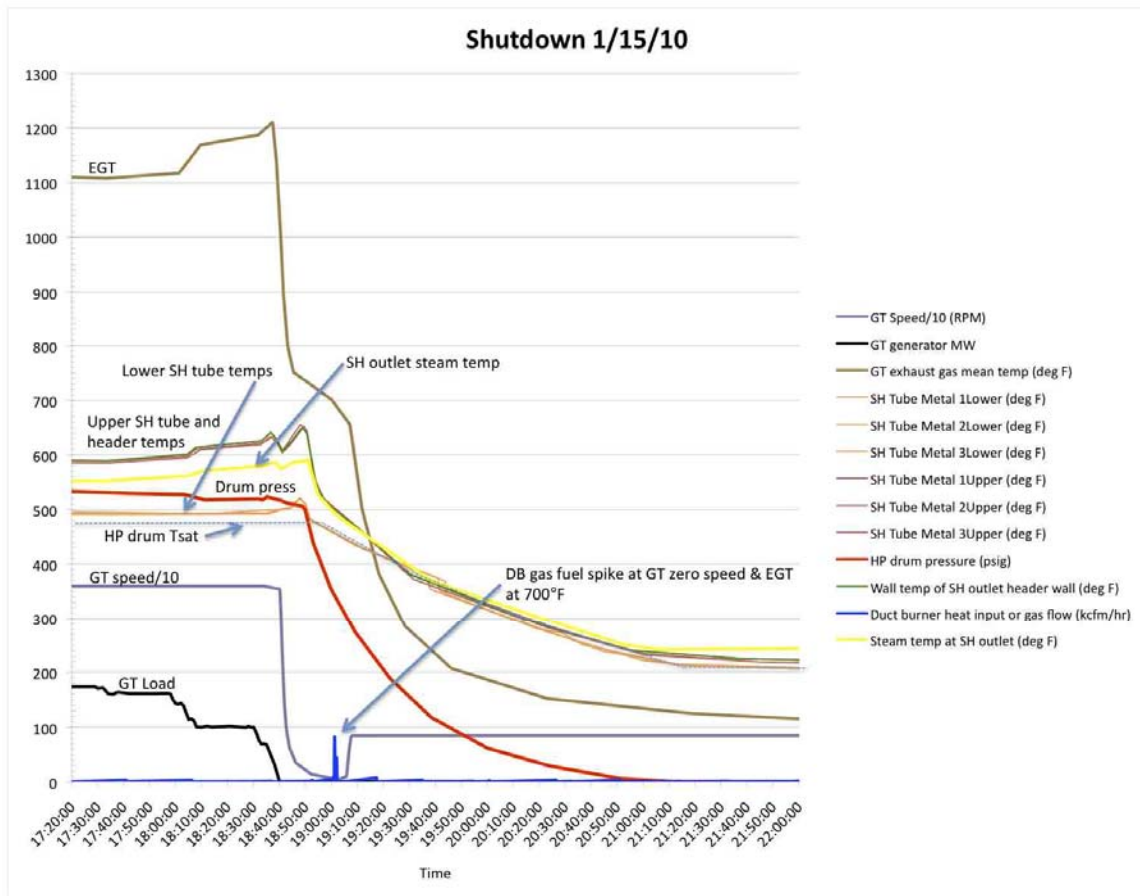
Figure 7 – Plots of DCS historical data during shutdown on 1/15/10

The ConEd condensate formation and drain flow capacity calculations are based on saturation temperature conditions in the SH during shutdown, which drop from 530psig to 160 psig. During the shutdown on 1/15/10 in Figure 7, no condensation occurred during the GT coast down to turning gear speed. During this period SH pressure dropped from about 530 psig to about 300 psig with the result that GT exhaust temperature remained about 250°F above saturation temperature. Condensation did not commence until about 40 minutes after GT firing ceased and by then was inconsequential.

The DCS historical data plots during the shutdown on 1/15/10 in Figure 7 show a spike increase in *Duct Burner Fuel Flow* after the GT has coasted to near zero speed and while exhaust temperature is about 700°F. Soon after forced cooling of the HRSG was initiated via unfired high speed cranking of the GT. It was reported that this spike is the result of depressurizing the duct burner fuel system in preparation for HRSG entry.

The indicated gas path temperature in Figure 7 at the time of the duct burner fuel spike is well below the published auto ignition temperature of natural gas (1076°F). However, it is suggested that yet more margin of safety between auto ignition temperature and gas path components could be attained if the duct burner fuel release were delayed until well into the time period the GT is intended to perform high speed unfired cranking, but also a reasonable period before cranking is suspended.

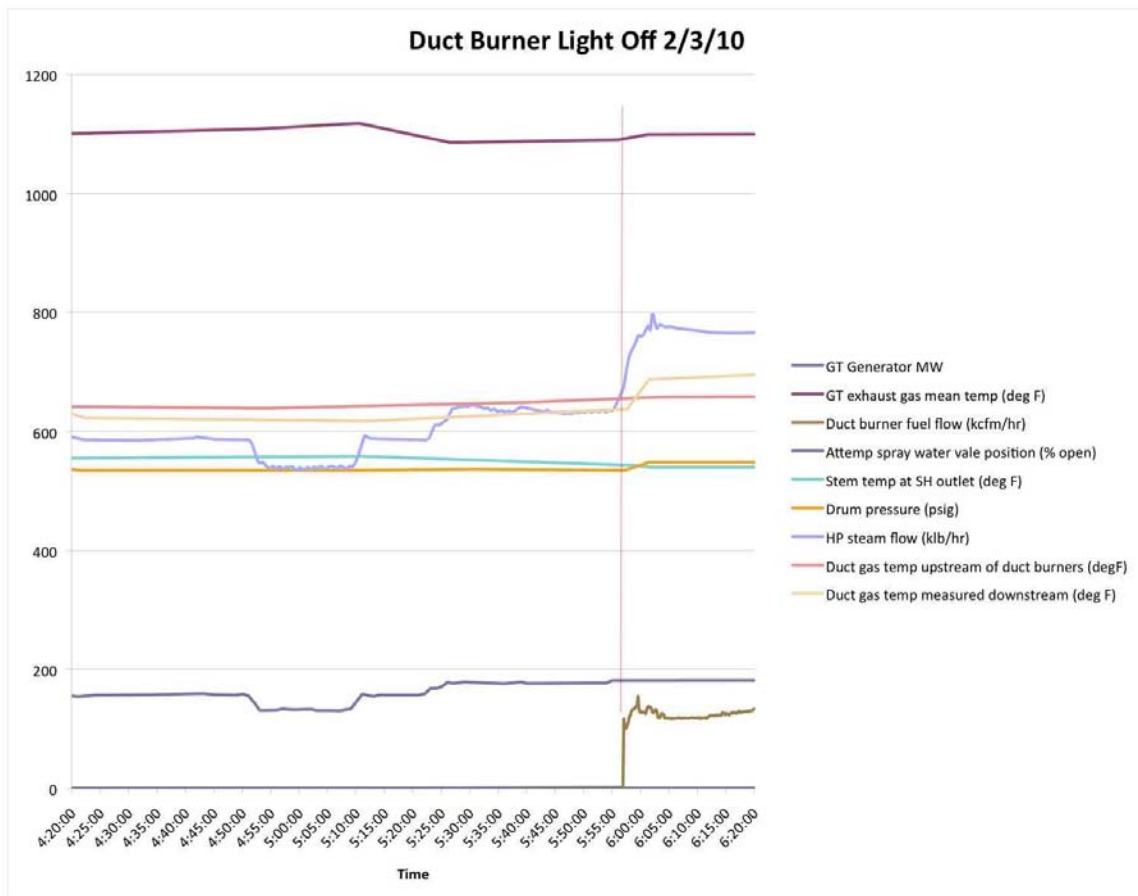
Figure 8 – Plots of DCS historical data during duct burner light off on 2/3/10

If overly aggressive initial firing rates are used when large duct burners are placed in service and/or overly aggressive firing rate increases occur, then excessive heat input to down stream evaporator tubes can result in abnormally rapid waterside deposit formation. This is due to a significant time delay between application of additional evaporator heat input and increase in evaporator circulation rate. Review of DCS historical data plots during the duct burner light off in Figure 8 and duct burner load

increase in Figure 9 on 2/3/10 indicate no excessive changes in gas duct temperature downstream of the duct burners.

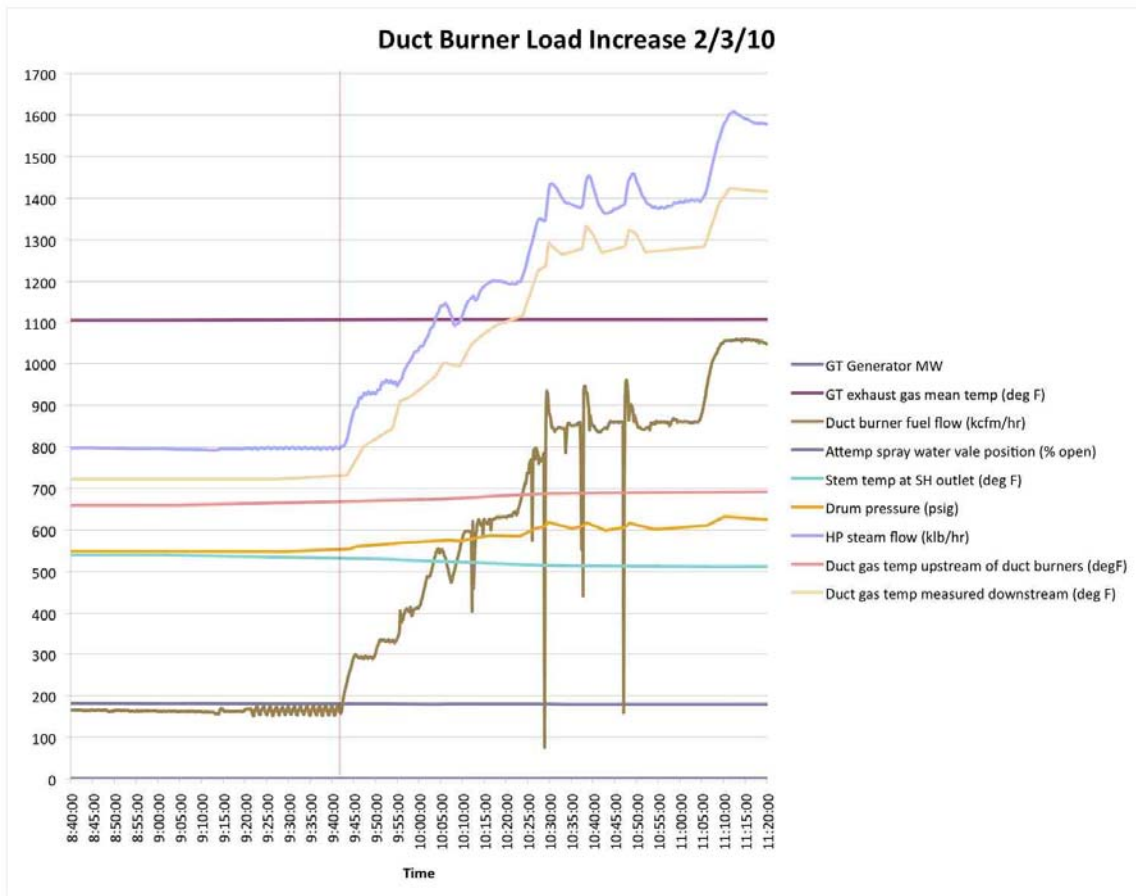
Figure 9 – Plots of DCS historical data during duct burner firing rate increase on 2/3/10

Irregularities in fuel gas distribution across duct burner runners and between one runner to another have in some other HRSGs created hot zones in the gas duct that resulted in excessive waterside deposits and under deposit corrosion. Permanent gas duct temperature probes are located near the HRSG sidewalls; hence their temperature indications are unlikely to be representative of peak gas temperature conditions in other locations across and from top to bottom in the gas duct. No instrumentation is currently installed in the East River HRSGs to give a quantitative indication of duct burner related gas temperature distribution. Installation of evaporator tube temperature thermocouples to confirm acceptable side-to-side and top-to-bottom gas temperature profiles during duct burner operation is possible, but generally too expensive to consider unless other indicators of a damaging gas temperature profile are present. Such indicators might include visual observation of non-uniform duct burner flames and discolored or distorted tubes and/or support structures downstream of the duct burner. No such indicators were noted during this assessment.

It is suggested that waterside video inspections be conducted on a number of tubes positioned across the gas path. The inspections should be conducted on the first row of evaporator #2 tubes (immediately downstream of the duct burner) as well as evaporator tubes in other locations. Significant differences in deposit appearance should be further investigated via removal of tube samples for deposit analysis (see Section 4i).

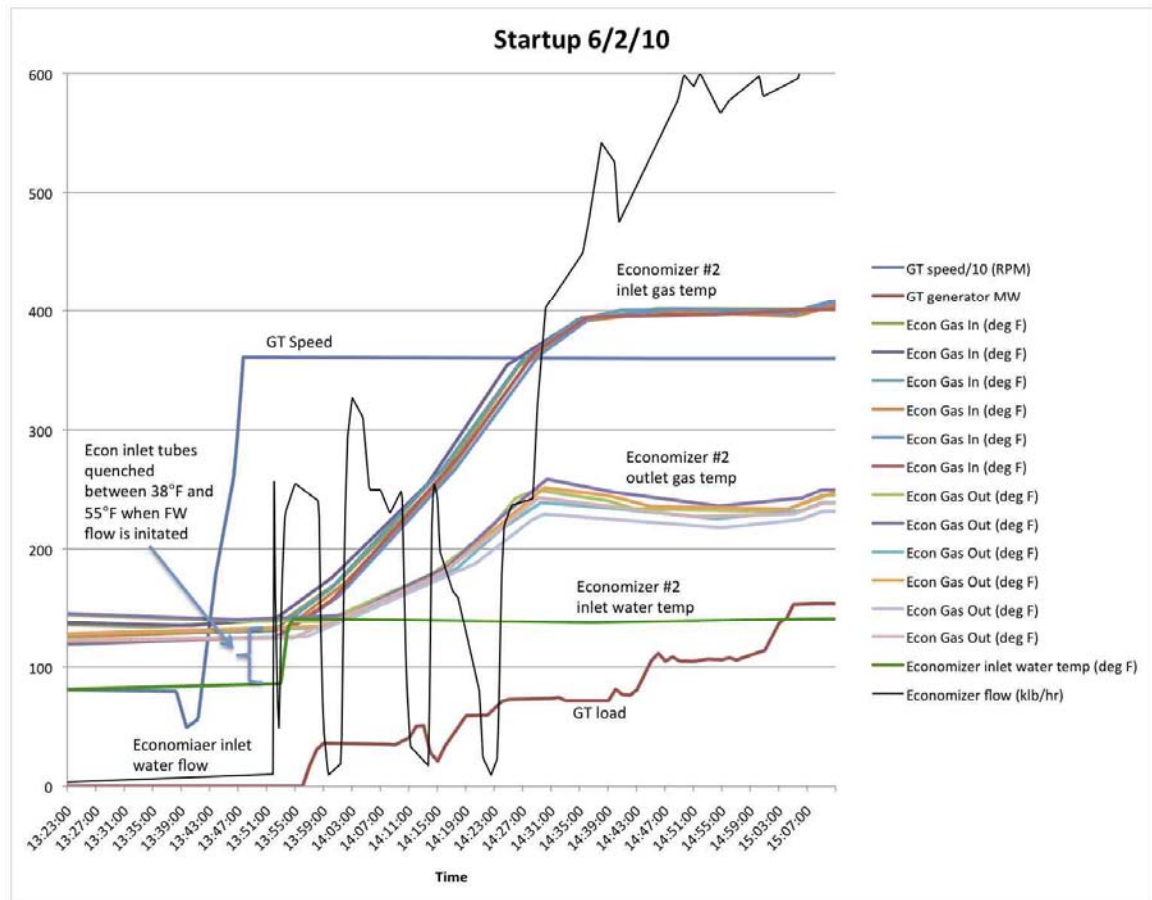
Figure 10 – Plots of DCS historical data during the startup on 6/2/10

During the initial stages of startup (when drum swell eliminates the need to add water to the drum) there is minimal water flow in economizer tubes to remove heat. What flow there is during this period is provided by vents on each economizer upper header routed to the drum via a single 2-inch motor operated valve. Consequently, economizer tubes heat soak close to higher than normal temperatures during these near static conditions. The DCS historical data plots during the startup on 6/2/10 in Figure 10 show that exhaust gas exiting economizer #2 is between 124°F and 133°F when feed water flow is

initiated. The initial feed water temperature is 86°F but very quickly increases to 141°F. This increase in feed water temperature indicates that the economizer-to-drum vent flow is insufficient to completely replace the 86°F water in the feed water piping with 141°F water from the DA storage tank (not surprising since there is no pressure differential between the economizer and the drum unless drum blowdown valves are opened relatively wide or significant feedwater flow is established. Tube temperature data from similar HRSGs has shown that when initial feed water flow rate is relatively low compared to normal flow rates, feed water will preferentially flow only in a few tubes closest to the economizer inlet nozzle. If tubes in the feed water inlet row of economizer #2 with little to no flow are assumed to be heat soaked to exhaust gas temperature, then they are chilled by approximately 38°F to 47°F when feed water flow is initiated. It is possible that some tubes near the economizer inlet nozzle are chilled to a lesser degree due some economizer-to-drum flow through the open vents. Non-uniform introduction of cooler feed water into heat soaked tubes results in some tubes of the feed water inlet pass being exposed to a chill while others remain for a short time at elevated temperature. Significant differences in the temperature of adjacent tubes creates bending stresses in tube-to-header weld connections and if repeated frequently will eventually result in tube failure.

The economizers in the East River HRSGs are of the cross flow harp configuration utilizing one-piece upper and lower headers. This configuration utilizes baffle plates inside the upper and lower headers to direct feed water alternately up and down through groups of tubes as the water passes from the inlet on one side of the harp to the outlet on the other side. As the water is heated in passing across the harp step changes in tube temperatures occur across the header baffle plates. When a one-piece lower economizer header is used, as in the East River HRSGs, thermal expansion of individual tubes is restricted. If the tube-to-tube temperature differences are too large, and occur too often, excessive bending stresses at tube-to-header welds can result in tube failure. Tube failures associated with cross-baffle temperature differences are more likely to occur in HRSGs exposed to very frequent start/stop operation. It is not anticipated to be a significant concern for the East River HRSGs due to their very limited number of startups.

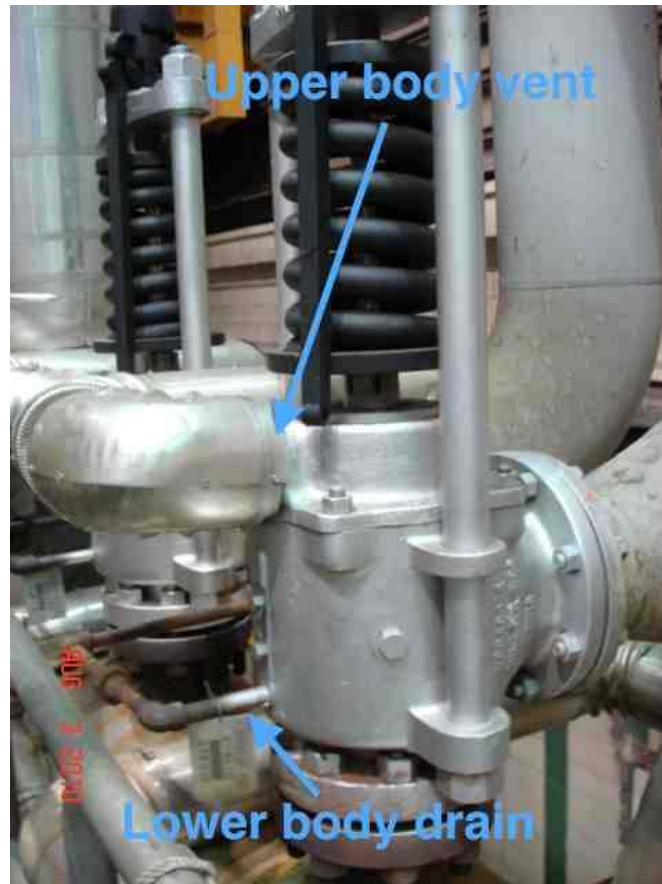
Figure 11– SH safety valve drain/vent connections.

The Consolidated SH safety valves installed on the East River HRSGs have a drain connection at the bottom-front of the valve body and another drain connection on the discharge elbow drain pan. A third connection is provided at the top-front of the valve body and is intended for use as a vent for air and steam in the upper valve body when the valve is open. If this vent flow is restricted by backpressure from the interconnected drains valve performance may be altered. This vent is typically piped so as to discharge to atmosphere in a location that takes into account personnel safety and prevents moisture from entering the vent pipe. The East River safety valves have the two drains and the body vent interconnected into a common drainpipe. See Figure 11. There have been cases reported where moisture from the drain system enters the valve body through the body vent connection resulting in corrosion of internal valve components and/or restriction of vent ID due to corrosion products. In such cases alteration of valve performance or failure of the valve to open can result.
