**CONTACT VOLTAGE TEST &
FACILITY INSPECTION
ANNUAL REPORT**

CONSOLIDATED EDISON COMPANY OF NEW YORK, INC.

Report on the results of contact voltage tests & facility inspections for the period beginning
January 1, 2017 and ending on December 31, 2017.

February 15, 2018

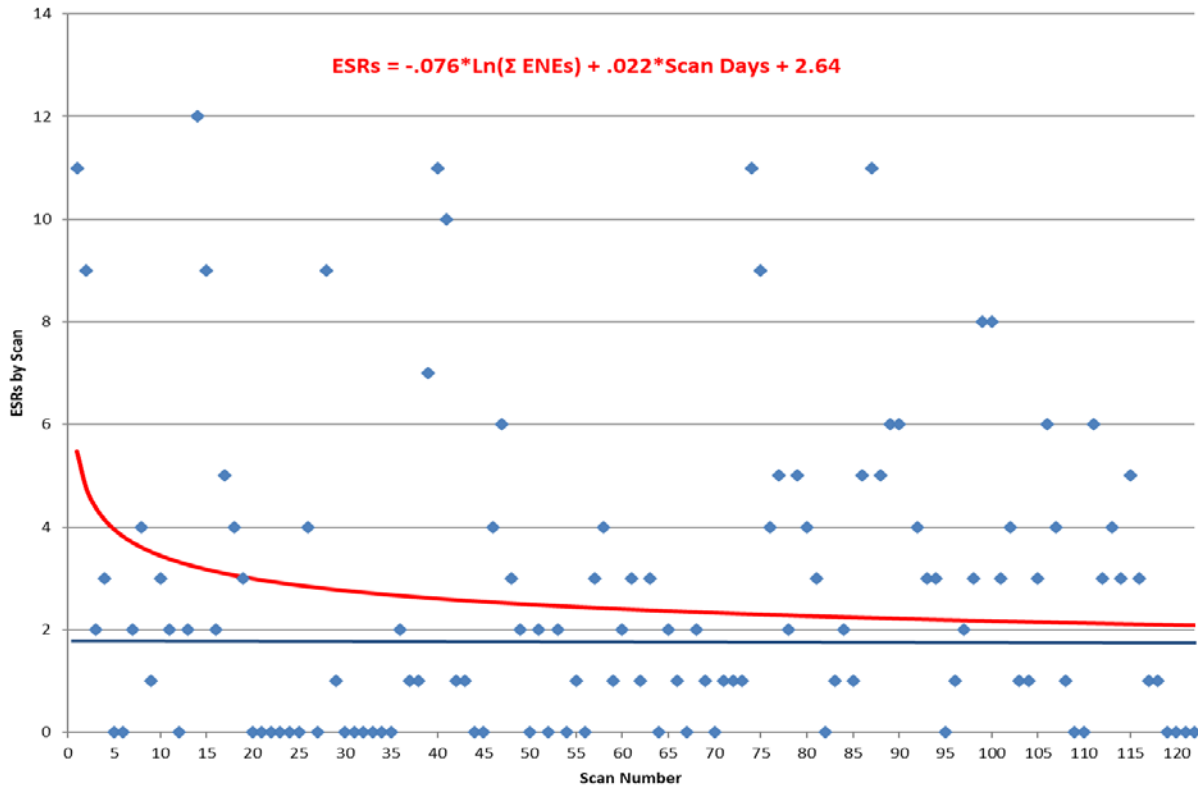
Chart 1
Con Edison ESR by Scan vs. Cumulative ENEs and Scan Duration

The ESRs associated with Con Edison’s equipment is shown in Chart 1. As mentioned above, weather also plays a role in ESR generation. This weather variable is accounted for in the underlying models and in both the 2017 and long term predictions. The duration between scans ranges from approximately 30 to 35 days per scan. If Con Edison continues with a comparable ENE repair rate and scan interval in 2018 and experiences similar weather patterns, the Company can expect ESRs to be approximately 2 per scan. In 2017, there were

23 shocks associated with the Company’s equipment which is a 23% improvement from last year.

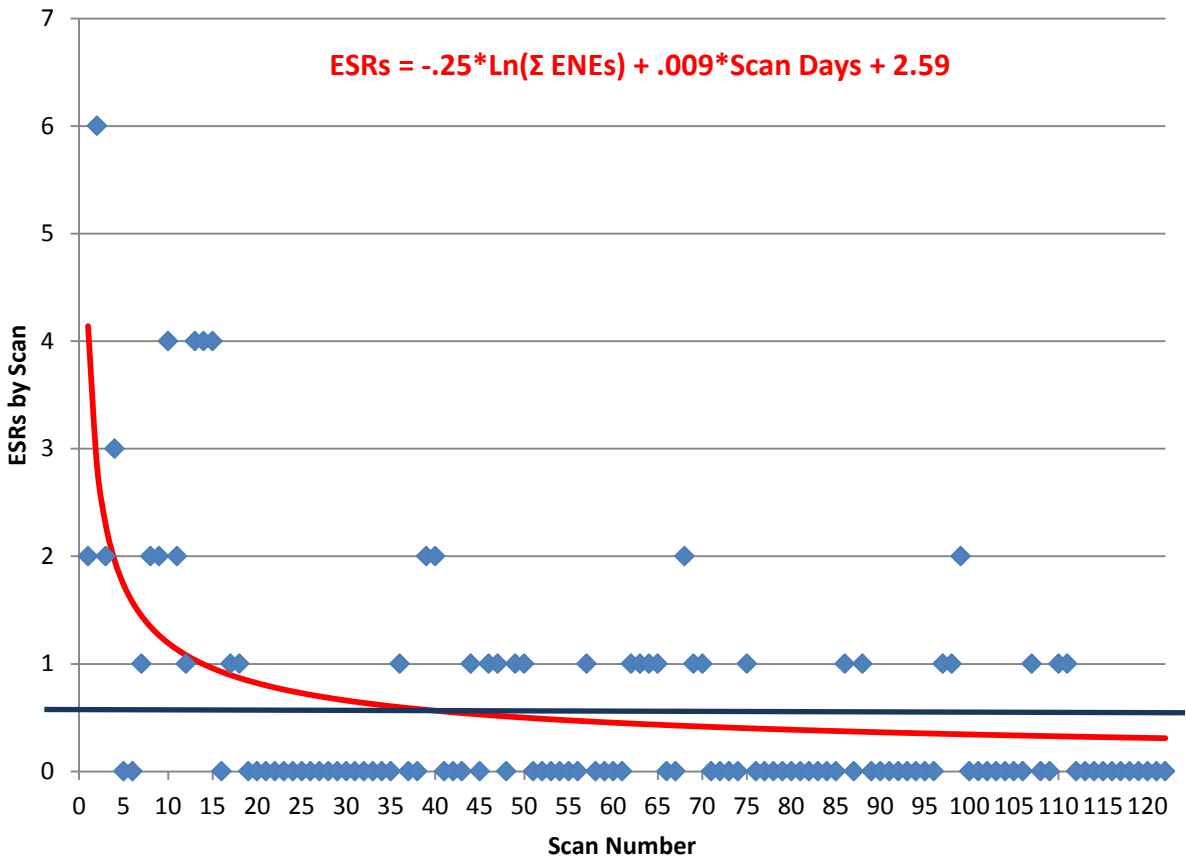
Chart 2
Other Utility/Government Agency Responsibility ESRs by Scan vs. Cumulative ENEs and Scan Duration

The ESRs due to “Other Utility/Government Agency Responsibility” equipment is shown on Chart 2. The duration of scans is 30 to 35 days per scan. If the Company continues a comparable ENE repair rate and scan duration in 2018, the Company can expect ESRs at this scan duration level to remain at approximately 1 per scan. In 2017, there were 5 shocks associated with “Other Utility/Government Agency Responsibility” equipment which is a 17% improvement from last year.

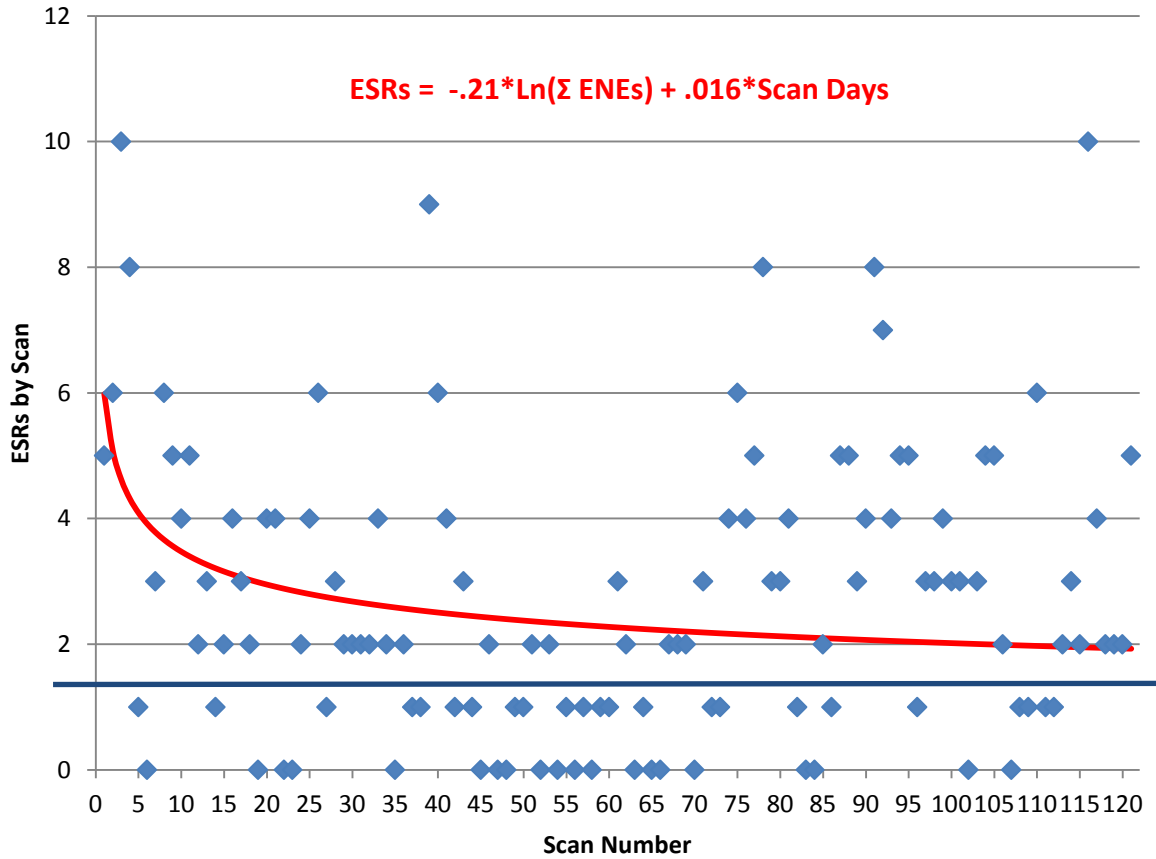
Chart 3
Customer (Public Access) ESRs by Scan vs. Cumulative ENEs and Scan Duration

The ESRs associated with Customer’s equipment is shown on Chart 3. The duration of scans is 30 to 35 days per scan. If the Company continues a comparable ENE repair rate and scan duration in 2018, the Company can expect ESRs to remain at 2 per scan, with no significant reduction anticipated below that level in the near future. The actual performance indicates that these shock events are less sensitive to our mitigation efforts. However, in 2017, the Company responded to 38 validated shock reports on publicly accessible customer equipment, which is a 46% increase from last year.

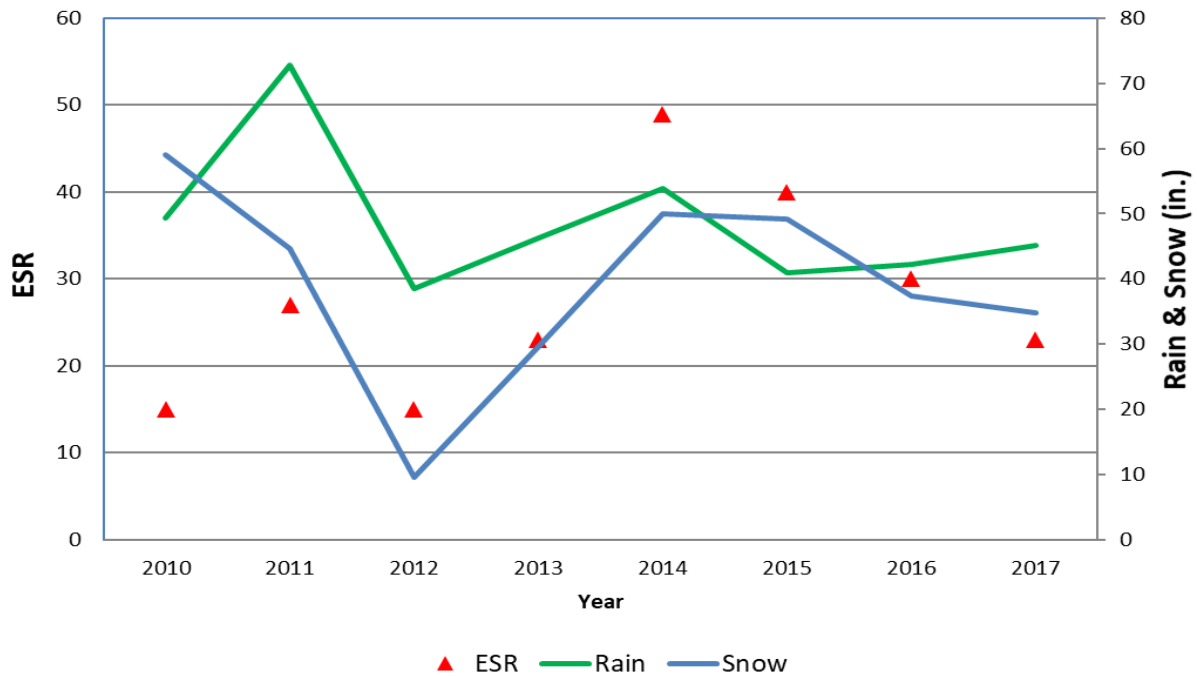
Chart 4
2010 – 2017 Rainfall, Snow vs. ESR

Weather continues to have a direct impact on the electrical system. As has been discussed in prior annual reports, the Company continues to observe a strong correlation between weather and shocks (Chart 4).

While there have been four consecutive years of harsh winter conditions, the ESRs that Con Ed was responsible for are showing a downward trend over the same period. Compared to last year, “Utility Responsibility” ESRs improved by 23% (23 vs. 30). Part of the reduction is attributed to the “Targeted Mobile” pilot program under which additional mobile scans were performed in areas that historically have had higher events activity. This program resulted in the discovery and repair of additional ENEs which could have potentially resulted in ESRs.

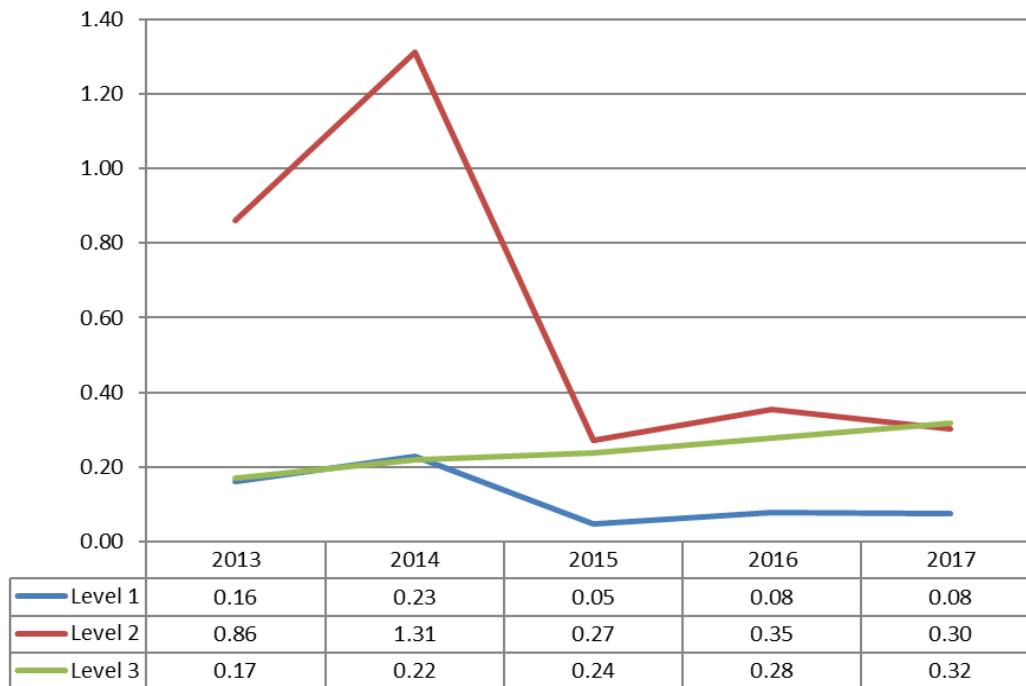
**Chart 5
Defect Rate by Level**

Chart 5 shows the number of defects found per inspection by classification level. As can be observed, the generation rate of defects found this year compared to 2016 remains the same (Level I) or has decreased (Level II) by 14%. Level III generation rate has increased by 14%. The increase in the Level III defects is mainly driven by missing grounds and broken tie wires is the overhead and damage secondary cable in the underground.

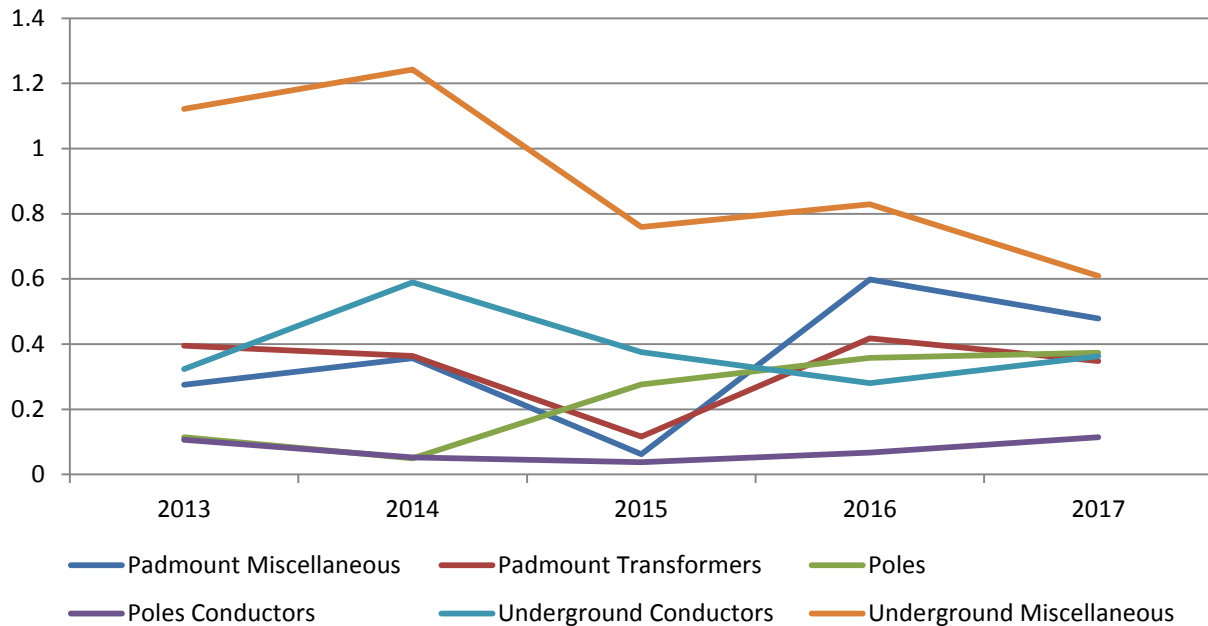
Chart 6
Defect Rate by Category

Chart 6 shows the 2017 Defect Rate by Category. The rate of defect increased in three categories: Pole conductors, Poles and Underground Conductors. The main driver in the Pole Conductor category was missing grounds (75% of defects). The main driver in the Poles category is broken tie wires and secondary wire damage which make 76% of the defects in this category. Finally the underground conductors are driven by improper connectors and damaged cable which makes 50% of the defects.
