**CENTRAL HUDSON GAS & ELECTRIC  
CORPORATION**

**CONTACT (STRAY) VOLTAGE TESTING**

**FACILITY INSPECTIONS**

**2019 Contact (Stray) Voltage Testing and Facility Inspections**

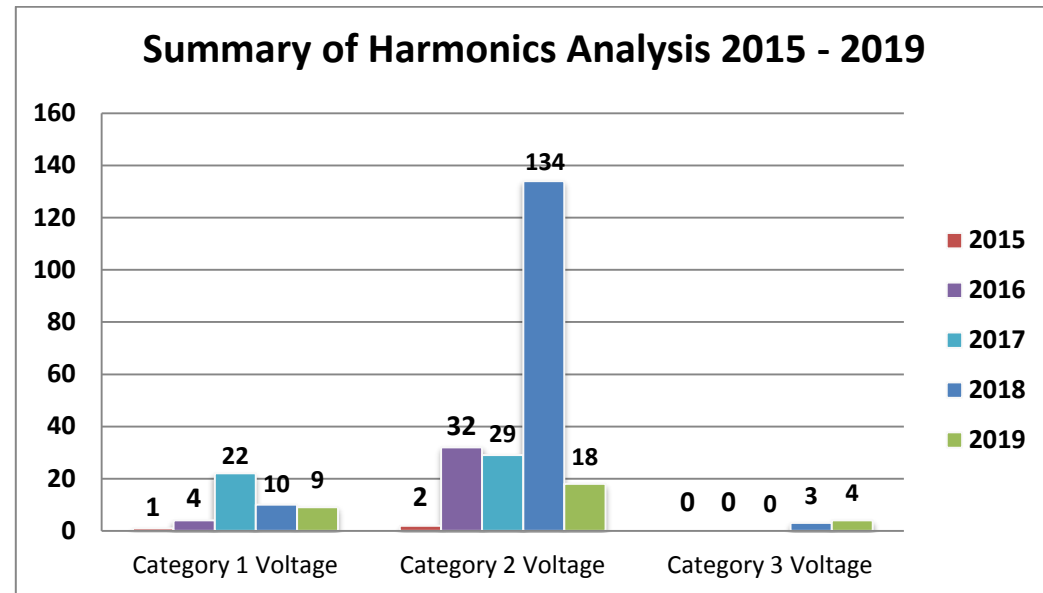
**Chart 1 - Summary of Harmonic Analysis**

Although there are fluctuations in the total number of category two voltage conditions, these naturally occurring conditions have accounted for 80.22% of the voltage findings from 2015-2019. Category two voltages are expected to fluctuate due to weather and load conditions. These voltages can be considered part of a properly functioning multi-grounded wye electric system, and pose no threat to the public. There have been no findings of naturally occurring voltage in the Underground (Non-URD) and Substation Fence groups (see Tables 2 & 3).

In 2019, there were four (4) instances of Category 3 voltage findings. The findings did not have a sinusoidal waveform and were 180 Hz dominant, but exceeded the voltage threshold of 4.5 volts. These findings occurred on distribution poles and were due to an issue with the connections to the system neutral. The voltages associated with these findings were mitigated to less than one volt at the time of discovery. Since 2011, Central Hudson has found only nine (9) instances of Category 3 voltages on Central Hudson's equipment.
