# Steam Distribution Pipeline Corrosion Study

Consolidated Edison Company of New York

**Report No.:** E-AD-SA (LMCK) 10310686, Rev. 0

**Date:** 11/30/2021

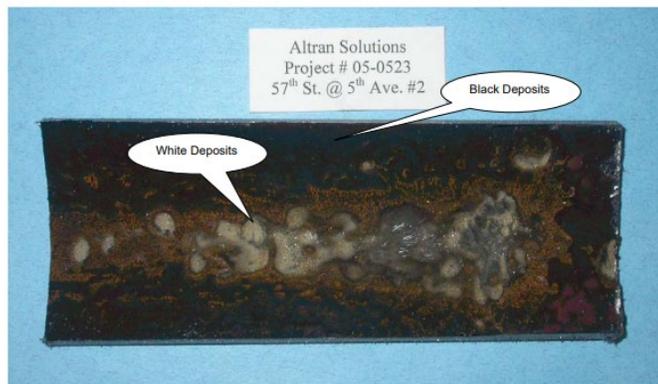
**Figure 7 - 57th Street and 5th Avenue**

Figure 7 and Figure 8 show some examples of the general corrosion that has occurred in the CECONY steam system in the past.

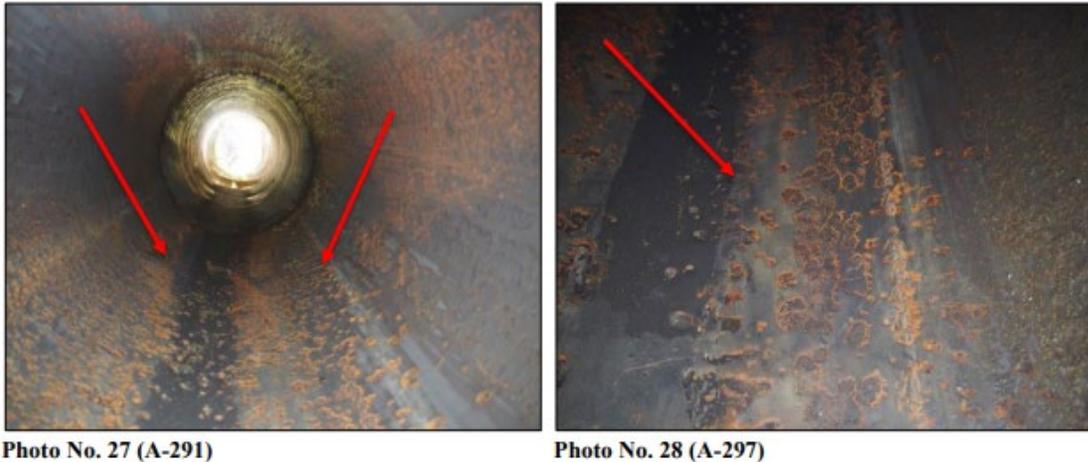
Figure 12 - From CECONY steam pipe rupture 20th street and 5th avenue 2018 Report No. LM-4213

Operating with low steam condensate pH as shown above, along with dissolved solids of chlorides and sulfates entering the steam system from drum carryover, places the steam system at risk for pitting. For pitting to occur, however, water must form in the steam system and become stagnant in non-flow areas or when a part of the steam system is removed from service. Figure 12 shows an example of pitting in the steam system at CECONY.

The ID surface of the pipe segment showed pitting and material loss along the bottom, indicating that condensate was present and eroding and/or corroding the pipe wall locally, (Photo Nos. 27 – 28).

Because CECONY is restricted in its ability to add chemicals to the system to elevate steam condensate pH, it must focus on preventing standing condensate in its pipes to the extent practical. Ensuring that traps are kept functioning, supports are maintained, and insulation is maintained can help in this effort. When portions of the steam system are removed from service, it is important to ensure the lines are drained completely. Any standing condensate in the system will increase corrosion rates. It is also important to ensure piping has not sagged in certain areas causing steam condensate to possibly collect in these areas.

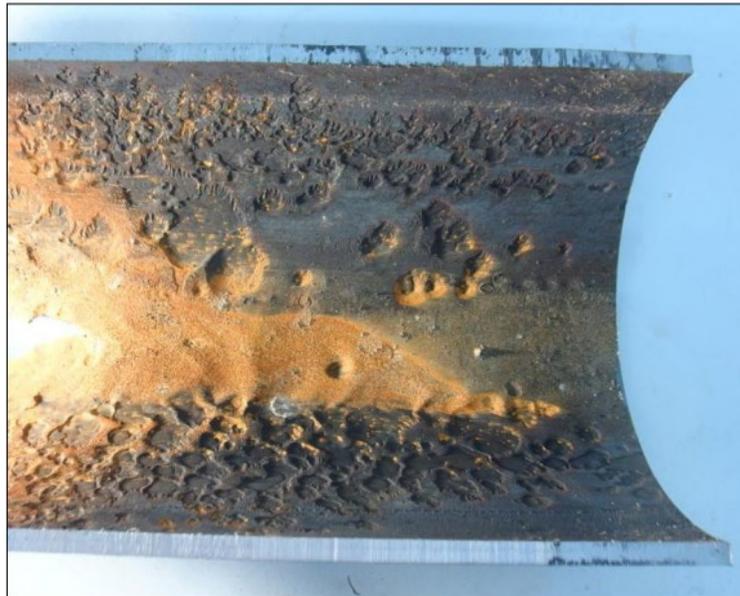
Figure 16 - West 58th Street Steam Pipe Failure

The CECONY steam system has experienced several two phase FAC events over its lifetime. Figures 12 thru 14 are various pictures from root cause failure reports on the CECONY system. These pictures show the two phase FAC mechanisms was present.
