**STATE OF NEW YORK  
PUBLIC SERVICE COMMISSION**

**Case 06-E-0894**

**PULP REPLY COMMENTS IN RESPONSE TO DPS STAFF  
FINAL REPORT ON ITS INVESTIGATION OF THE JULY 2006  
EQUIPMENT FAILURES AND POWER OUTAGES  
IN CON EDISON'S LONG ISLAND CITY NETWORK  
IN QUEENS COUNTY, NEW YORK**

March 30, 2007

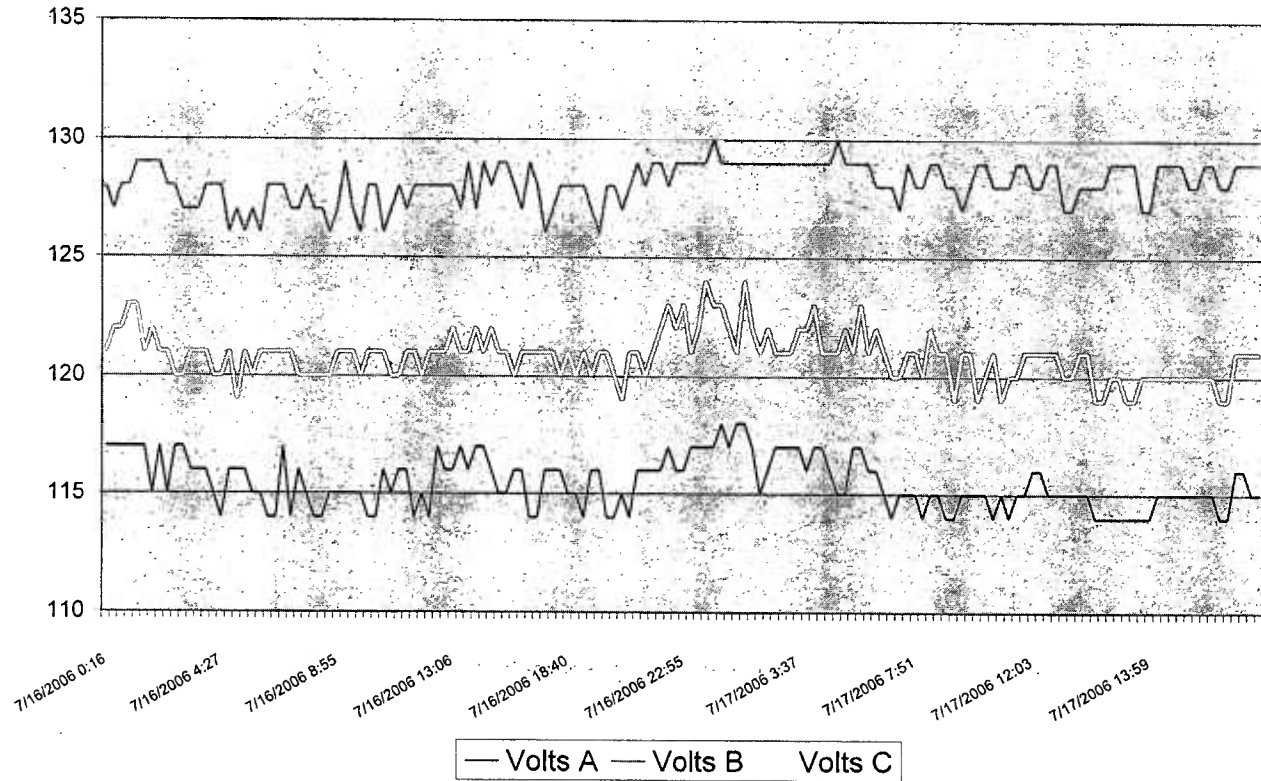
Feeder 16 - VS5213 Sensor Readings Through 07/17/06 15:50pm

PULP's analysis of RMS sensor data obtained in discovery has revealed that there was a sustained low voltage condition on July 16 and 17 in the area of the fire, prior to its occurrence.<sup>19</sup> This new evidence shows that one phase at transformer VS5213 had voltages well below the normal 126 Volts.

<sup>19</sup> See attachment of July 16 and 17 voltage data for the sensor on transformer VS5213. In its discovery responses, Con Edison identified VS5213 as the transformer upon which the burned secondary cable was most dependent. Pending PULP discovery seeks RMS data for the prior week.

The *Report of Incident Investigation Committee* lends credence to the TGE hypothesis because that Con Edison report identifies pre-outage events - localized secondary overloading due to transformer outages - and because Con Edison's consultants cannot explain the fire based on that condition alone. PULP's discovery now establishes that there was sustained low voltage at the transformer serving the line that burned, during the 27 hours preceding the fire. *See attachment.*
