**CONTACT VOLTAGE TEST &
FACILITY INSPECTION
ANNUAL REPORT**

CONSOLIDATED EDISON COMPANY OF NEW YORK, INC.

Report on the results of contact voltage tests & facility inspections for the period beginning
January 1, 2021 and ending on December 31, 2021.

February 15, 2022

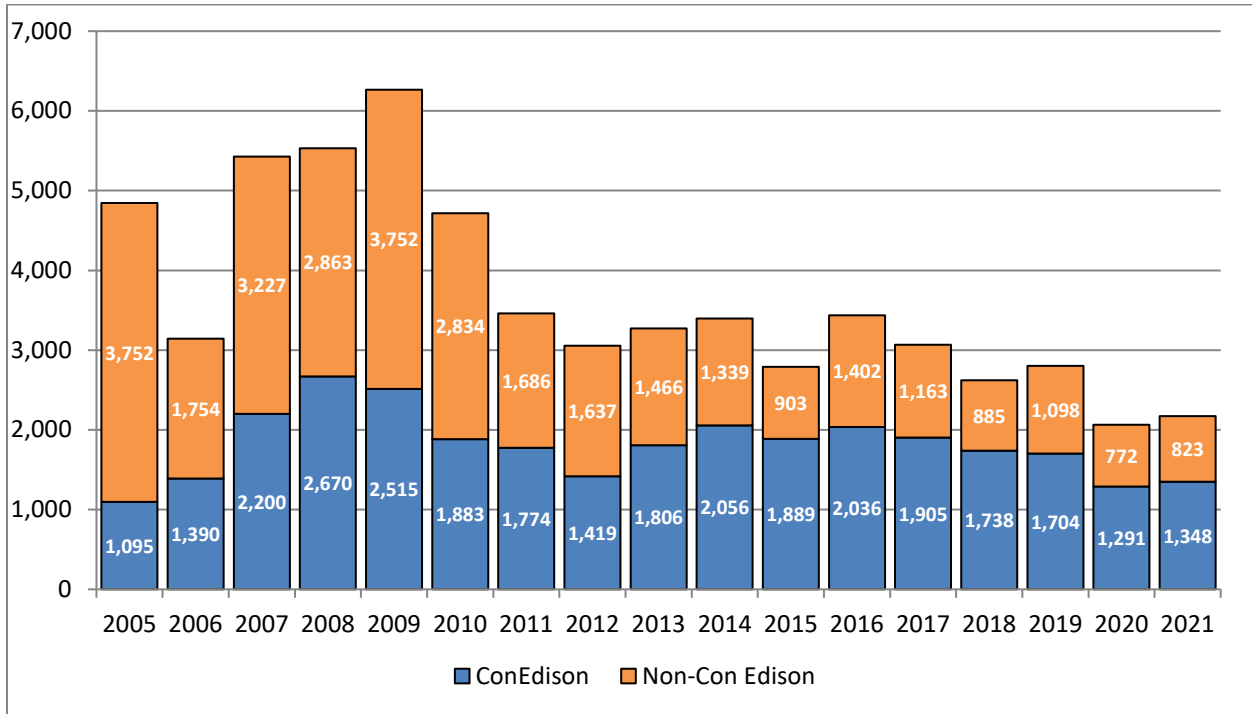
Chart 1
ENE Sources

Since the likelihood of an ESR will increase or decrease in proportion to the total number of energized structures and exposure time, the timely detection and repair of identified sources of contact voltage is the principal mitigation effort for reducing ESRs. Each completed repair effectively represents a mitigation of possible ESRs and over time, the potential ESRs decrease accordingly. As observed in Chart 1, the sources of ENEs have been decreasing since the inception of the program.

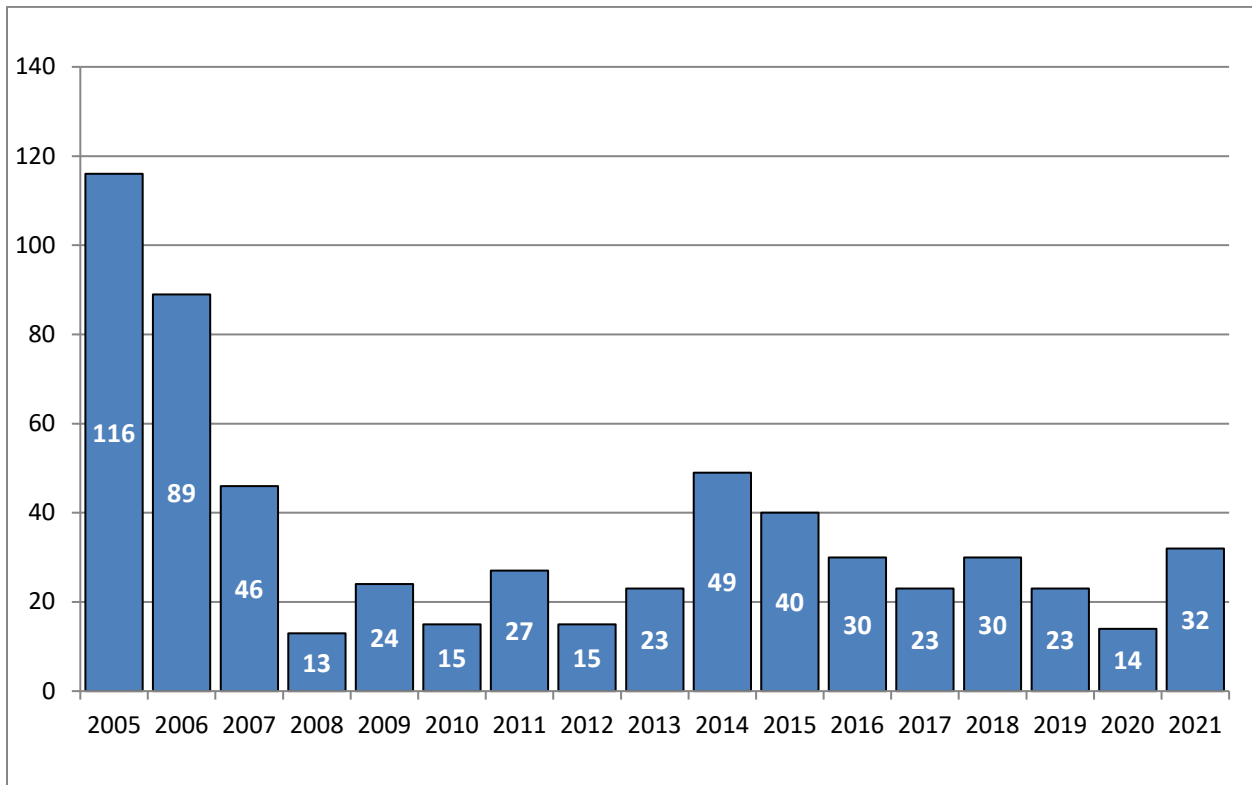
Chart 2
Con Edison ESR

In addition, voltage and current levels on conductive surfaces may appear and/or change due to environmental factors such as moisture, humidity, soil, or concrete resistivity. This was demonstrated in February 2021 when significantly higher salt spread (~254,000 tons) and snow accumulation (~26 inches) was the most in a single month over the last 5 years. Con Edison saw a slight increase in ESRs in 2021 which can likely be attributed to the snowfall and salt spread of February 2021.

Lastly, high pedestrian/animal traffic increases the likelihood of an ESR. As COVID-19 restrictions, including lockdowns, indoor dining, and school closures, were removed, that likelihood increased in 2021, contributing to increased numbers of ESRs.

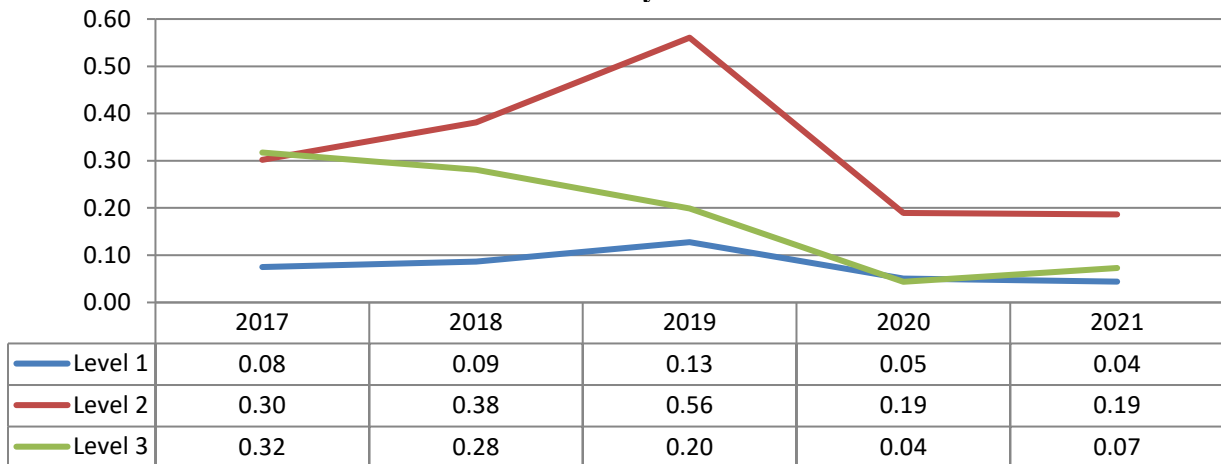
**Chart 5
Defect Rate by Level**

Chart 5 shows the number of defects found per inspection by classification level. In 2021, the Company experienced a generation rate of L1 defects that was lower than 2020, while L2 defects remained the same, and L3 defects experienced a slight increase.

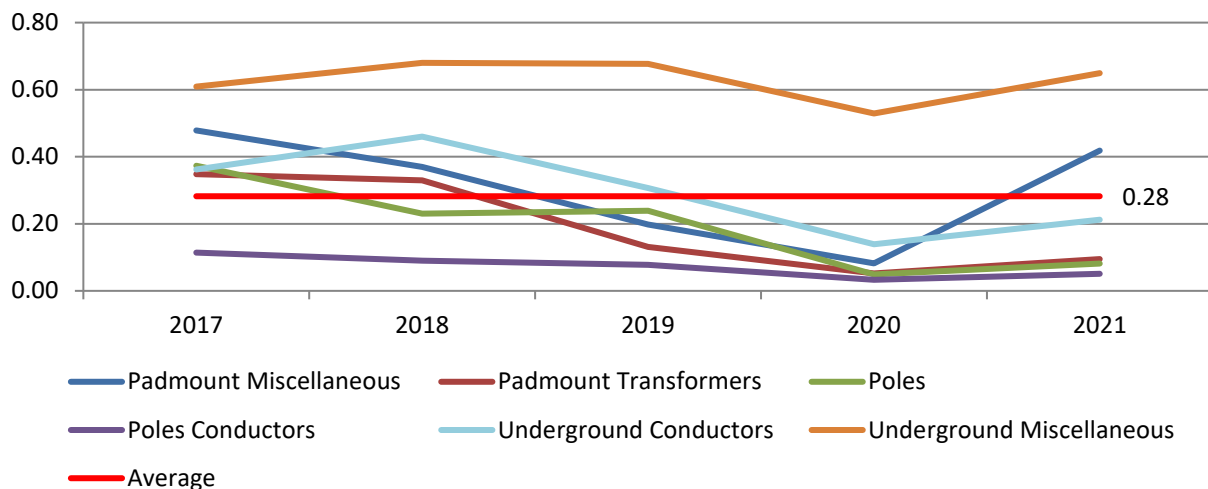
**Chart 6
Defect Rate by Category**

Chart 6 shows the 2021 Defect Rate by Category. The largest defect increase is in the category of Padmount Miscellaneous specifically due to the hazard warning label missing, followed by Underground Miscellaneous due to increased use of infrared imaging, resulting in more hot spots being identified.
