Consolidated Edison Company of New York, Inc.'s *2018 Contact Voltage
Test and Facility Inspection Annual Report*

**CONTACT VOLTAGE TEST &
FACILITY INSPECTION
ANNUAL REPORT**

CONSOLIDATED EDISON COMPANY OF NEW YORK, INC.

February 15, 2019

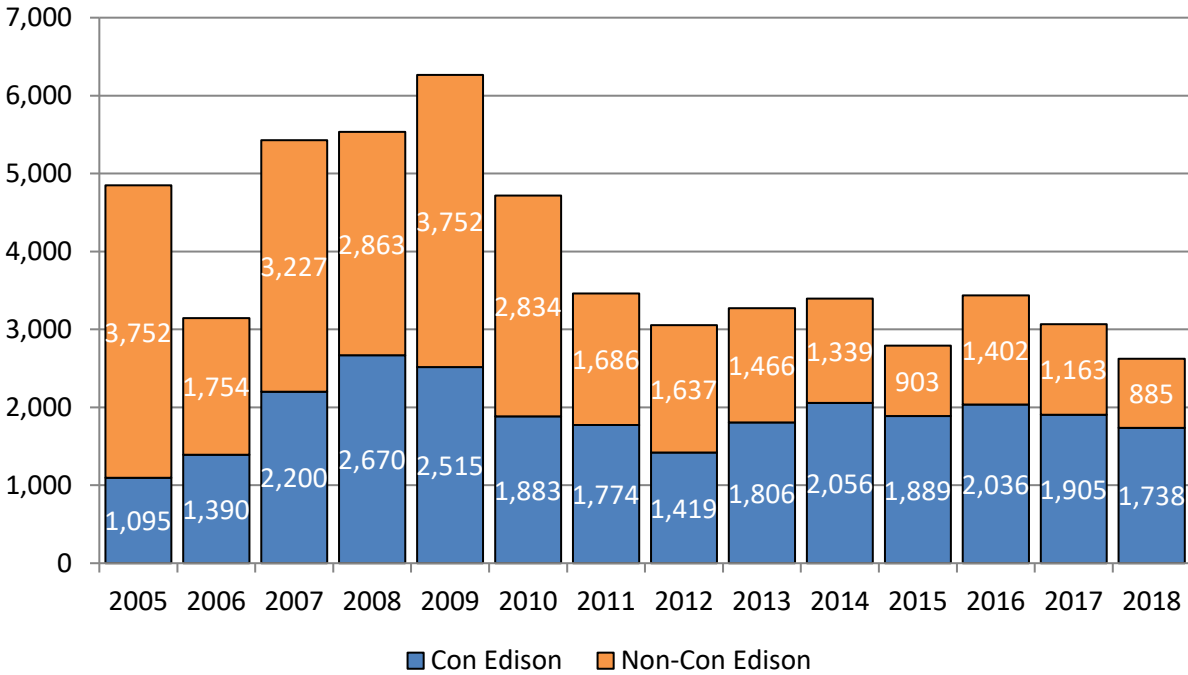
Chart 1
ENE Sources

Since the likelihood of an ESR will increase or decrease in proportion to the total number of energized structures, the detection and repair of identified sources of contact voltage is the principal mitigation effort for reducing ESRs. Each completed repair effectively represents a mitigation of possible a ESR and over time, potential ESRs decrease accordingly. As can be observed in Chart 1, the sources of ENEs have been decreasing since the inception of the program. Similarly, the ESRs that are the responsibility of Con Edison (Chart 2) and Non-Utility responsibility ESRs (Chart 3) show a similar trend.

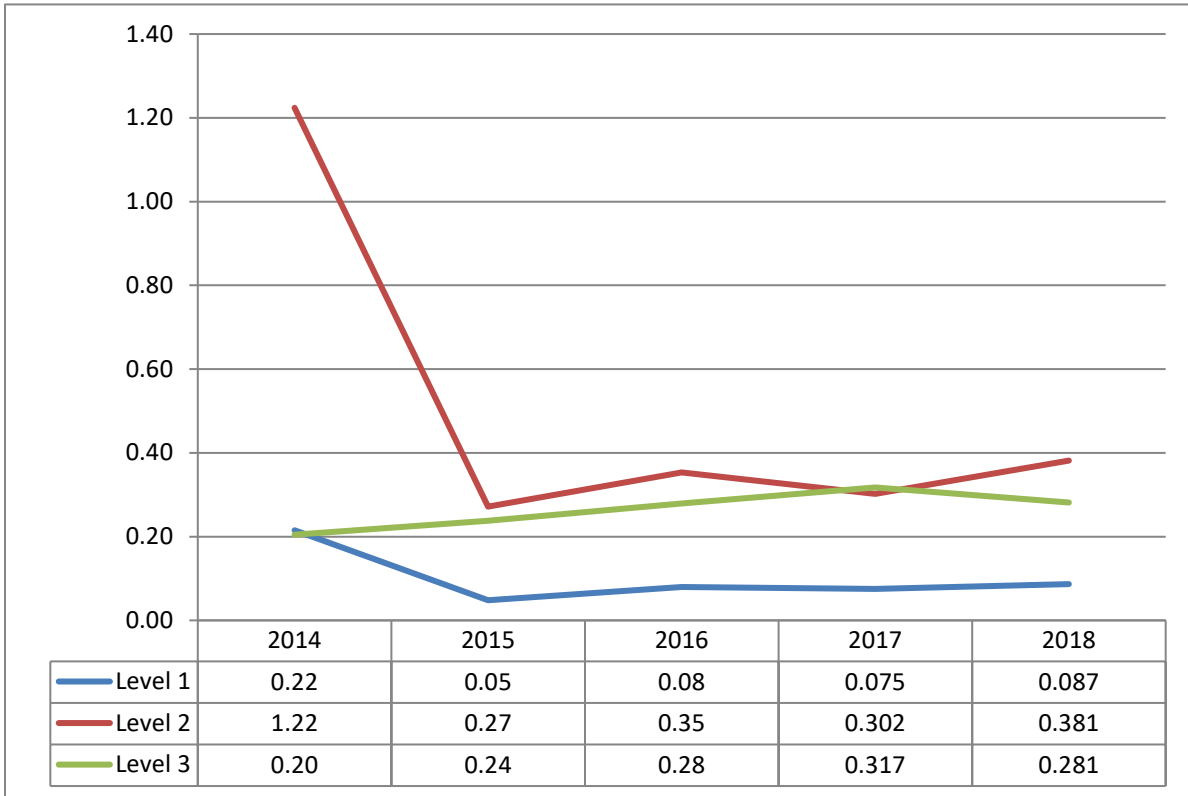
**Chart 5
Defect Rate by Level**

Chart 5 shows the number of defects found per inspection by classification level. The generation rate of L1 defects found this year is comparable to last year. Level III defects have decreased by 7% and Level II defects shows an increase mainly driven by “Unsealed Secondary End Caps” and “Unsealed Service Ducts”.

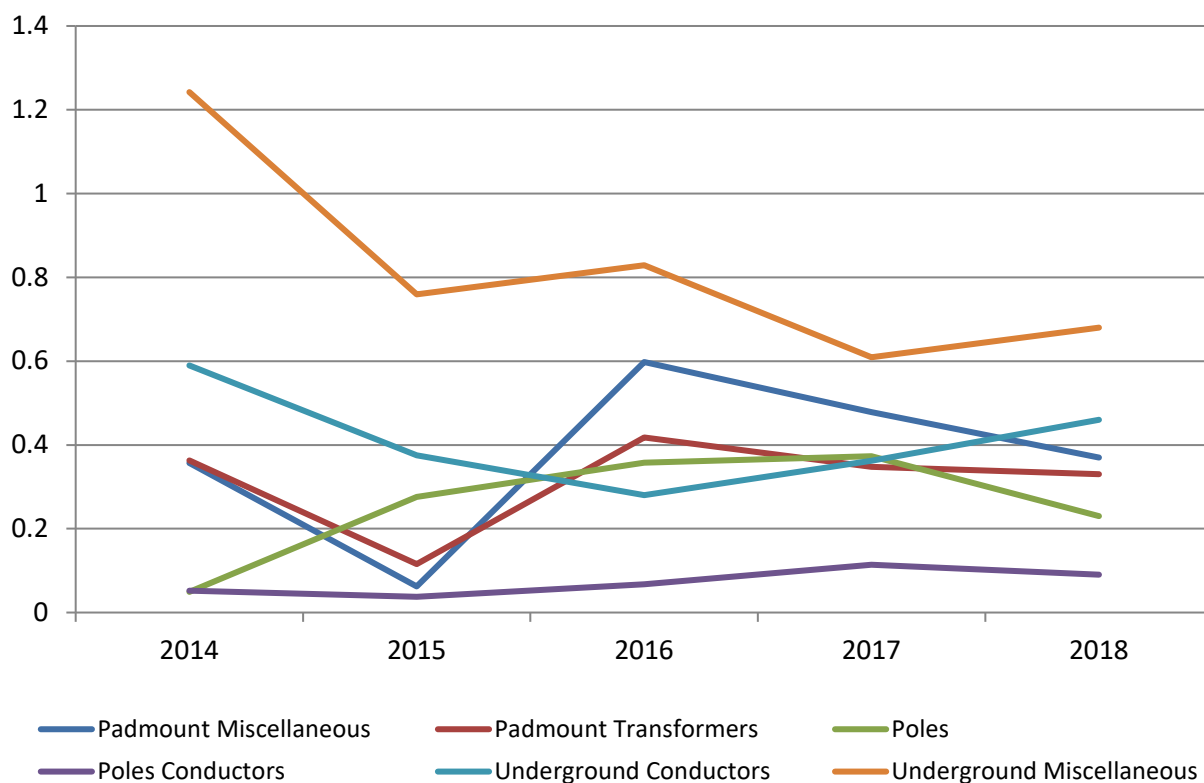
**Chart 6
Defect Rate by Category**

Chart 6 shows the 2018 Defect Rate by Category. The rate of defects increased in two categories: Underground Conductors and Underground Miscellaneous. The main driver in the Underground Miscellaneous category was Improperly Sealed End Caps and Unsealed Service Ducts (83% of defects). Finally, the increase in the Underground Conductors category was driven by Exposed Conductors and Damaged Secondary Service which makes 40% of the defects.
