Consolidated Edison Company of New York, Inc.'s *2015 Contact Voltage
Test and Facility Inspection Annual Report*

**CONTACT VOLTAGE TEST &
FACILITY INSPECTION
ANNUAL REPORT**

CONSOLIDATED EDISON COMPANY OF NEW YORK, INC.

Report on the results of contact voltage tests & facility inspections for the period
beginning January 1, 2015 and ending on December 31, 2015.

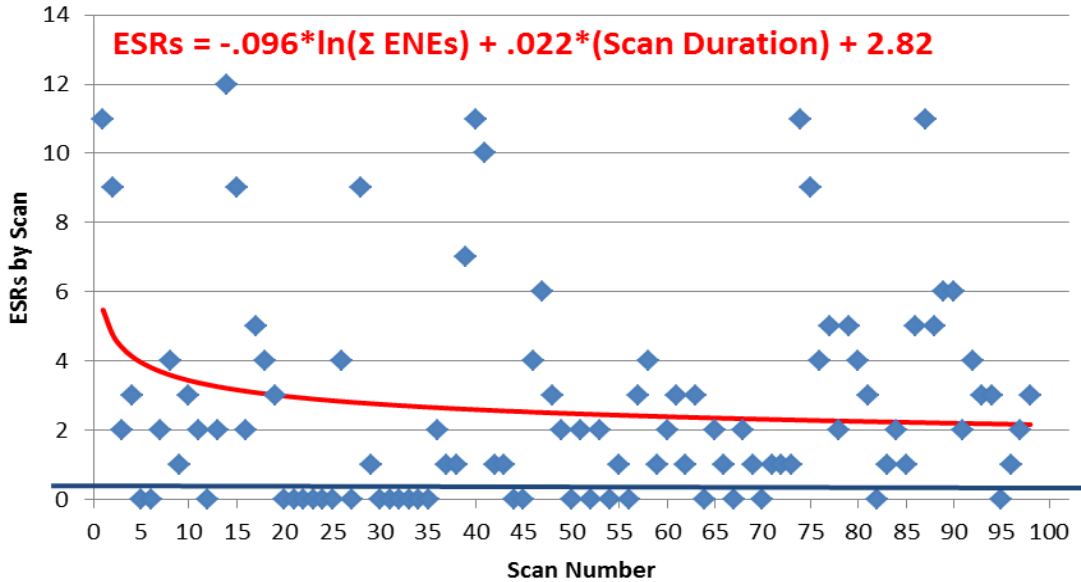
Chart 1
Con Edison ESR by Scan vs. Cumulative ENEs and Scan Duration

The ESRs associated with Con Edison’s equipment appear on Chart 1. As mentioned above, weather also plays a role in ESR generation. Higher precipitation in 2015 increased the generation rate of ESRs associated with Con Edison’s equipment. This weather variable is accounted for in the underlying models and in both the 2015 and long term predictions. The duration between scans ranges from approximately 30 to 35 days per scan. If Con Edison continues with a comparable ENE repair rate and scan interval in 2016 and experiences similar weather patterns, the Company can expect ESRs to be approximately 2 per scan. In 2015 there were 40 shocks associated with the Company’s equipment. This result is above the projection but well below pre-safety program performance and more consistent with weather related influences.

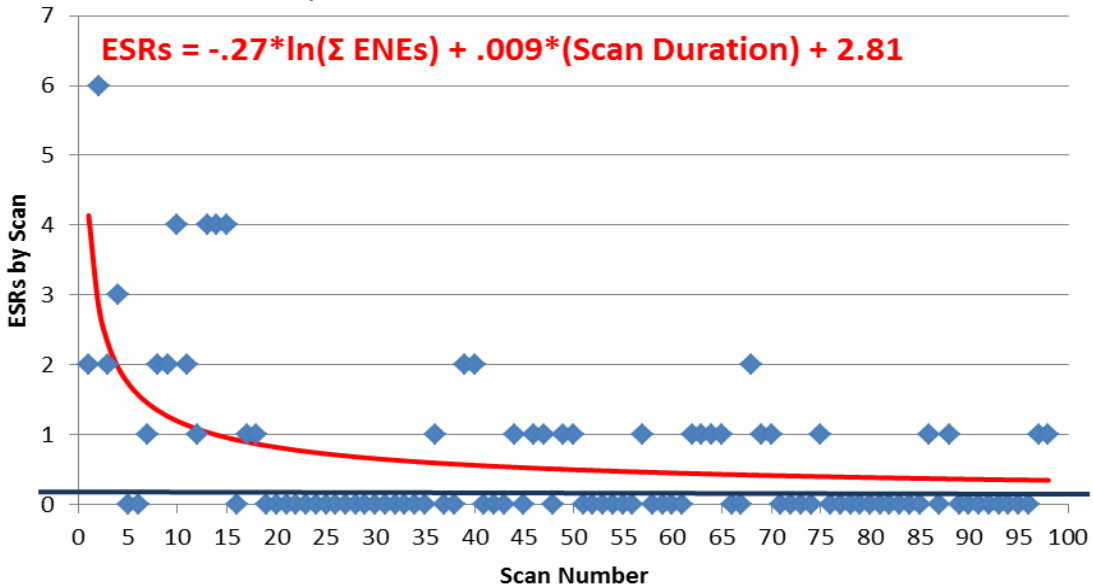
Chart 2
DOT ESRs by Scan vs. Cumulative ENEs and Scan Duration

The ESRs associated with DOT equipment appear on Chart 2. The duration of scans is 30 to 35 days per scan. If the Company continues a comparable ENE repair rate and scan duration in 2016, the Company can expect ESRs at this scan duration level to remain at approximately 1 per scan. In 2015 there were 3 shocks associated with DOT equipment failures. This result is below the company's projections and shows performance continues to improve from the various programs implemented by both DOT and Con Edison to mitigate shocks.

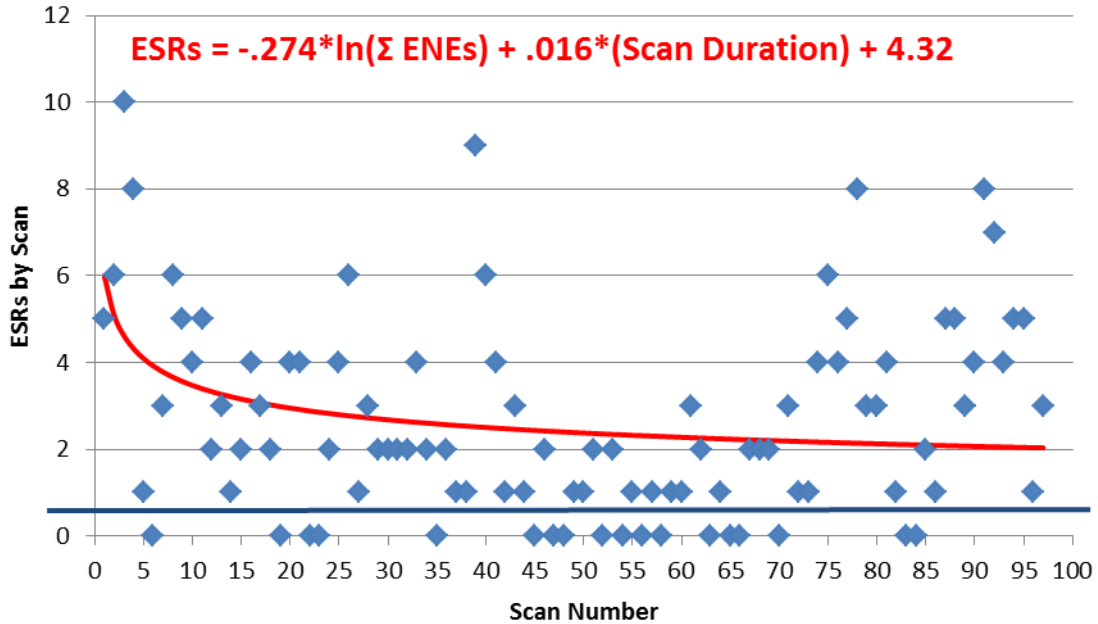
Chart 3
Customer (Public Access) ESRs by Scan vs. Cumulative ENEs and Scan Duration

The ESRs associated with Customer’s equipment appear on Chart 3. The duration of scans is 30 to 35 days per scan. If the Company continues a comparable ENE repair rate and scan duration in 2016, the Company can expect ESRs to remain at 2 per scan, with no significant reduction anticipated below that level in the near future. The actual performance indicates that these shock events are less sensitive to our mitigation efforts than we initially projected. In 2015, the Company responded to 40 validated shock reports on publicly accessible customer equipment.

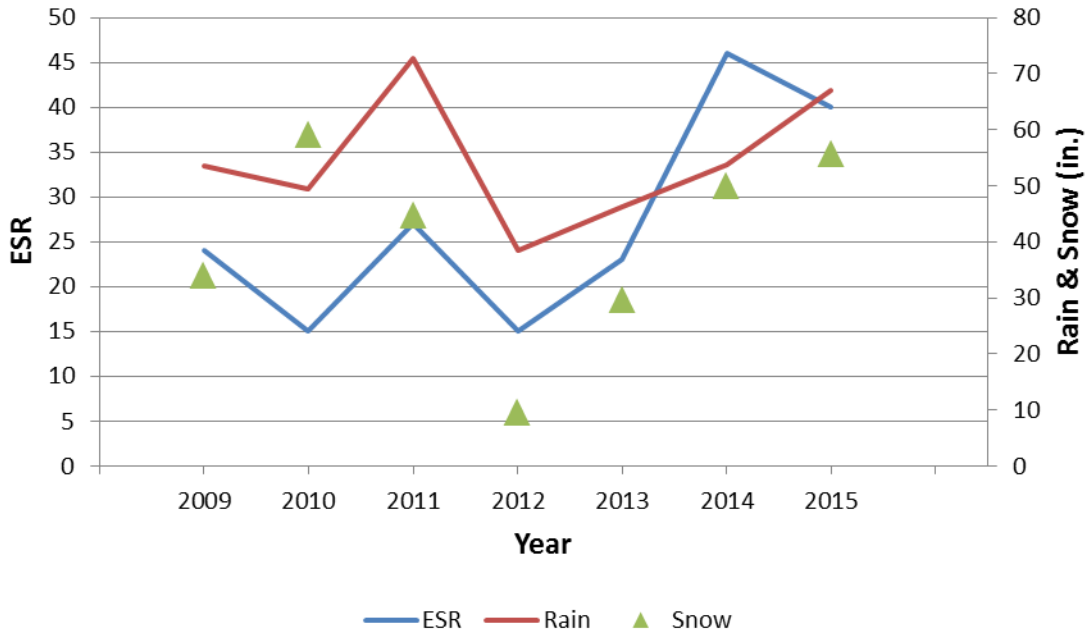
**Chart 4
2009 – 2015 Rainfall vs. ESR**

In evaluating snow and rainfall in successive years (Chart 4), the system response to ground conditions, such as the level of precipitation, changes from 2009 to 2015. As snowfall and rainfall trended upwards from 2009 to 2015, ESRs also trended upwards. Although snow and rainfall increased there is a decrease in number of ENE/ESRs in 2015. The Company will continue to monitor this correlation in 2016.

Weather continues to have a direct impact on the electrical system. The months of January, February and March accounted for 98% of the snowfall this winter season. The snow precipitation for these three months was 2.2 times higher than the historical average. Approximately 485,191 tons of salt was distributed, making this the highest salt distribution in the last ten winter-seasons. Despite harsh winter conditions for a second consecutive year, 2015 energized objects (ENEs) detected and electric shock reports (ESRs) decreased significantly (21% and 7.1% respectively) from 2014. ESRs remain well below their pre-program historical values, e.g., in 2004 there were 285 ESRs. These weather-driven fluctuations demonstrate that the Con Edison Public Safety Programs continue to control risk.

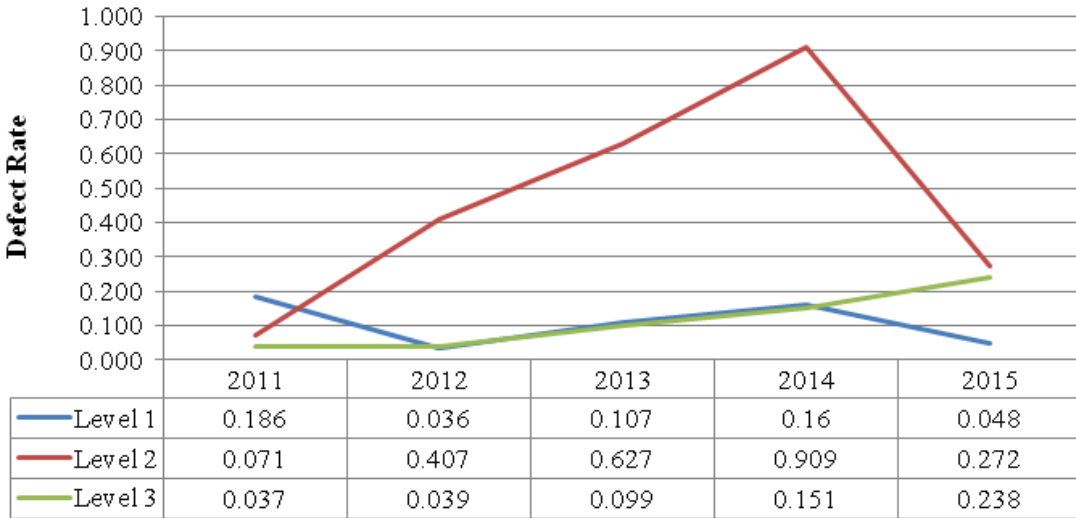
**Chart 5
Defect Rate by Level**

Chart 5 shows the number of defects found per inspection by their classification level. There has been a 79% decrease in both the Level I and Level II defect rate from 2014 to 2015, while Level III has increased by 7%.

The generation of Level I and Level II defects show a downward trend. The main driver for the reduction in Level I was the 79% reduction from 2014 in “cable or crab in contact with frame or cover”. The main driver for the reduction in Level II was: Improperly seal caps and ducts (80% reduction) and damaged secondary mains (41% reduction). In addition, the combined underground defect generation rate had a 36% improvement over 2014

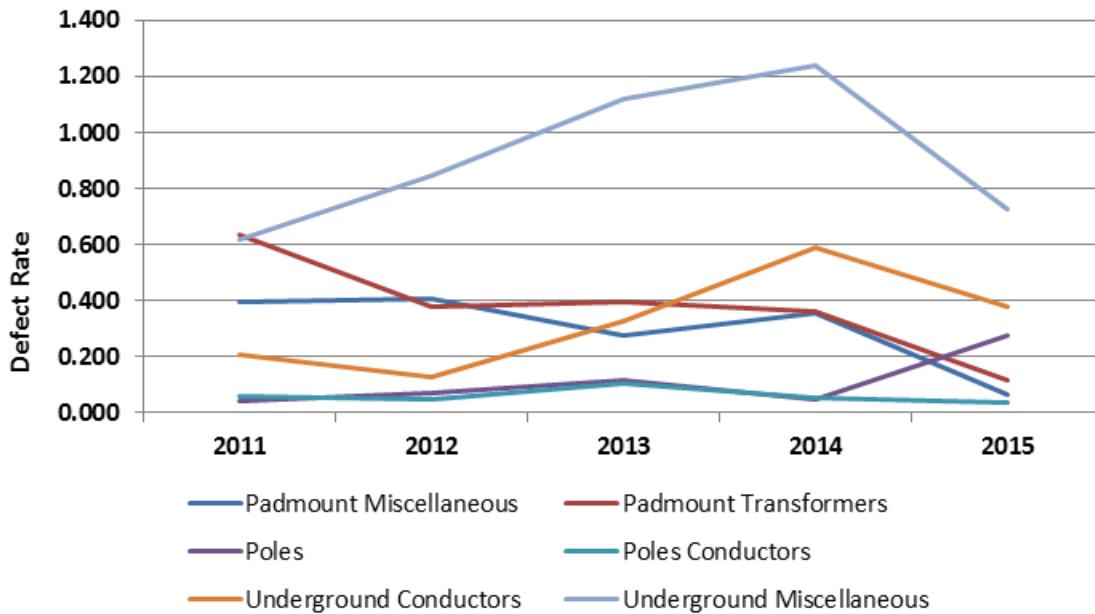
**Chart 6
Defect Rate by Type of Repair**

There is an increase in the Level III generation from 2014. Chart 6 shows the defect rate by type of repair. As can be observed, the increase in Level III defects is in the “Pole” category mainly due to the introduction of a new defect added to the overhead in 2015 “Missing tap between primary down guy and system neutral”. This new defect was added because it was determined that it could potentially become a safety concern to the public. In addition, there has been an increase in the number of “ground” defects found. This is attributed to the clarifications made to the training of the new contractors on what type of defects we were looking for in the “Pole Ground” category. As for example, ground wire detached from the pole but still electrically connected is now being captured as a Level III defect.

If the new generated defects were to be removed from the 2015 defect count, it would result in a Level III generation rate of 0.096 which is a 59% reduction from the Level III generation rate in 2014.
