BEFORE THE  
STATE OF NEW YORK  
PUBLIC SERVICE COMMISSION

In the Matter of  
Consolidated Edison Company of New York, Inc.

Case 22-G-0065

Prepared Exhibits of:

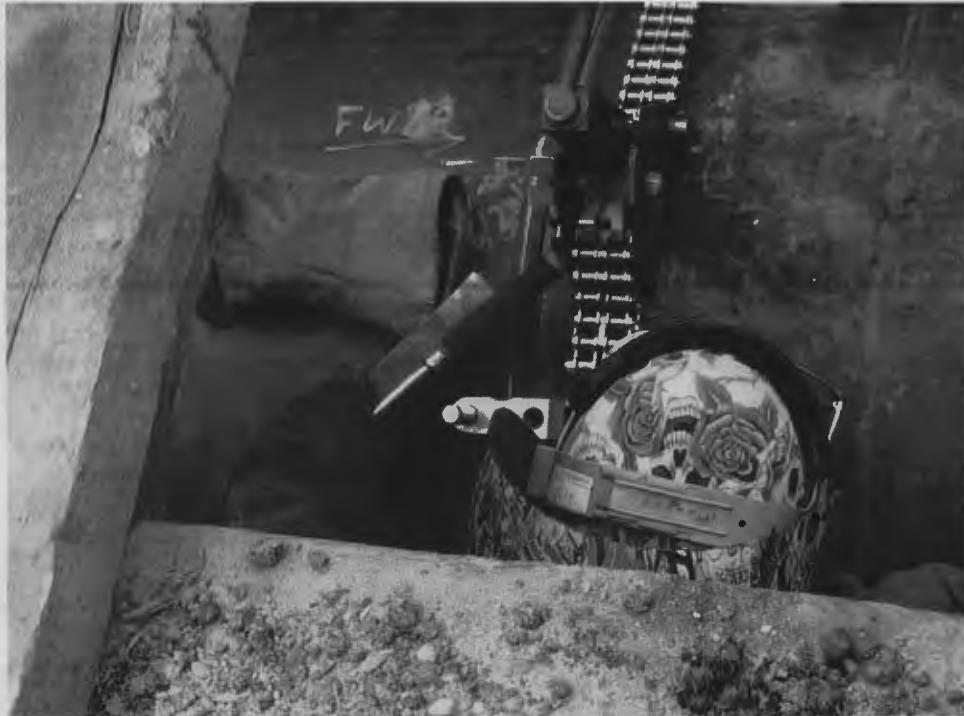
After Staff reported the issue, during a meeting on 9/13/17, CECONY stated that additional length was cutout on each side to meet the minimum requirements per procedure.

Image: FW#83 Taken on 9/11/17 – Cutout of FW#83 with less than 24-inches on each side of cutout prepared for welding (picture taken by Staff)

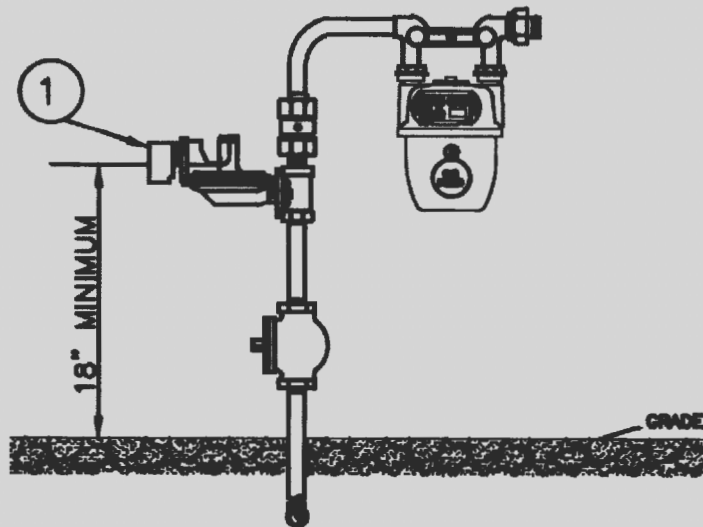
**FOR OUTDOOR REGULATOR**

CECONY Procedure G-11838-12 – *High Pressure Gas Service Inspection* states in Section 4.3(A) “Each vent inspection shall include: The proper location of the vent terminus or verification that a VLP has been installed in flood prone areas.” CECONY Engineering Drawing EO-17118 – *Regulator Vent Installation* depicts vent terminus minimum height to be 18-inches from final grade.

- On 8/1/17, Staff observed a high pressure service regulator inspection located at [REDACTED]. The CECONY mechanic measured the service regulator vent terminus height to be 14.5-inches. The mechanic corrected the issue and brought the regular vent terminus to specification. Staff requested the most recent CECONY visit to the location and found a high-pressure inspection performed on 7/23/17, which was nine days prior to Staff's visit. The earlier inspection record did not note any issues with regulator vent terminus and piping.
