Re: Case 04-M-0159, Proceeding on the Motion of the Commission to  
Examine the Safety of Electric Transmission and Distribution Systems

**CONTACT VOLTAGE TEST &  
FACILITY INSPECTION  
ANNUAL REPORT**

**CONSOLIDATED EDISON COMPANY OF NEW YORK, INC.**

Report on the results of contact voltage tests & facility inspections for the period beginning  
January 1, 2020 and ending on December 31, 2020.

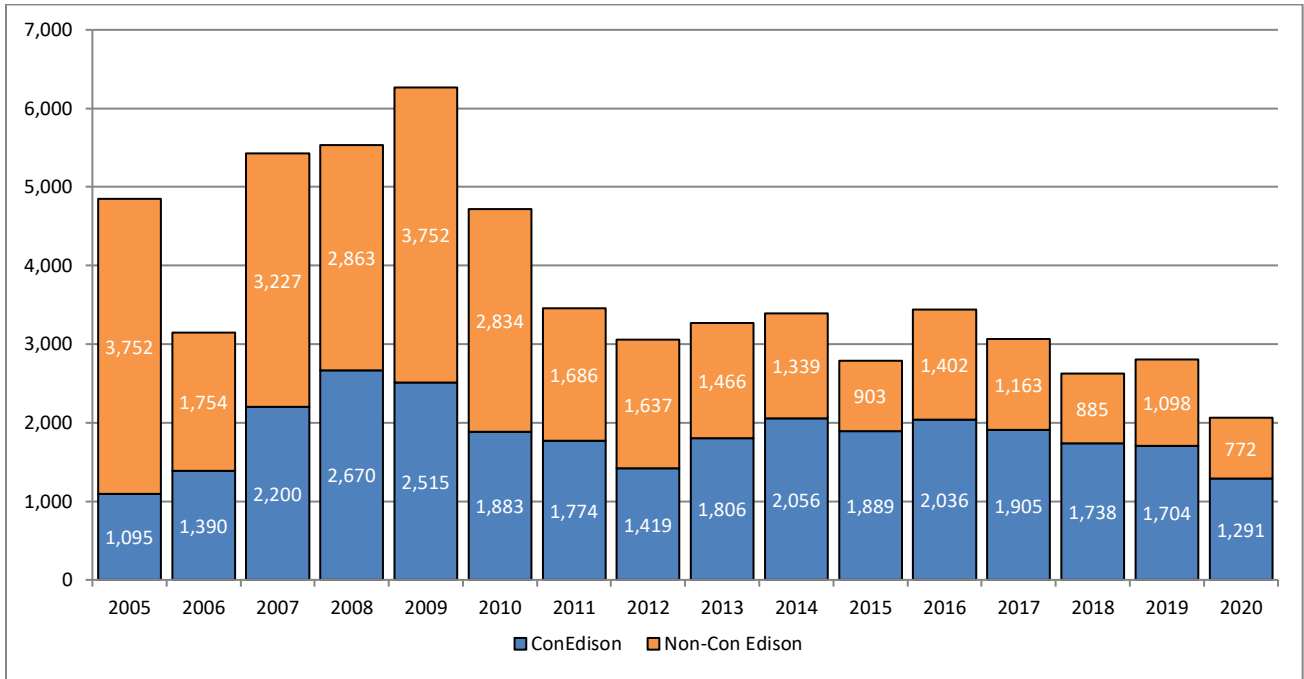
**Chart 1**  
**ENE Sources**

Since the likelihood of an ESR will increase or decrease in proportion to the total number of energized structures and exposure time, the timely detection and repair of identified sources of contact voltage is the principal mitigation effort for reducing ESRs. Each completed repair effectively represents a mitigation of possible ESRs and over time, the potential ESRs decrease accordingly. As can be observed in Chart 1, the sources of ENEs have been decreasing since the inception of the program. Similarly, the Con Edison responsibility ESRs (Chart 2) and Non-Utility responsibility ESRs (Chart 3) show a similar trend.

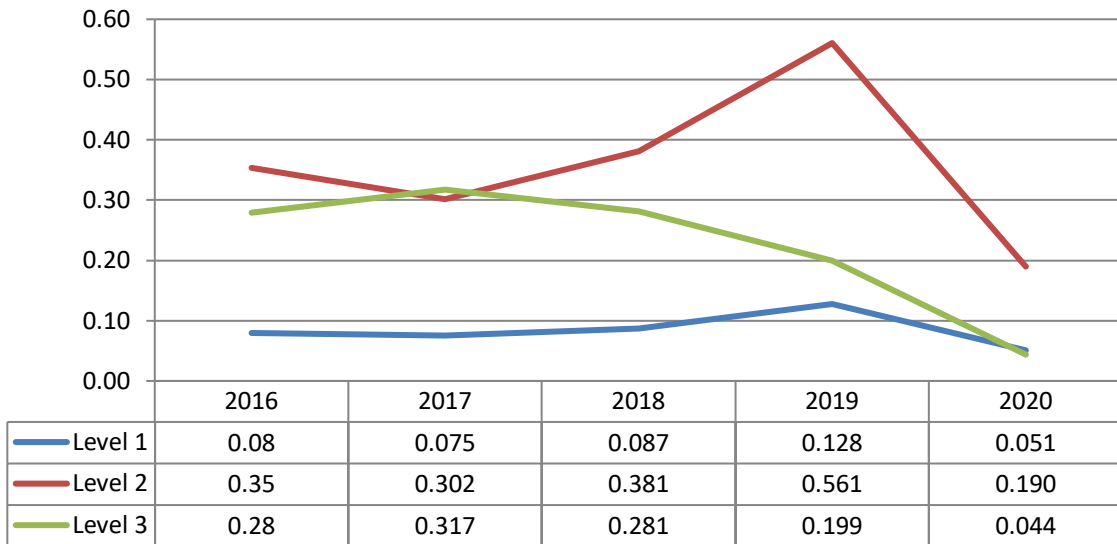
**Chart 5**  
**Defect Rate by Level**

Chart 5 shows the number of defects found per inspection by classification level. The generation rate of L1, L2 and L3 defects found this year show a downward trend and are below the five-year average.

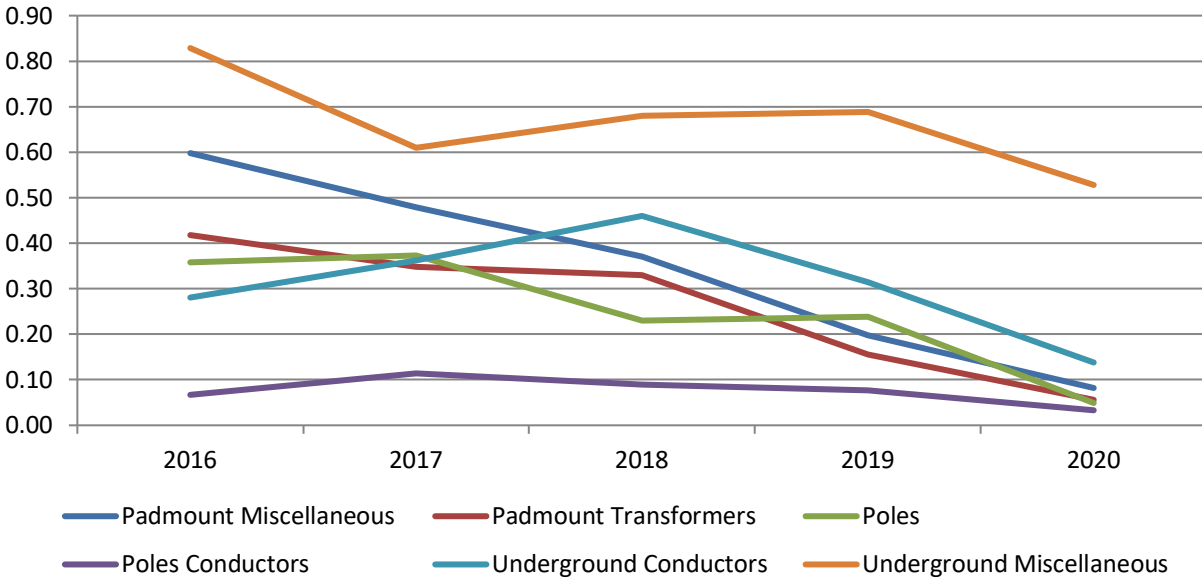
**Chart 6  
Defect Rate by Category**

Chart 6 shows the 2020 Defect Rate by Category. The Defect Rate shows a downward trend for all the six major categories listed and they are all below the five-year average.
