STATE OF NEW YORK  
PUBLIC SERVICE COMMISSION

CASE 22-G-0425 - Proceeding on Motion of the Commission  
Regarding a Staff Investigation into New York  
State Electric and Gas Corporation's Response  
to a Natural Gas Incident at 2592 Carmel  
Avenue, Brewster, New York.

ORDER ADOPTING TERMS OF SETTLEMENT AND INITIATING NEW PROCEEDING

National Transportation Safety Board  
Safety Recommendation Report  
Installation of PermaLock Mechanical Tapping Tee Assemblies  
June 18, 2018

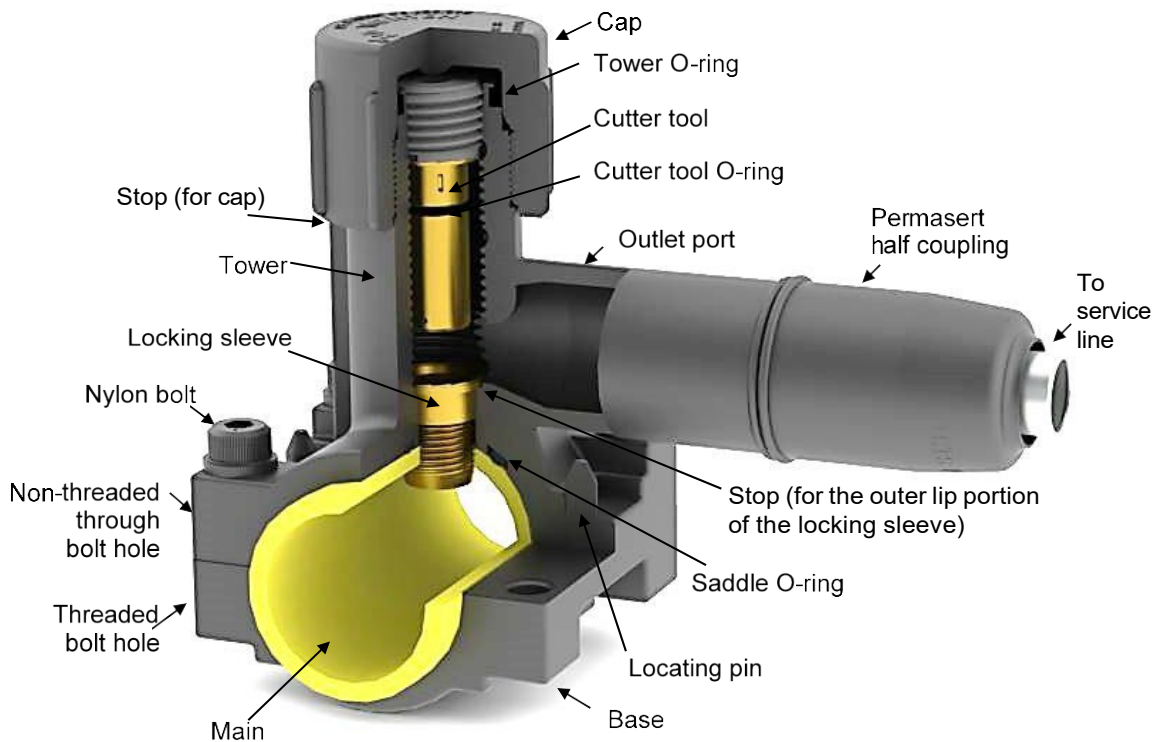
**Figure.** Cross-section diagram of an exemplar PermaLock mechanical tapping tee assembly, provided by Honeywell.

NTSB examination of the PermaLock tee assembly involved in the accident has revealed that the tee assembly was incorrectly installed. Although the cutter tool pierced a hole in the main, the locking sleeve did not progress down far enough into the tower to form threads in that hole. As a result, the locking sleeve was not attached to the main.<sup>6</sup> The NTSB also found that two of the four Nylon bolts on the tee assembly were fractured in a manner consistent with *slow crack growth*.<sup>7</sup> These findings indicate the likelihood of varying tee assembly installation techniques.

crack growth when overtightened. Therefore, the NTSB recommends that Honeywell specify in its PermaLock mechanical tapping tee assembly installation instructions a not-to-exceed torque limit for Nylon bolts and have that value checked and adjusted with a torque wrench immediately after installation.
