STATE OF NEW YORK  
DEPARTMENT OF PUBLIC SERVICE

Report on  
Steam Pipeline Rupture  
41<sup>st</sup> Street & Lexington Avenue  
Consolidated Edison Company of New York. Inc.  
July 18, 2007  
(CASE 07-S-0984)

Safety Section  
Office of Electric, Gas & Water  
February 2008

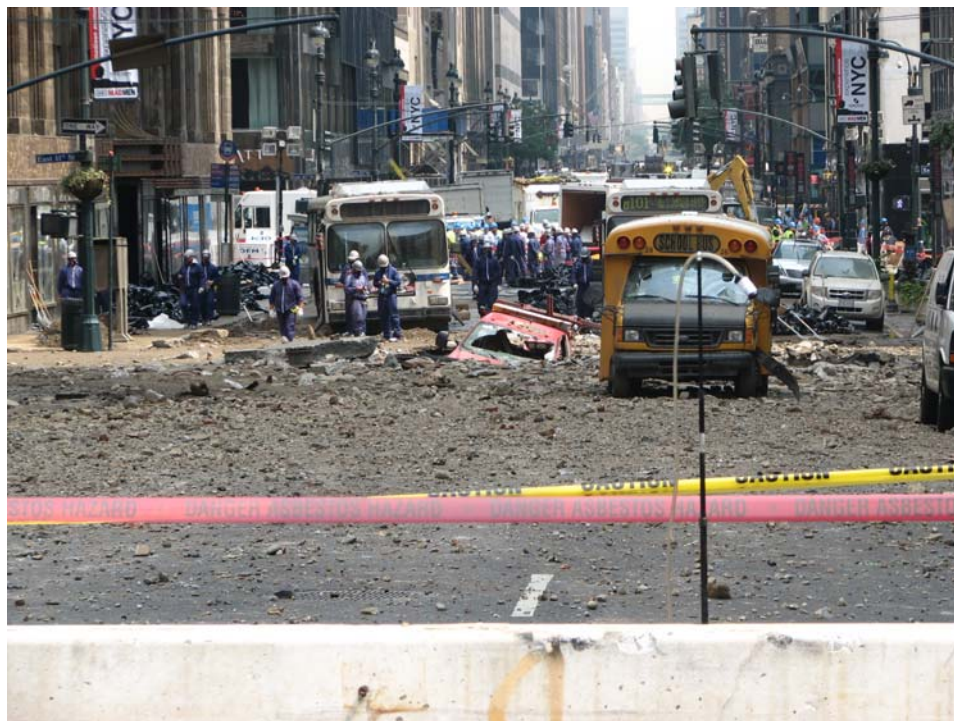
At approximately 5:56 PM, a section of steam main in the intersection of 41<sup>st</sup> Street and Lexington Avenue catastrophically ruptured. The rupture created a crater in the intersection at least 30 feet in diameter and 16 feet deep. A tow truck traveling south on Lexington Avenue fell into the crater. Flying debris and the plume of steam from the ruptured main caused damage to building fronts and nearby vehicles. Many windows in nearby office buildings were broken. The steam roared loudly. Dozens of people were injured, including the tow truck driver and a passenger who both sustained serious burns. One person reportedly suffered a fatal heart attack while attempting to flee the scene. The surrounding buildings, primarily office buildings, were evacuated.

Figure 3 – Photo of Incident Site on July 18 Looking North

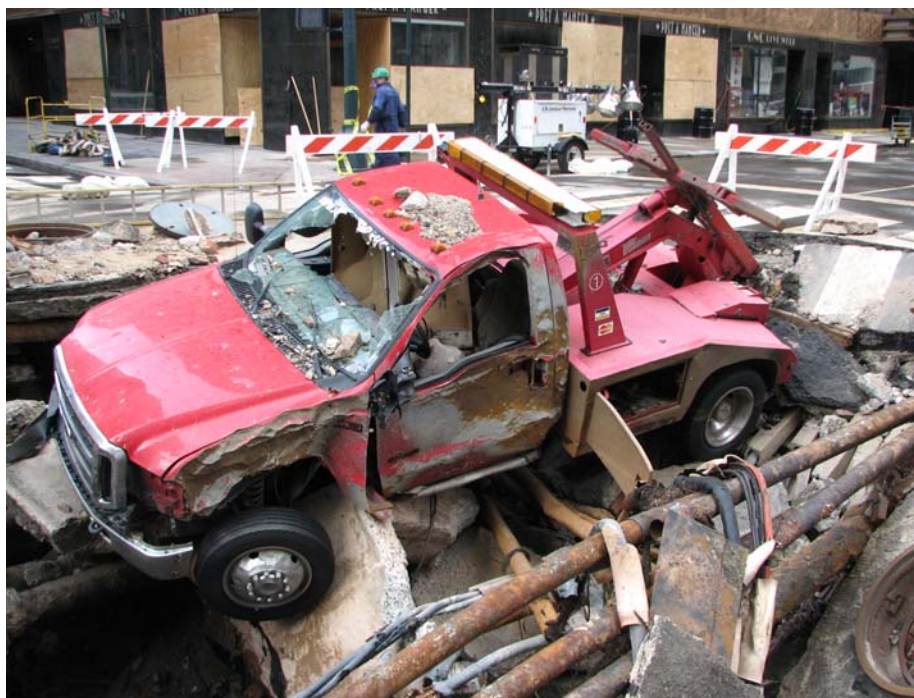
Figure 4 – Photo of Tow Truck in Crater

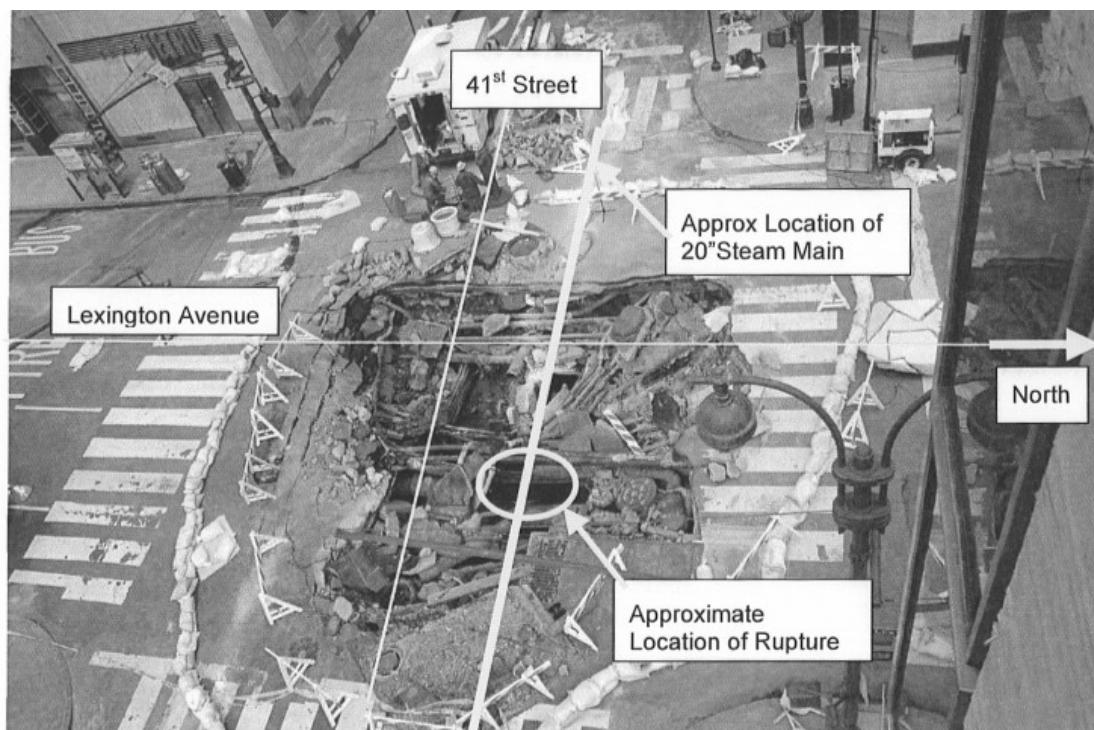
Figure 5 – Image of Crater during Debris Removal  
Source: ABS Report 1763931-R-001

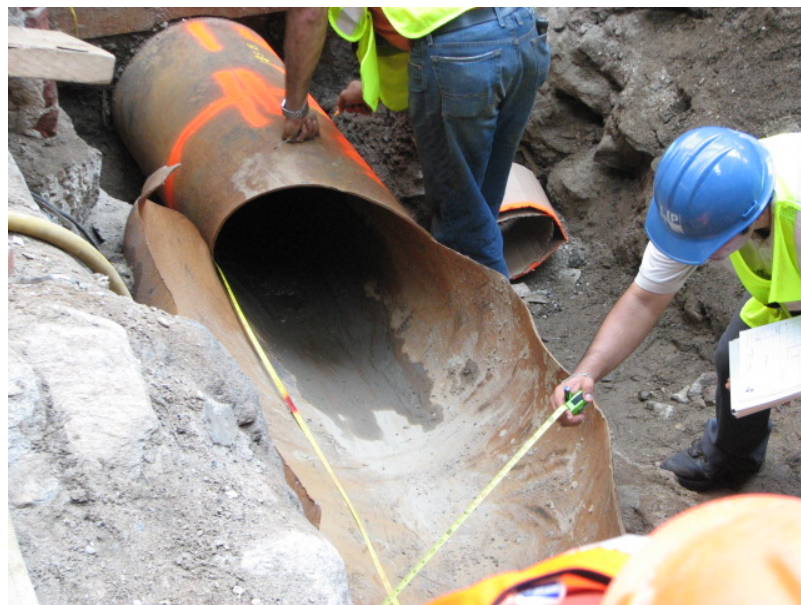
<sup>5</sup> The rupture occurred on the top part of the file 3 bend.

The steam main was first exposed in the crater on July 30. At this time Staff was able to view the ruptured portion of the main. By August 2, the area around the steam main had been sufficiently abated and the excavation shored so that Staff could gain close access to the main. As shown in the Figure 6 below, taken on August 2, the rupture opened in a flap approximately 47 inches long, unpeeling the top half of the pipe.

Figure 6 – Photo of Ruptured Main Exposed at Site

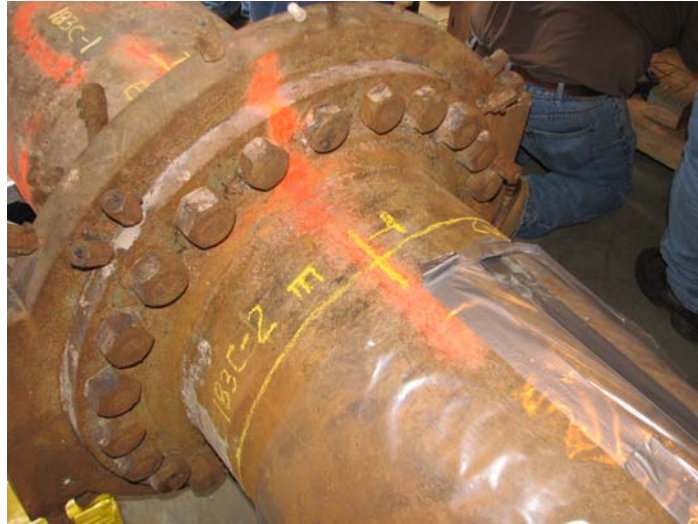
- Con Edison's control of the process for sealing flange leaks and replacing defective pipe was lax. On several occasions over the two years prior to the incident, Con Edison injected sealant into the flange connection within the manhole at 41<sup>st</sup> Street and Lexington Avenue to stop leakage. The debris that clogged the steam traps was analyzed and found to contain the leak sealant material that had been injected into the flange. The company's contract with the vendor who performed the leak sealant injection stated that the quantity of material injected must be minimized based on a calculation of the volume needed to stop the leak. Con Edison could not produce any documentation to demonstrate that such calculations were performed. The company relied on the vendor technician who performed the leak sealing procedure as to the acceptability of repeated attempts to seal the flange leak. Additionally, the leak sealing process was sometimes done with the steam main in operation and sometimes not. On eight of the ten occasions when the leaking flange was sealed since July 2005, the section of steam main was shut down specifically to facilitate the leak sealing process. There is concern that these conditions can allow the sealant to enter the steam pipe. Occasions when the steam main was shut down also offered opportunities to make a permanent repair or eliminate the flange. According to Con Edison management, there were plans to do so on at least two occasions, but the work was delayed in favor of other work, and was never carried out.

The flanged pipe connection in the manhole to the west of the rupture was found to be intact (see Figure 7 below). It was evident that the flange connection had been previously repaired by a technique that required the installation of an encapsulating clamp, enabling injection of sealant into the joint.

Figure 7 – Photo of Flange with Leak Sealant Injection Clamp

- 11) Con Edison must discontinue the use of leak sealant injections as a method to repair leaks unless it can demonstrate that effective controls are in place to verify the proper quantity of material injected, limit excessive applications, and ensure that the steam system components will not be adversely affected.

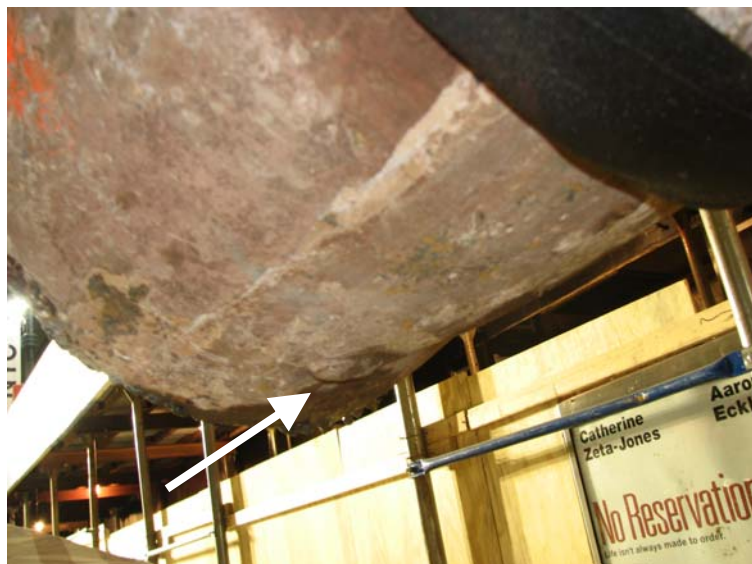
- Con Edison's procedures for evaluation of identified pipe damage were deficient. There were two dents on the bottom of the pipe on the west side of the flange within the manhole at 41<sup>st</sup> Street and Lexington Avenue. A welded leak repair was made on a crack in one of the dents more than two years prior to the incident. The pipe rupture did not initiate at this prior repair and it did not contribute to the failure. However, Con Edison records indicate that the pipe needed to be replaced, but no investigation or analysis was conducted to determine the cause of the dents. It is likely that the dents resulted from a prior less-severe water hammer event at the location, which caused the pipe to jump or lift off its support and slam back down. Also, no action was taken to replace the damaged pipe section prior to the rupture.

Approximately twelve inches west of the flange, Staff noted two dents at the bottom of the pipe, spaced so as to suggest they were due to some sort of force against pipe supports, although no pipe supports were found in the manhole. There was visual evidence that one of the dents had been repaired with a puddle weld, i.e. weld filler material deposited to fill in the dent.

Figure 8 – Photo of Puddle Weld

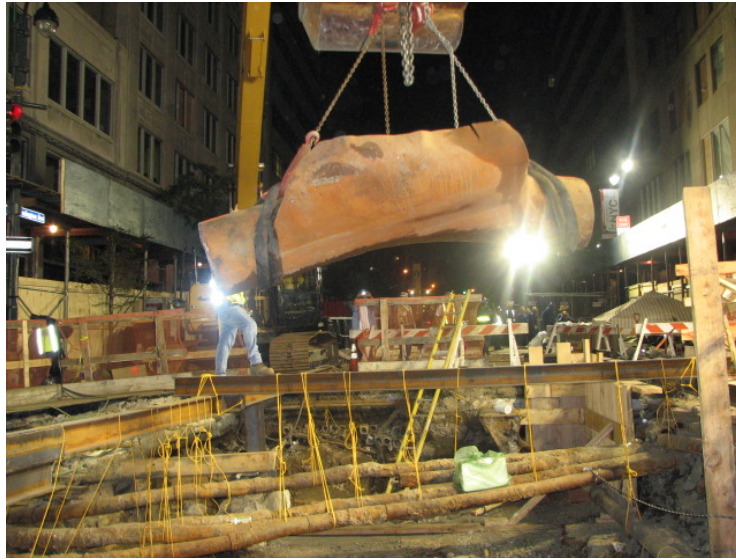
Figure 9 – Photo of Rupture Section Removed from Site

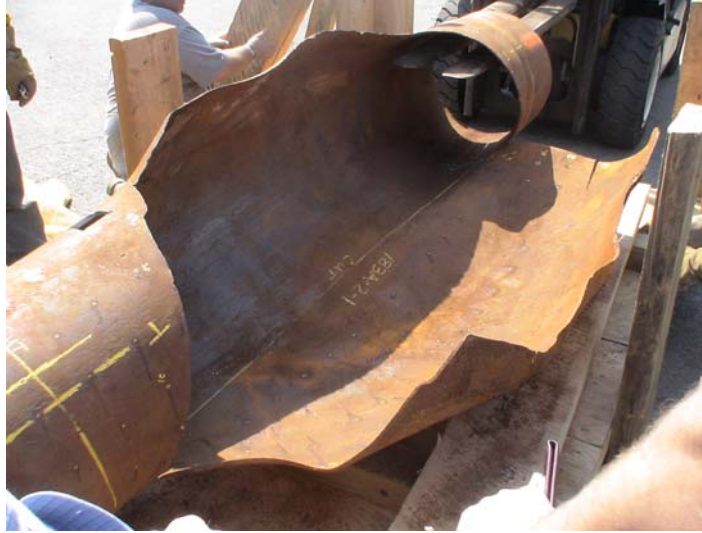
Figure 10 - Photo of Ruptured Steam Main at Astoria Site

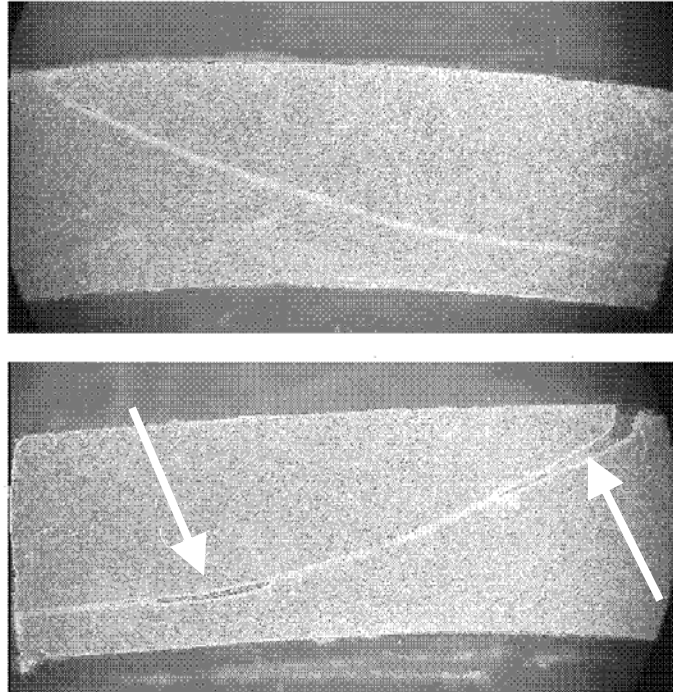
the environment for some time. This suggests that the seam may have partially opened due to an earlier overpressure condition, such as a previous, yet less severe, water-hammer event(s). However, given the buried location of the seam, the partial opening would not have been discovered by Con Edison during normal operations.

Figure 11 - Macrospecimens Showing Inclusions in Lap Weld  
Source - LPI Report

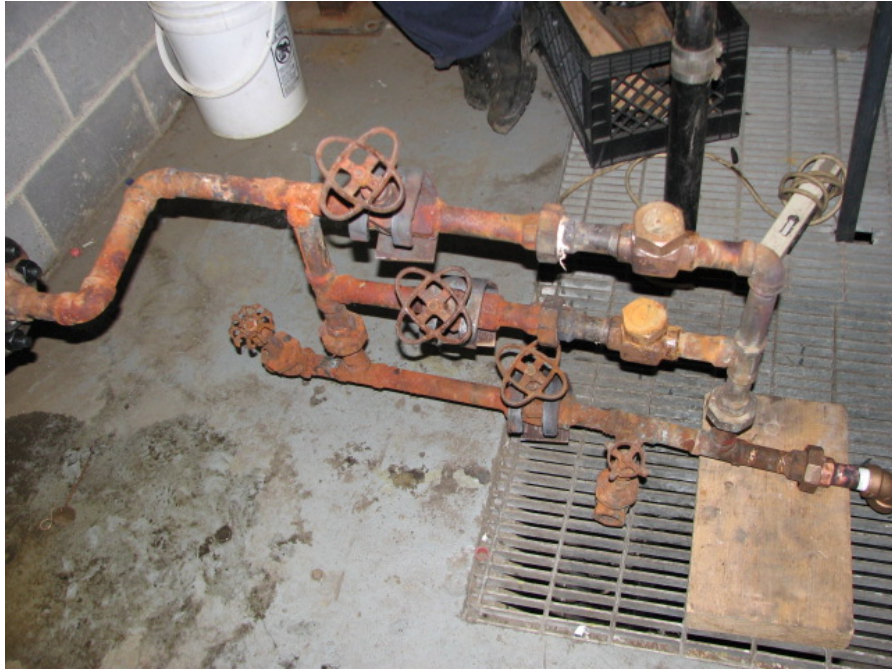
The test pressure was approximately 160 psig. During the test the trap assembly did not appear to be operating properly. Rather than pulse, a constant but small amount of condensate and steam seemed to be flowing out of the traps. Attempts to isolate each of the two traps to encourage operation failed. It seemed possible that the bypass valve on the assembly could be leaking, allowing condensate to pass, rather than build up to the level required to open the traps.

Figure 14 - Photo of Steam Trap Assembly - First Bench Test

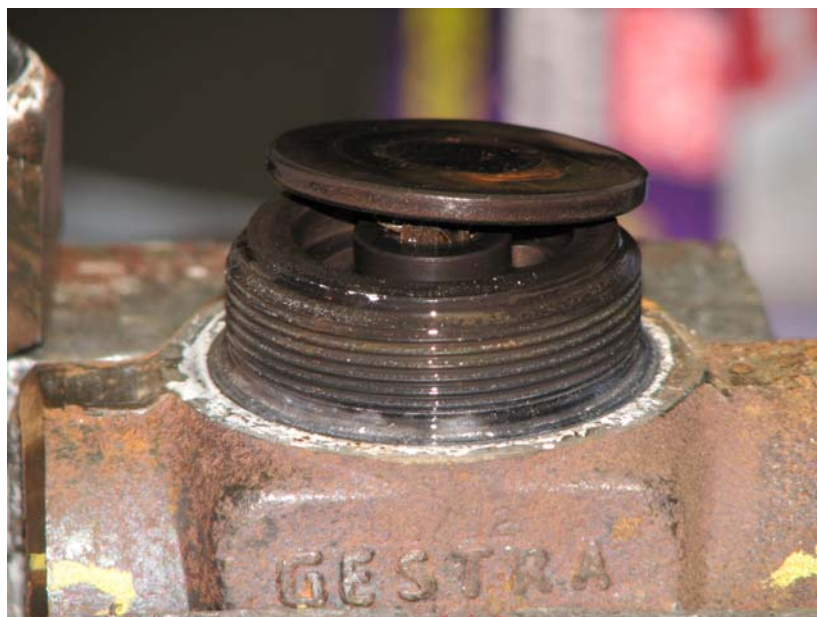
After these bench tests, the traps were turned over to LPI for further testing. Under Staff observation, the two traps were removed from the assembly and radiographed, which indicated that the mechanical disk inside the traps was not seated as expected. All of the steam piping was inspected and found to be visibly free of debris. After the traps were disconnected from the assembly piping, their inlet and outlet ports were inspected from the outside, and no debris was visible. The caps of both traps were removed. The disks of both traps were found askew, pushed up in both cases by masses of debris protruding from the internal inlet ports. The debris in both traps appeared visually similar, consisting of wet, clumped masses, which were brown and orange in color (see Figures 15 and 16 below). The cap was replaced on the bottom trap, so that the trap could be maintained as found, should future testing be required.

Figure 15 – Photo of Steam Trap (top) With Cap Removed

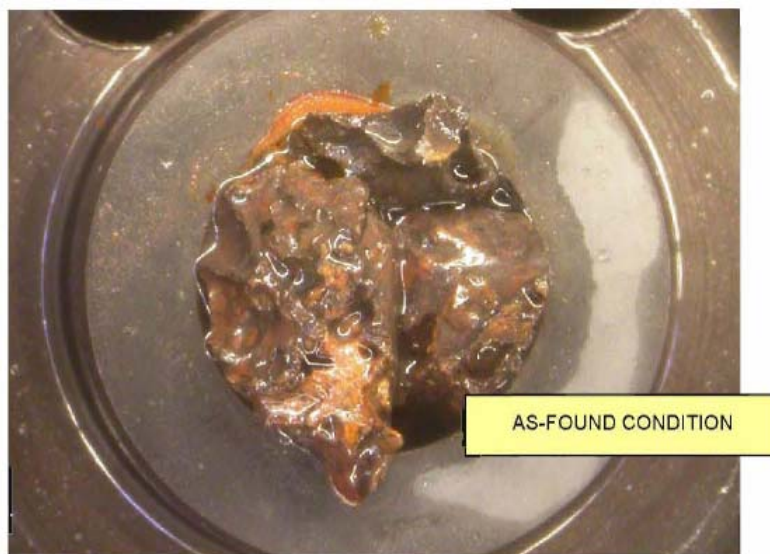
incident, the steam traps were found to be nearly completely clogged with debris, severely reducing their ability to eliminate the condensate from the steam main. This was the second primary causal factor that contributed to the rupture.

Figure 16 - Photo of Close up of Debris in Inlet Port  
Source: ABS Report 1763931-R-001

The debris from the top trap was carefully removed and collected in layers. The materials were sent out to the University of San Diego (USD)<sup>12</sup> for detailed composition analysis. The materials were found to be chemically similar to samples of leak sealing epoxy taken from the nearby flanged main connection.

- 4) Con Edison must establish a detailed trap inspection procedure sufficient to periodically ensure that the steam traps are clear of any debris and can freely operate at its design capacity. At a minimum, it will require the replacement of all traps on an annual basis and internal inspection of all traps removed from service. Traps that fail inspection must be immediately replaced and promptly investigated to determine the cause of failure.

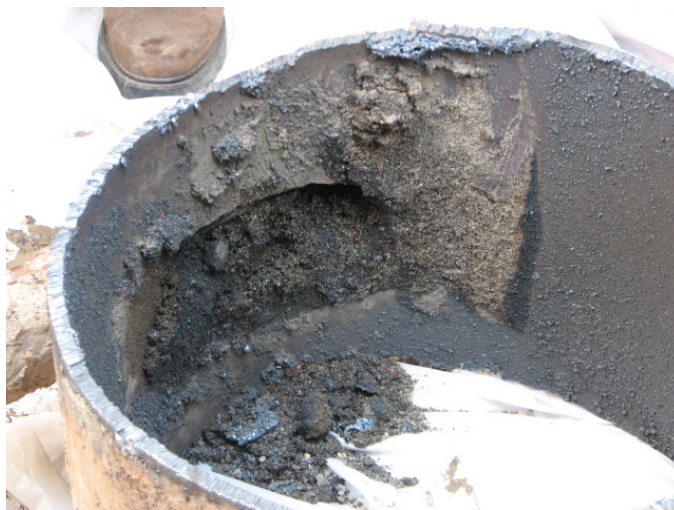
When the fish-mouth connection piping was removed in the field, a large amount of sediment was found caked in the connection. The connection piping was taken apart in pieces, so that samples of the sediment within the fish-mouth connection could be retrieved in layers. The concern was that there was a potential that stratified layers of distinctive sediment would have built in the fish-mouth connection over time, and would have impeded the ability of condensate in the system to flow to the traps and be discharged. These samples were also sent to the USD for testing, which determined they were the result of post-incident debris accumulation, including asbestos from the pipe insulation material, but contained no epoxy sealant materials.

Figure 17 – Photo of Debris in Fish-mouth Connection

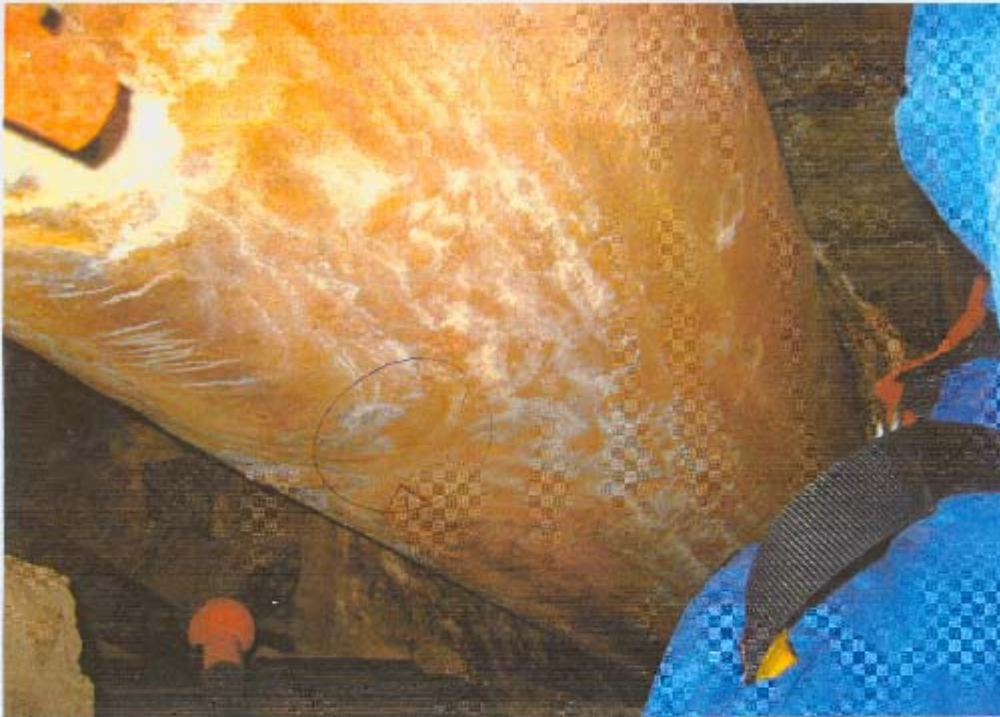
Photo Taken June 24, 2006

(11/5/06) (Lester)  
Single Hens right  
Flange leak

Previous welds repair  
Pipe is rusted & pitted in several  
places. Should change pipe!
