Re: Case 06-M-1078 – Proceeding on Motion of the Commission to
Audit the Performance of Consolidated Edison Company of
New York, Inc. in Response to Outage Emergencies

Case 06-E-0894
Investigation of Electric Power Outages in Con Edison's Long Island City Network

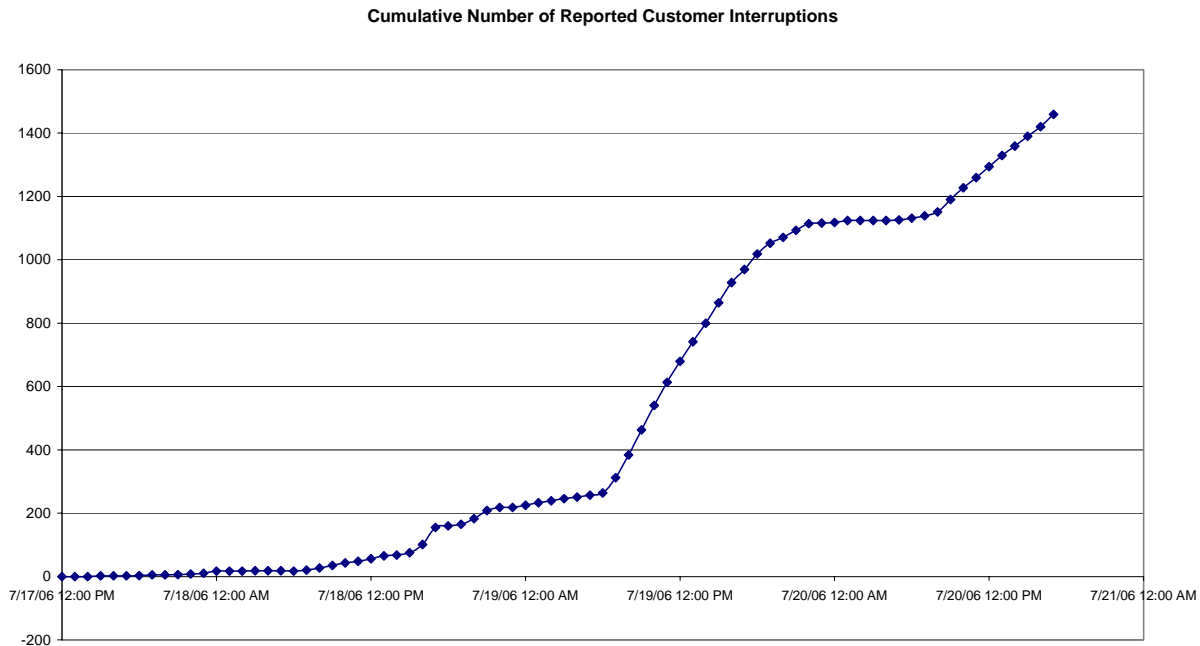
**Figure 3.3.2-1 – Cumulative Number of Reported Customer Interruptions on Long Island City Network
From July 17-21, 2006**

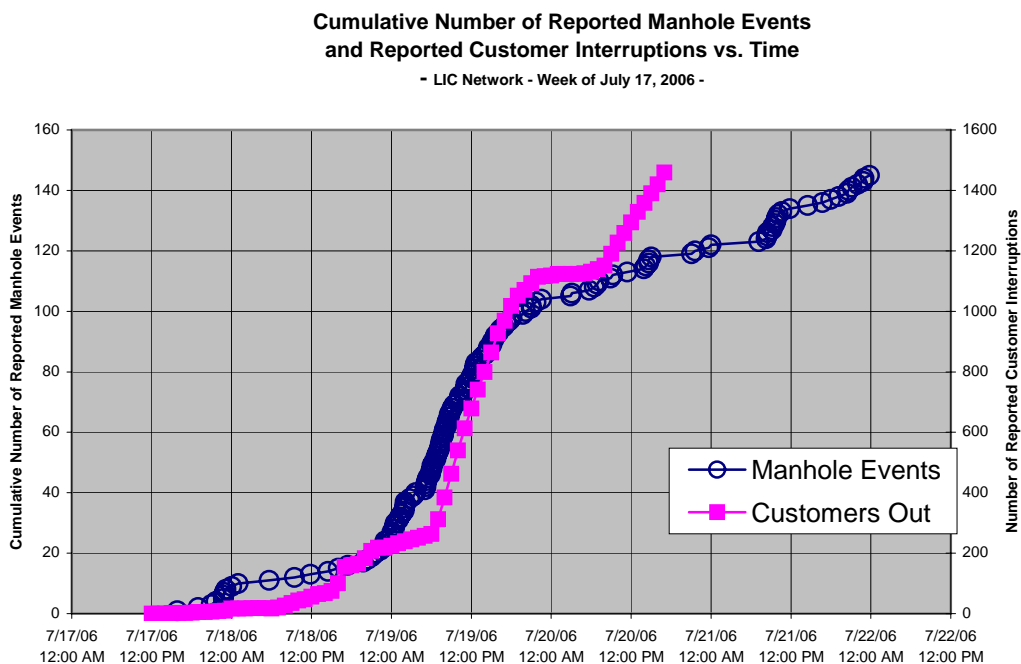
Other mechanisms exist that can indirectly indicate significant secondary damage and potentially customer interruptions. Manhole events are reported to the control center, and the number is tracked. Figure 3.3.2-2 below shows the number of Long Island City network manhole events that were reported to Con Edison during the week of July 17, 2006. Figure 3.3.2-2 also shows the number of reported customer interruptions to Con Edison during that period.²³ There is a correlation between the number of manhole events and the number of reported customer interruptions.

Figure 3.3.2-2 – Cumulative Number of Reported Manhole Events and Customer Interruptions vs. Time

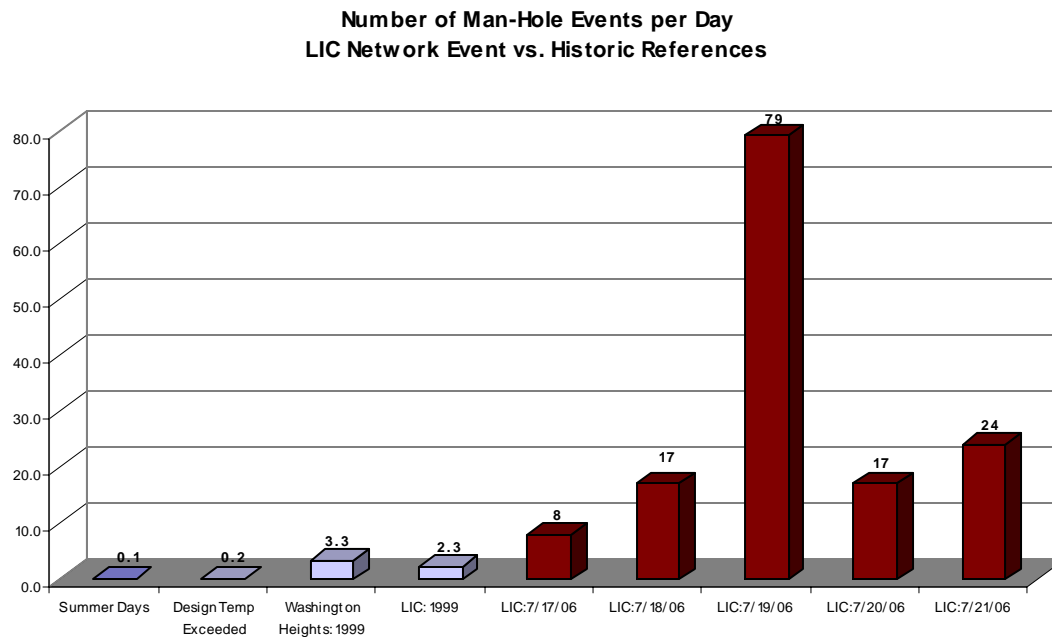
Figure 3.3.2-3 below shows the number of manhole events that occurred per day for the Long Island City network event and selected reference points. The right side of Figure 3.3.2-3 shows the reported manhole events per day for the Long Island City event, July 17 through

July 21. The left side of the figure shows the reported manhole events per day for selected reference points, including a network average for summer days, days when the design temperature is exceeded, the per-day average for the Washington Heights event during July 1999, and the per-day average for the Long Island City network during the same period in July 1999.

Figure 3.3.2-3 – Number of Manhole Events Per Day, for the Long Island City Network and Selected Reference Points

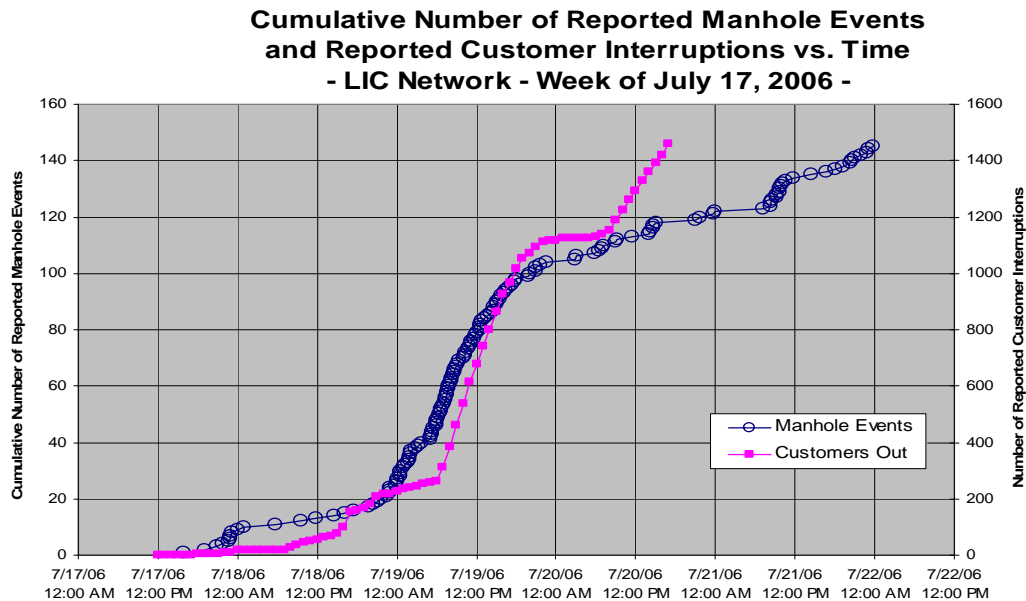
Figure 3.3.6-1

Had sufficient response personnel been mobilized at this point in time Con Edison would have been able to address the secondary damage and customer outage approximately two days in advance of when they actually began to respond appropriately to these events.

Following the Thursday overnight survey, Con Edison finally realized that the customer outage count was dramatically understated and the magnitude of the secondary system damage was much greater than it initially thought. As a result, in response to the actual magnitude of the electric system conditions, the response to this portion of the system was finally initiated at the appropriate level on Friday, July 21st.

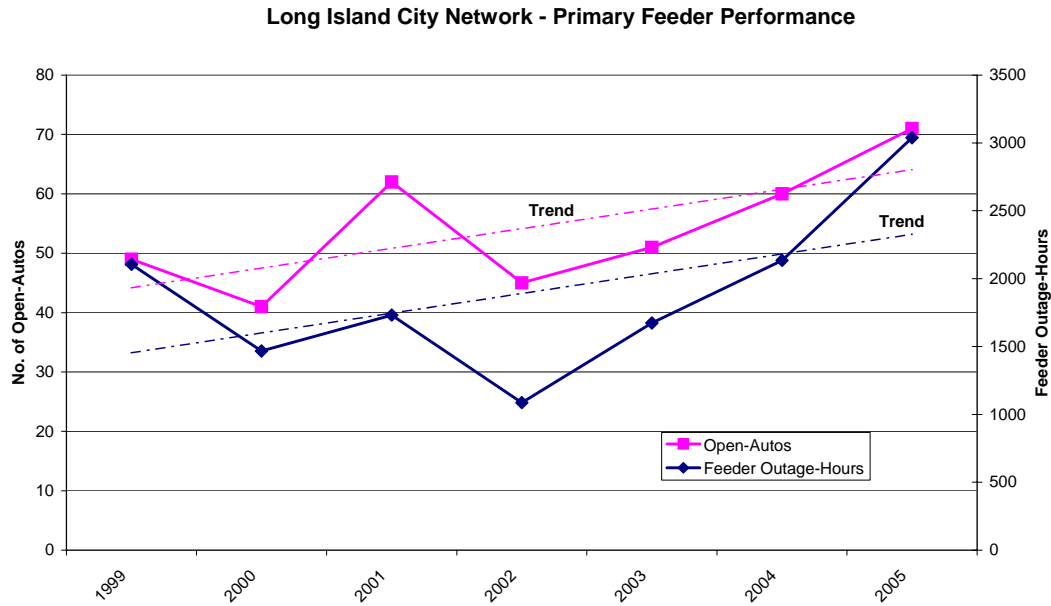
Figure 4.1-1 - Number of Open-Autos and Feeder-Outage Hours for Long Island City Network ⁴⁹

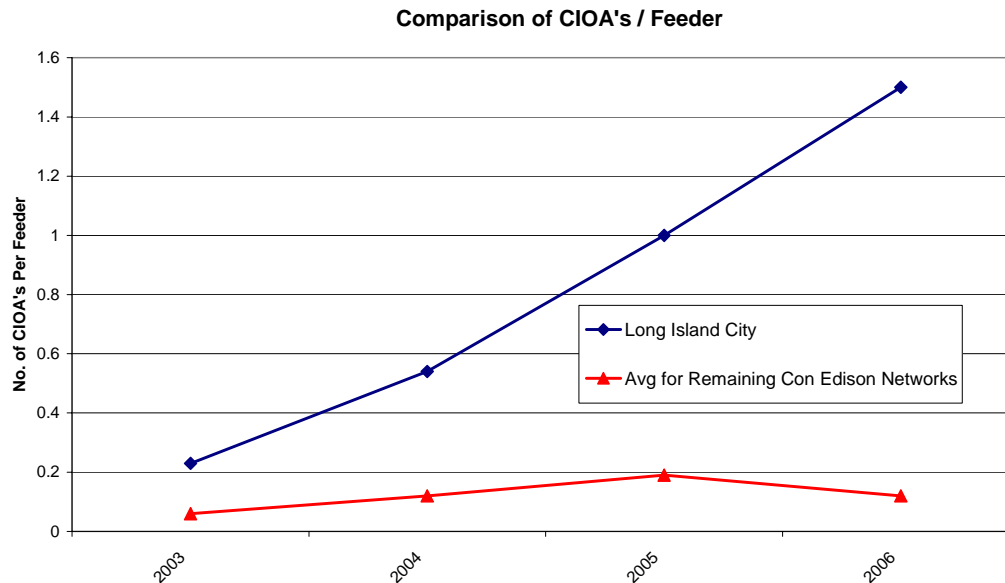
experienced by other Con Edison networks from 2003 through 2006. Figure 4.1-2 also illustrates that the number of CIOA's on the Long Island City network has been increasing since 2003.

Figure 4.1-2 – Number of CIOA's/Feeder for Long Island City Network and Remainder of Con Edison Networks

The high number of CIOAs may be partially explained by the relatively long feeders on the Long Island City network. The average feeder length on Long Island City's network is 12.41 miles, which is approximately 2 times longer than the average feeder length of 6.05 miles for all of Con Edison's networks. But the average feeder length does not account for all of the difference between the number of CIOAs for the Long Island City network and the Company's other networks. The increasing number of CIOAs per feeder on the Long Island City network should have been a cause of concern for Con Edison and should have been analyzed by Con Edison before the summer of 2006.

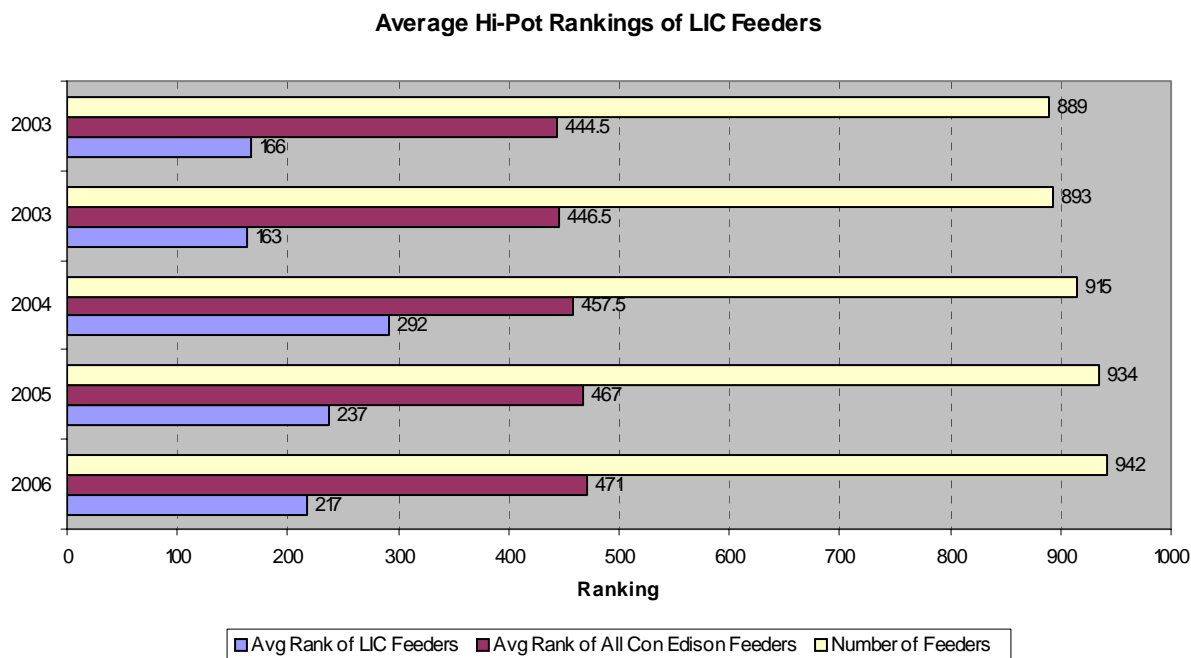
network feeder. A noticeable improvement was made in the Long Island City network average feeder ranking in 2004, but the average ranking has been declining since that time.

Figure 4.1-3 – Average Hi Pot Rankings of Long Island City Network Feeders Compared to All Con Edison Network Feeders⁵²

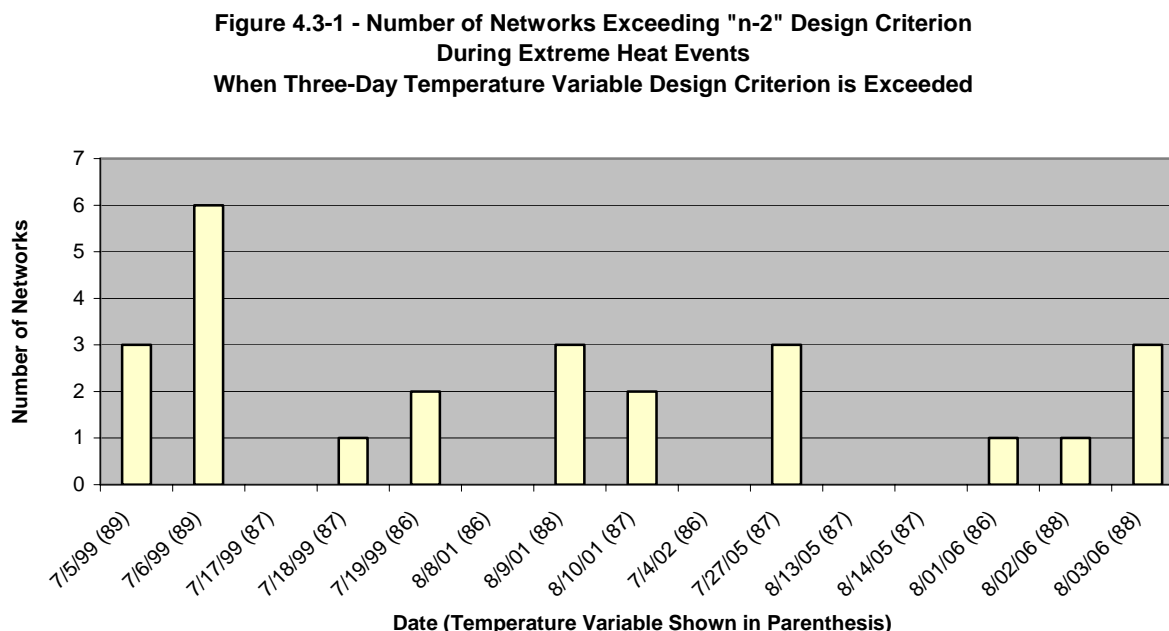
There have been 15 days since August 1997, during which the temperature-variable design criterion of 86 degrees was exceeded.⁵⁶ Figure 4.3-1 below shows the number of networks on the Con Edison system that exceeded the n-2 design criterion on these days.⁵⁷

A visual examination of the data in Figure 4.3-1 above illustrates that there is no upward trend in the number of networks exceeding the n-2 design criterion during extreme heat events. This can be concluded even if July 6, 1999 is not considered. From this perspective, the performance of Con Edison's networks during heat events has not been degrading since 1997.

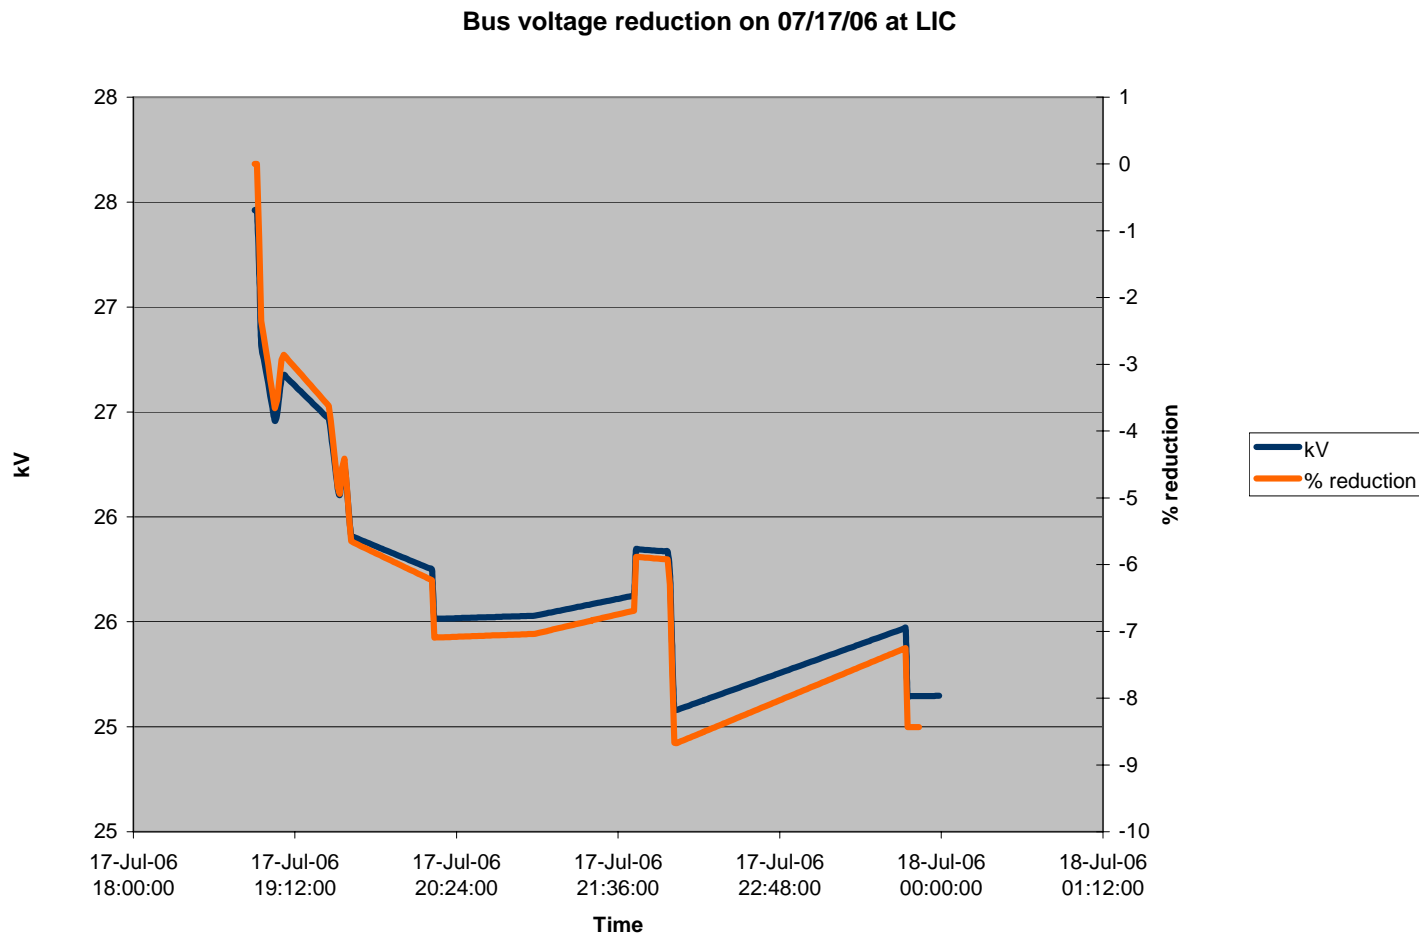
Figure 1

Voltage reduction on 07/17/06 during the Long Island City event

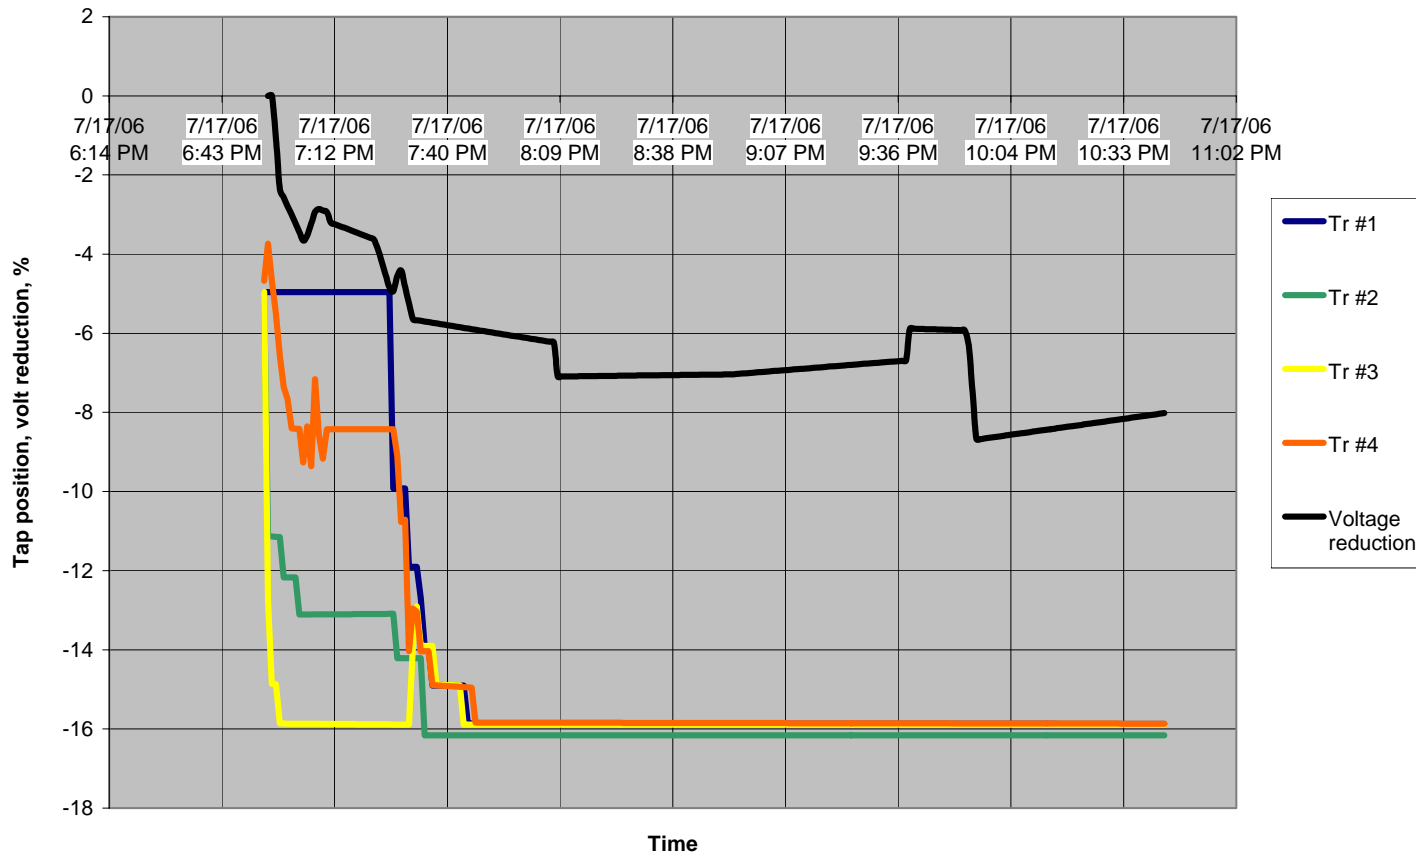
Figure 2

Change of tap position during voltage reduction

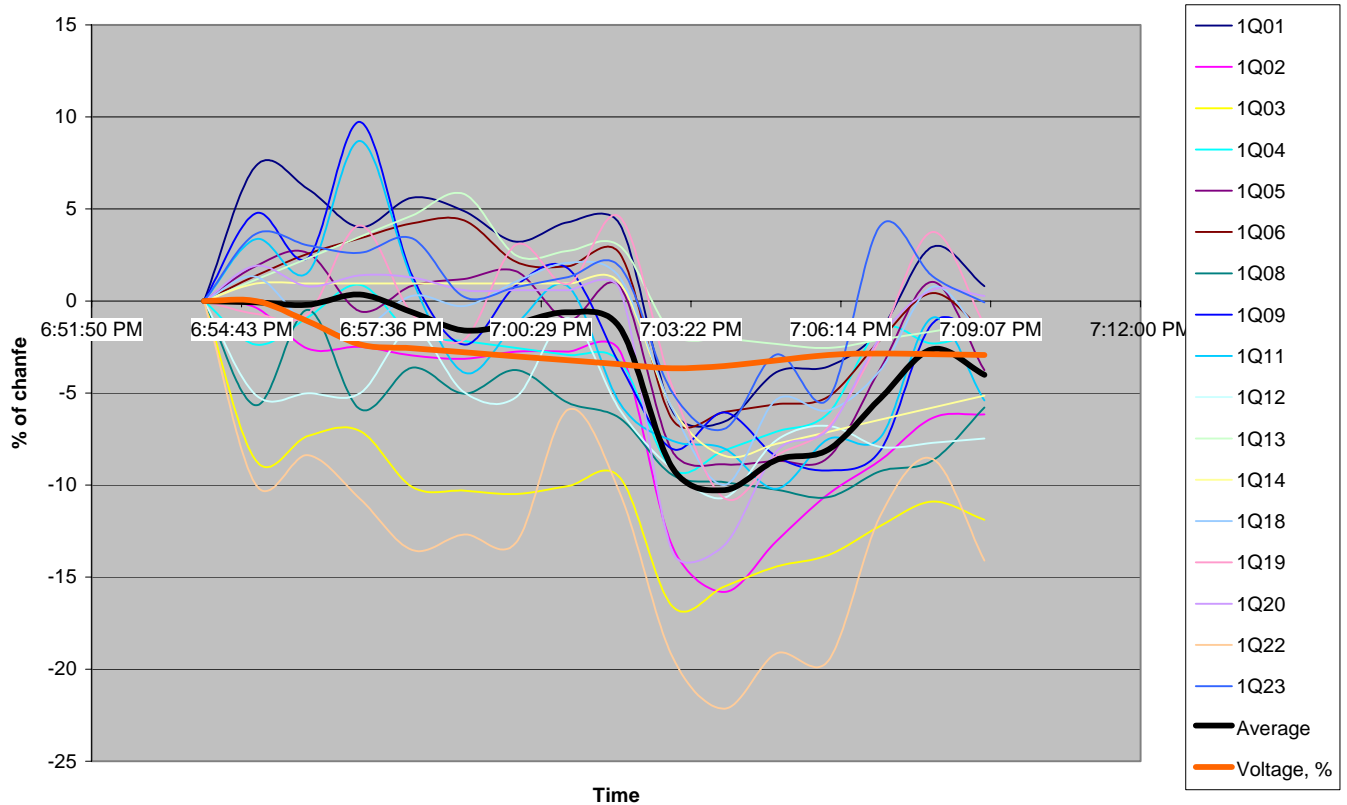
Figure 3

Change of feeder currents after voltage reduction
