Re: Case 06-M-0878 – Joint Petition of National Grid PLC and KeySpan Corporation for Approval of Stock Acquisition and Other Regulatory Authorizations – Annual Asset Condition Report Filing by Niagara Mohawk Power Corporation d/b/a National Grid

REPORT ON THE CONDITION OF PHYSICAL ELEMENTS OF TRANSMISSION AND DISTRIBUTION SYSTEMS

CASE 06-M-0878

OCTOBER 1, 2012

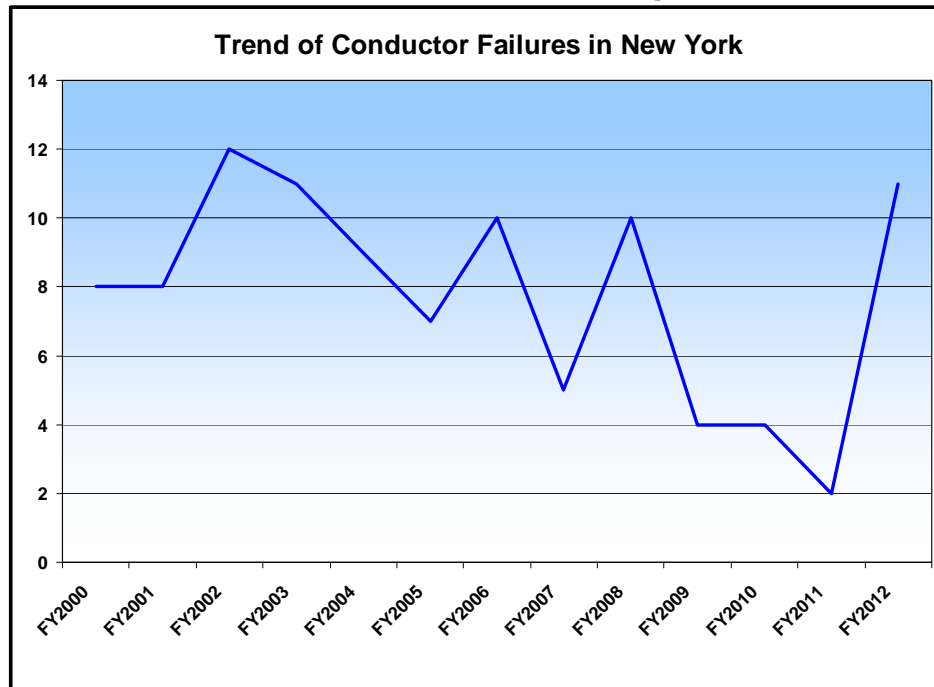
Figure 2-17
Transmission Conductor Failures Long Term Trend

The trend of conductor failures from FY1999/00 to FY2010/12 (Figure 2-17) shows a recent increase in conductor failures but still within recent historical variations.

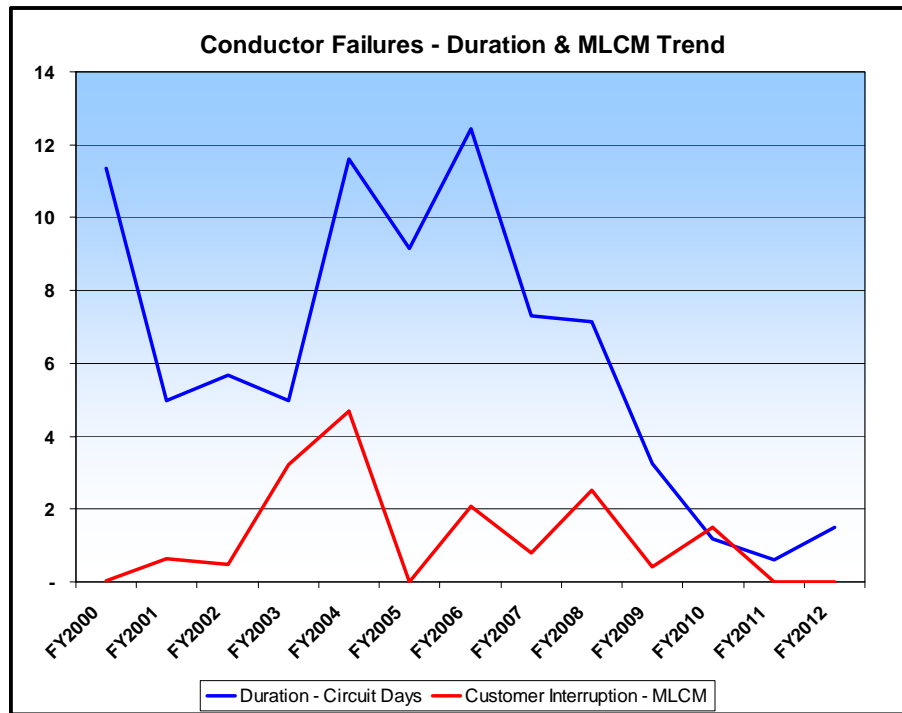
Figure 2-18
Lost Customer Minutes Due to Conductor Failures

The total outage duration due to conductor failures shown in Figure 2-18 shows a small rise in duration but an overall downward trend in customer interruptions.¹¹

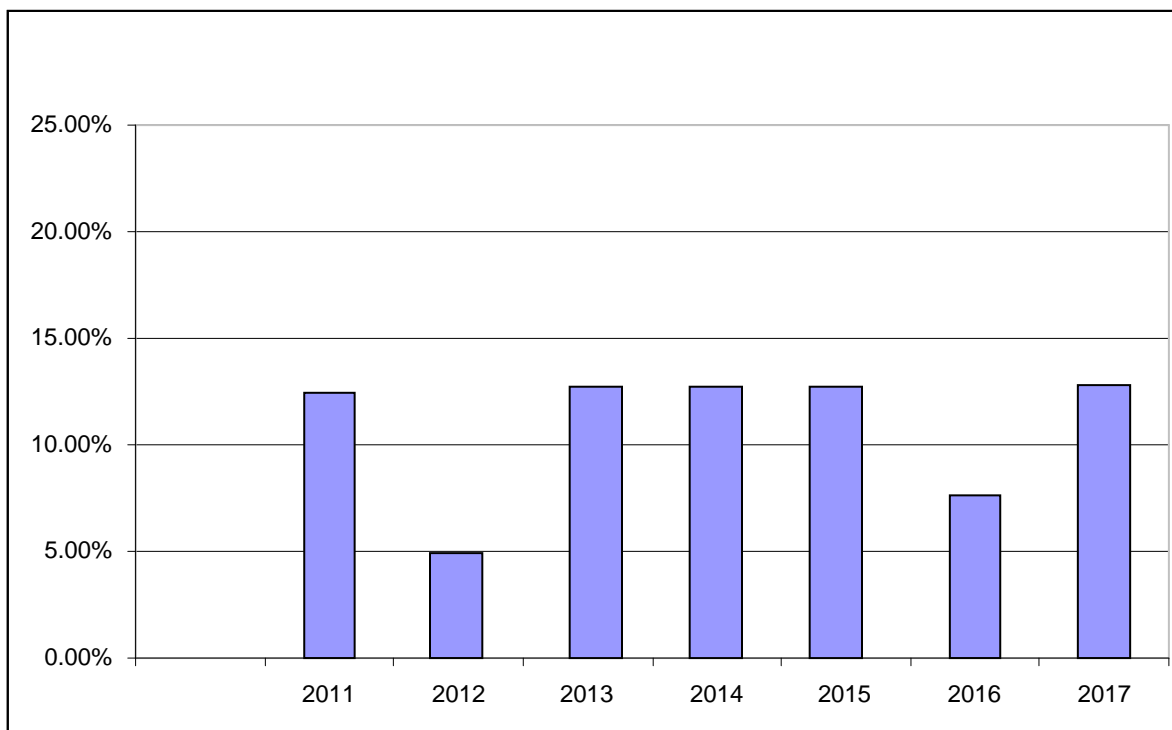
Figure 2-78
Forecasted Percent of Relay Population to be Tested (by Year)

The 2012 data shows testing through part of the year. The Company expects to complete testing on an additional 5% of relays during the remainder of 2012.
