# REPORT ON THE CONDITION OF PHYSICAL ELEMENTS OF TRANSMISSION AND DISTRIBUTION SYSTEMS

CASE 06-M-0878

THE STATE OF NEW YORK PUBLIC SERVICE COMMISSION

OCTOBER 1, 2012

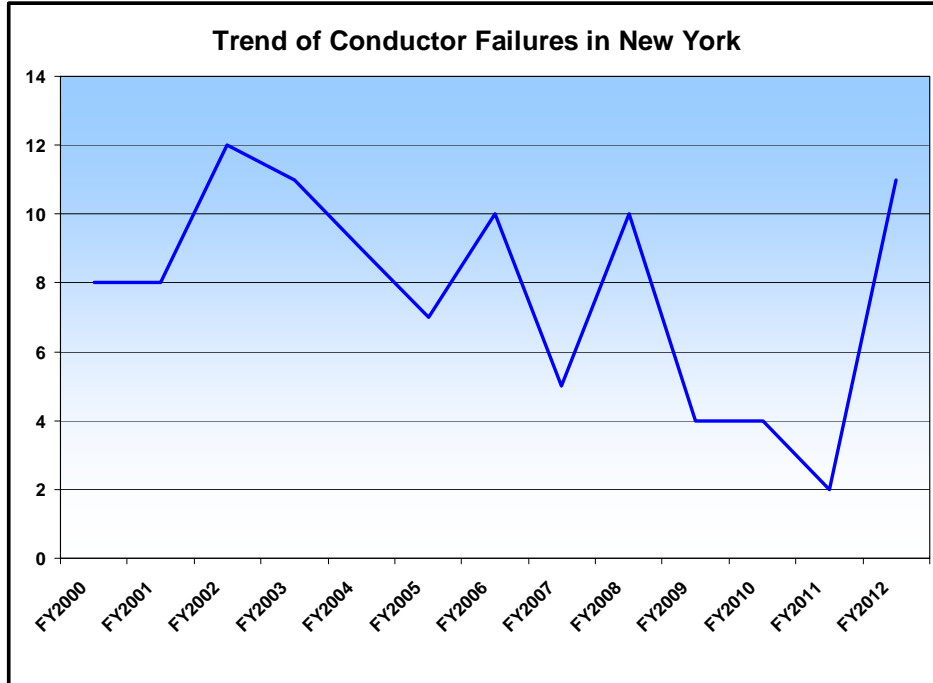
**Figure 2-17**  
**Transmission Conductor Failures Long Term Trend**

The trend of conductor failures from FY1999/00 to FY2010/12 (Figure 2-17) shows a recent increase in conductor failures but still within recent historical variations.

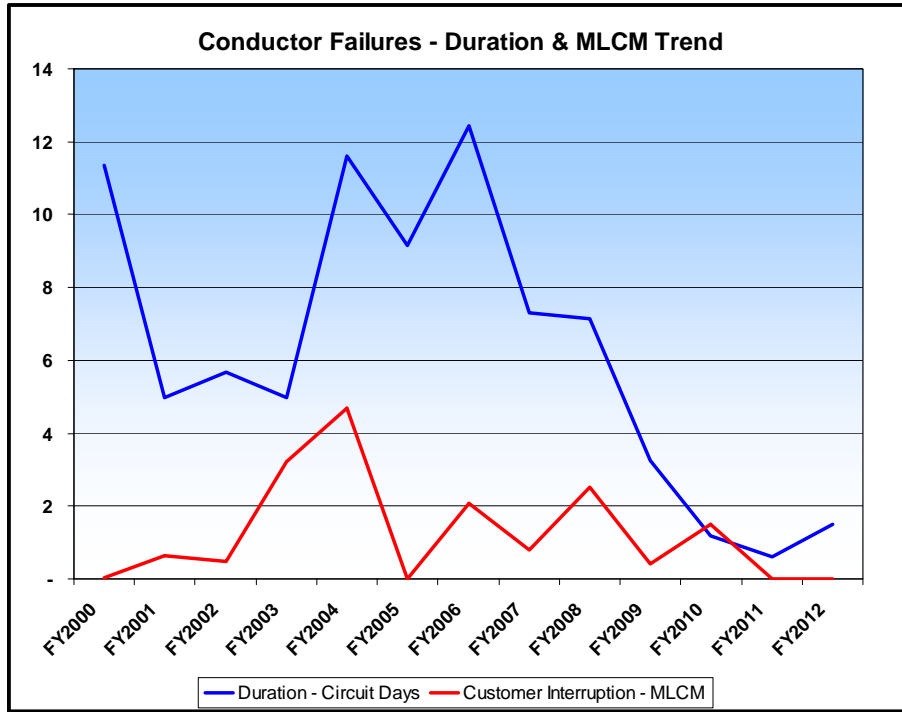
**Figure 2-18  
Lost Customer Minutes Due to Conductor Failures**

The total outage duration due to conductor failures shown in Figure 2-18 shows a small rise in duration but an overall downward trend in customer interruptions.<sup>11</sup>
