Client Name: NYSEG

Site Location: Horseheads, New York

11176689

PHOTOGRAPHIC LOG

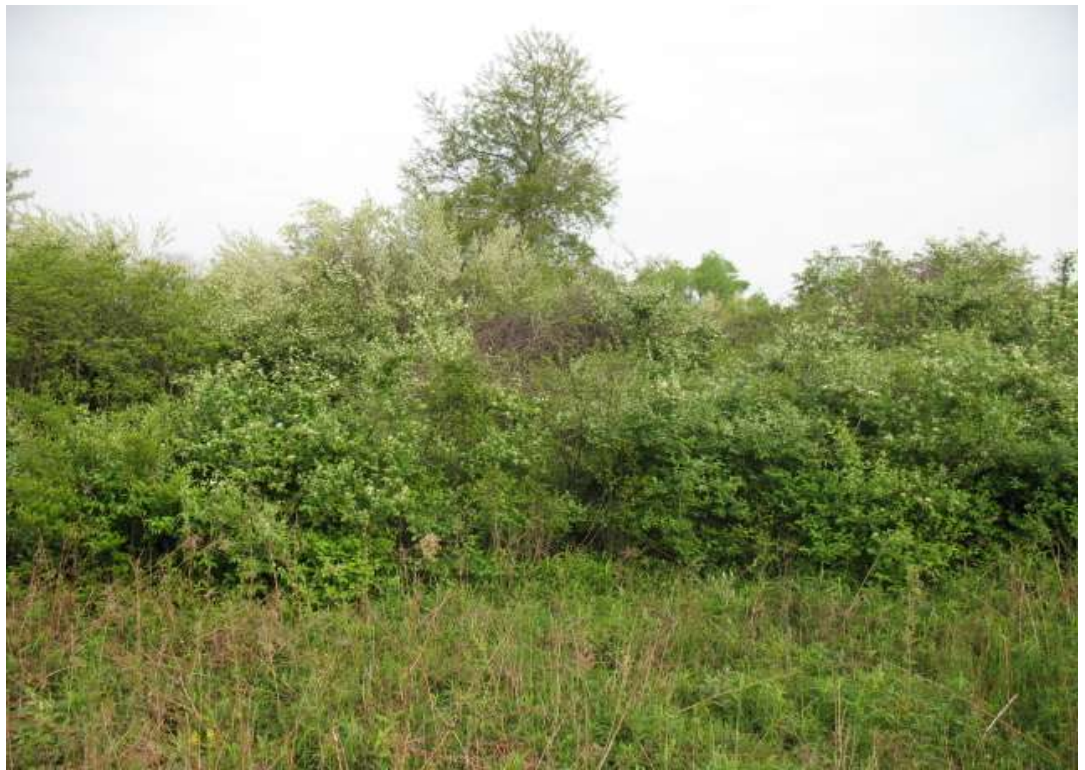
Photo No.
1

Honeysuckle in typical view of project corridor edge.

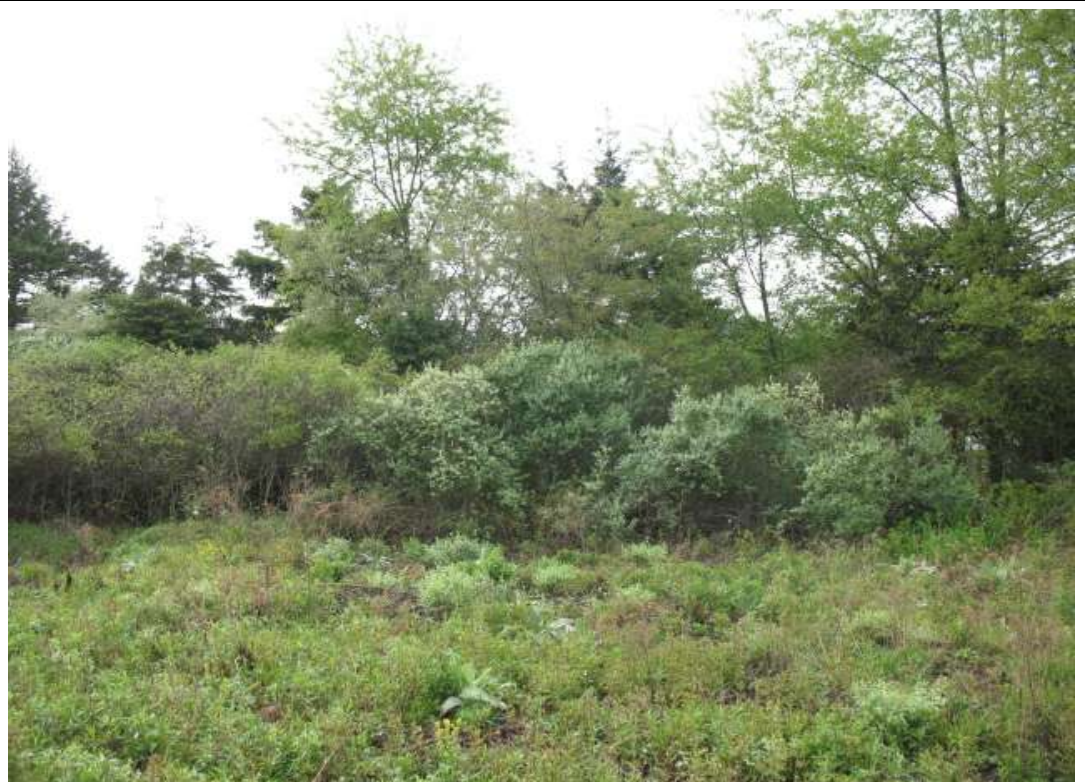
Photo No.
2

Honeysuckle in typical view of project corridor edge.

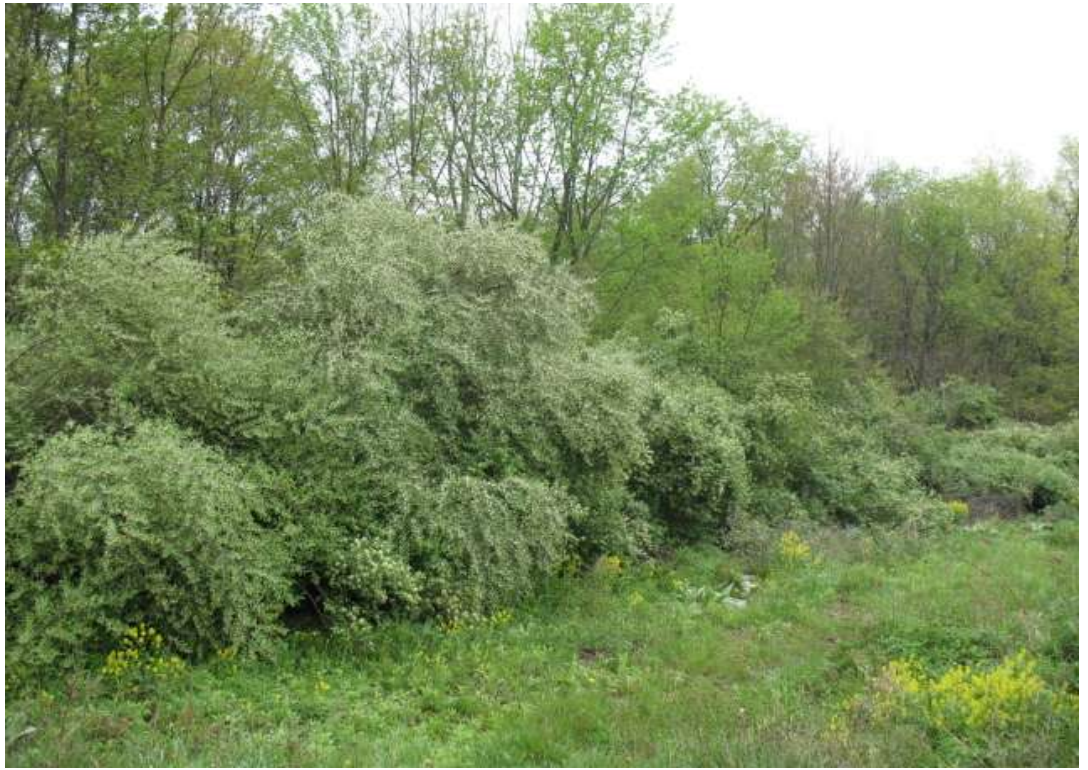
Photo No.
3

Honeysuckle in typical view of project corridor edge.

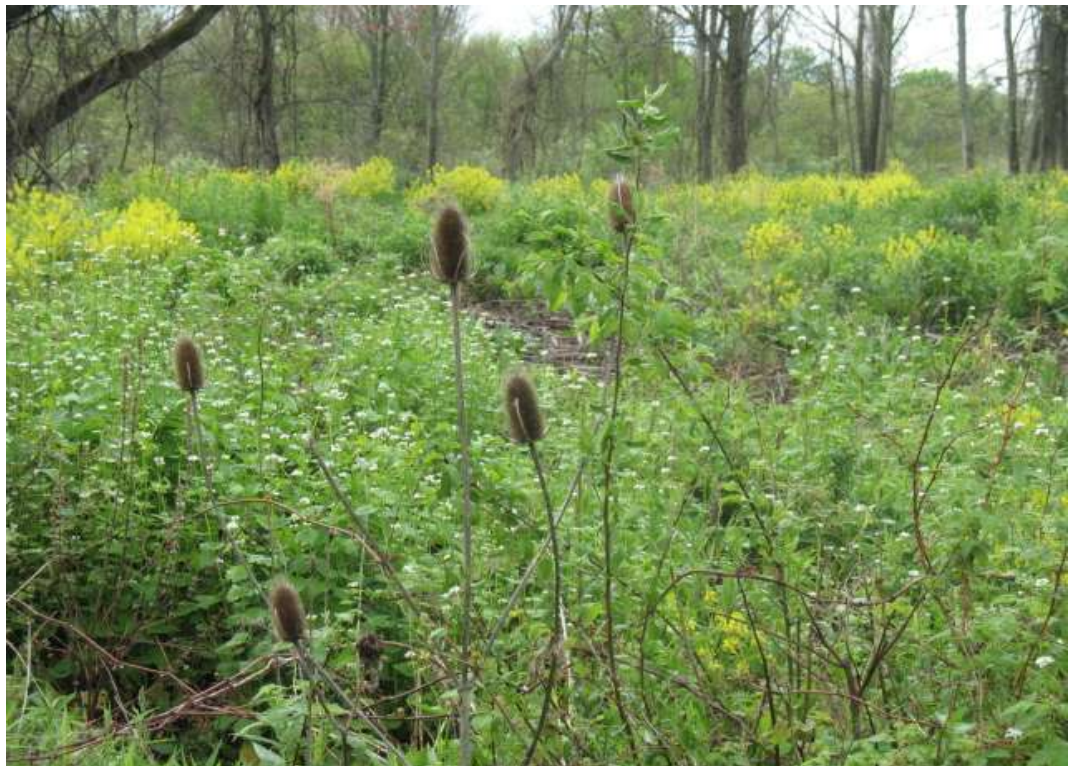
Photo No.
4

Typical small area of teasel and garlic mustard within project corridor.

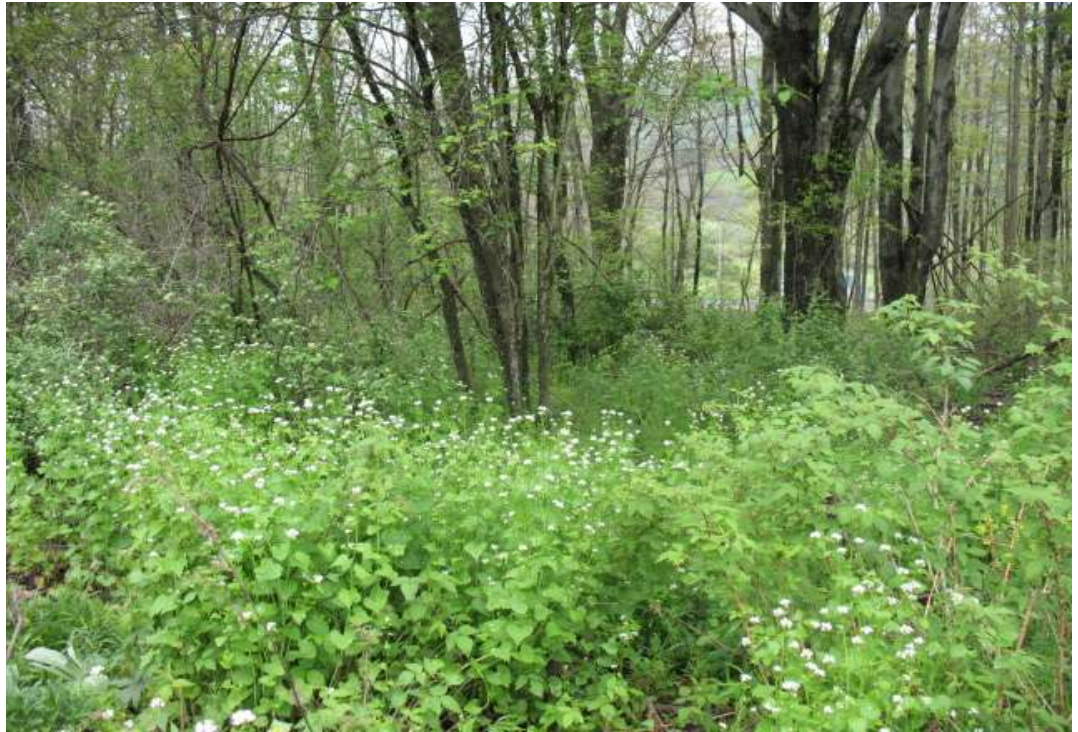
Photo No.
5

Small area of garlic mustard within project corridor (Hickory Grove road through trees).

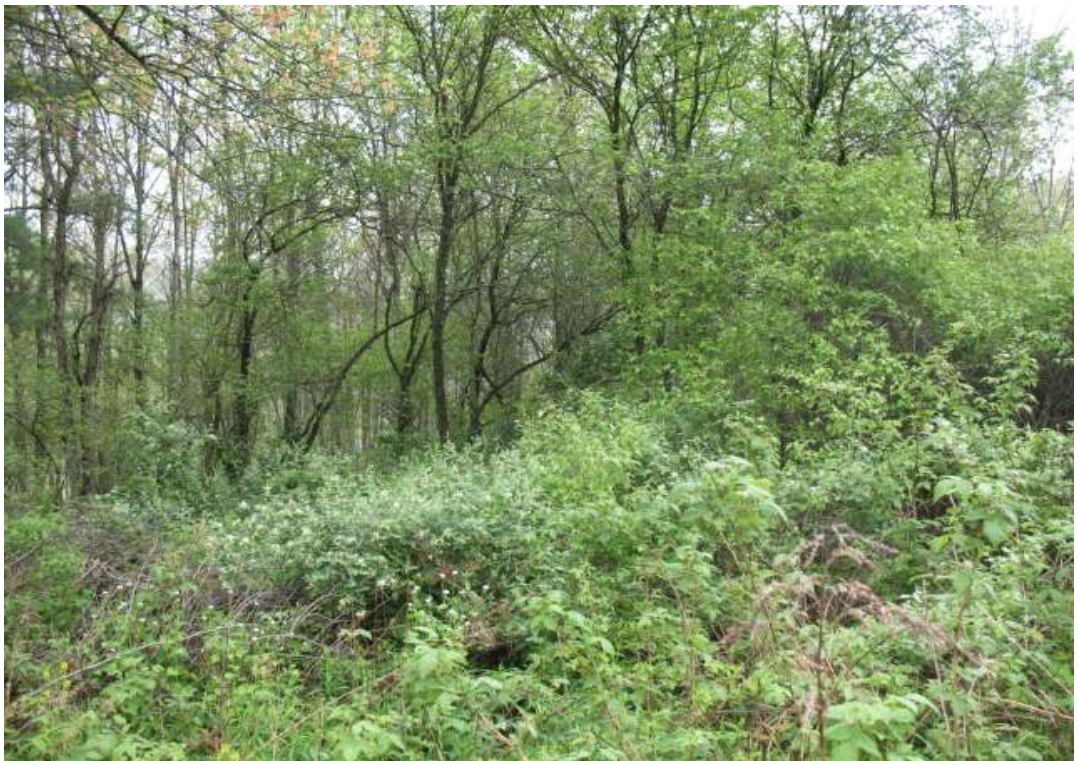
Photo No.
6

Typical view of honeysuckle and multiflora rose along project corridor boundary.

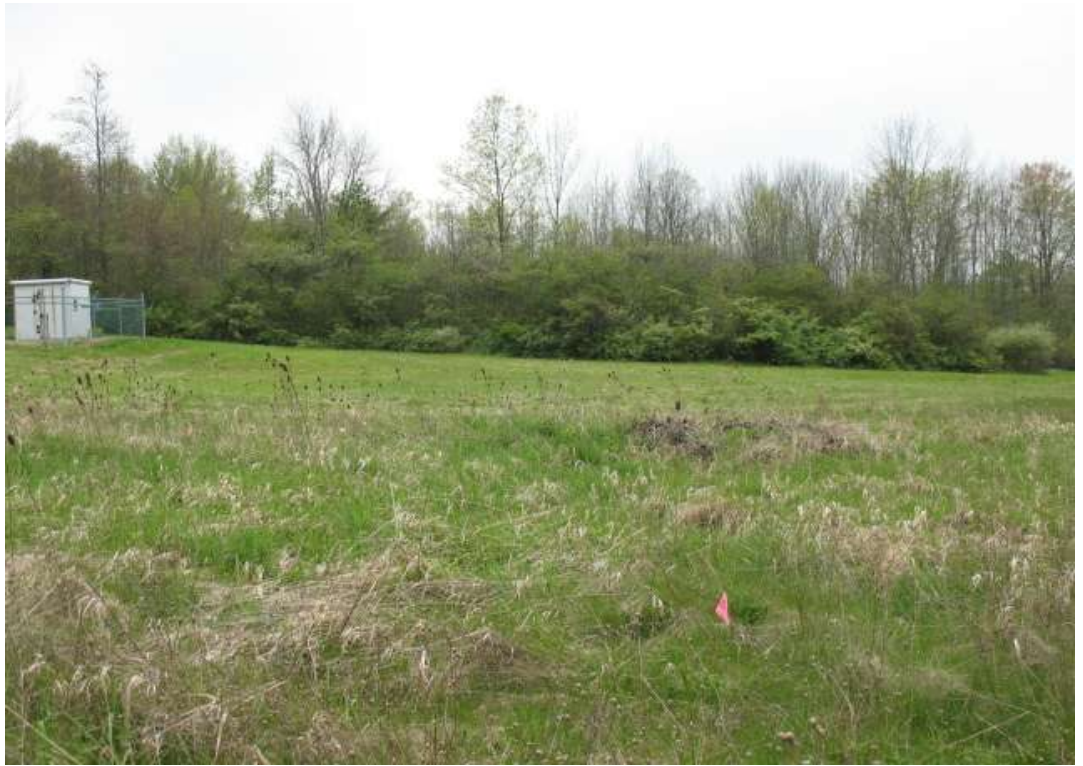
Photo No.
7

Small area of teasel within project corridor, honeysuckle and multiflora rose in background along edge of corridor.

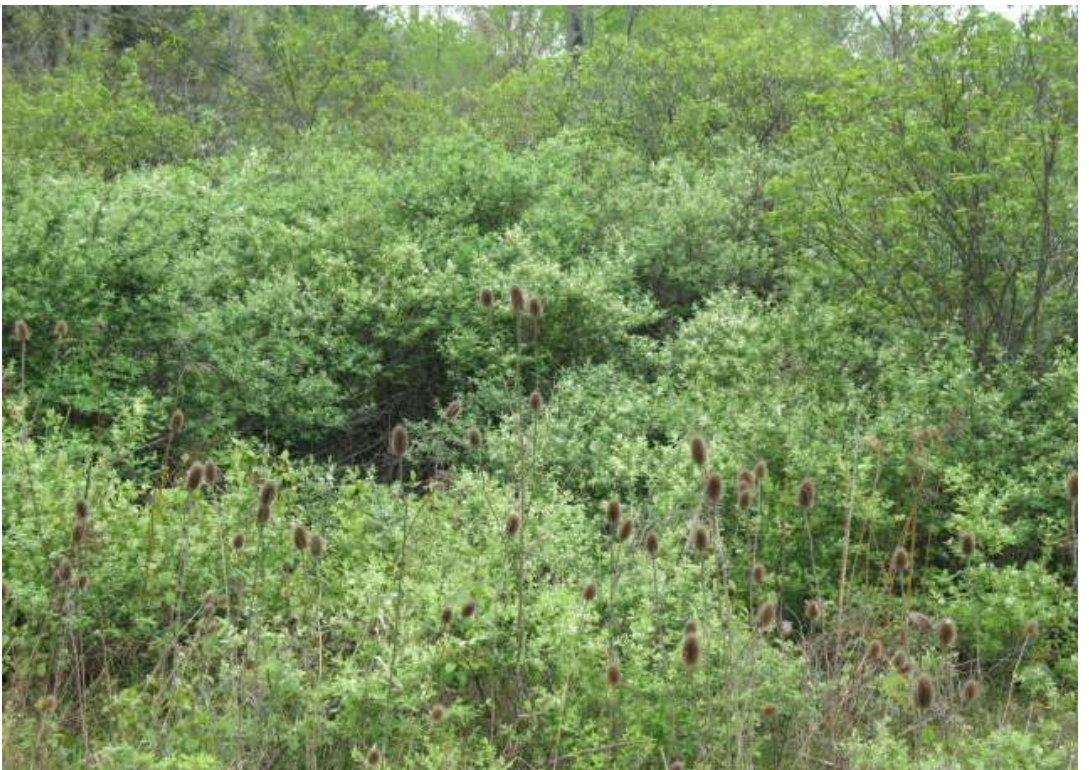
Photo No.
8

Small area of teasel, typical view of honeysuckle along edge of project corridor.

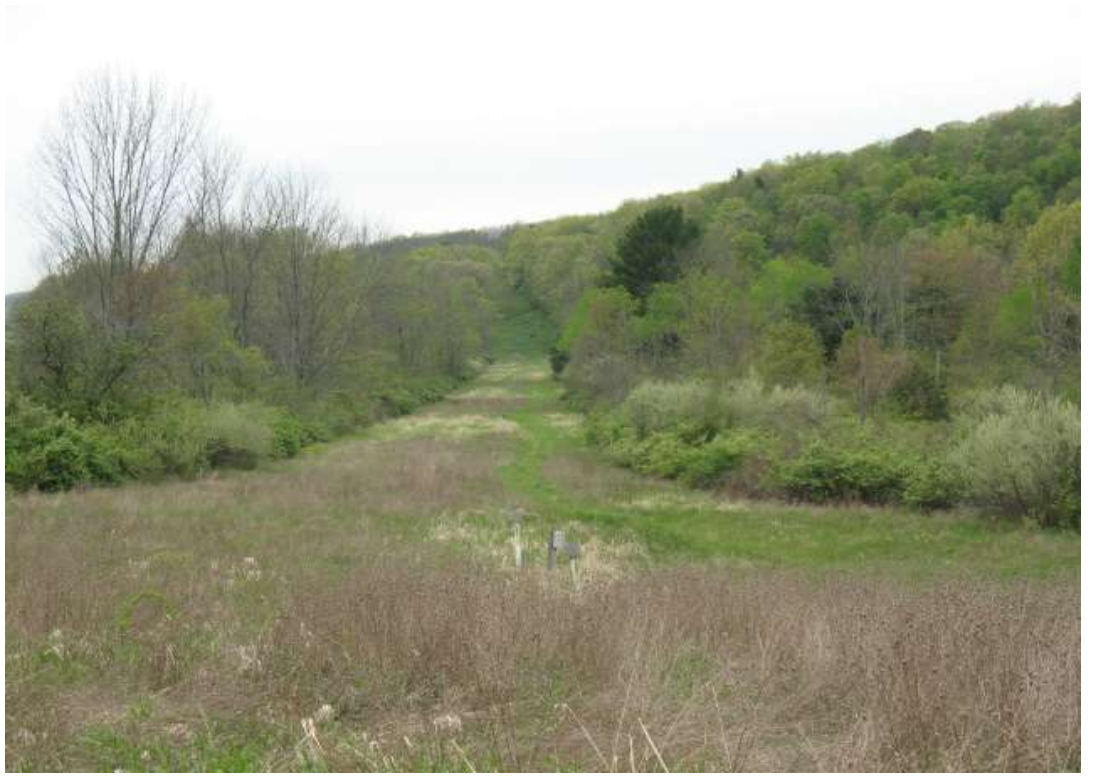
Photo No.
9

Typical view of project
corridor with
honeysuckle on either
side.

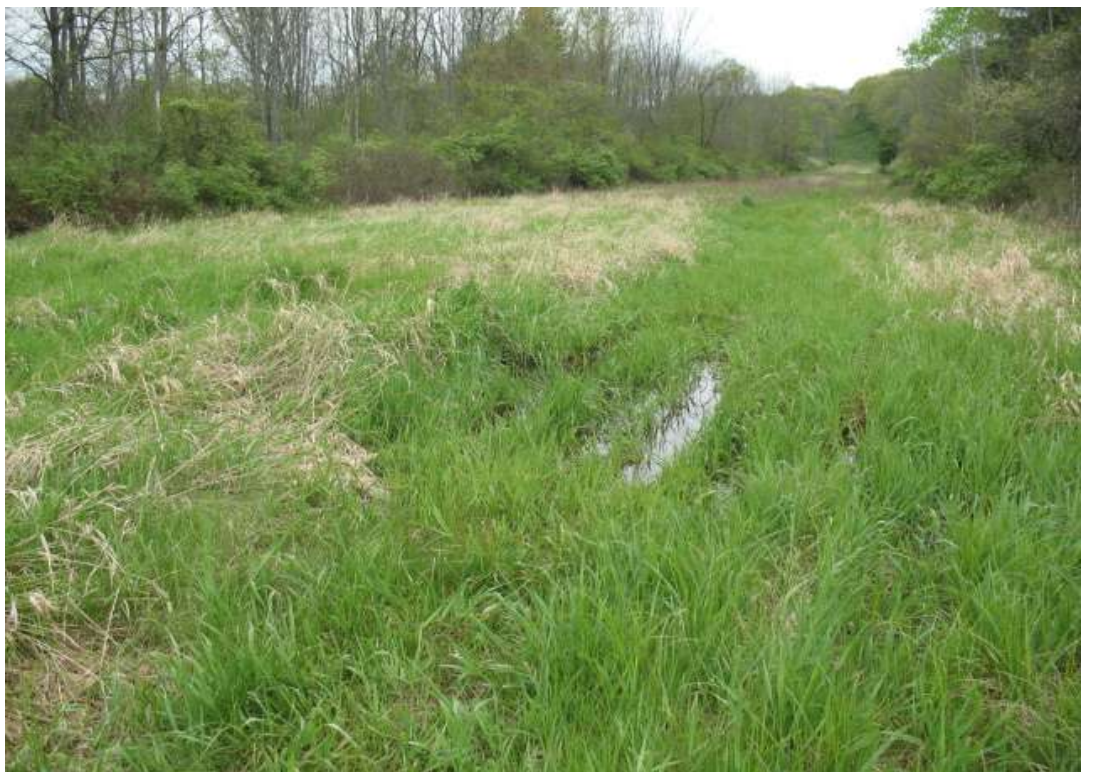
Photo No.
10

Small area of
reed
canarygrass within
project corridor.

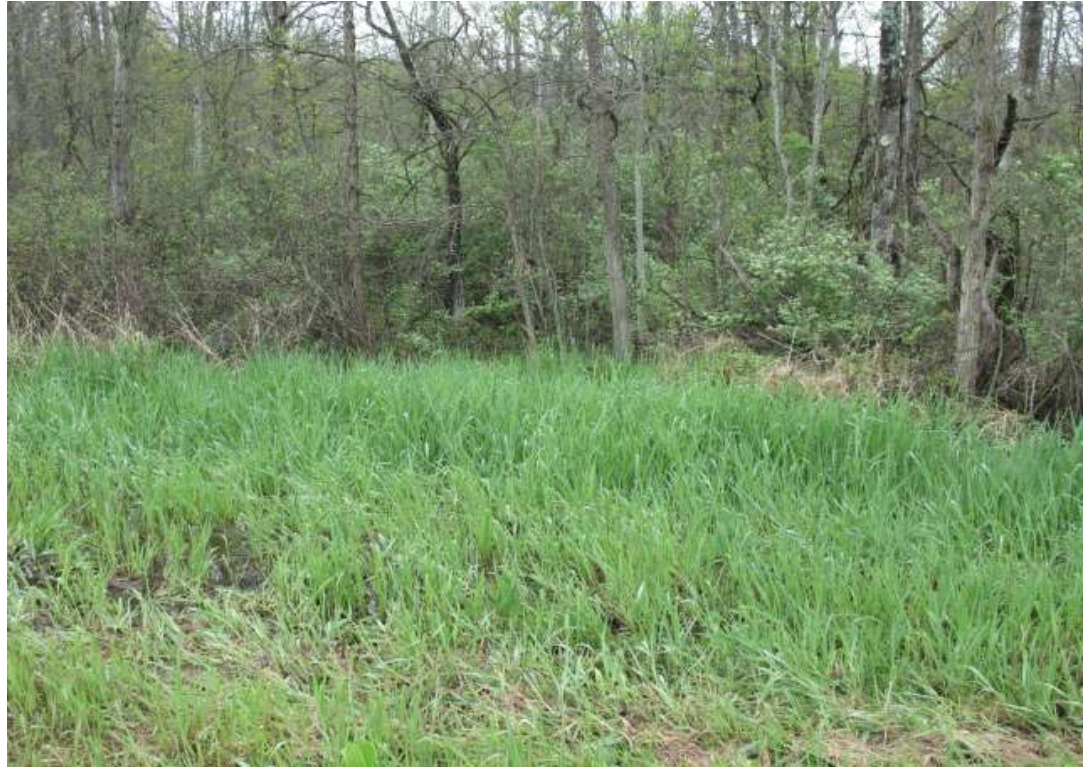
Photo No.
11

Small area of reed canarygrass within project corridor.

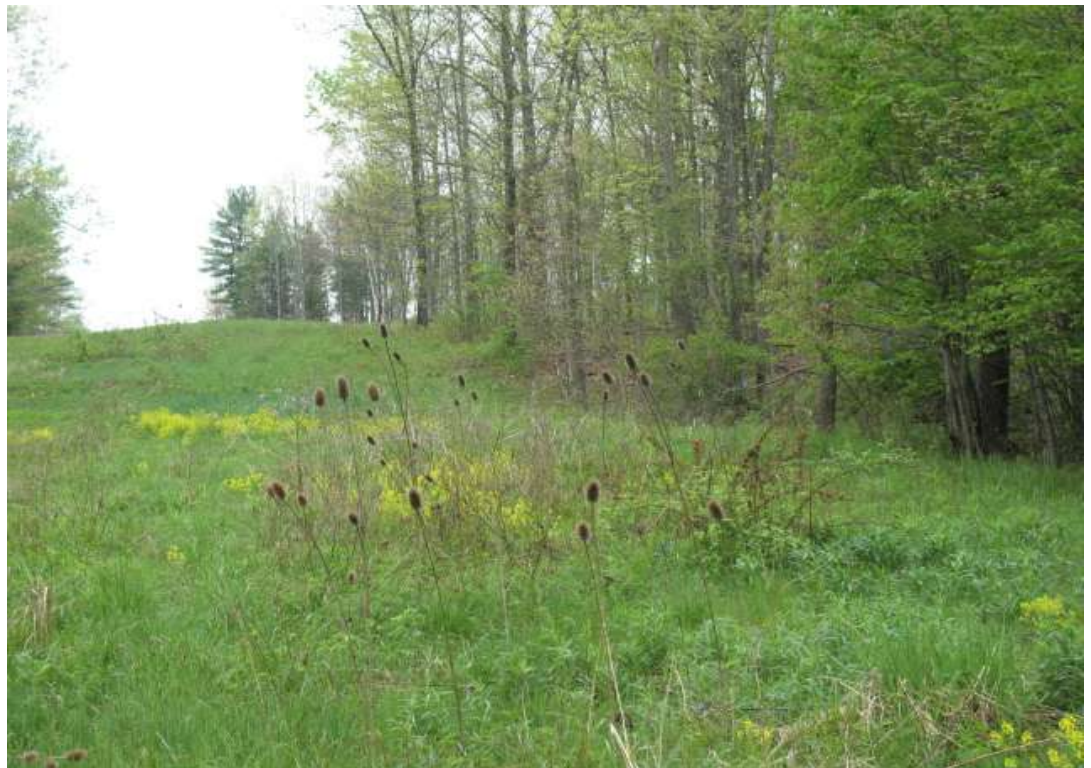
Photo No.
12

Typical view of maintained right-of-way and small growth of teasel within project corridor.

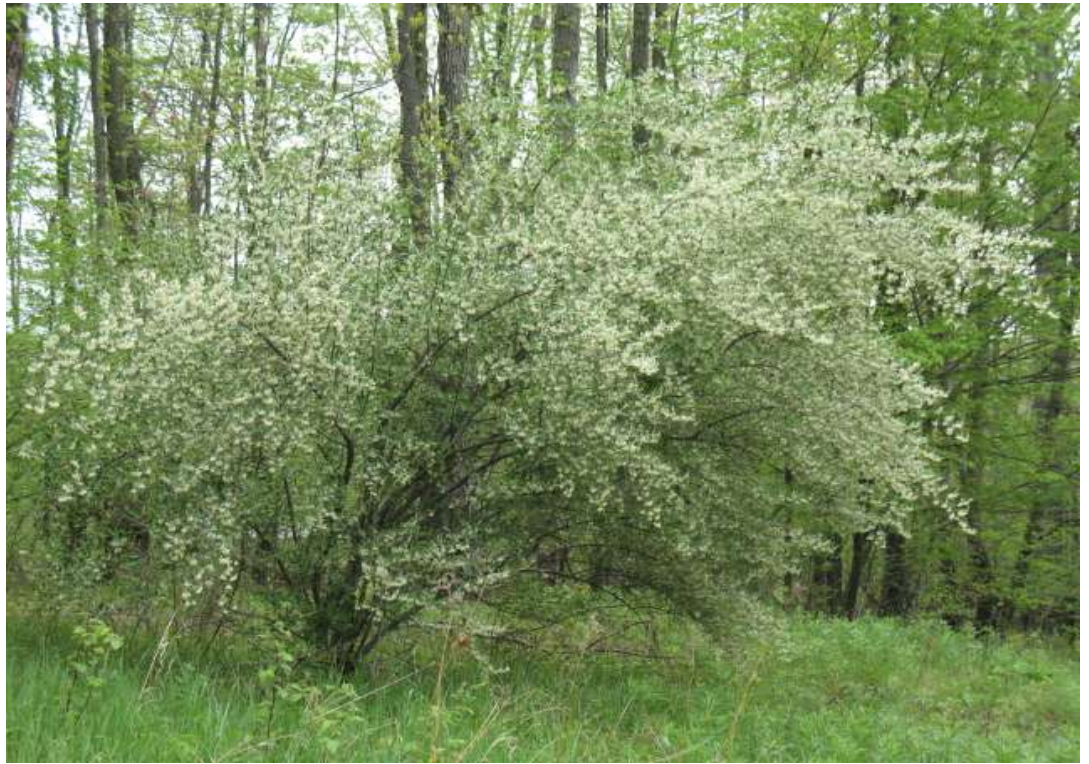
Photo No.
13

Typical shrub honeysuckle along edge of project corridor.

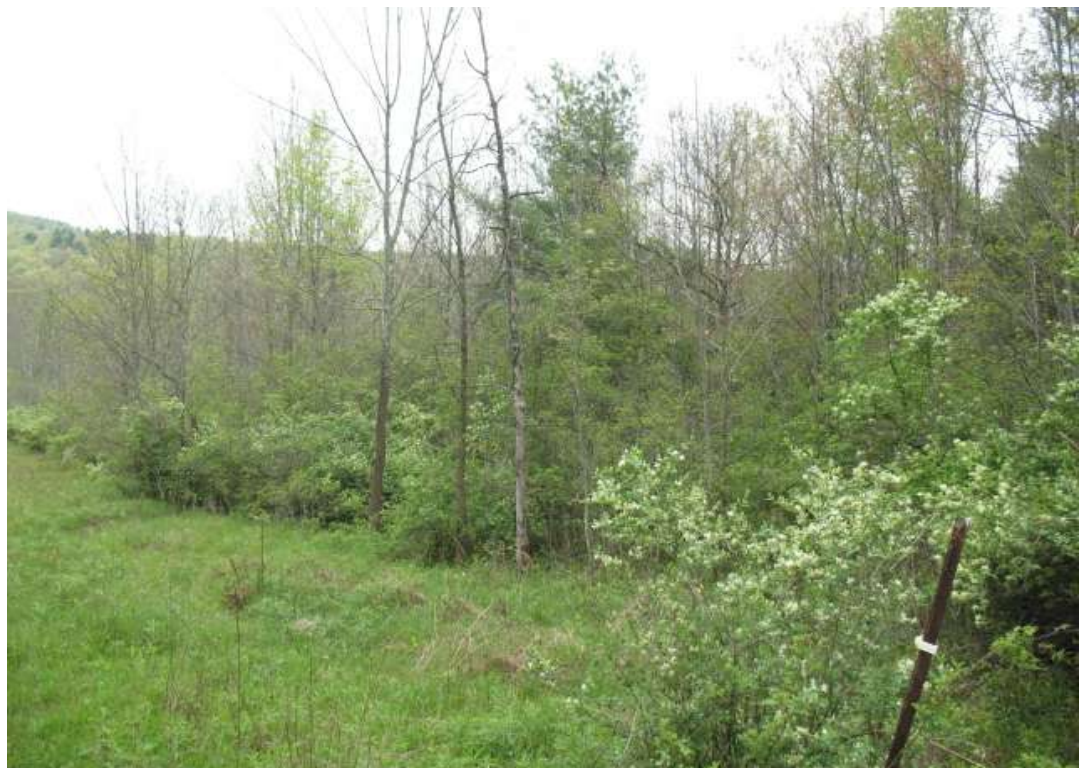
Photo No.
14

Typical view of edge of maintained right-of-way and edge of project corridor.

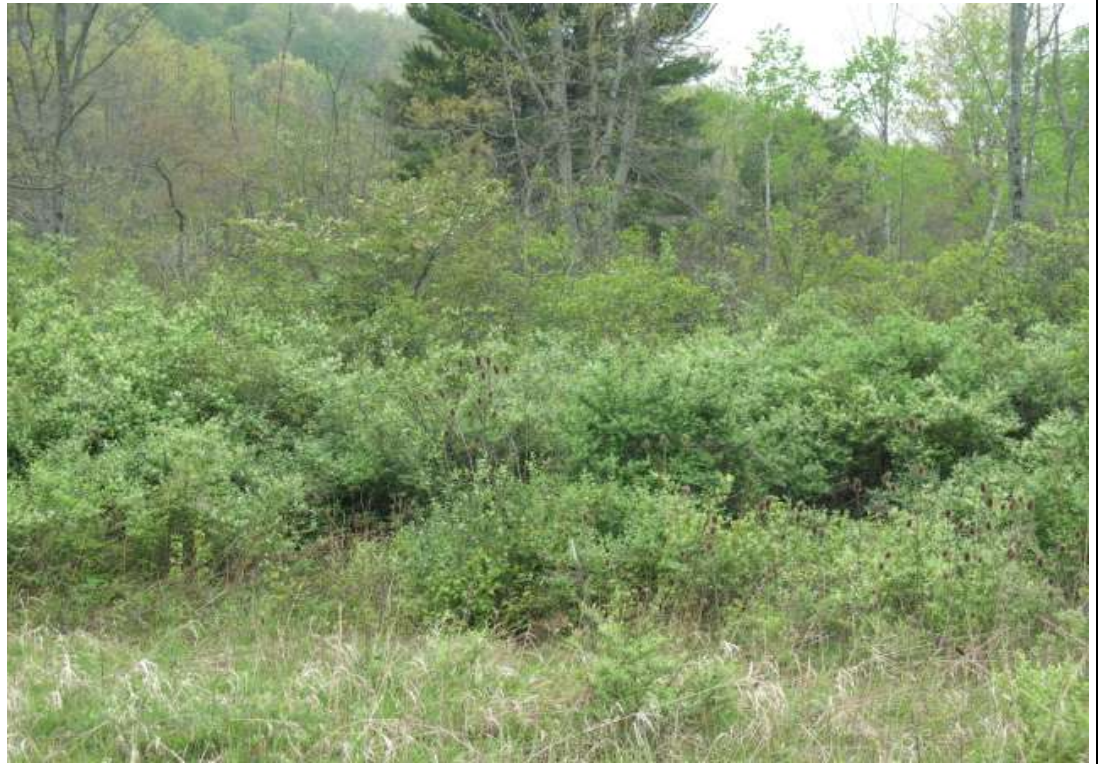
Photo No.
15

Typical view of edge of project corridor, with teasel, honeysuckle, multiflora rose.

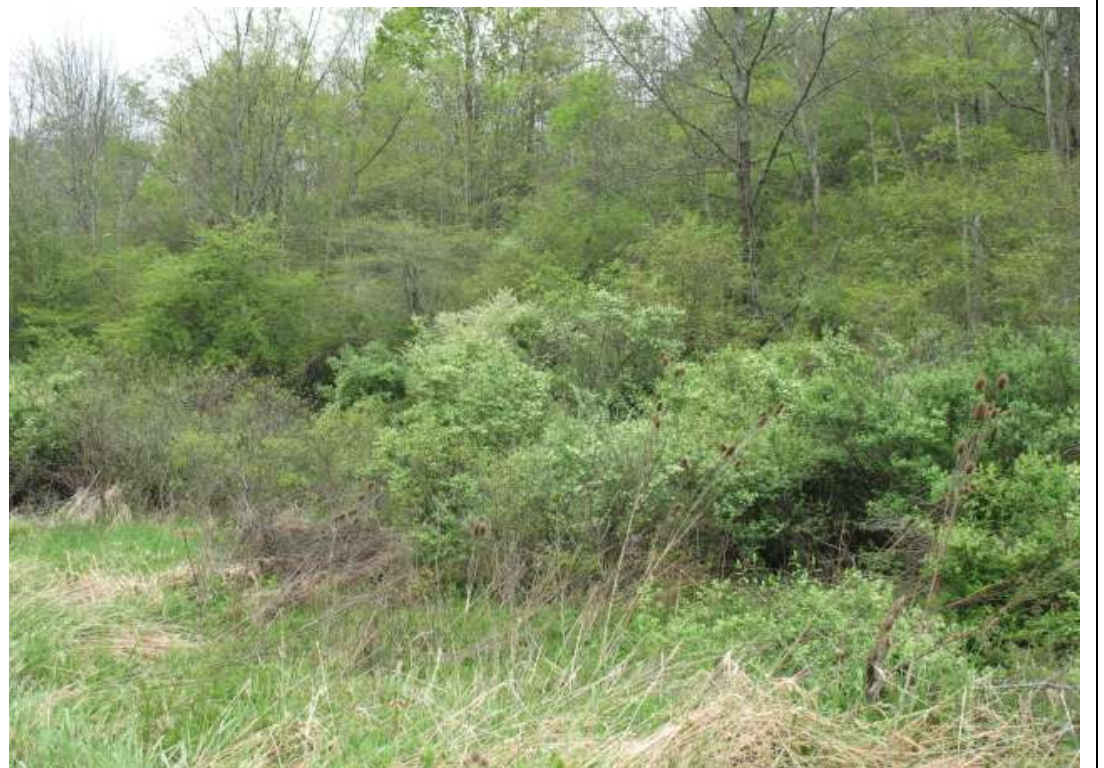
Photo No.
16

Typical view of edge of project corridor, with teasel, honeysuckle and multiflora rose.

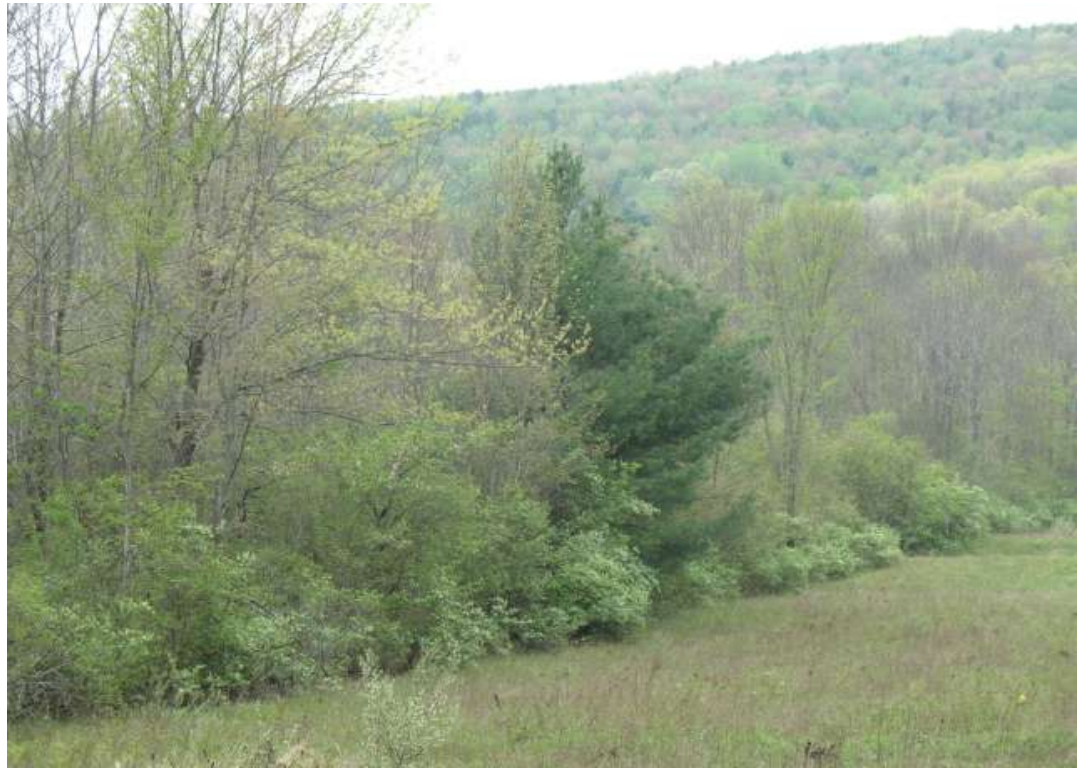
Photo No.
17

Typical view of maintained right-of-way and honeysuckle along edge of project corridor.

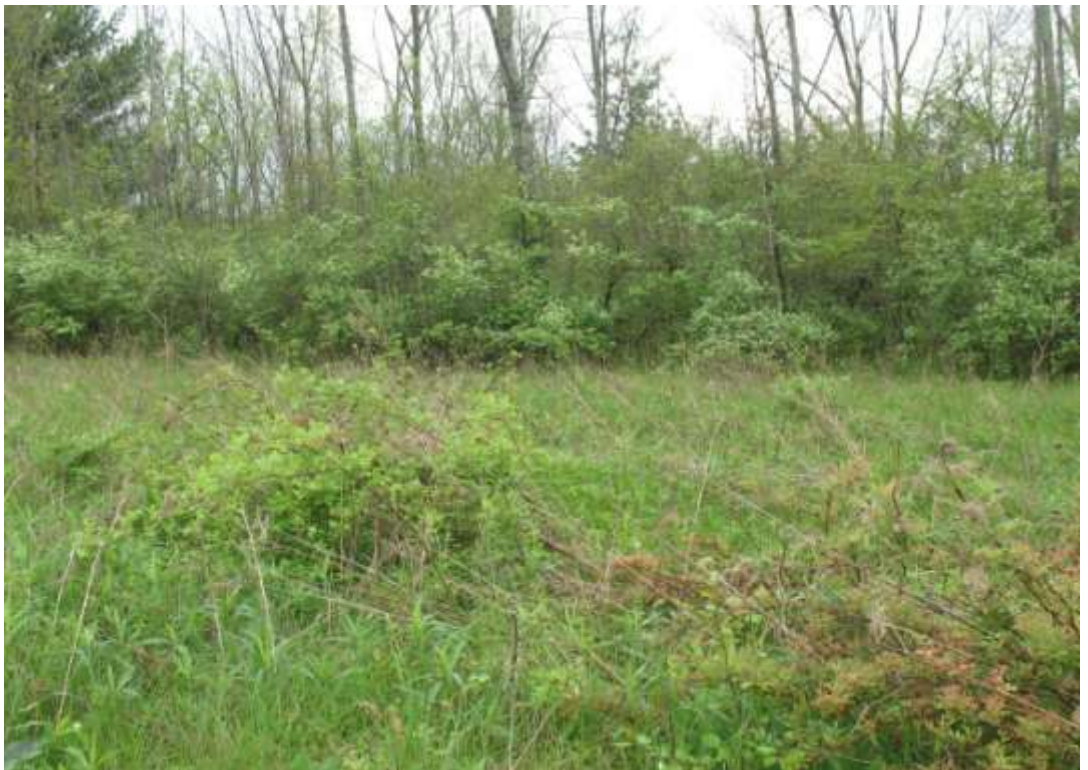
Photo No.
18

Small multiflora rose shrubs within project corridor.

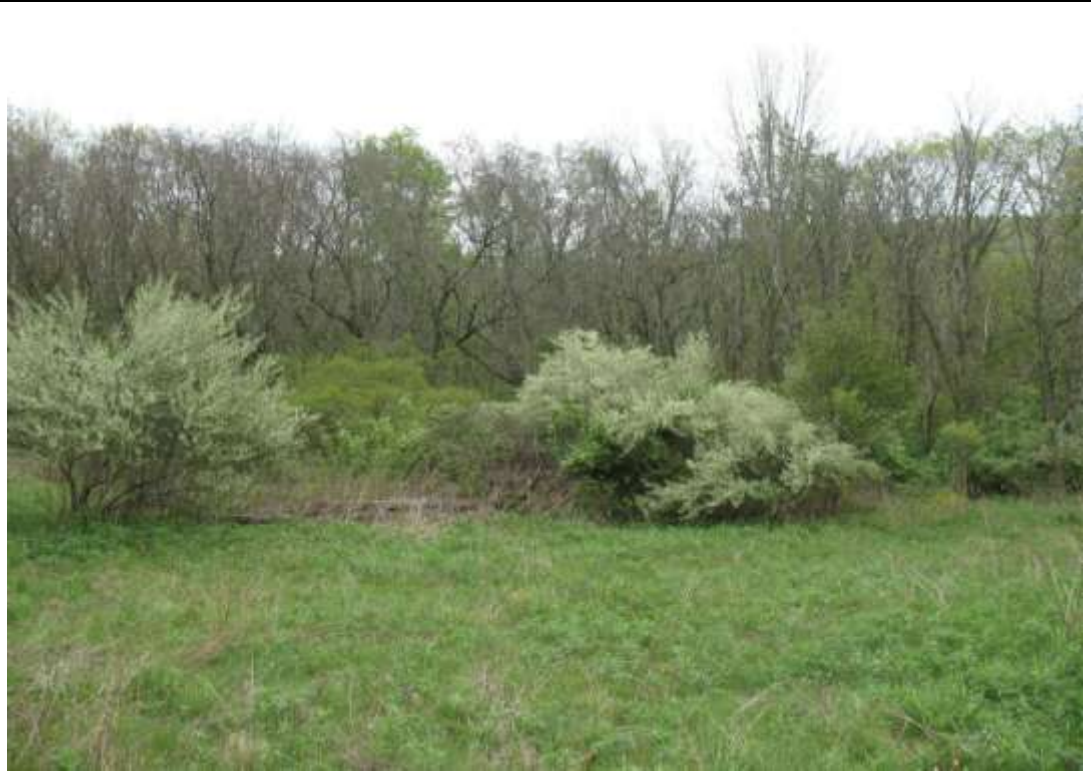
Photo No.
19

Typical view of edge of project corridor, showing honeysuckle.

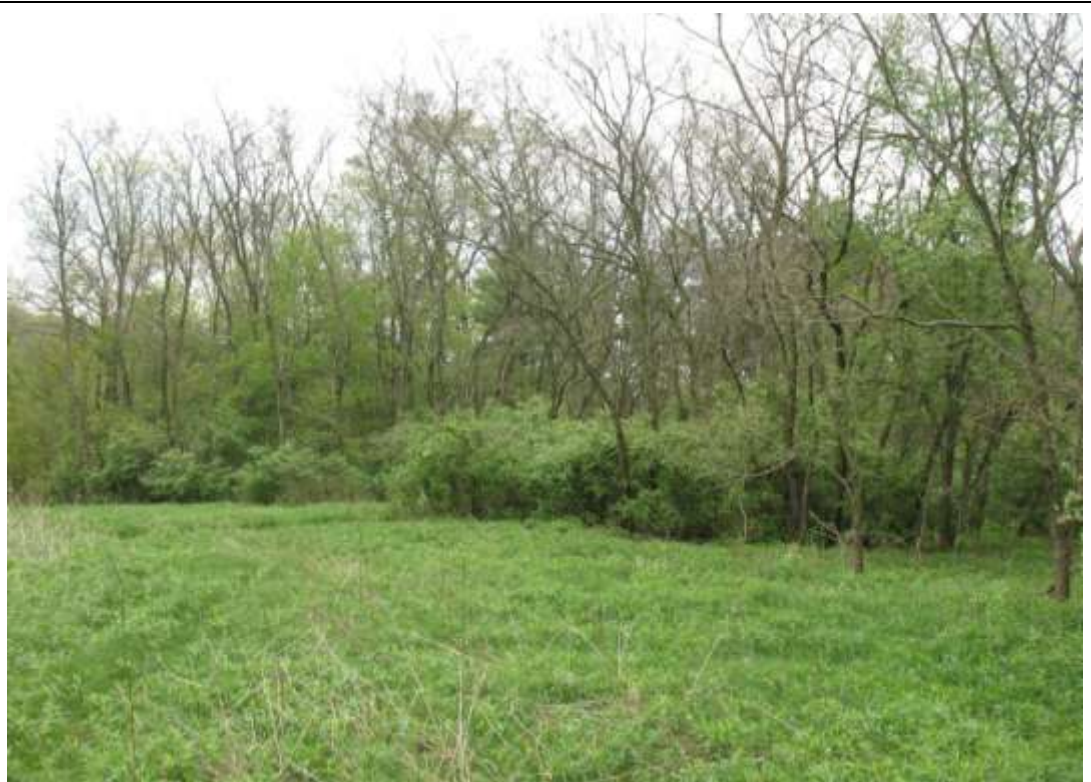
Photo No.
20

Typical view of maintained right-of-way and edge of project corridor, showing honeysuckle.

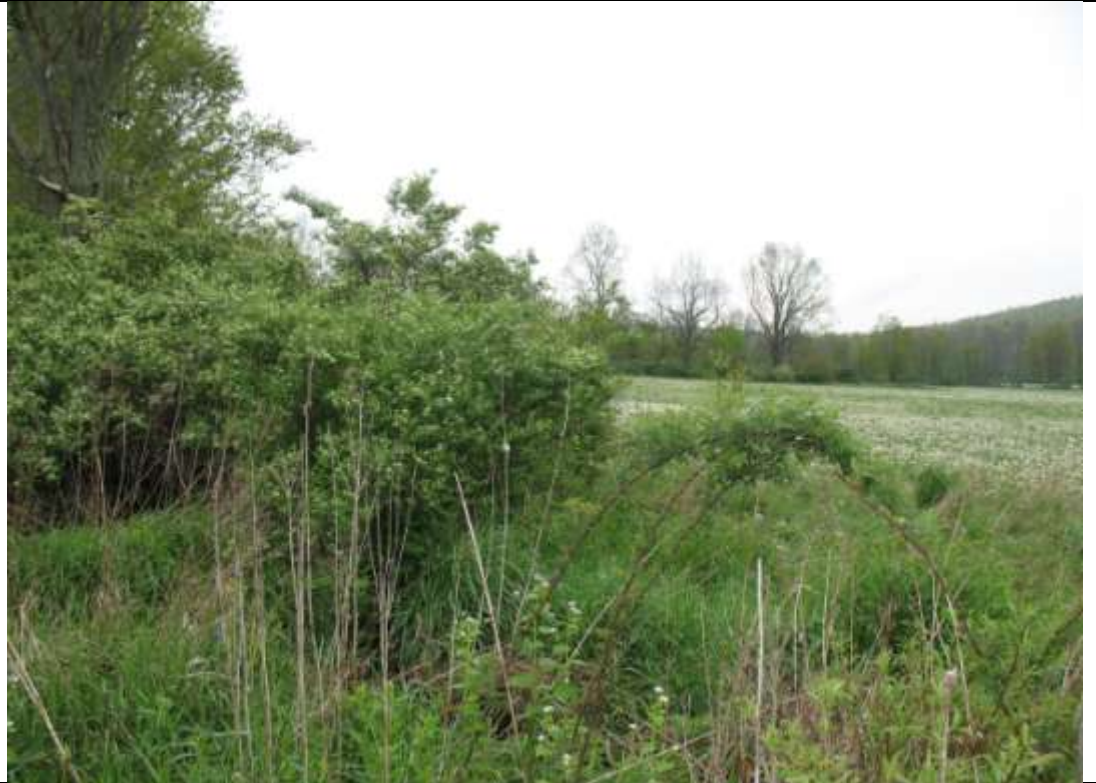
Photo No.
21

Typical view of edge of project corridor, showing multiflora rose, honeysuckle and garlic mustard.

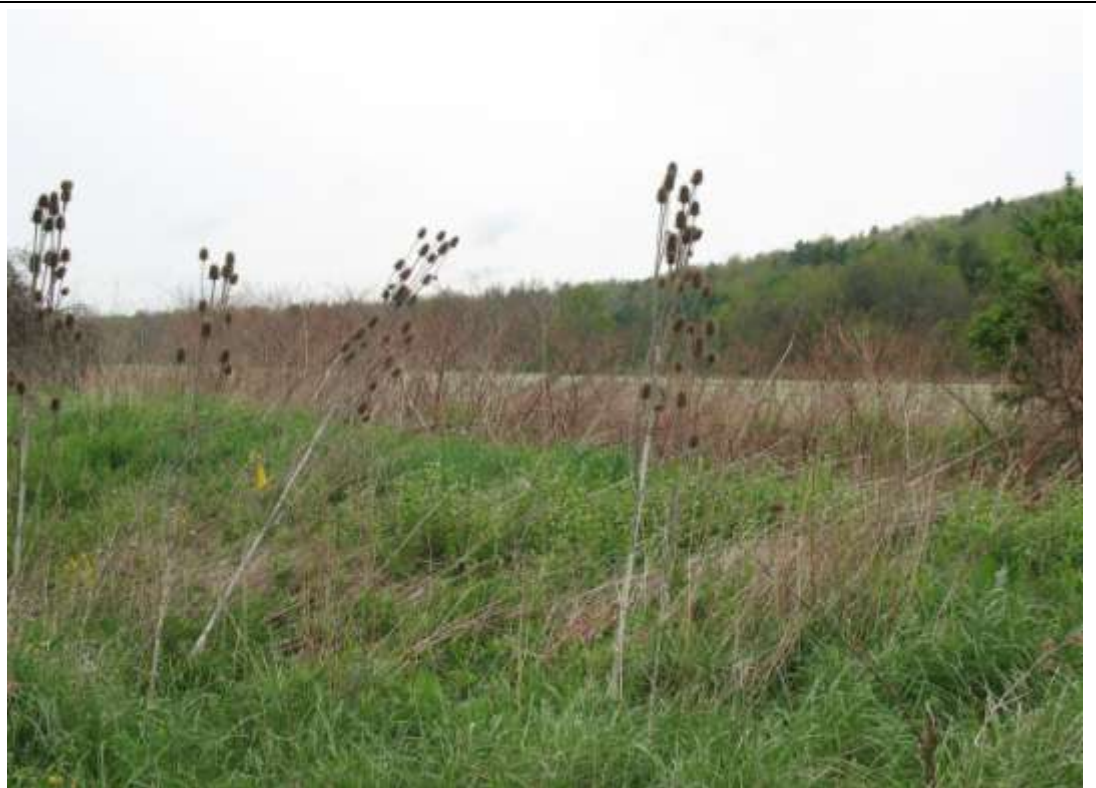
Photo No.
22

Small area of teasel along edge of project corridor.

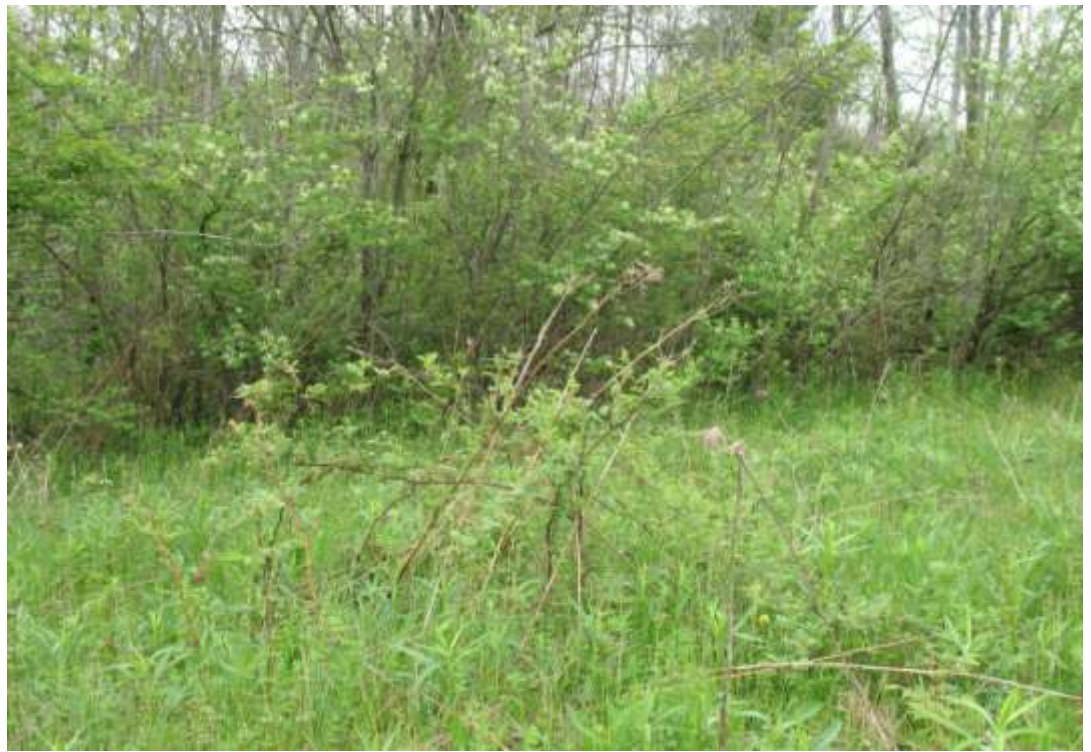
Photo No.
27

Typical multiflora rose within project corridor, honeysuckle along edge.

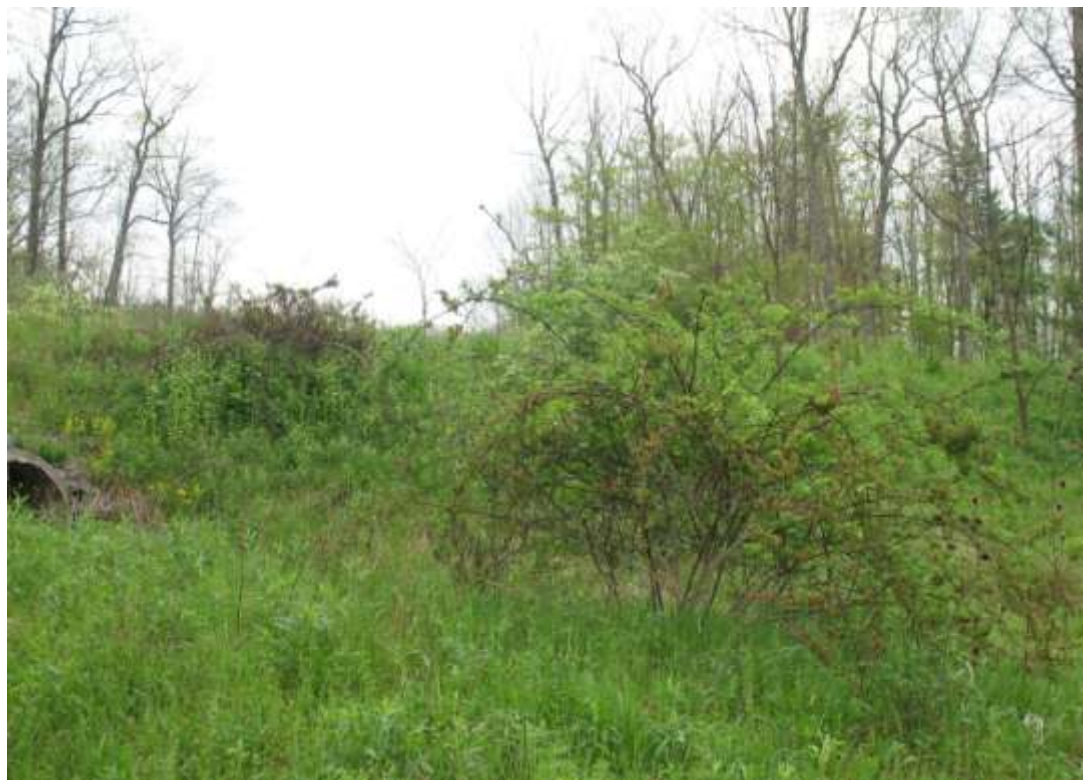
Photo No.
28

Typical multiflora rose within project corridor.

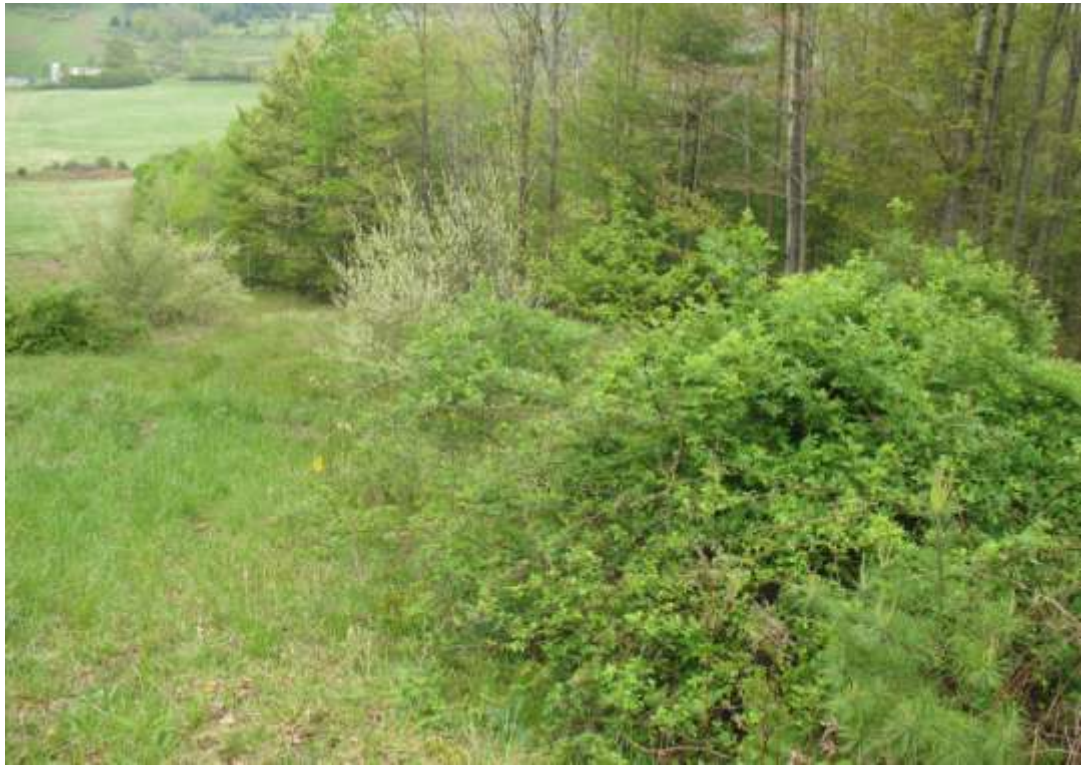
Photo No.
29

Typical view of honeysuckle and multiflora rose along project corridor.

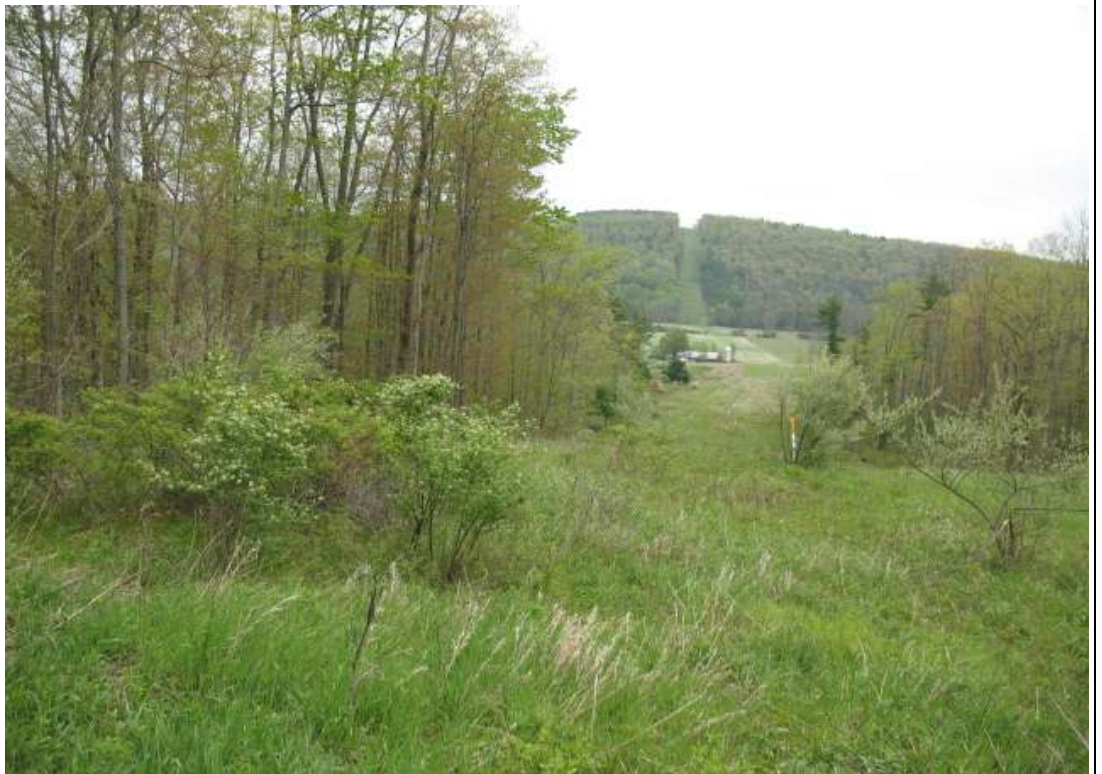
Photo No.
30

Typical view of project corridor, with honeysuckle in view.

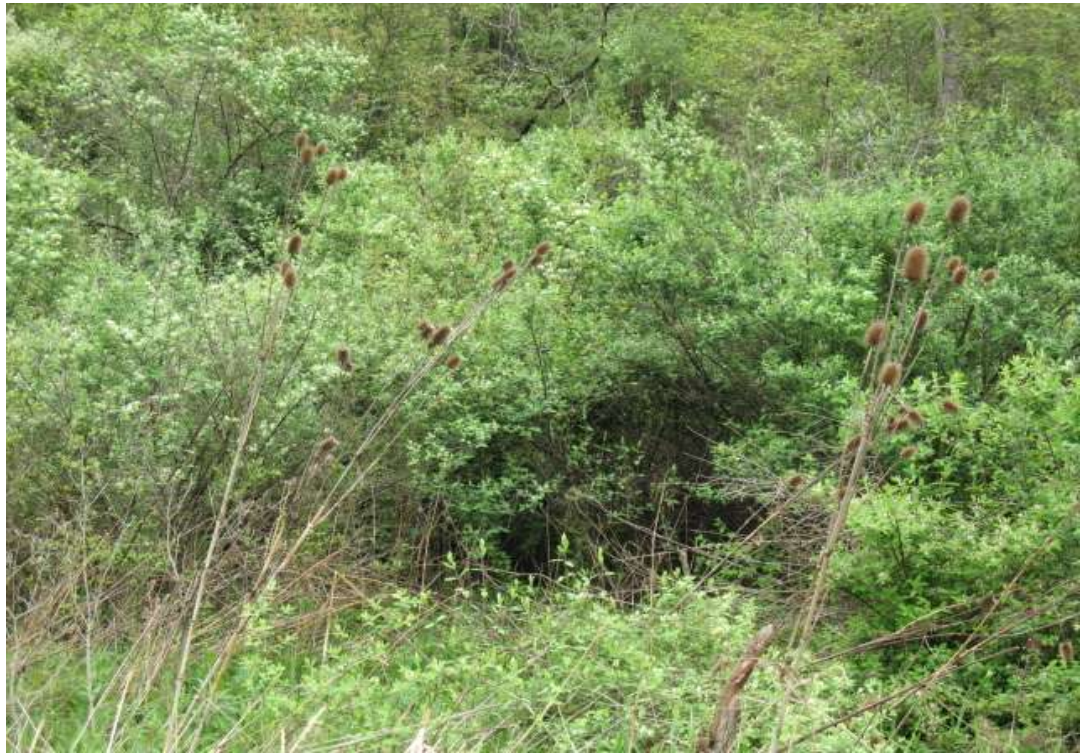
Photo No.
31

Typical view of edge of corridor, showing honeysuckle and small area of teasel.
