Client Name: NYSEG

Site Location: Horseheads, New York

11176689

PHOTOGRAPHIC LOG

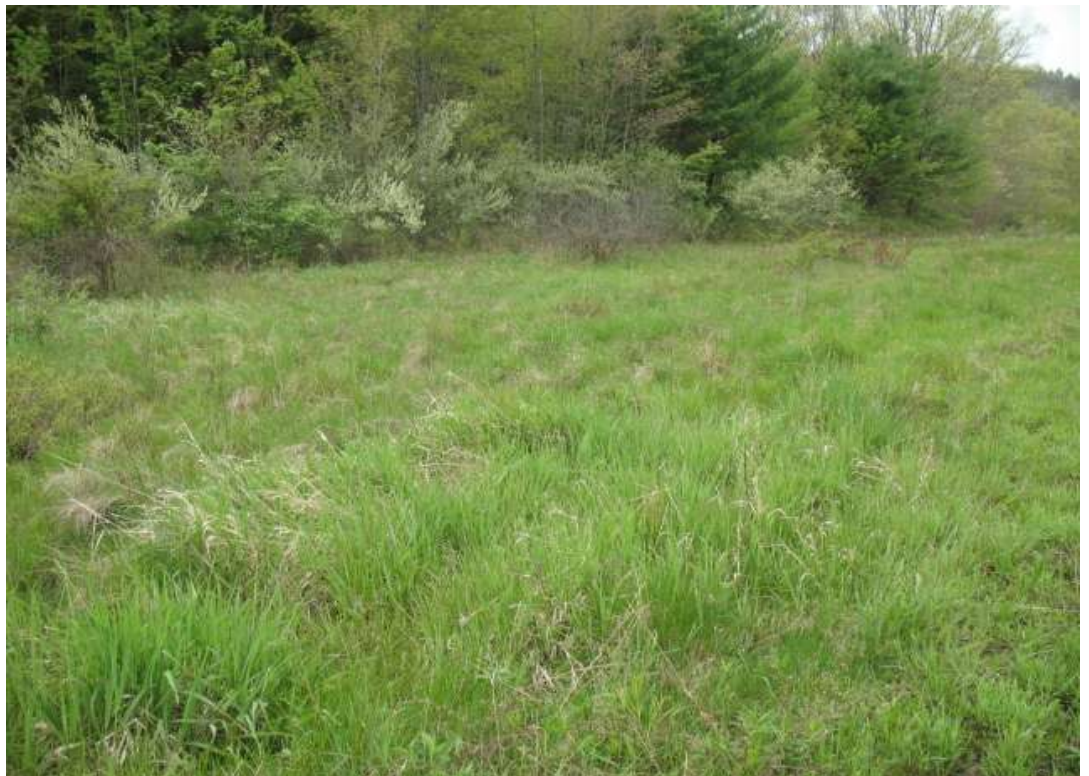
Photo No.
32

Reed canarygrass within project corridor.

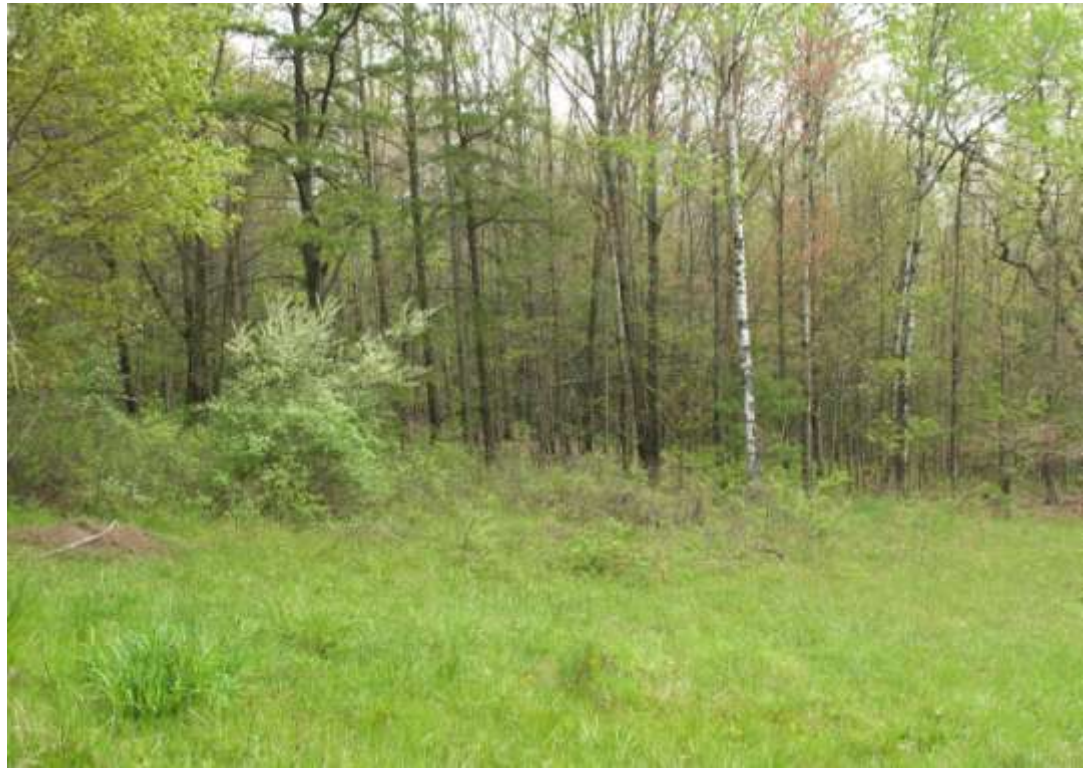
Photo No.
33

Typical view of edge of project corridor.

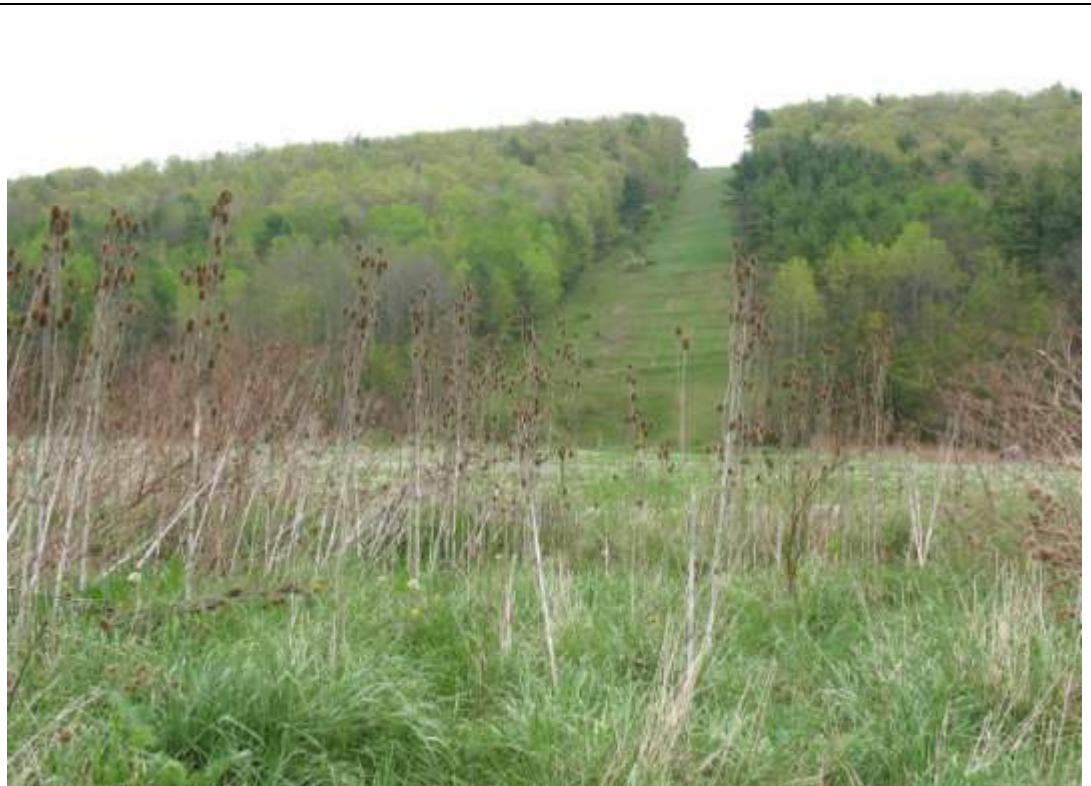
Photo No.
34

Teasel within project corridor.

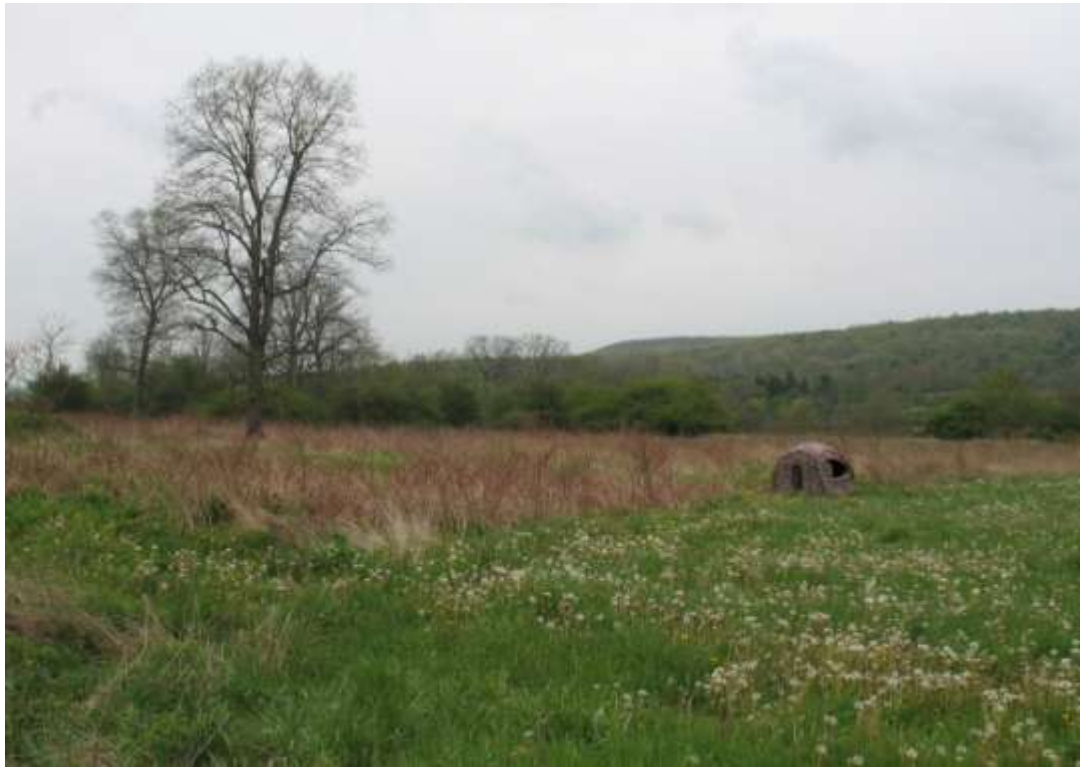
Photo No.
35

Japanese knotweed adjacent to project corridor.

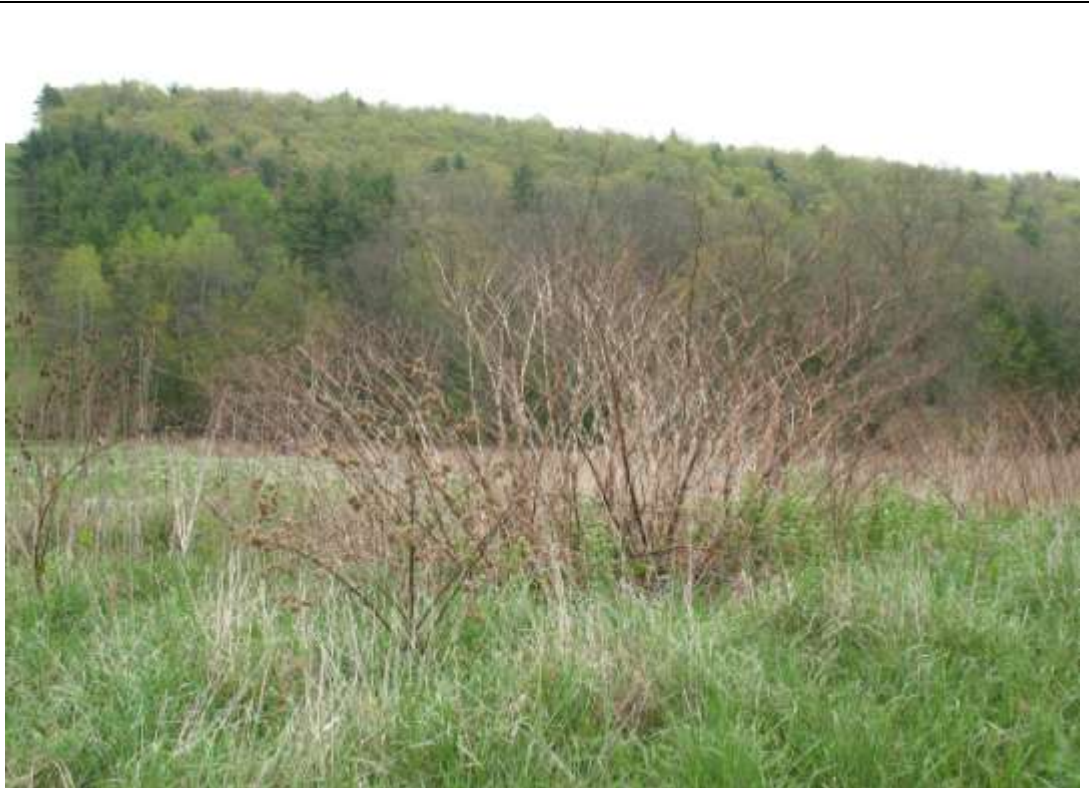
Photo No.
36

Japanese knotweed within project corridor.

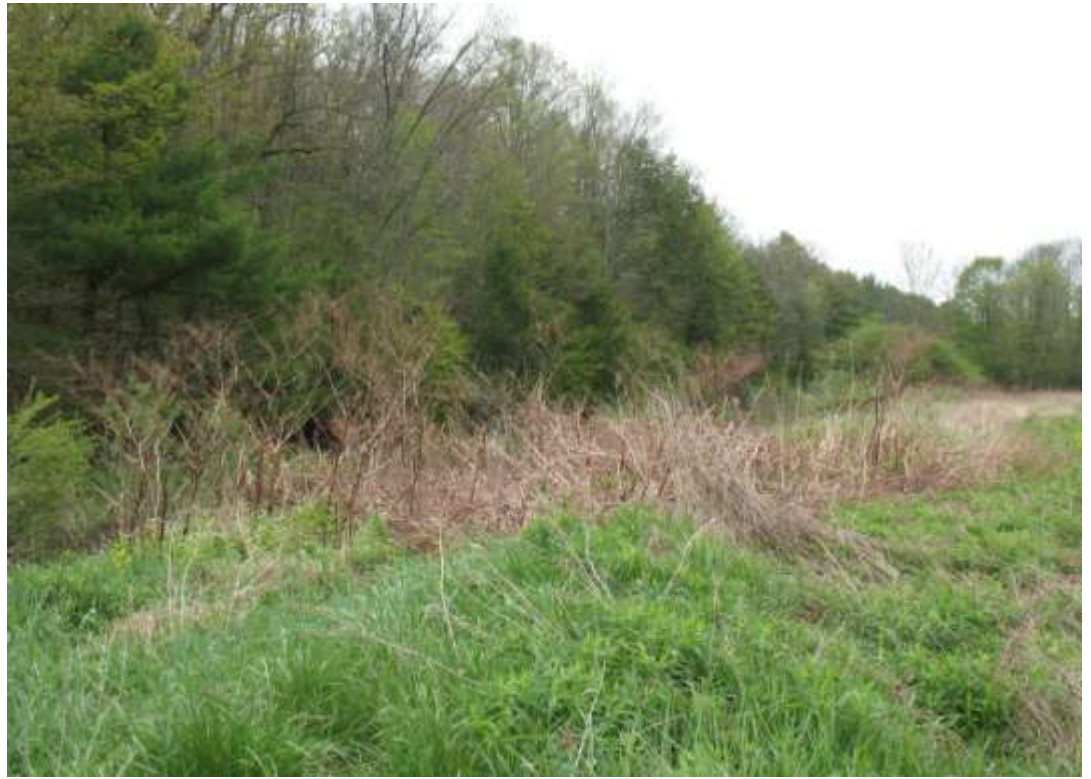
Photo No.
37

Japanese knotweed adjacent to project corridor.

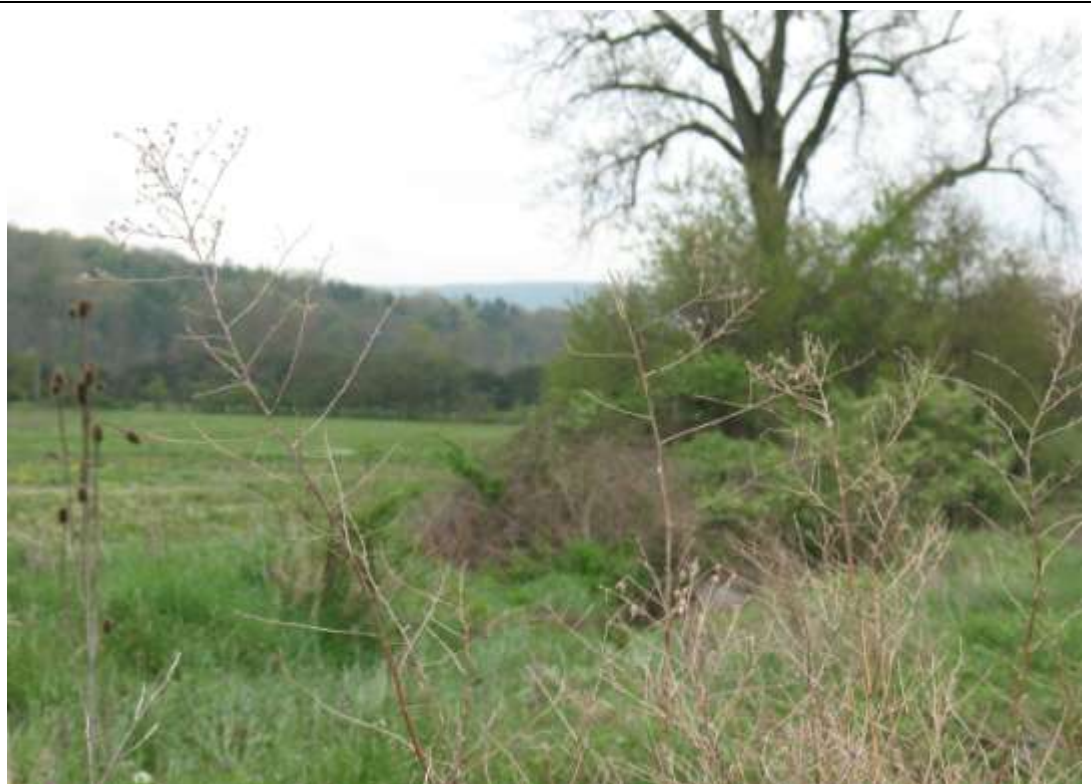
Photo No.
38

Typical view of teasel, multiflora rose and honeysuckle (background).

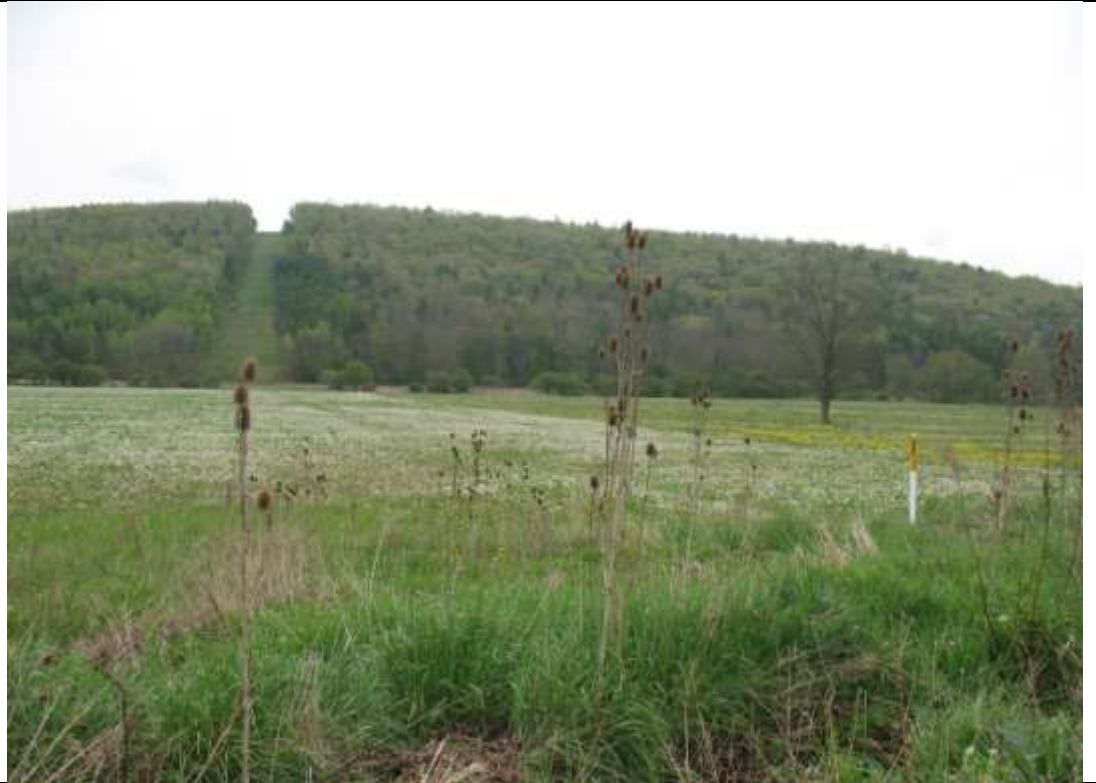
Photo No.
39

Teasel.

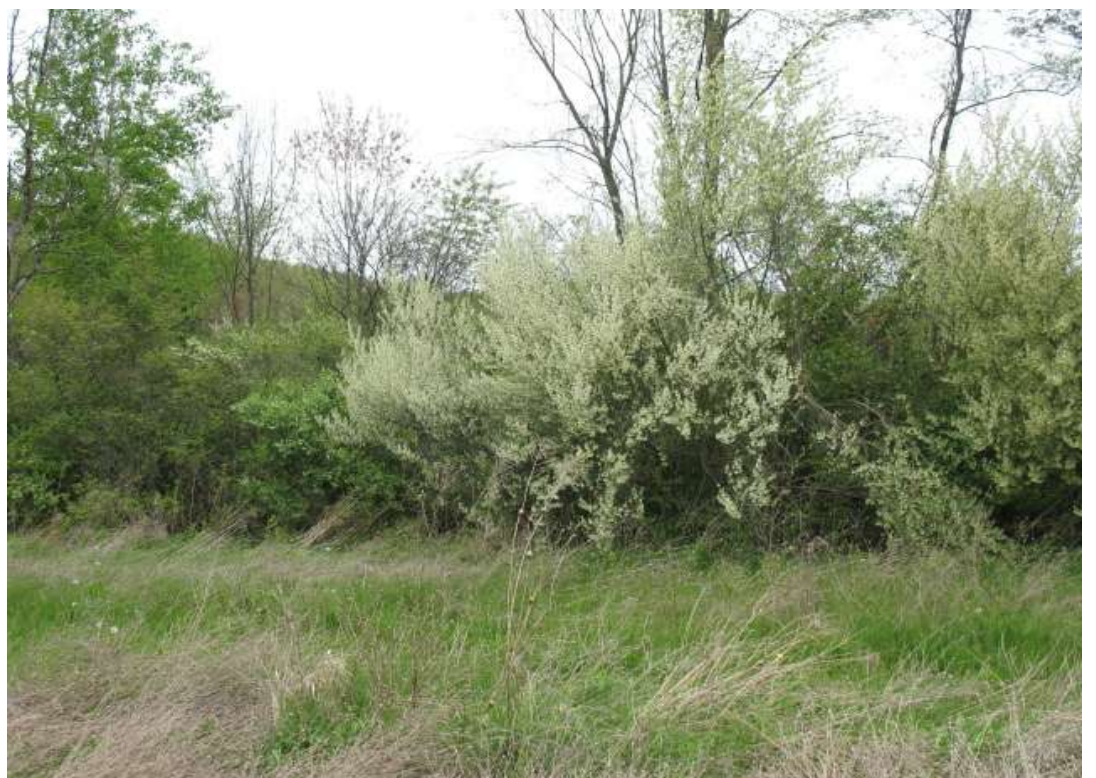
Photo No.
40

Typical view of edge of project corridor, showing honeysuckle.

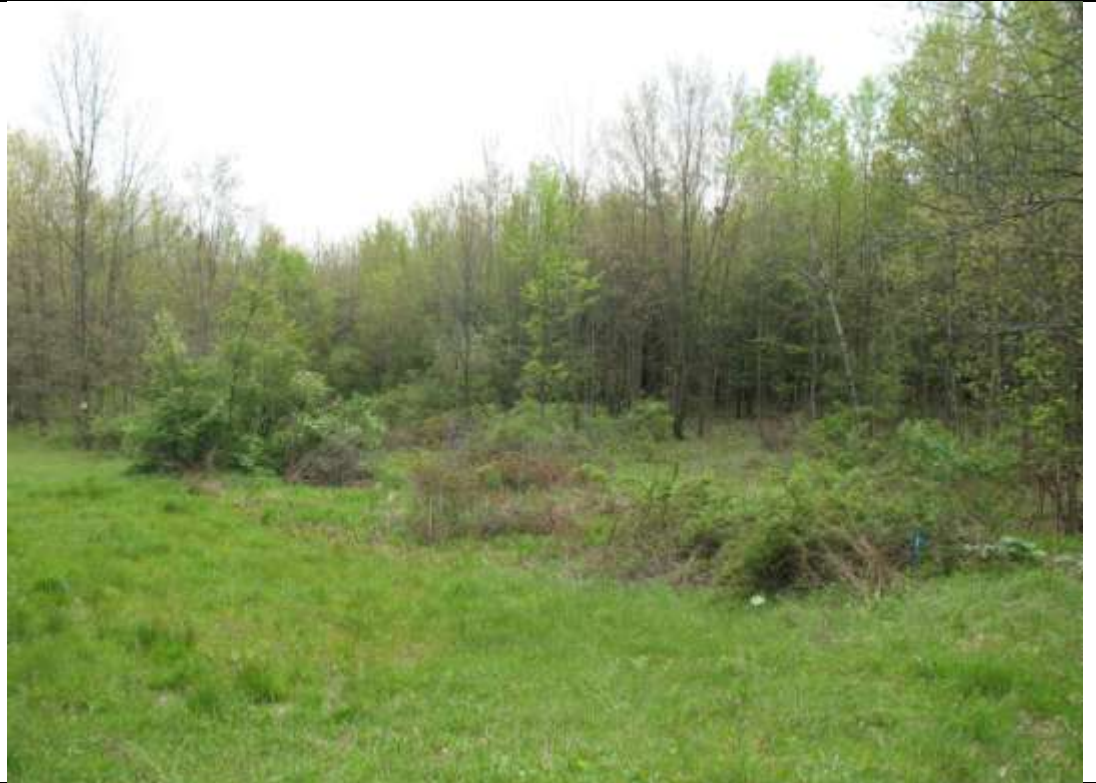
Photo No.
41

Typical view of edge of project corridor, showing multiflora rose.
