21029 Agricola Wind- Rapid Ordinary High Water Mark (OHWM) - OHWM Form 1.1	
Project	21029 Agricola Wind Project
ID	378464
Survey Date	08/15/2023
User	Rachel Nazak
General Information	
Project ID #	05-ST003
Site Name	21029 Agricola Wind
Date	08/15/2023
Time	02:38 PM
Location	
Latitude	42.73166717
Longitude	-76.501242
Datum	NAD83/2011
Investigator(s)	JK JP
Step 1: Site overview from remote and online resources	
Check boxes for online resources used to evaluate site	LIDAR, climatic data, geologic maps, land use maps, other, satellite imagery, topographic maps
Other	Natural Resource Mapper
Describe land use and flow conditions from online resources.	Stream occurs between road and agriculture field. Rain within 24 hours prior to survey. This stream partially corresponds with a NYSDEC mapped unprotected stream.
Step 2: Site conditions during field assessment	
Describe Site Condition	Stream is a roadside drainage ditch with steep walls. Vegetation around stream is mowed. Fish observed in pool to north of culvert. Water present in stream channel at time of survey.

Towns of Scipio and Venice, Cayuga County, New York

Wetland and Stream Delineation Report

Agricola Wind Project

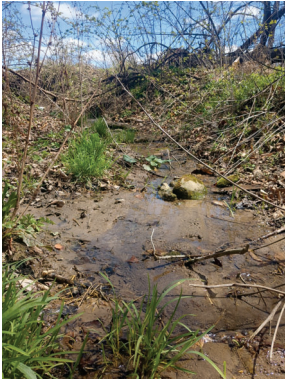
Leaf litter washed away

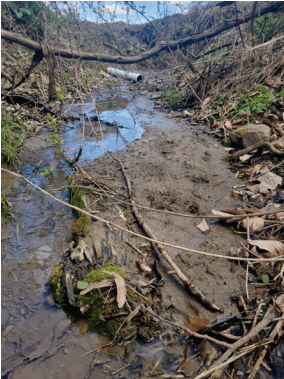
Break in slope on the bank. Drain tile outlet.

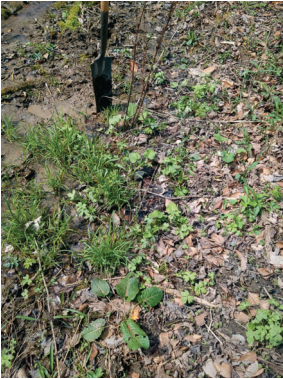
Transition in vegetation, water staining

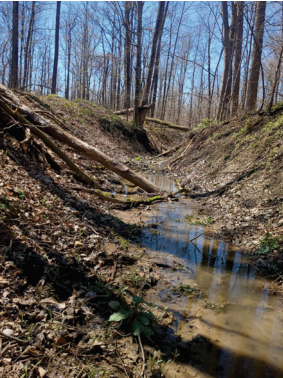
Break in slope on the bank. Leaf litter disturbed. Water staining

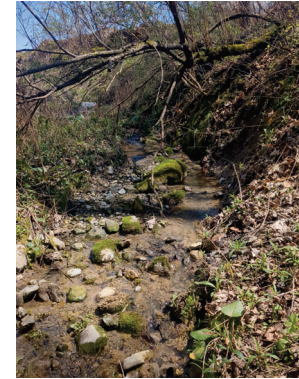
Erosional bedload indicator.

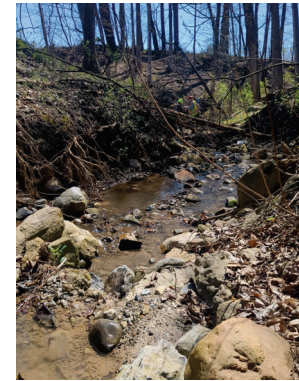
Undercut banks, break in slope on the bank, and exposed roots.

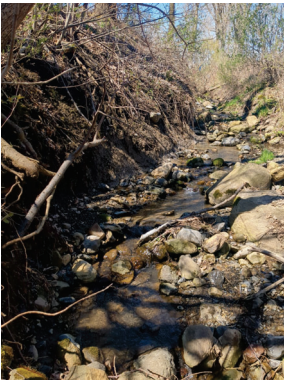
channel bar

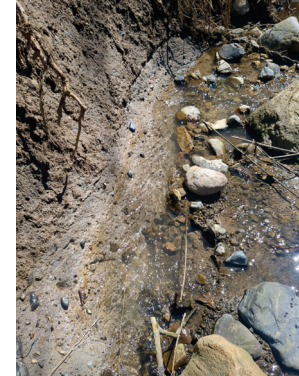
Changes in character of the soil. Erosional bedload.

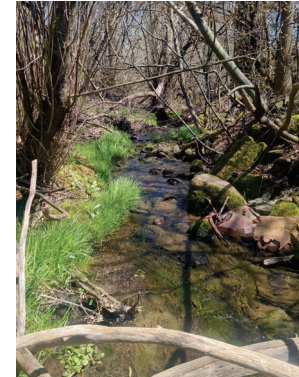
Transition in vegetation, break in slope on the Bank

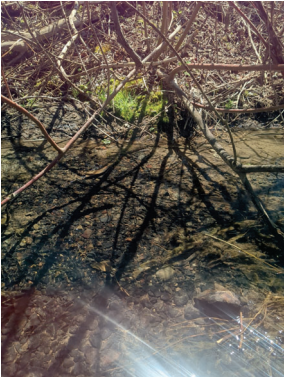
Changes in character of the soil.

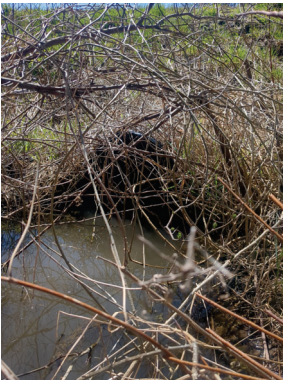
Culvert outlet.

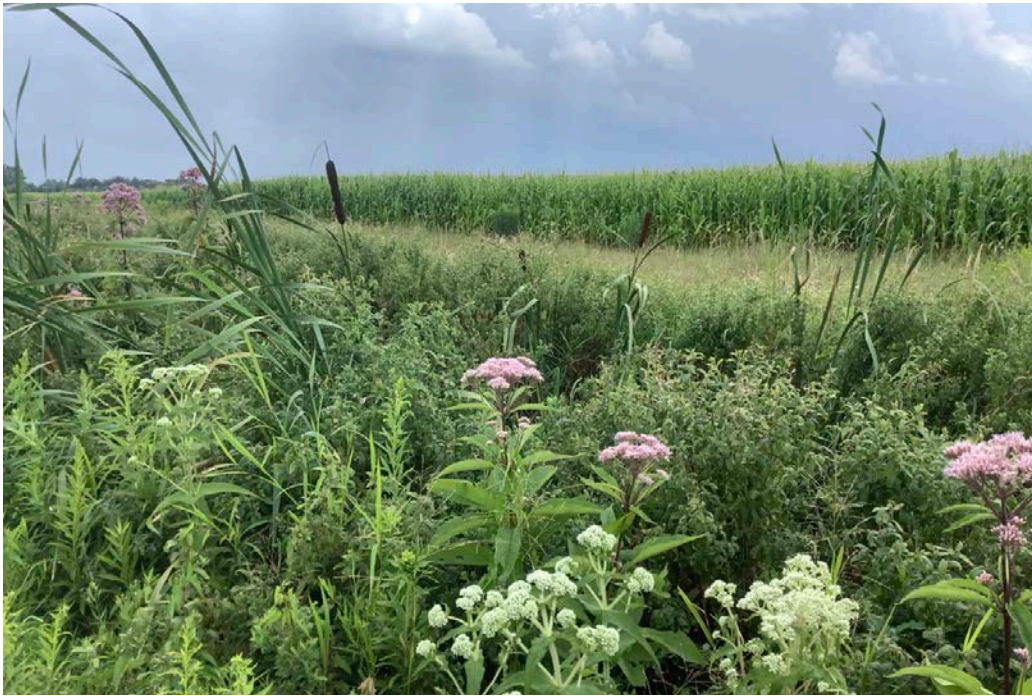
Photo 1

Representative palustrine emergent (PEM) wetland community.

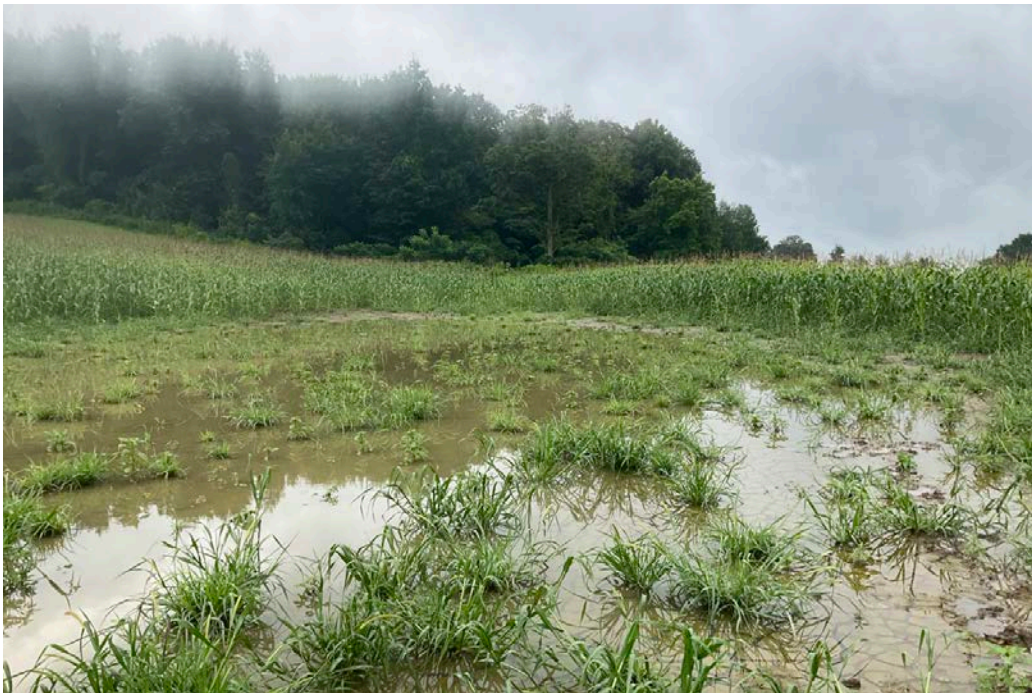
Photo 2

Representative palustrine emergent (PEM) wetland community.

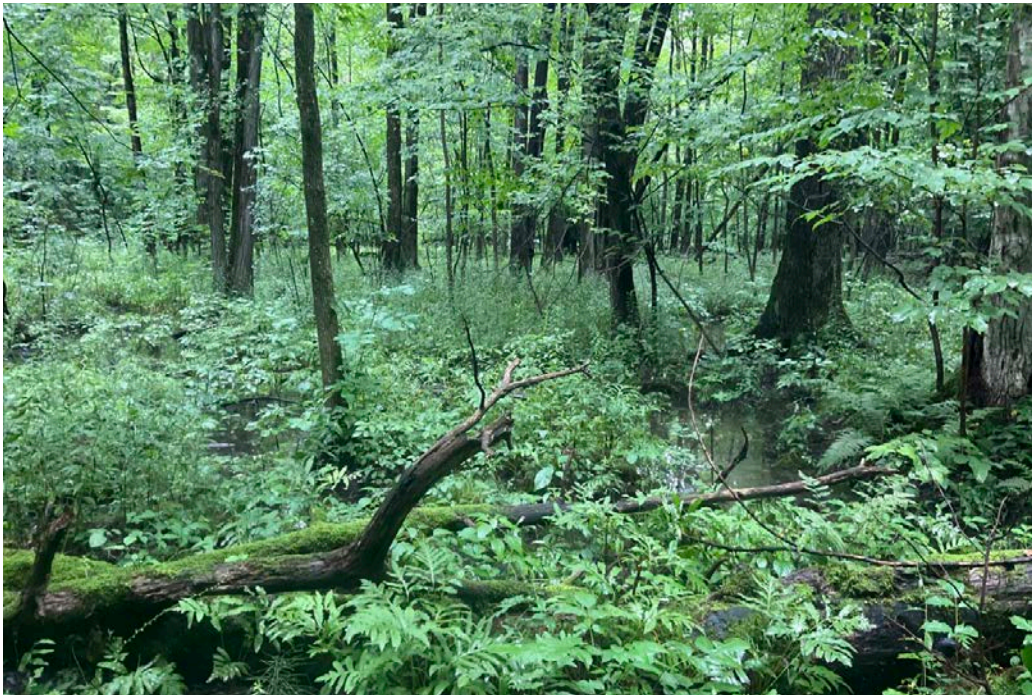
Photo 3

Representative palustrine forested (PFO) wetland community.

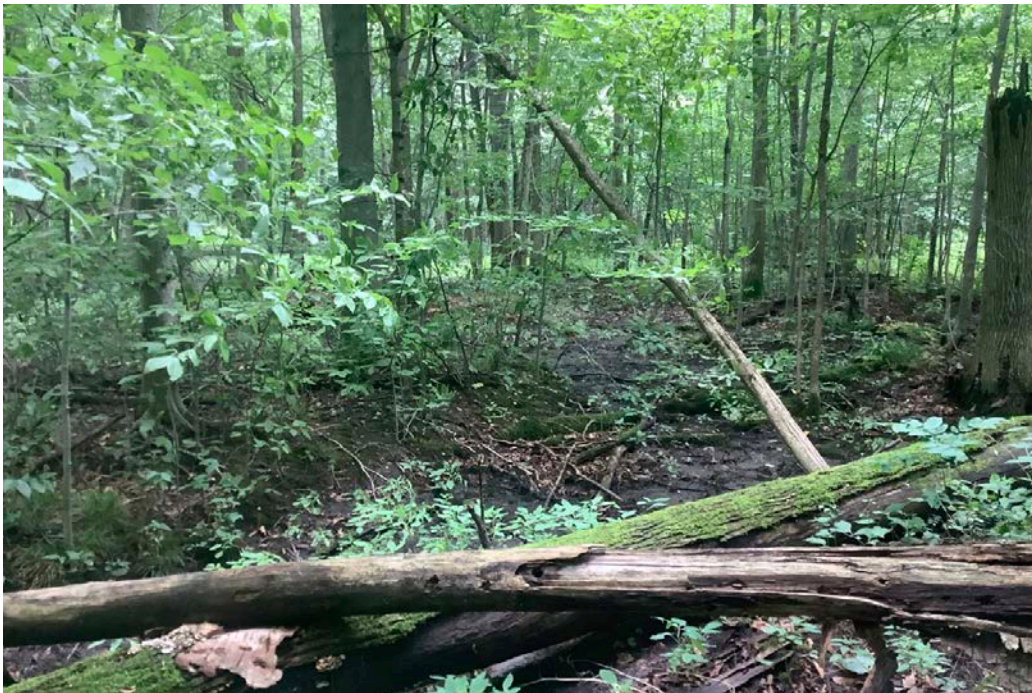
Photo 4

Representative palustrine forested (PFO) wetland community.

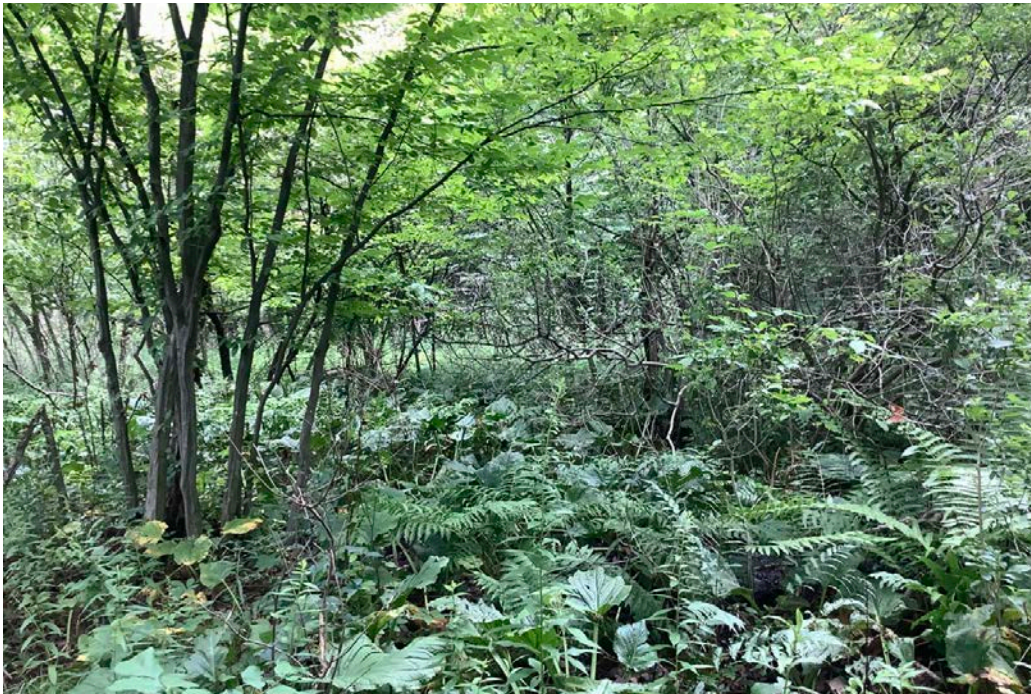
Photo 5

Representative palustrine scrub-shrub (PSS) wetland community.

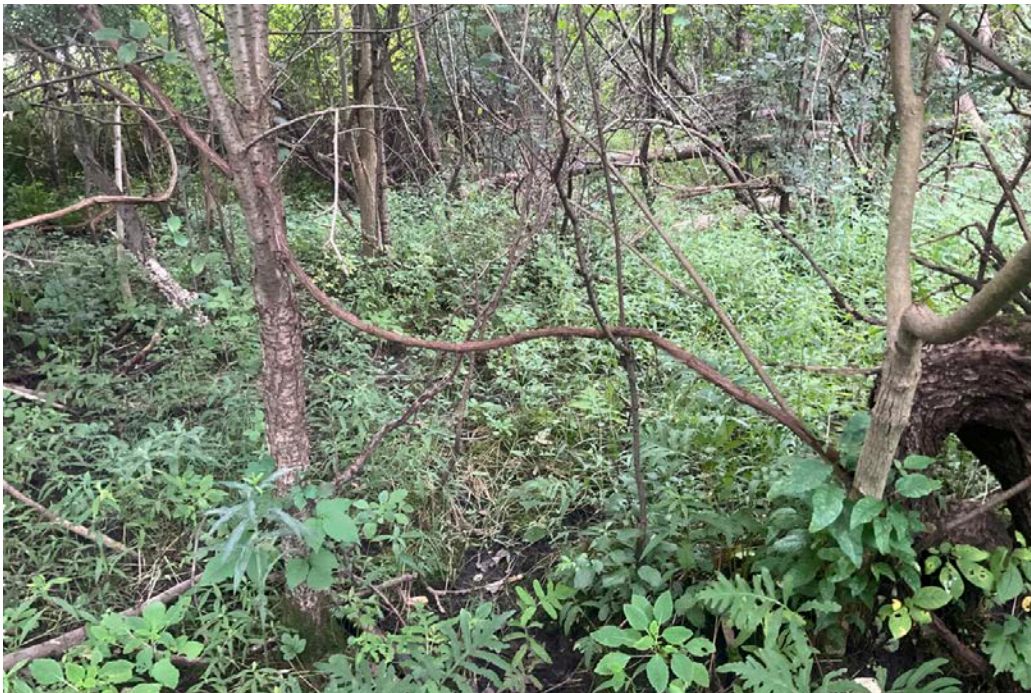
Photo 6

Representative palustrine scrub-shrub (PSS) wetland community.

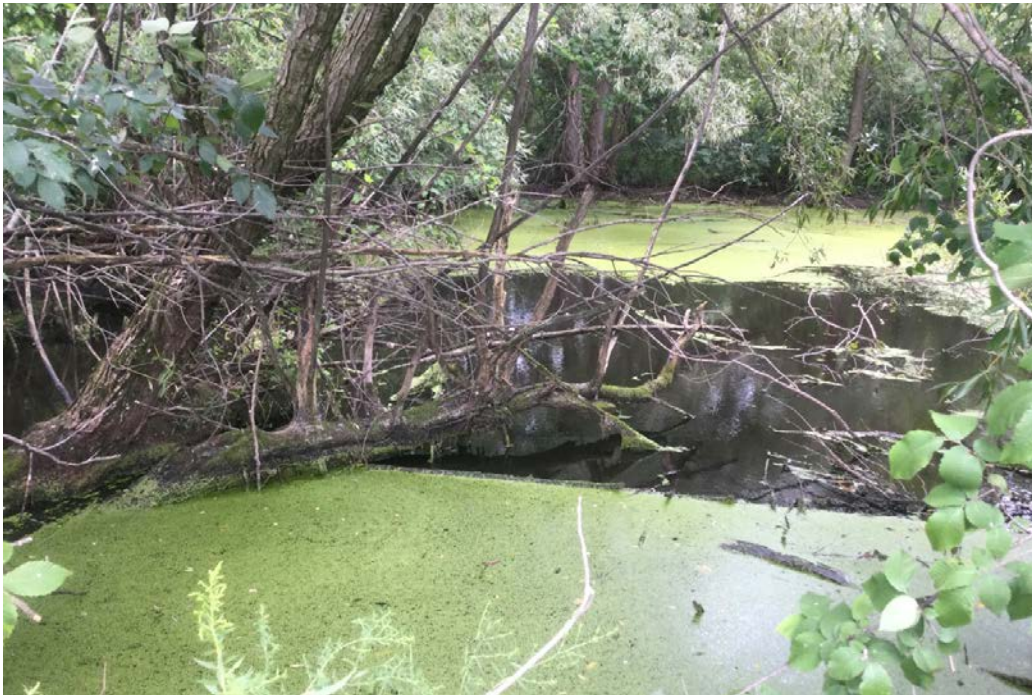
Photo 7

Representative palustrine open water (POW) wetland community.

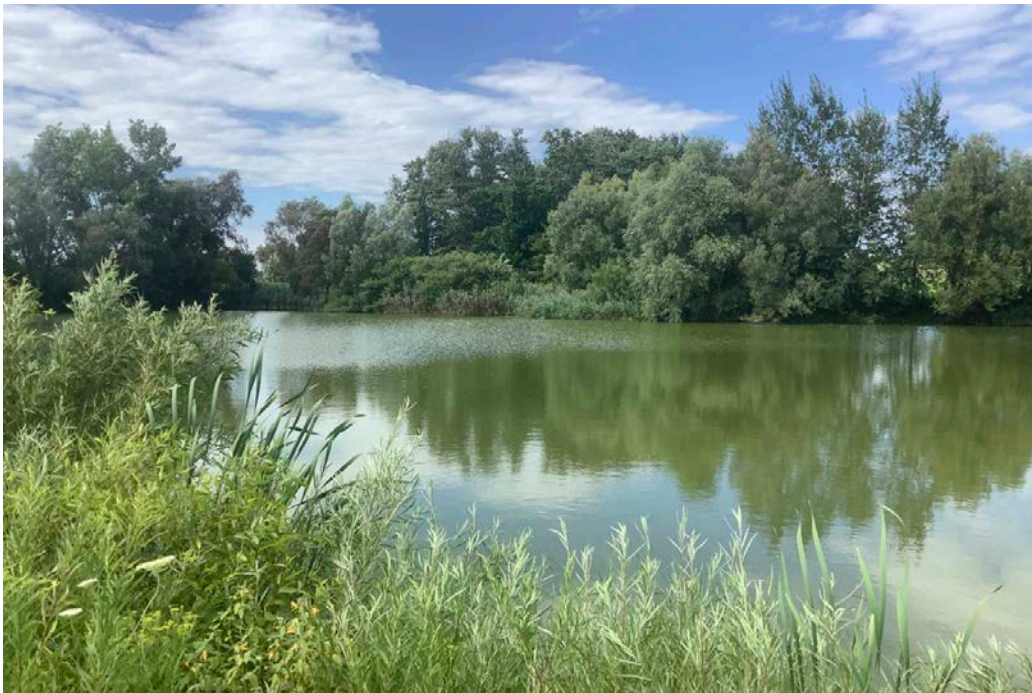
Photo 8

Representative palustrine open water (POW) wetland community.

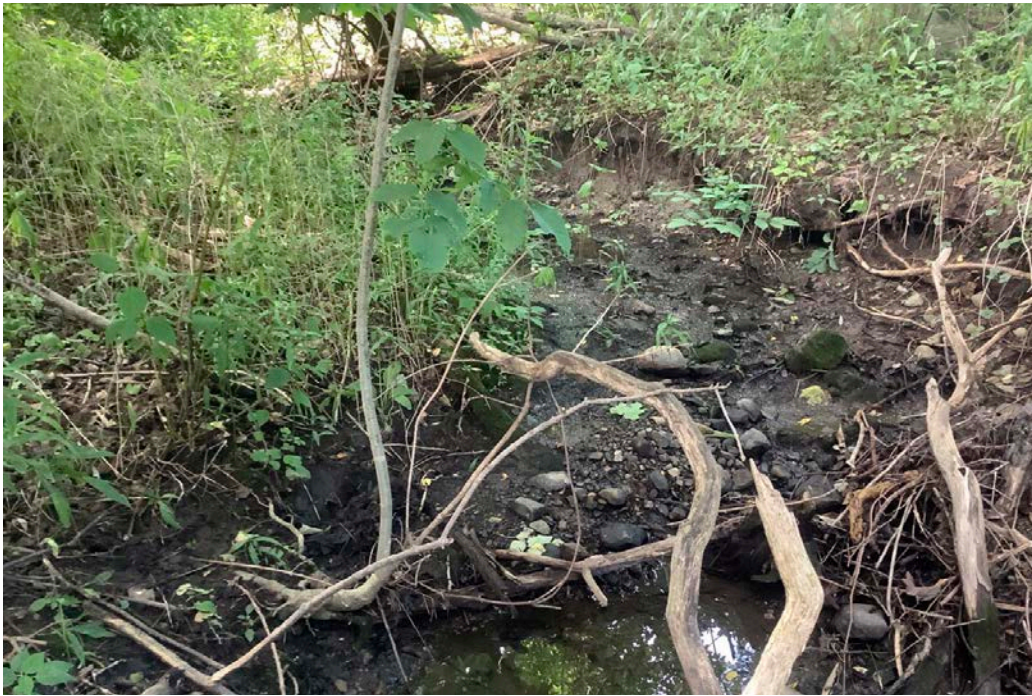
Photo 9

Representative intermittent stream (R4).

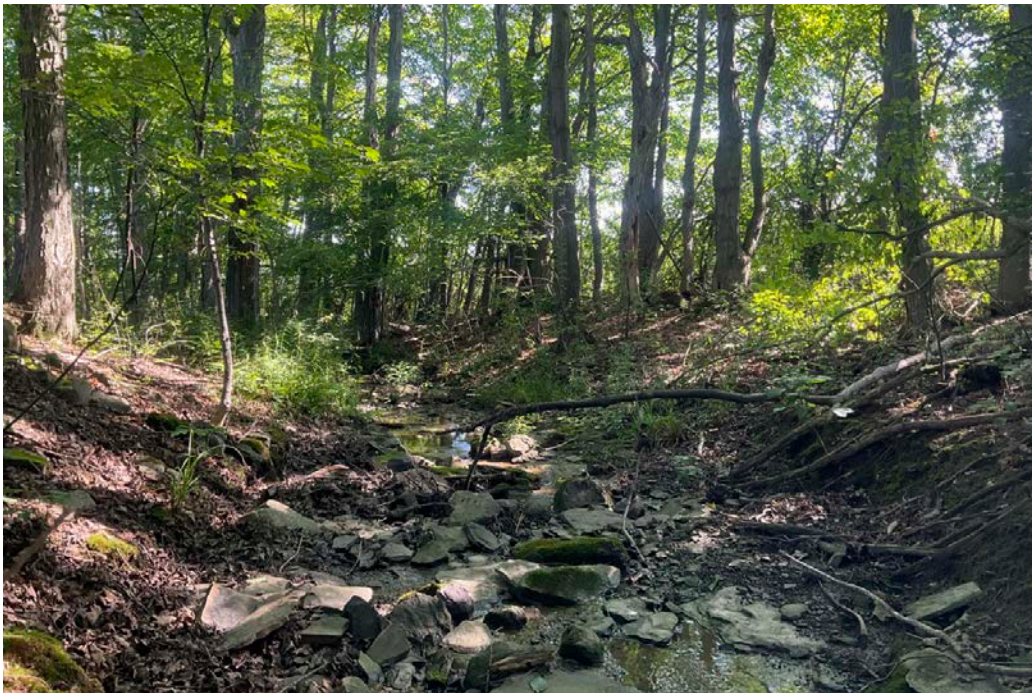
Photo 10

Representative intermittent stream (R4).

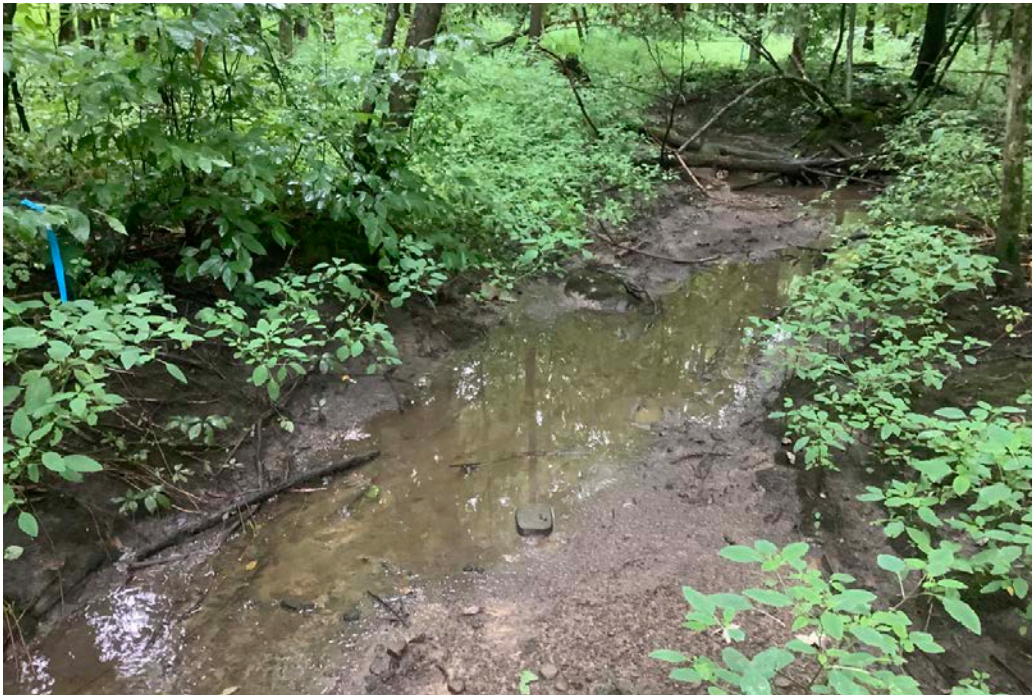
Photo 11
Representative intermittent stream (R4).

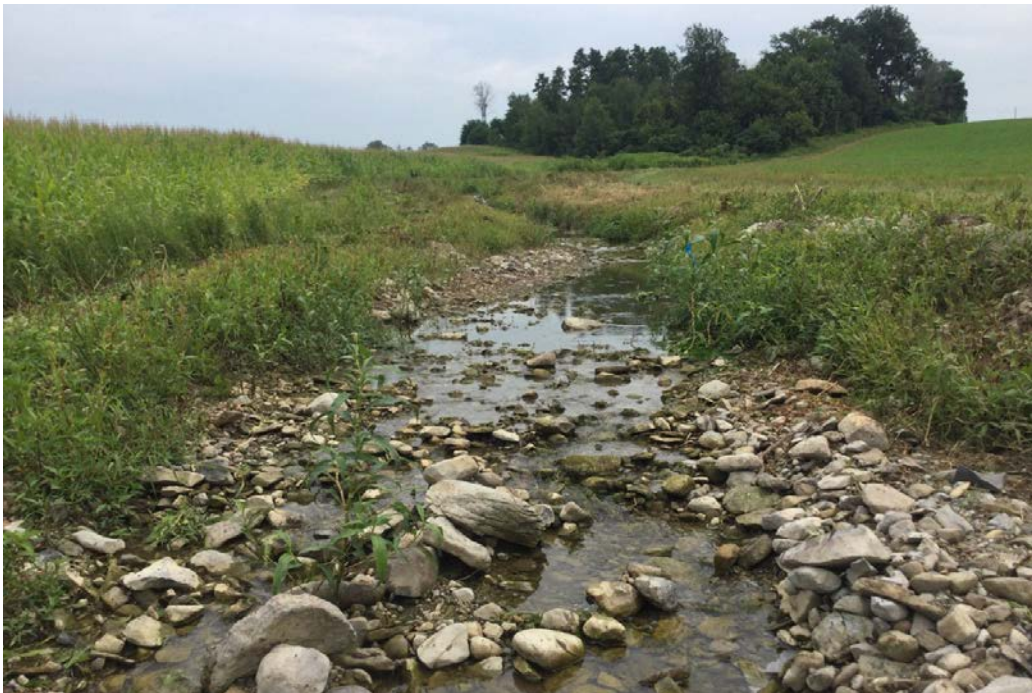
Photo 12
Representative perennial stream (R3).

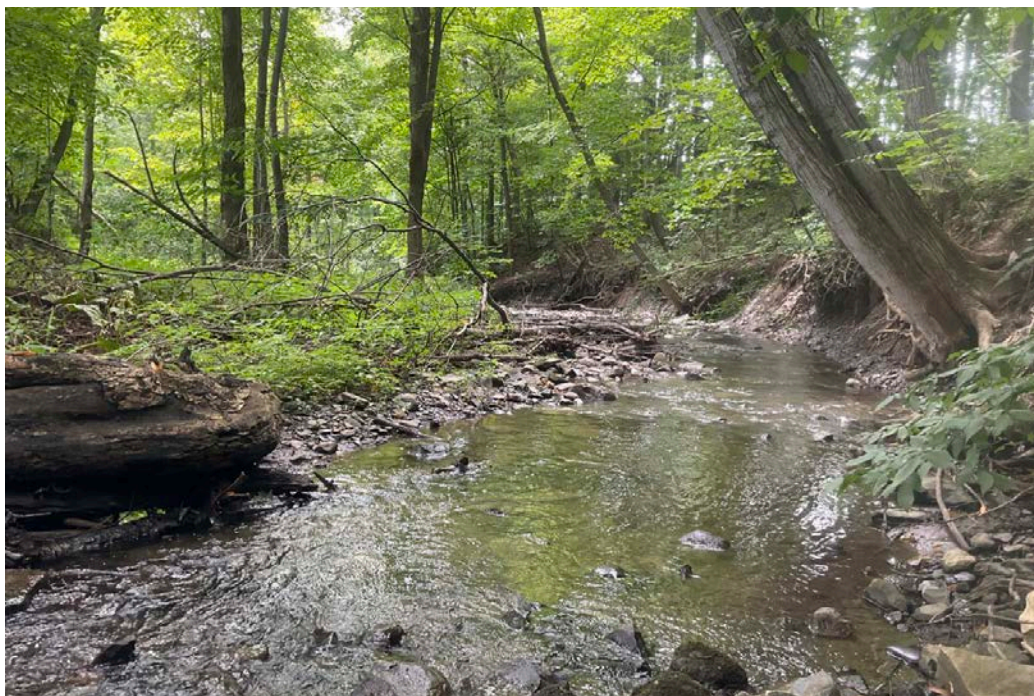
Photo 13

Representative perennial stream (R3).

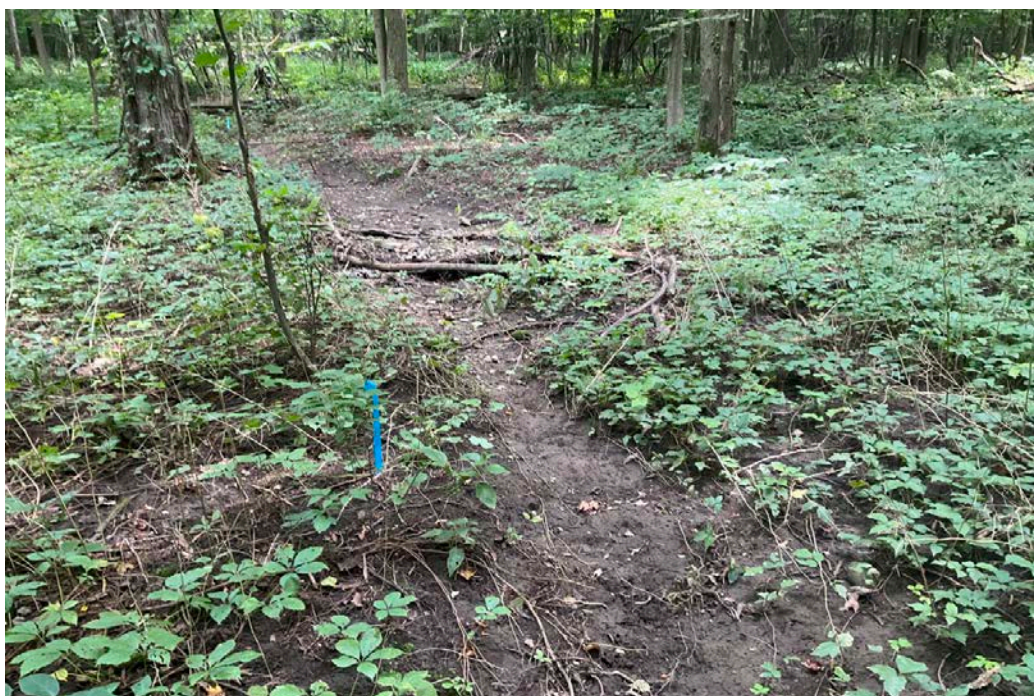
Photo 14

Representative ephemeral stream (R6).

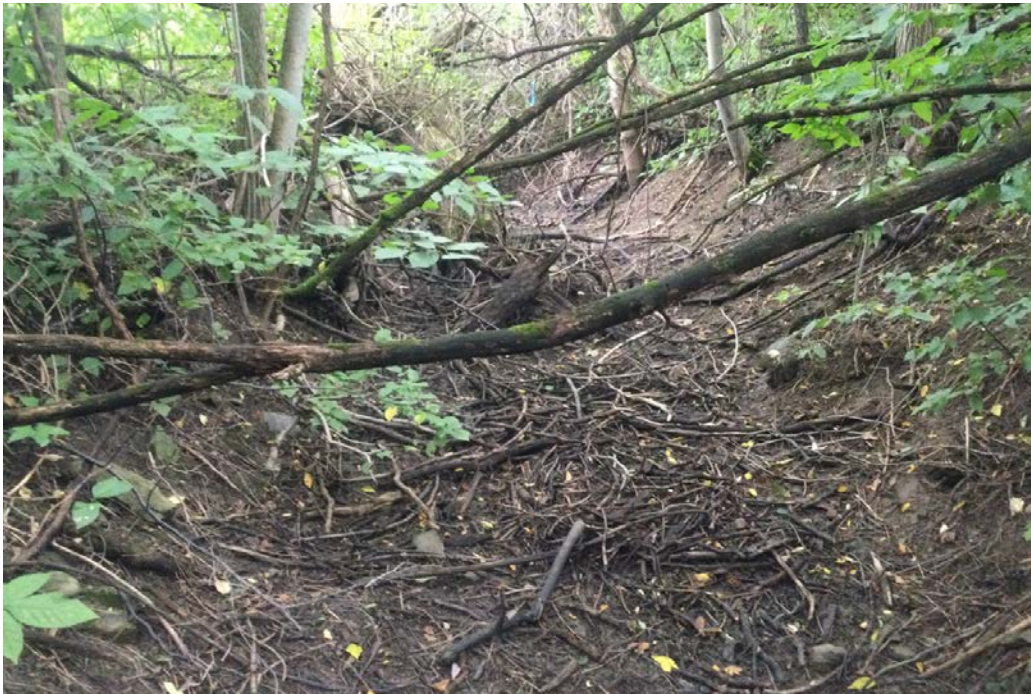
Photo 15
Representative ephemeral
stream (R6).

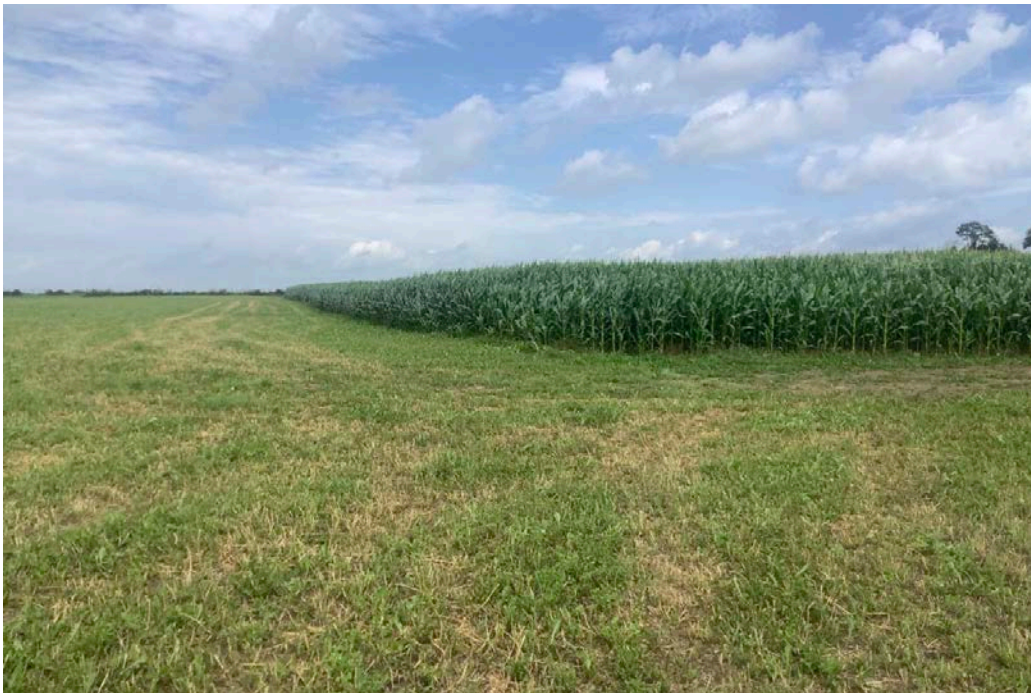
Photo 16
Representative upland
agricultural community.

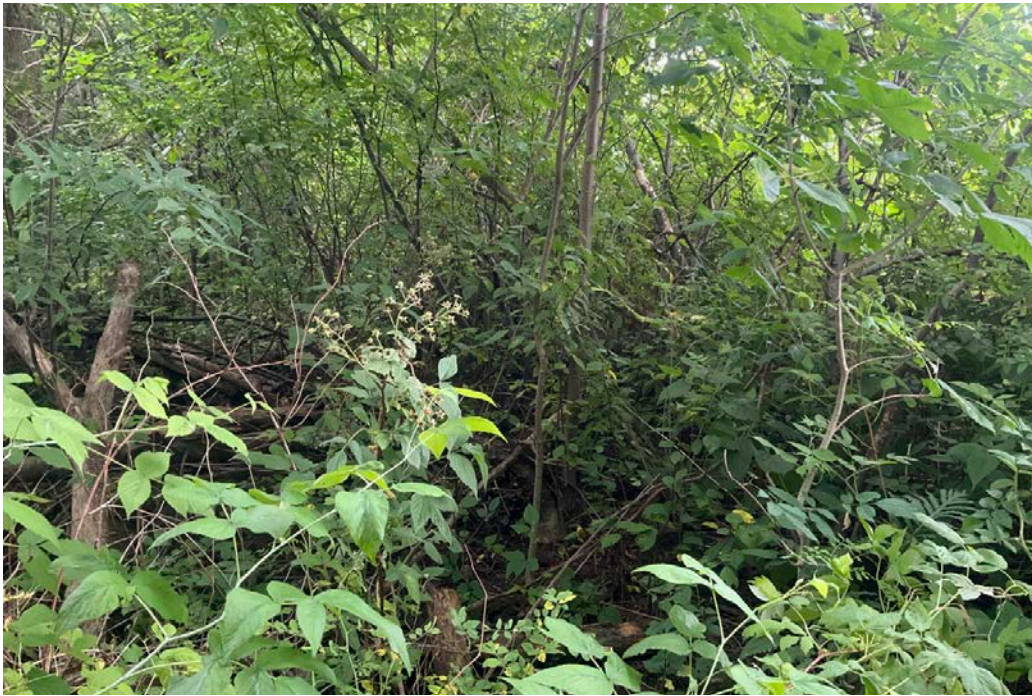
Photo 17
Representative upland scrub-shrub community.

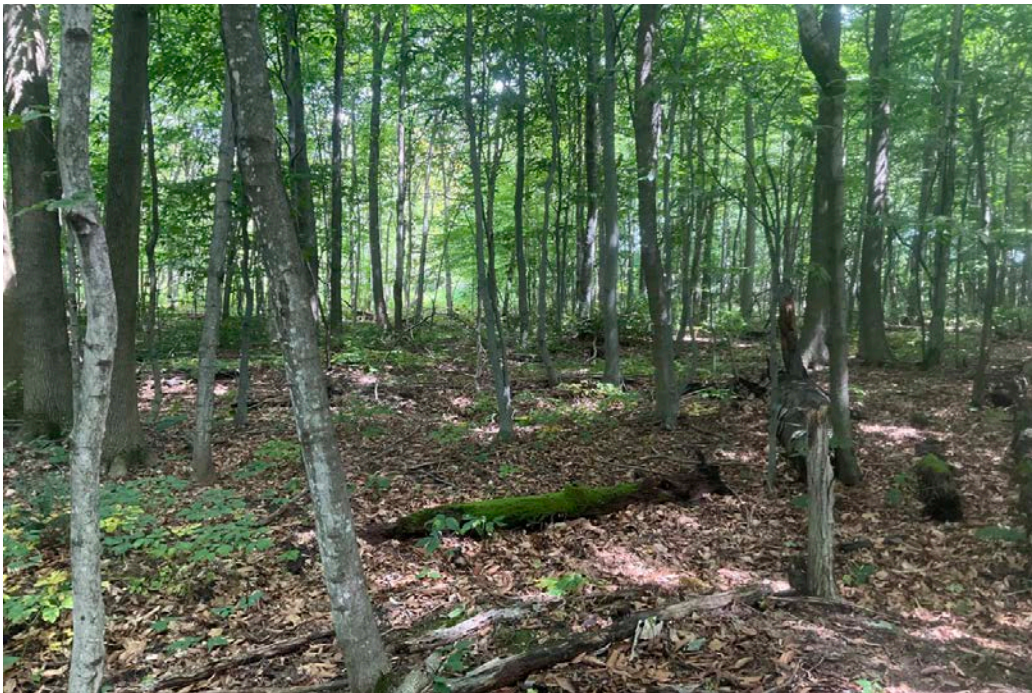
Photo 18
Representative upland forest community.
