## 21028 Hoffman Falls - Rapid Ordinary High Water Mark (OHWM) 1.1

Project	21028 Hoffman Falls Wetland Delineation
ID	364360
Survey Date	06/27/2023
User	Joseph Knight

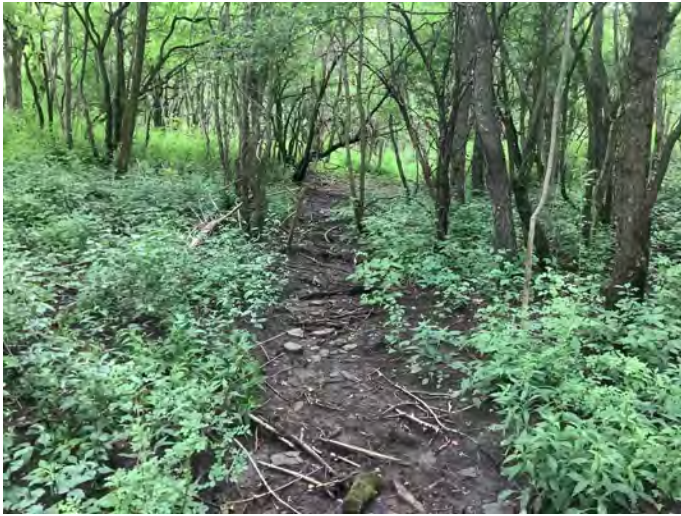
Vegetation transition

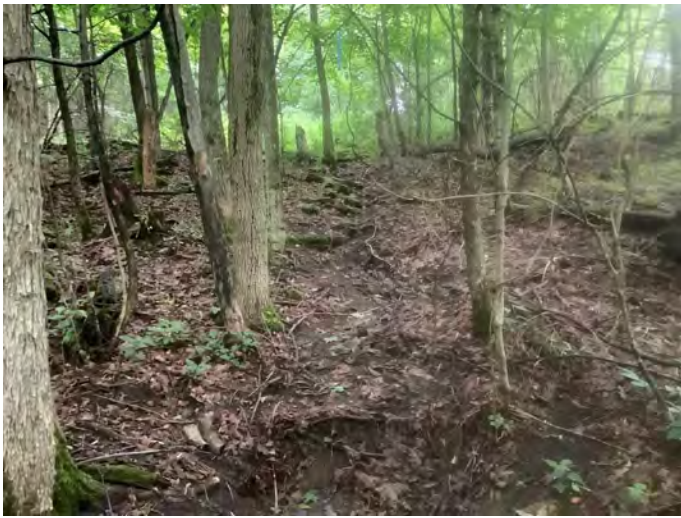
Photograph depicting significant leaf litter washout within the stream channel. Break in slope also evident.

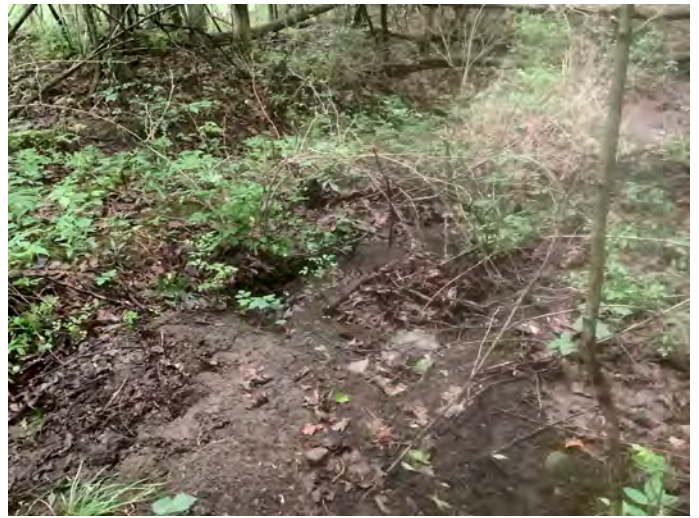
End of stream where it meets with wetland 26-W014.

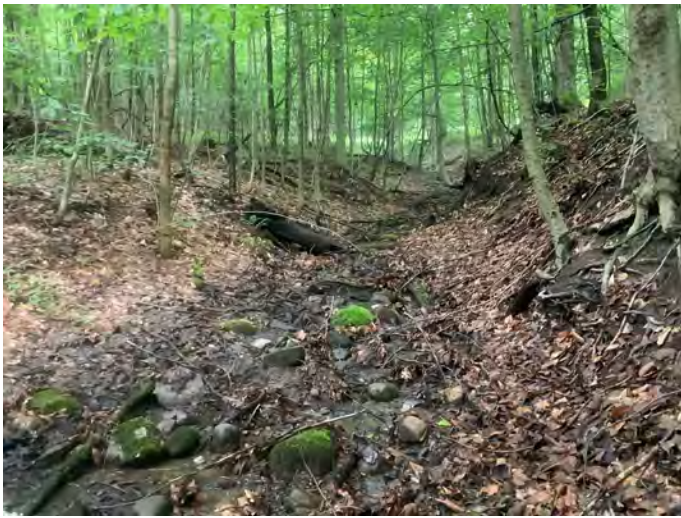
Leaf litter pushed to the side due to downward flow of water. Water staining in stream bed below OHWM.

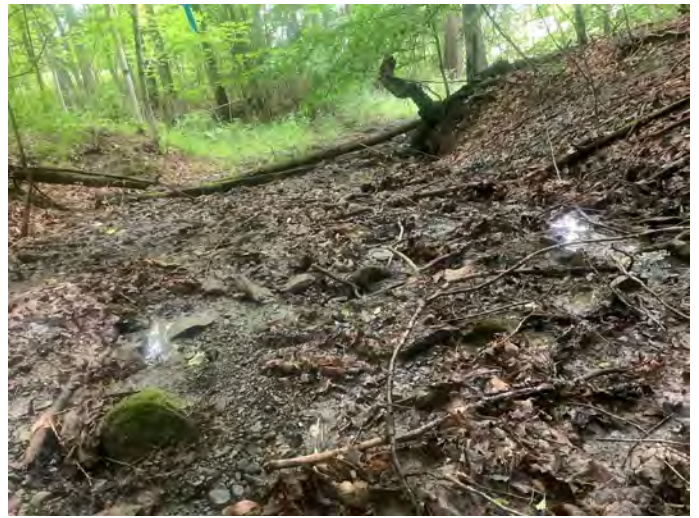
Presence of large wood hanging off of stream banks

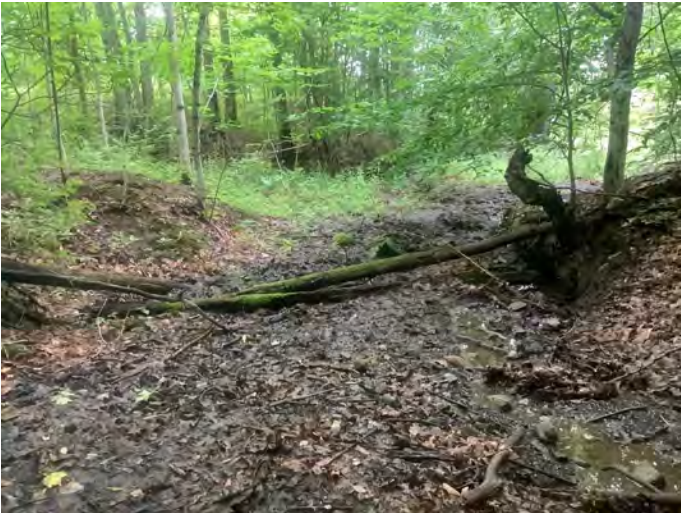
Large wood found at stream OHWM, water staining found below OHWM and wracking within stream channel.

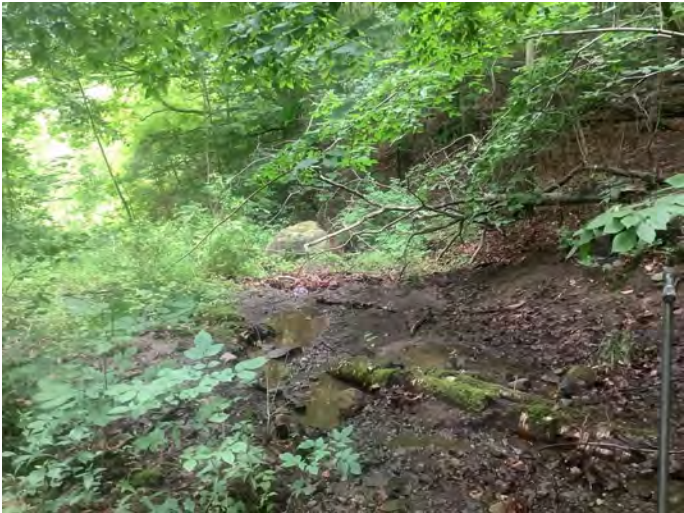
View of stream break in slope found at the streams OHWM. View of change in vegetation from absent to forbs at OHWM.

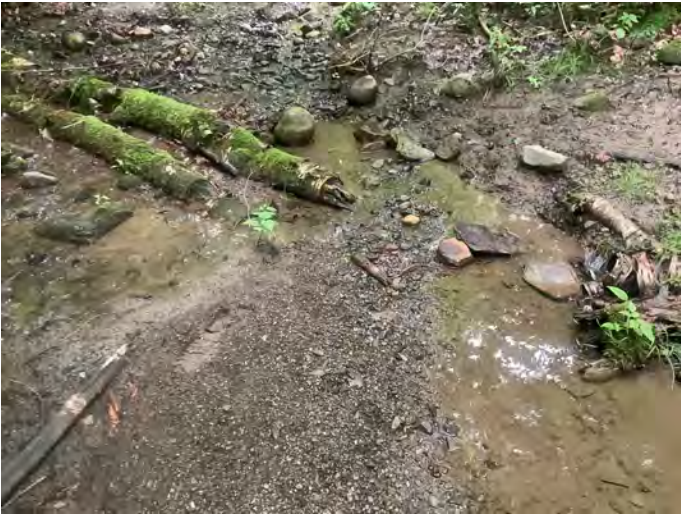
View of in stream channel bar and large wood found below the streams OHWM.

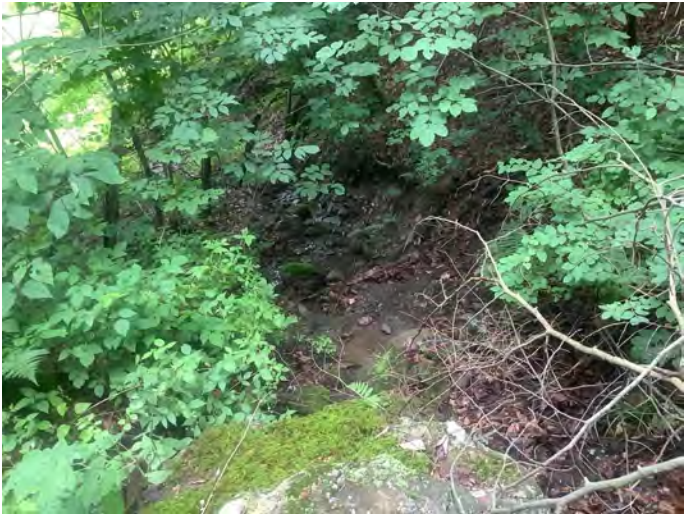
View of stream break in slope.

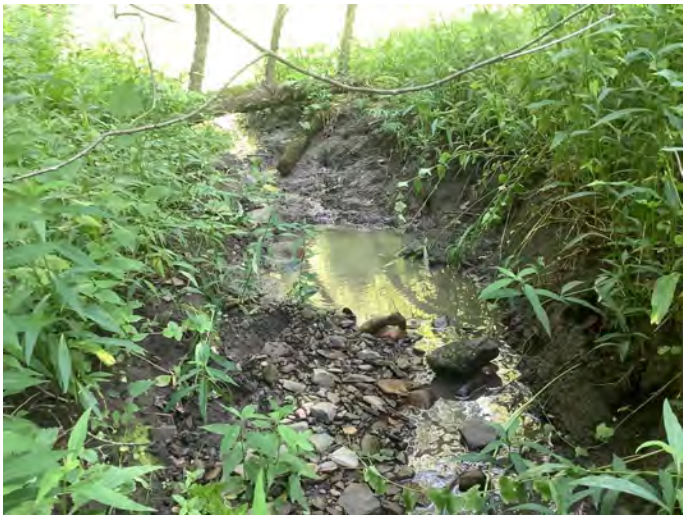
View of change in sediment size distribution, break in slope, and change in vegetation found at the OHWM. Also a view of the channel bar forming within the stream bed.

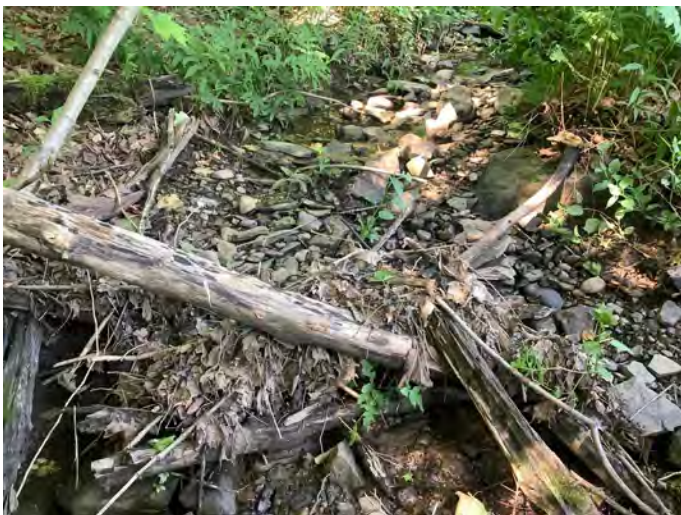
View of significant wracking and large woody debris observed at the stream OHWM.

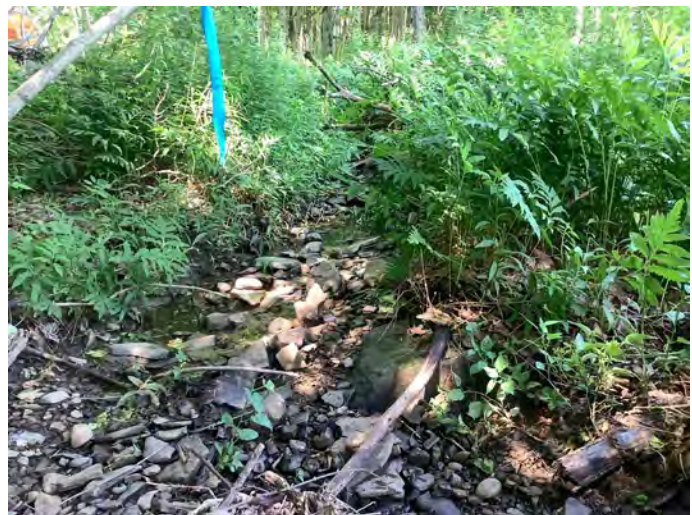
View of change in vegetation type and density from absent to forbs below the OHWM, change in particle size distribution below the OHWM and break in slope at the OHWM of the stream.

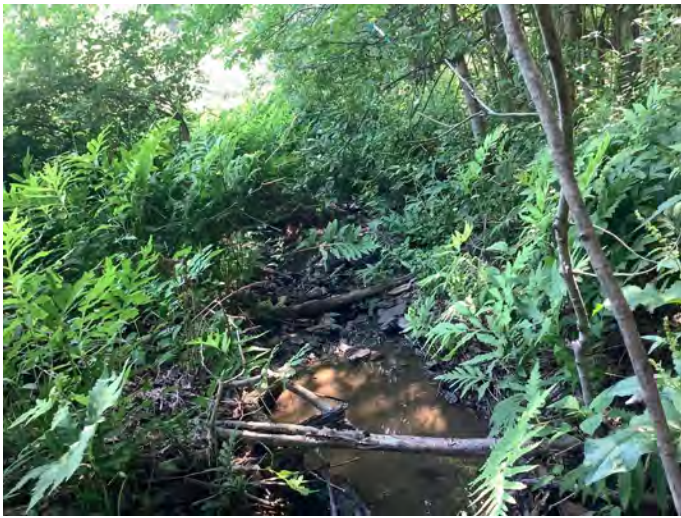
View of change in vegetation type and density, and break in slope within stream bed.

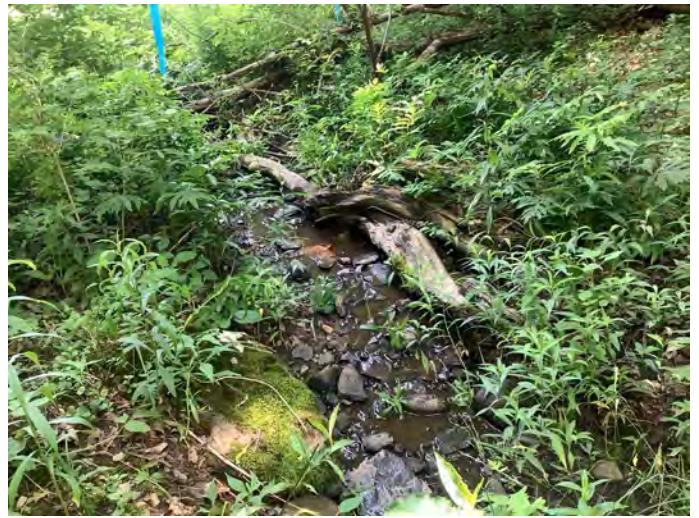
View of large woody debris, change in particle size distribution and change in vegetation type and density.

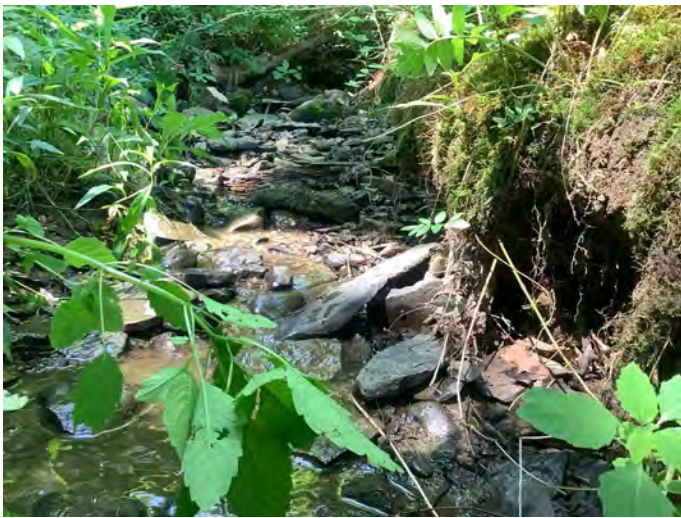
view of undercut bank, above stream OHWM.

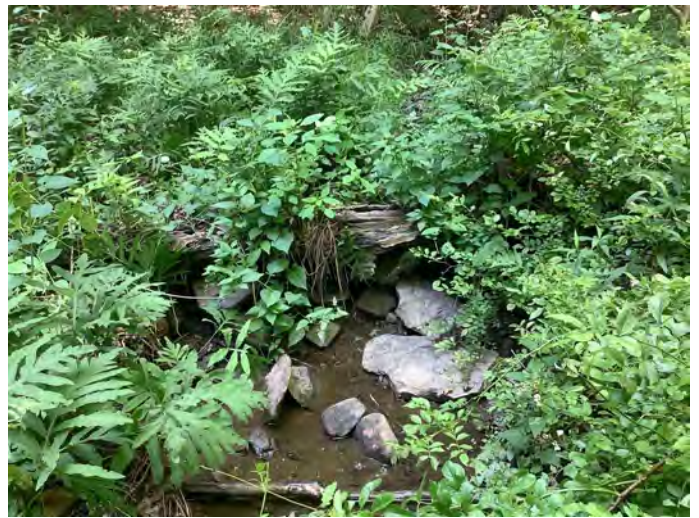
Change in veg density and particle size distribution.

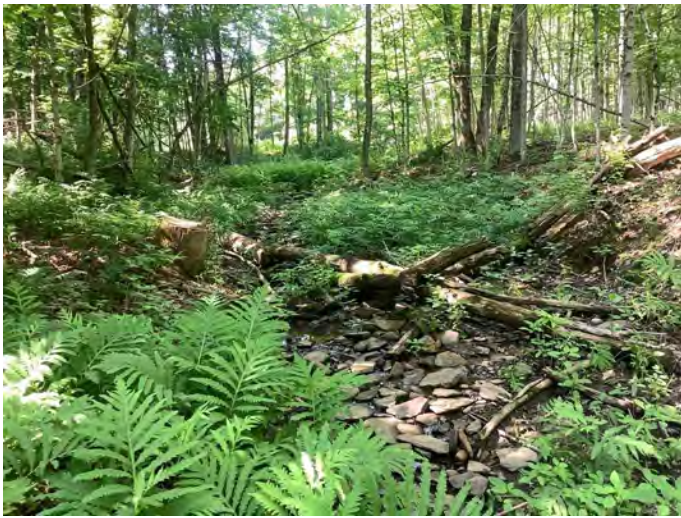
View of large woody debris, change in vegetation type and density

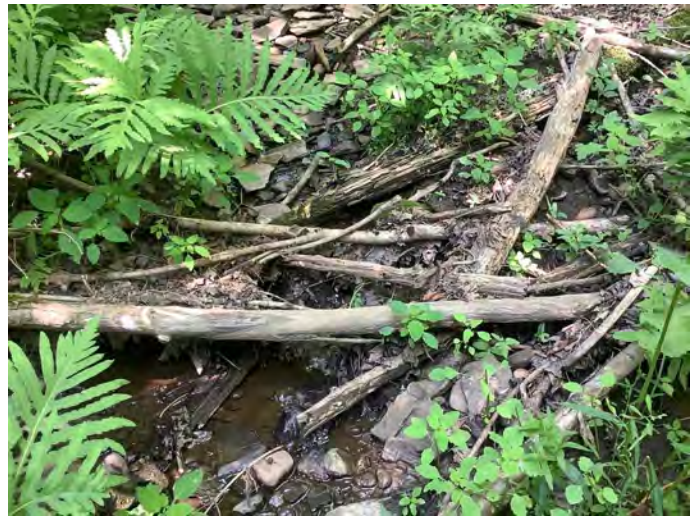
View of woody debris within stream channel.

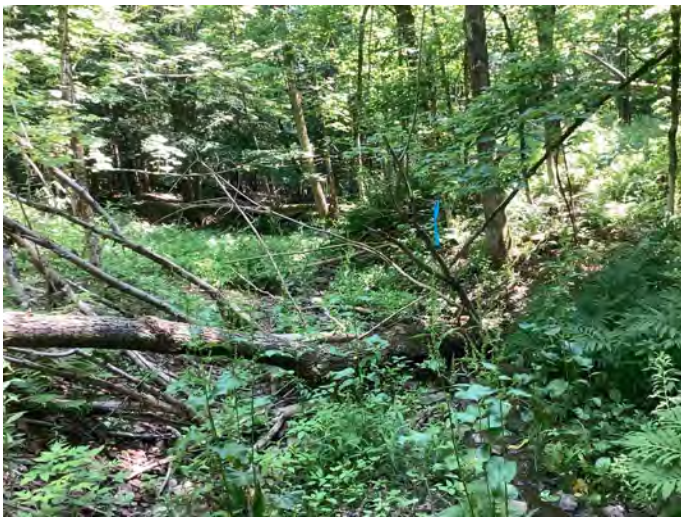
View of large woody debris within stream channel.

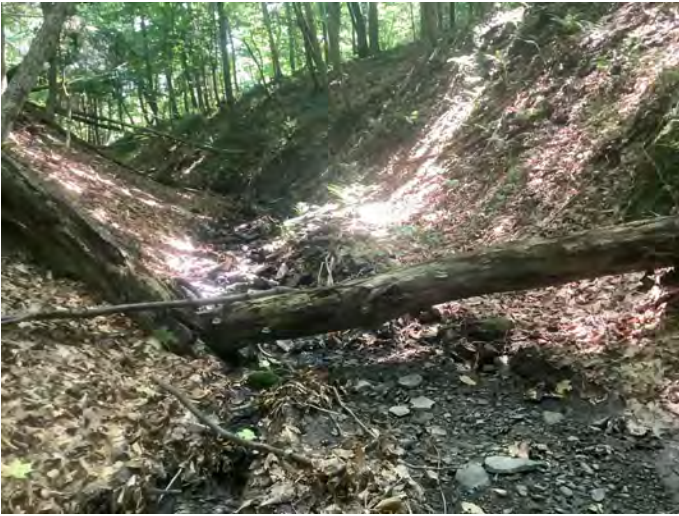
View of large wood located at the stream OHWM.

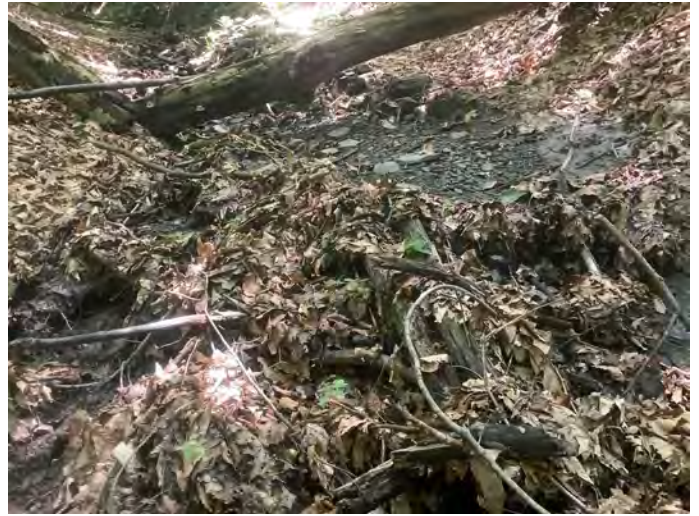
View of wracking at OHWM.

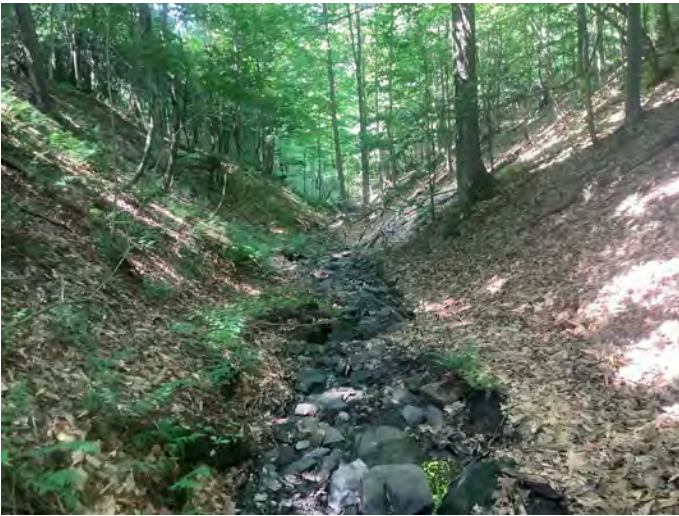
View of water staining, change in particle size distribution and break in slope located the the streams OHWM.

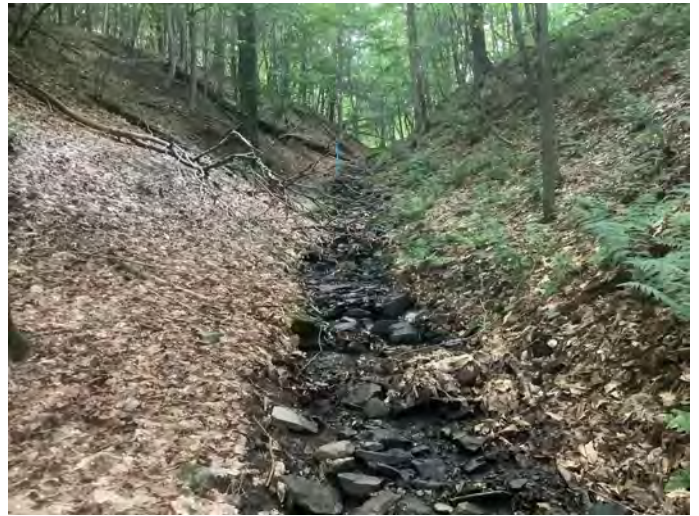
View of water staining, change in particle size distribution and break in slope located the the streams OHWM.

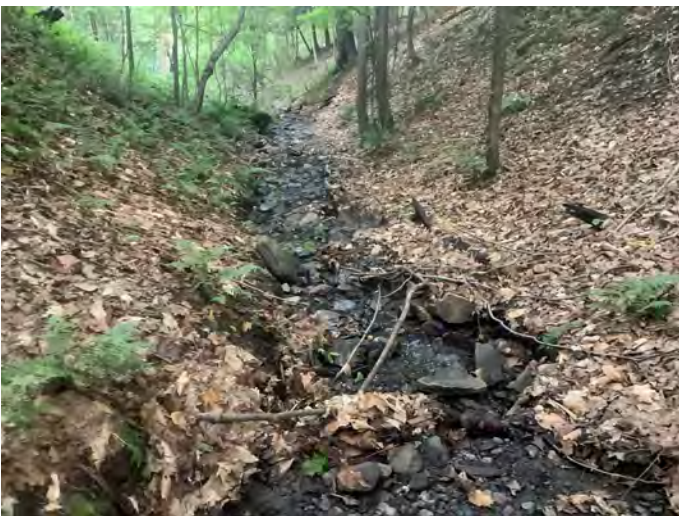
View of wracking within streams OHWM.

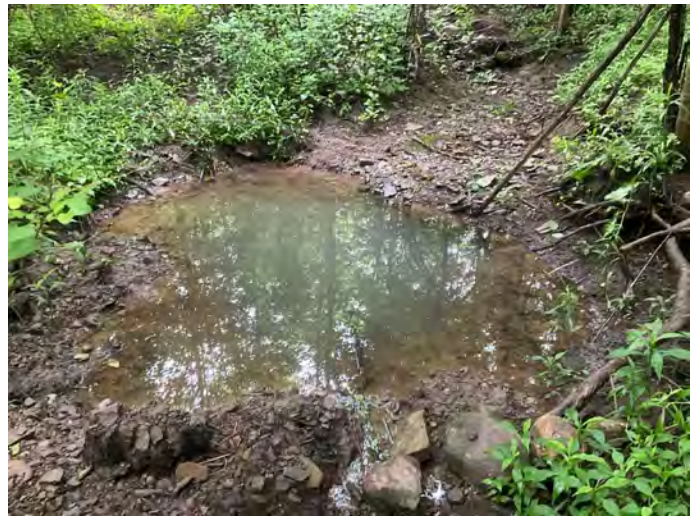
Upstream photograph, with deep excavated pool.

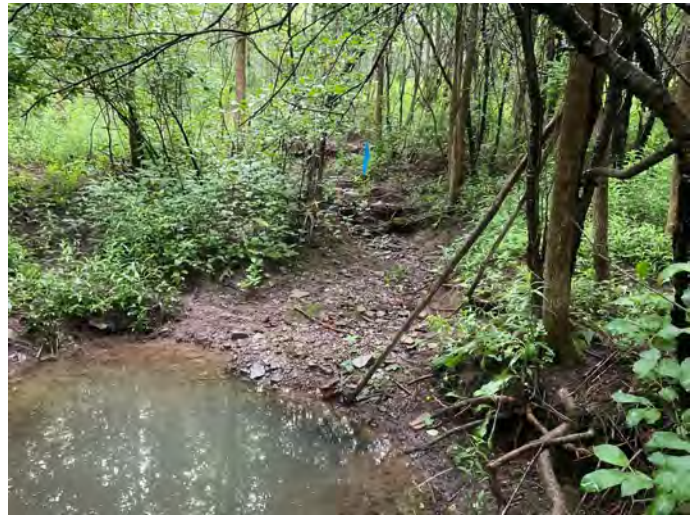
Upstream photograph, with break in slope present.

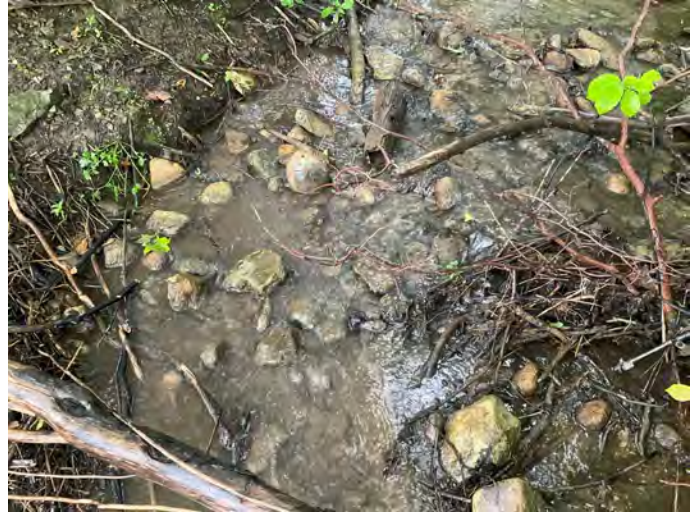
Indicators represented in this photo include changes in particle size distribution, wracking, exposed fibrous roots, disturbed leaf litter, and a break in slope on the bank.

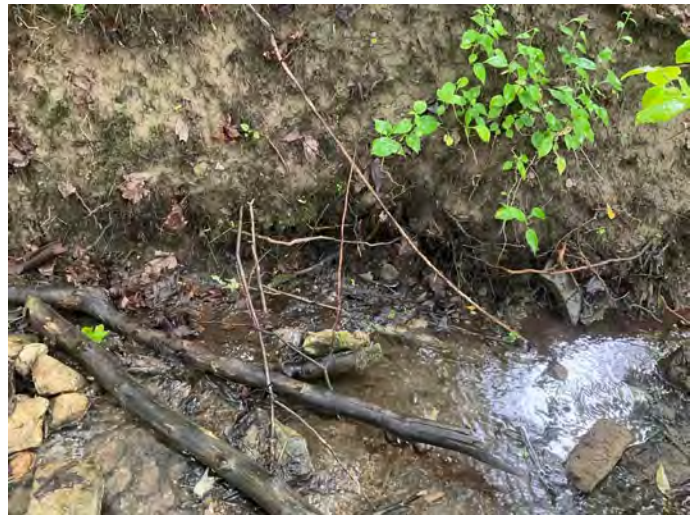
Indicators represented in this photo include changes in particle size distribution, wracking, disturbed leaf litter, a break in slope on the bank, and the manmade berm.

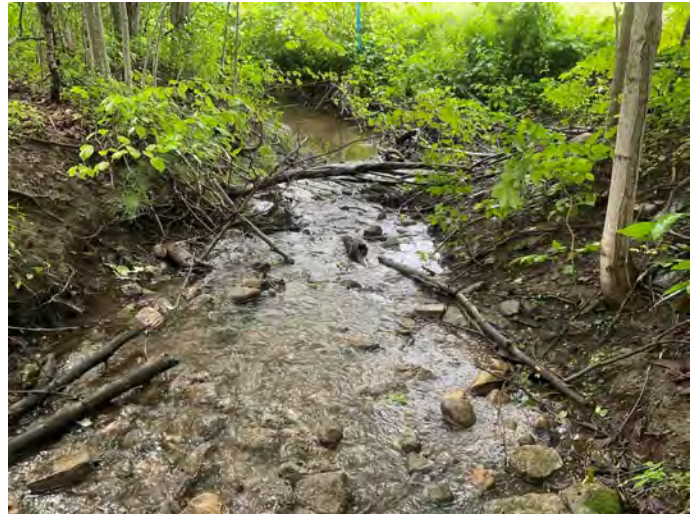
Indicators represented in this photo include a break in slope on the bank, shelving within the stream, instream bedforms (riffles), the presence of large wood, exposed fibrous roots, and disturbed leaf litter.

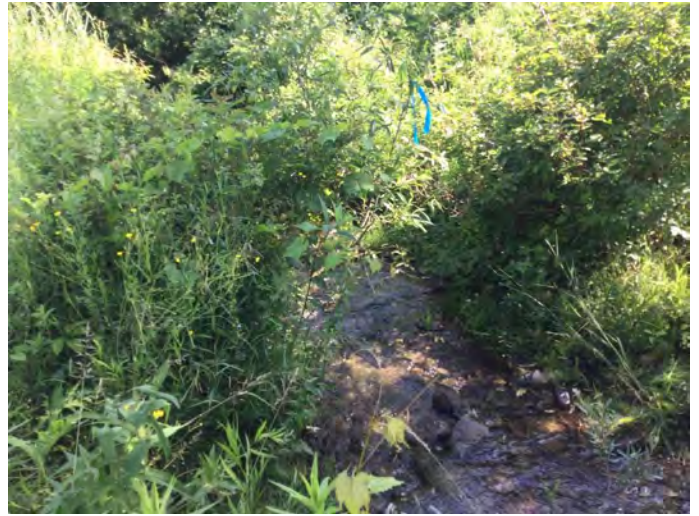
downstream, note the particle size of the substrate

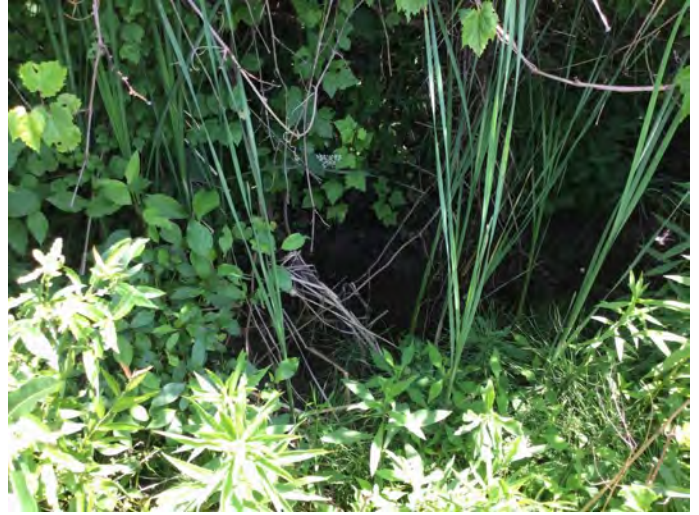
Dense vegetation begins at OHWM.

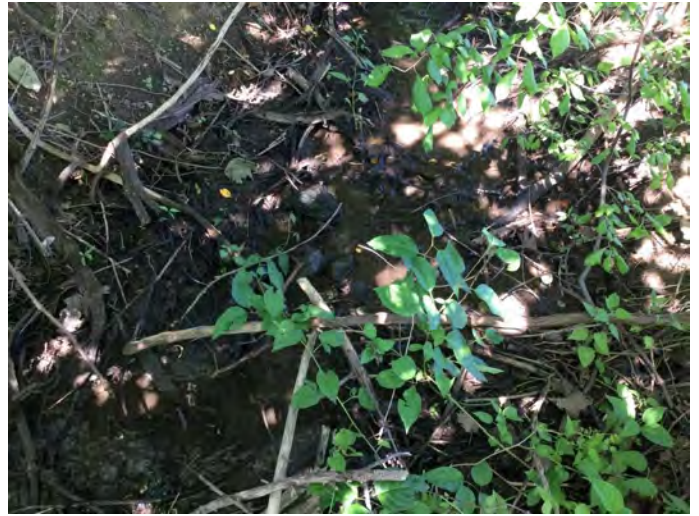
Stream substrate photograph.

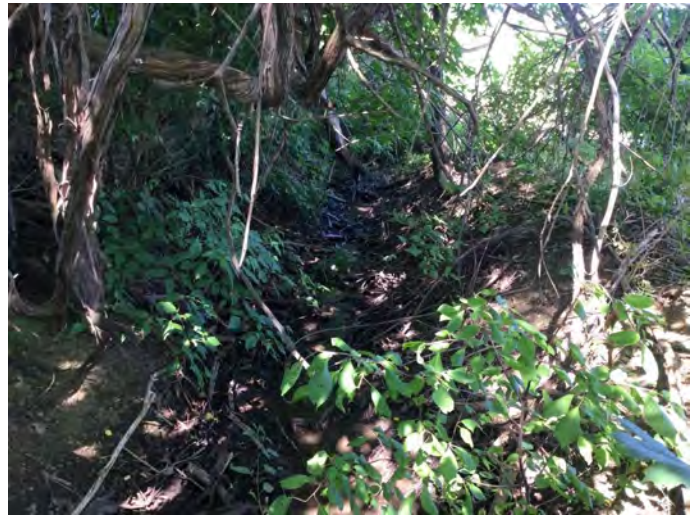
Upstream photograph with wracking present on stream banks.

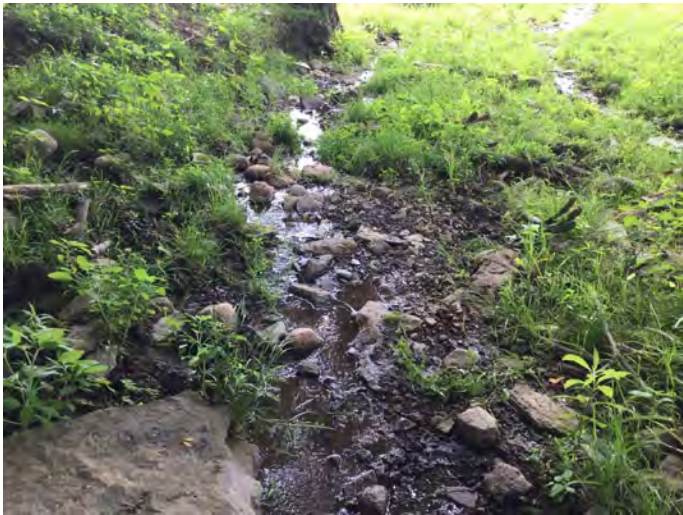
Vegetation observed within the streambed, and below the OHWM.

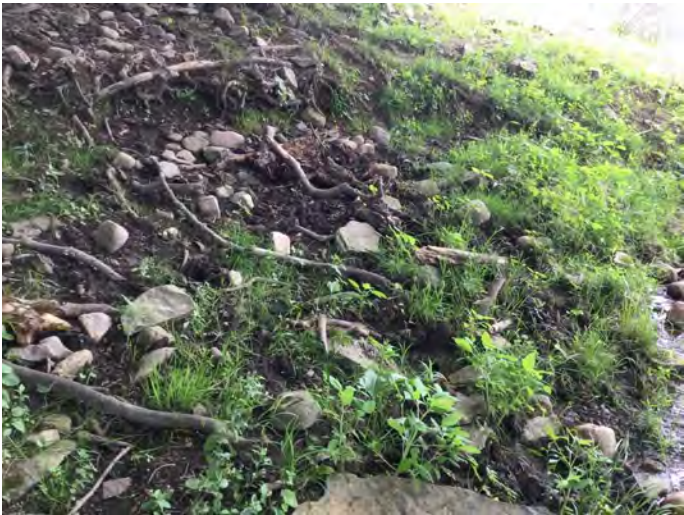
Exposed roots above the OHWM.

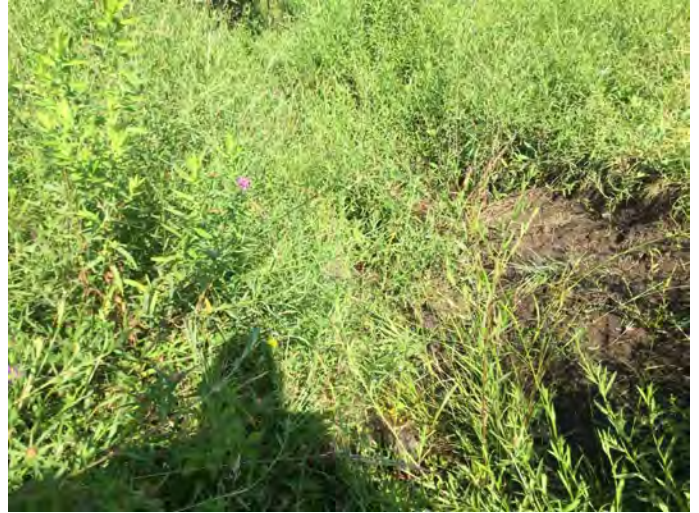
Transition from graminoids to absent vegetation.

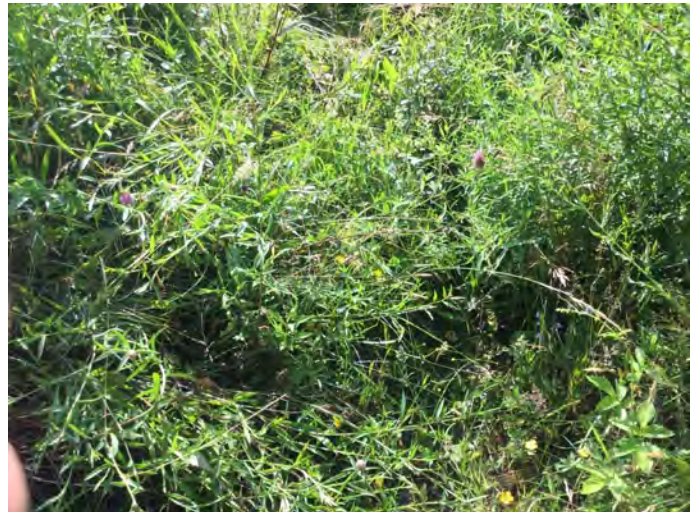
Stream channel where vegetation present.

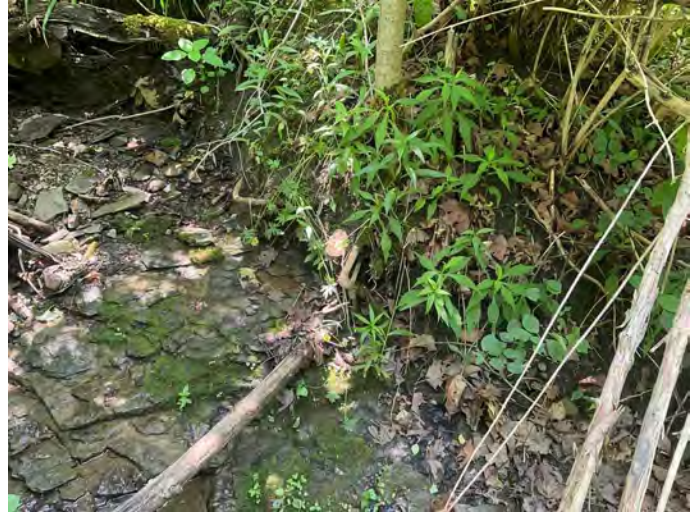
Soil development change from silt to gravel

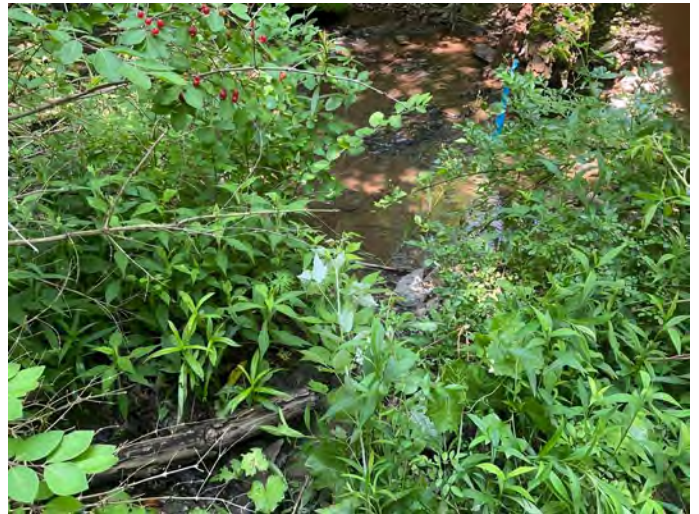
Downstream connects to perennial stream

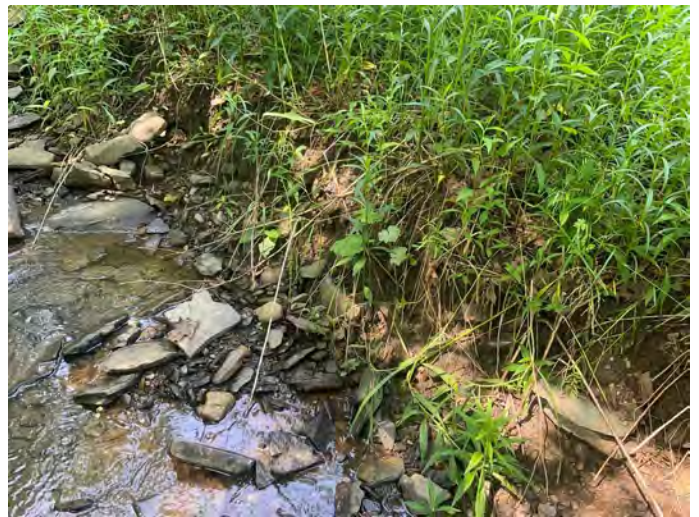
break in slope and particle size change

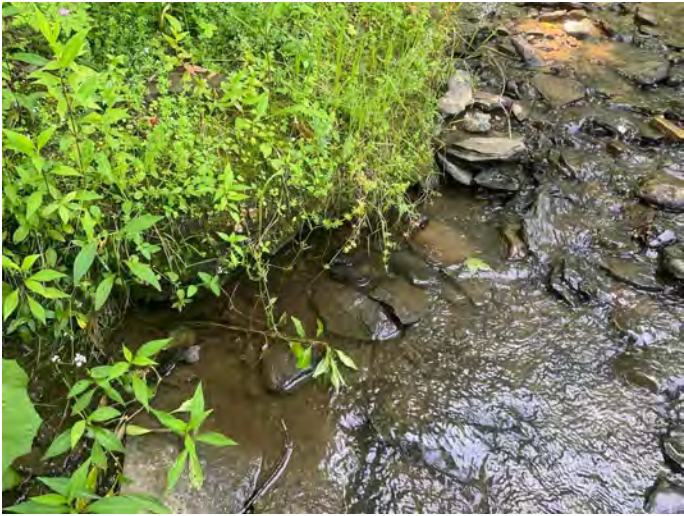
shelving

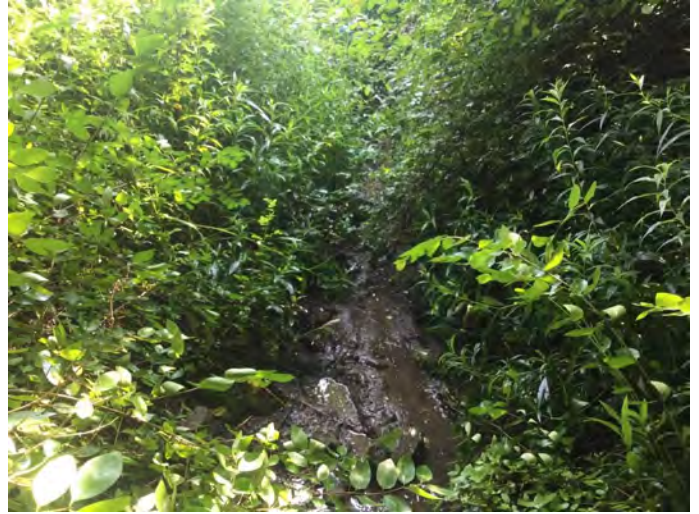
Transition in vegetation.

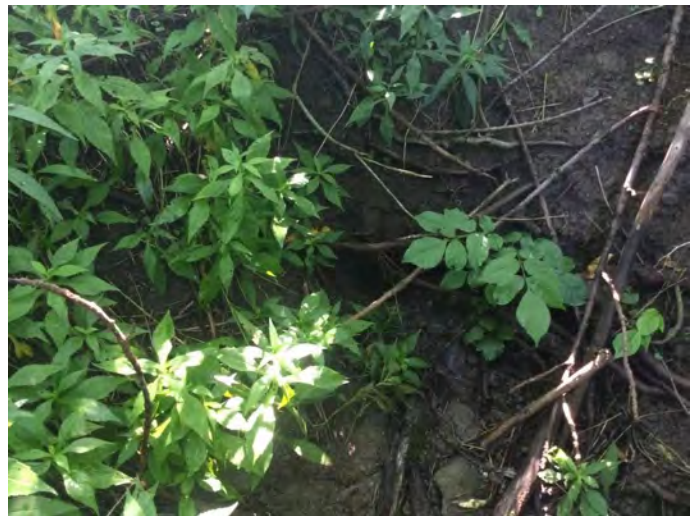
Undercut bank.

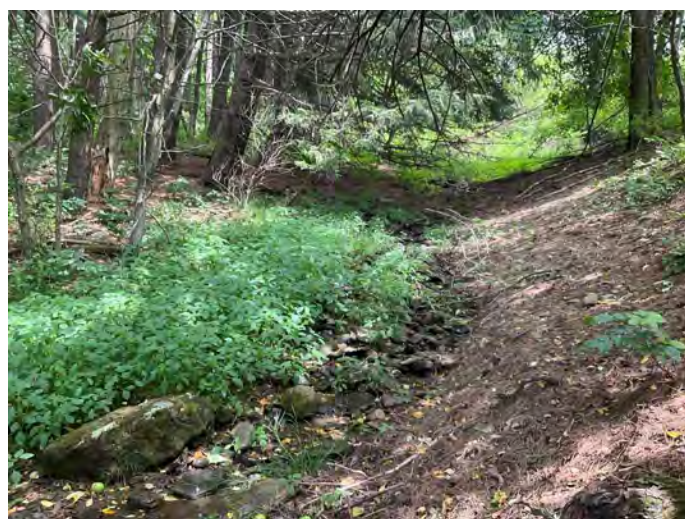
Upstream photo. Break in slope on the bank and transition in vegetation. Shelf at top of bank

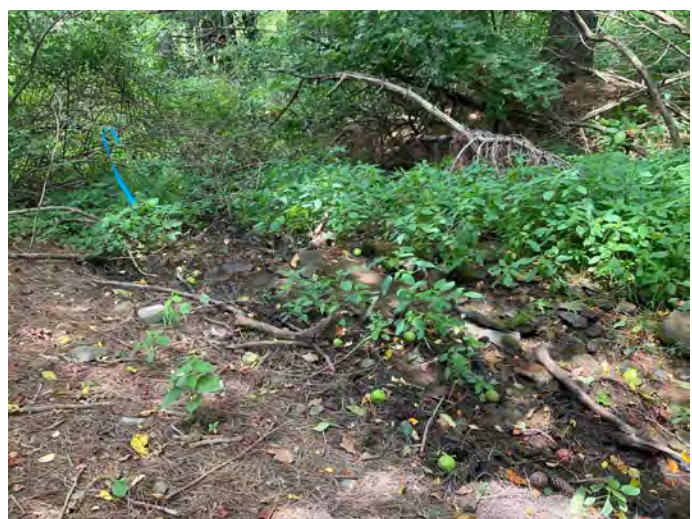
Downstream photo. Water staining

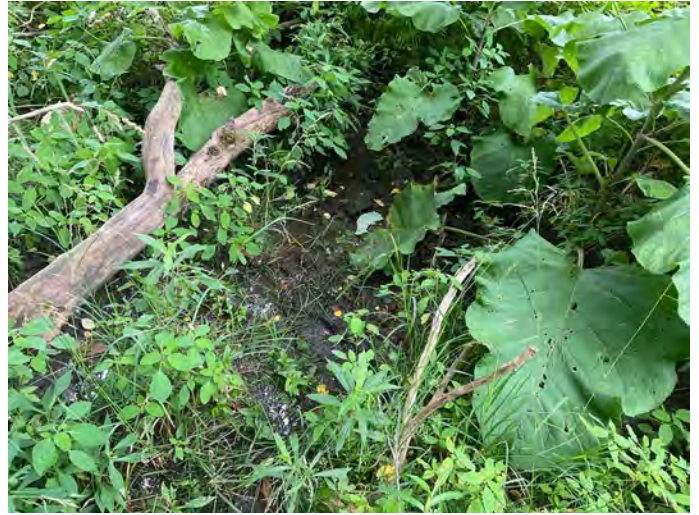
Stream substrate photograph, where cobble in stream bed transitions to clay loam above the bank.

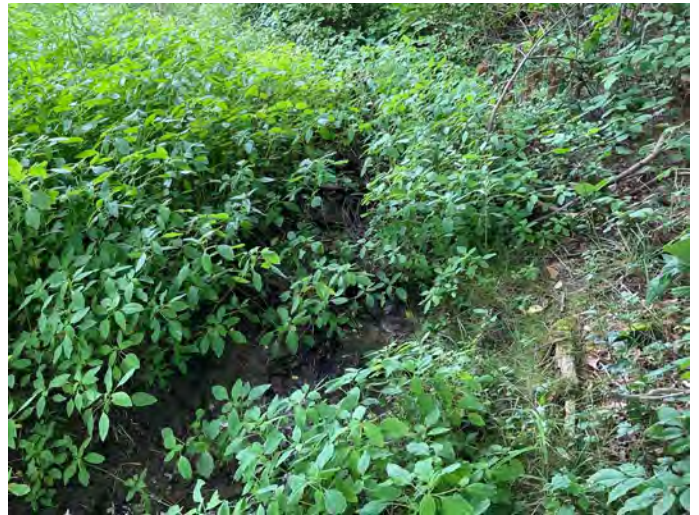
Downstream photograph with break in slope present.

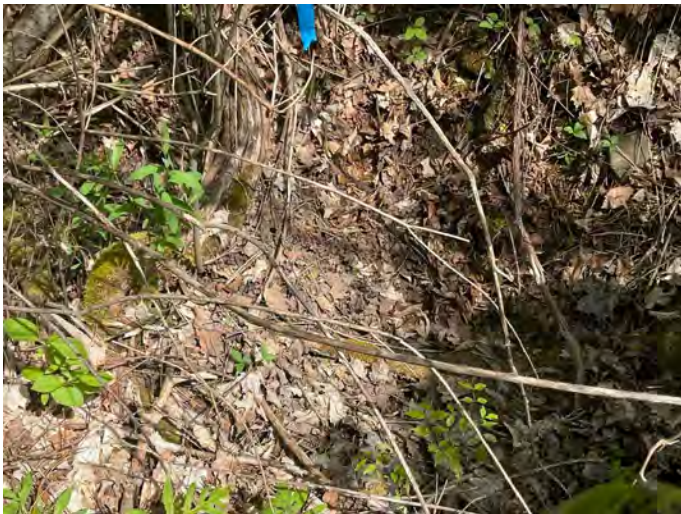
Stream substrate, with a break in slope occurring above the OHWM. Some water staining is present below leaf litter.

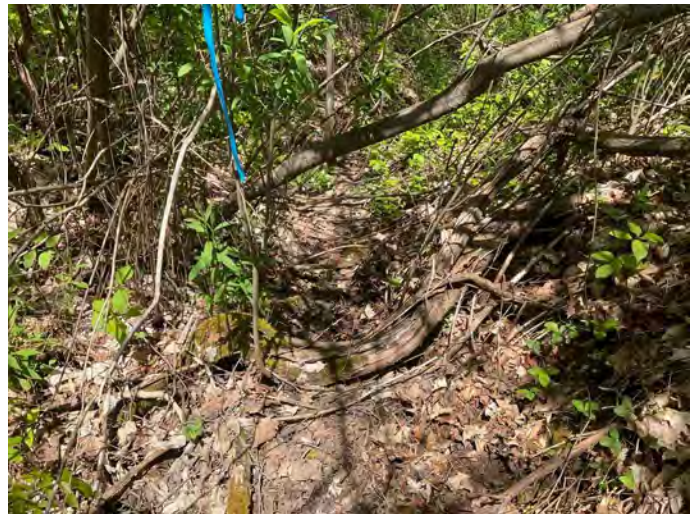
Downstream photograph, with break in slope present above the OHWM. Water staining below leaf litter is present.

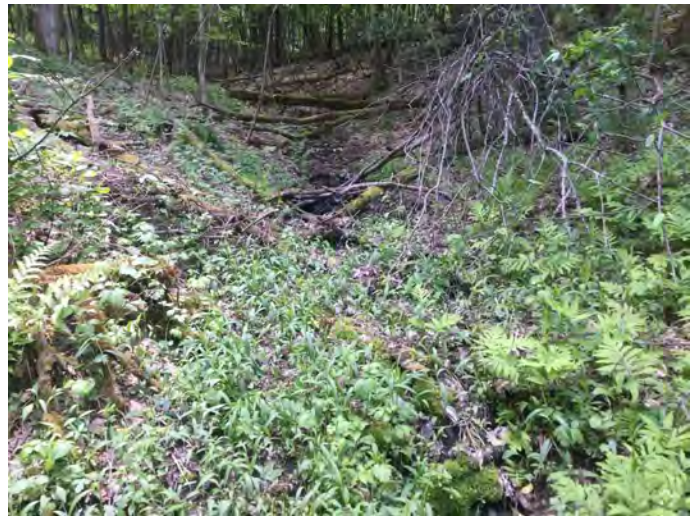
Break in slope present, facing upstream.

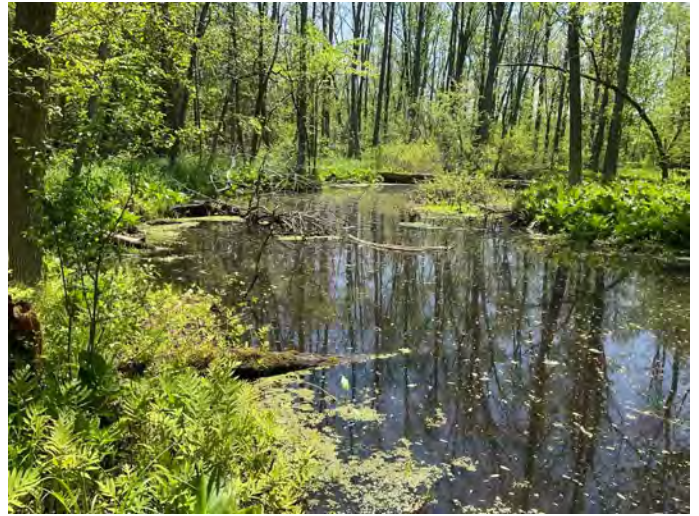
Downstream photograph, with transition from unvegetated stream channel to forbs.

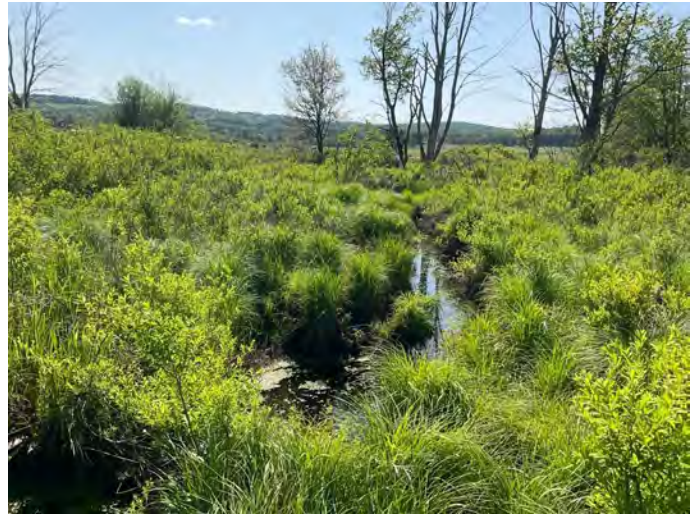
Upstream photograph, with a break in slope present.

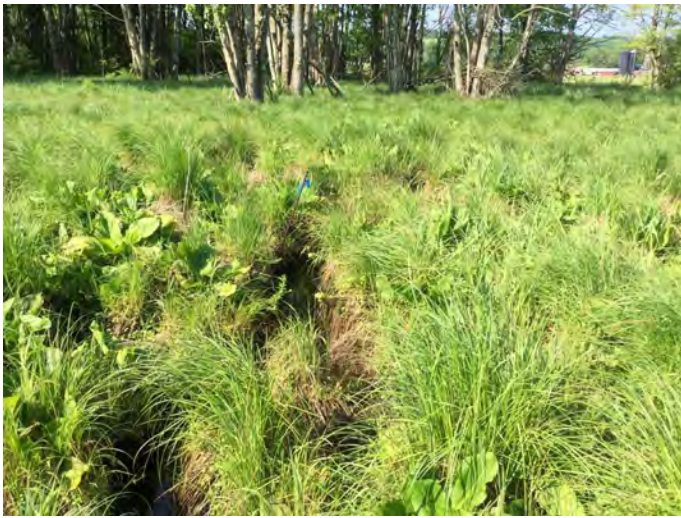
Upstream photograph, with break in slope and vegetation transition present.

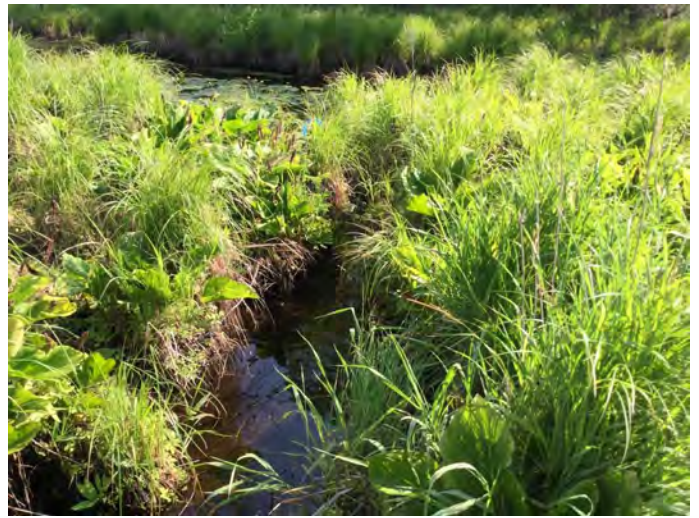
Upstream photograph, with break in slope and vegetation transition present.

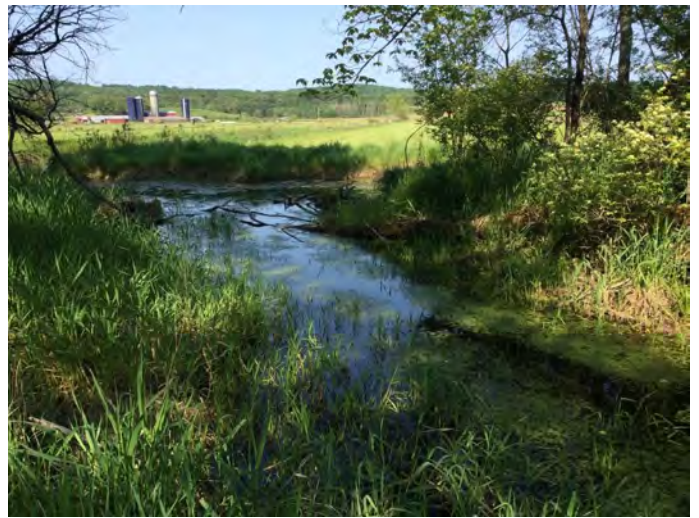
Upstream photograph at confluence of delineated stream 23-ST004.

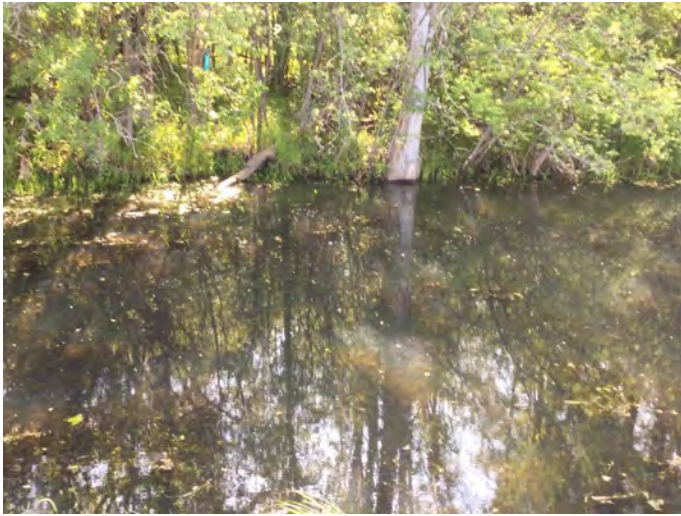
Transition in vegetation present within stream channel.

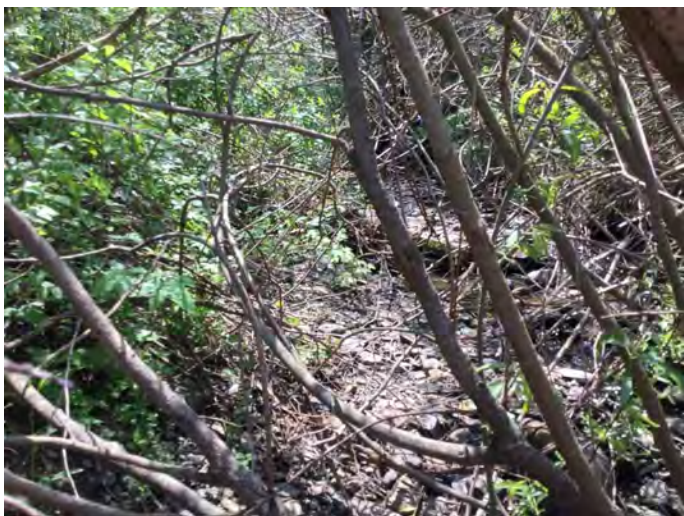
Upstream photo, with break in slope present.

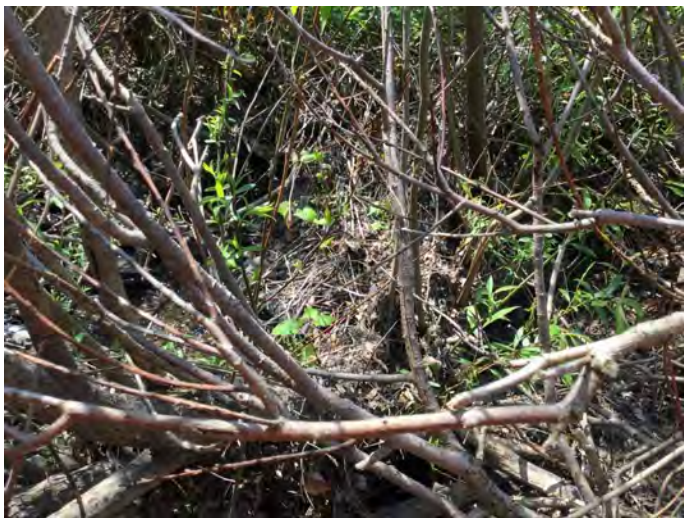
Additional wracking of organic material.
