Re: Case 06-T-0650 – Application of New York Regional Interconnect Inc. for a Certificate of Environmental Compatibility and Public Need Pursuant to Article VII for a high voltage direct current electric transmission line approximately 190 miles in length running between a converter station with an AC interconnection to National Grid's Edic Substation in the Town of Marcy and a converter station with an AC interconnection to Central Hudson Gas & Electric's Rock Tavern Substation in the Town of New Windsor.

BEFORE THE  
STATE OF NEW YORK  
PUBLIC SERVICE COMMISSION

Application of New York Regional Interconnect Inc. for a Certificate of Environmental  
Compatibility and Public Need Pursuant to Article VII for a High Voltage Direct Current  
Electric Transmission Line Running Between National Grid's Edic Substation in the Town of  
Marcy, and Central Hudson Gas & Electric's Rock Tavern Substation Located in the Town of  
New Windsor

Testimony of: Christopher A. Waite

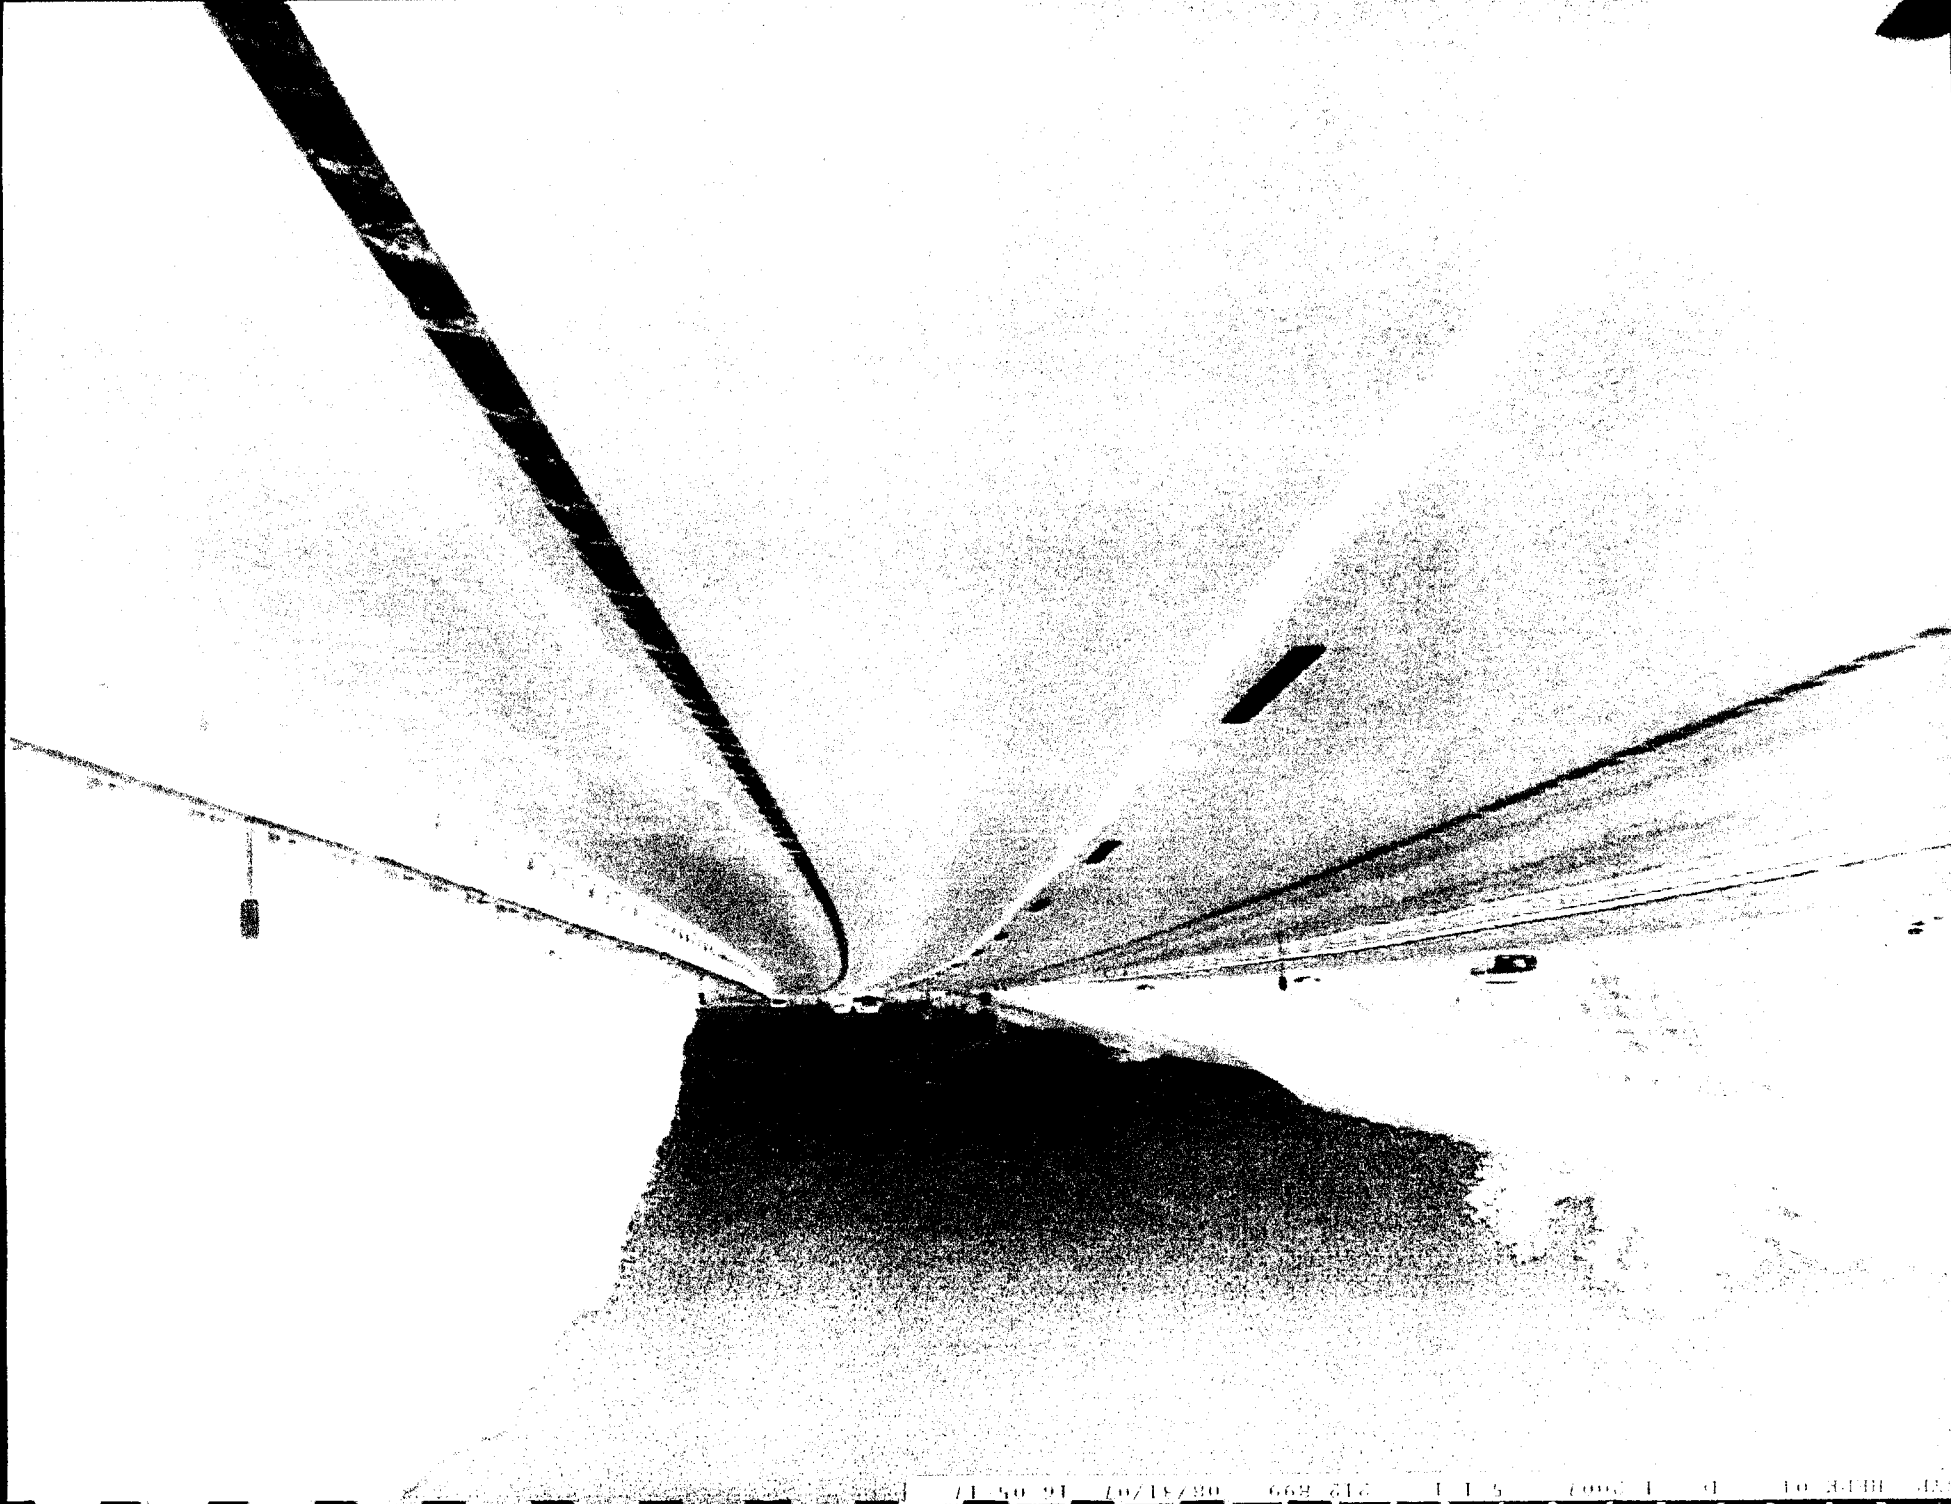
19 A. Those are photographs taken of the rock cut at approximately mile  
20 post 121.3. These photographs fairly and accurately depict the road and  
21 rock cuts at this location.

1 A. Those are photographs of the rock cut at approximately mile post  
2 212.9. These photographs fairly and accurately depict the road and rock  
3 cut at this location.

8 A. The Thruway has many rock cuts that abut the highway. These  
9 rock cuts cannot be trenched. We do not know if the contemplated cables  
10 can be placed in borings. Even if this is possible, the rock cuts generally  
11 cannot be bored because the rock is granite or other igneous rock. The  
12 fiber optic line was therefore placed in the median or shoulder in more  
13 than 40 locations from MP 13 to MP 238. The fiber optic cable was also  
14 required to cross underneath the Thruway in additional locations and  
15 travel along the southbound lanes of the Thruway. It is extremely unlikely  
16 that the CARI Alternative will be able to be located in these areas already  
17 occupied by the fiber optic line.

5 A. These are examples of rock cuts that occur frequently along the  
6 Thruway ROW. As noted above, at these and other rock faces, rock also  
7 likely exists four feet below the surface of the road, shoulders, and  
8 median. Between mile post 13 and mile post 238, the Thruway has  
9 catalogued more than 300 major rock faces on the southbound side,  
10 northbound side, and exit and entrance ramps. There are also additional  
11 smaller rock faces or cuts in this portion of the Thruway.
