**INVASIVE SPECIES SURVEY
NYSEG TRANSMISSION LINE PROJECT
COLUMBIA COUNTY, NY**

Attachment B
Photographic Log

Client Name: NYSEG

Site Location: Columbia County, New York

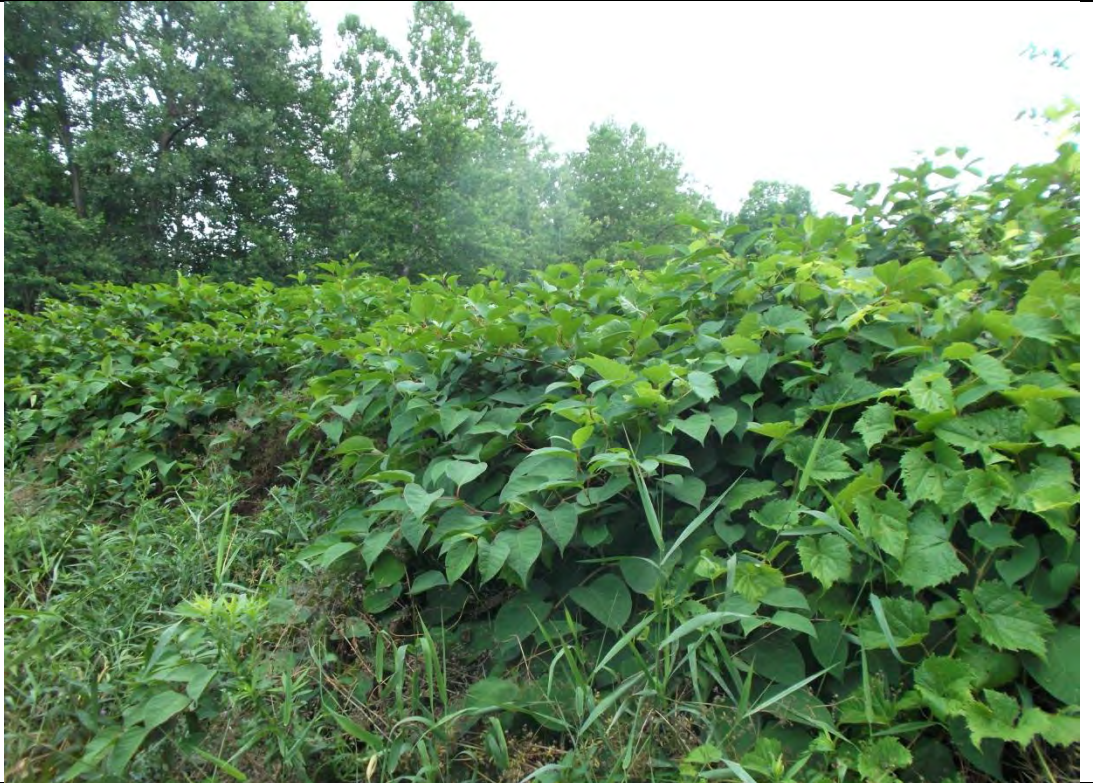
Photo No.
1

Area 1:

Stand of Japanese knotweed on south bank of Kline Kill Creek. Crosses full width of ROW.

Approximately
15 feet x 150 feet.

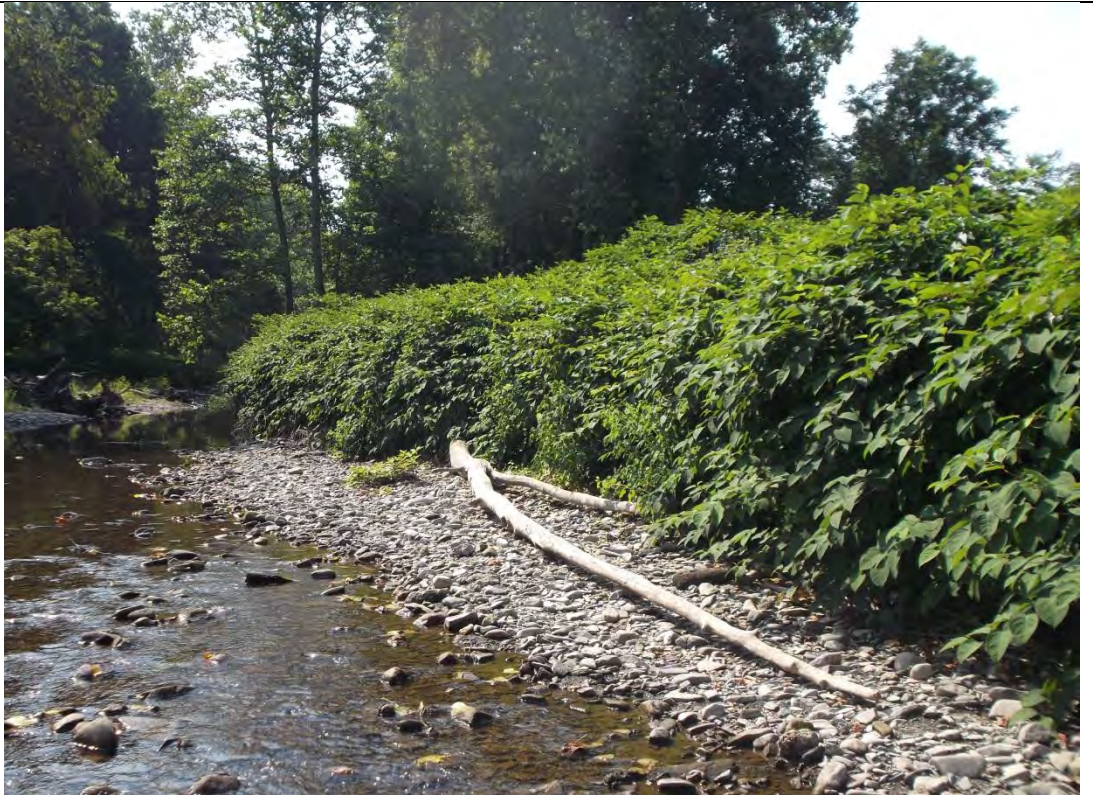
Photo No.
2

Area 1:

Stand of Japanese knotweed on south bank of Kline Kill Creek. Crosses full width of ROW.

Approximately
15 feet x 150 feet.

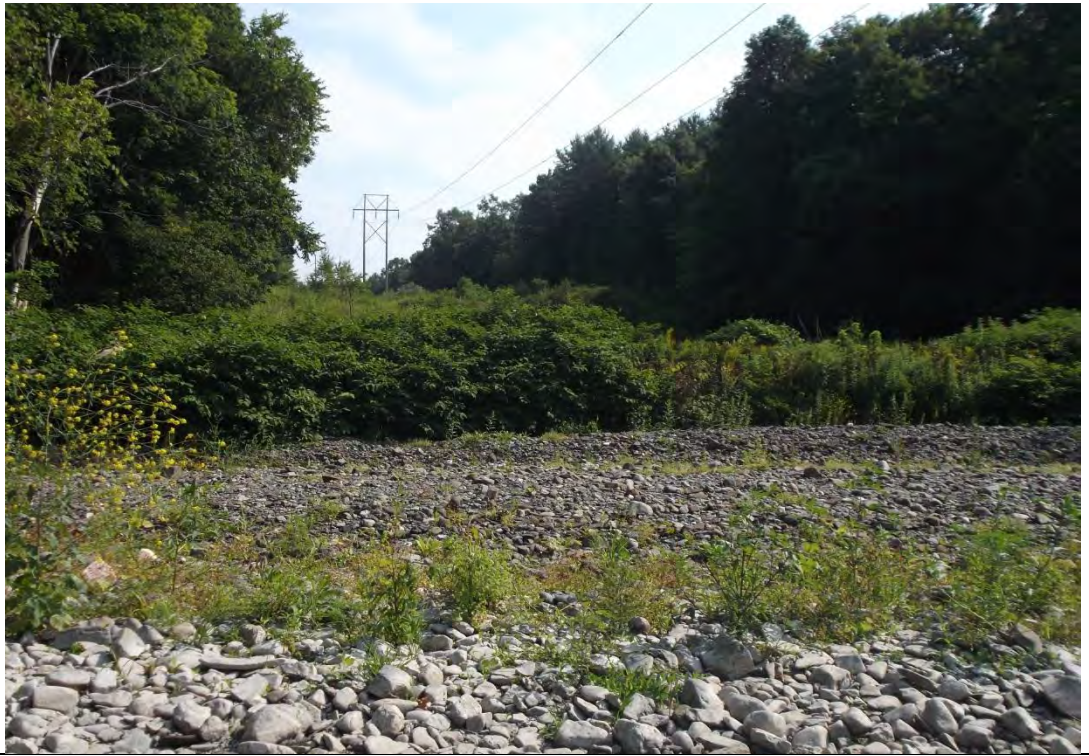
Photo No.
3

Area 2:

Stand of Japanese knotweed on north bank of Kline Kill Creek. Spans half the ROW width.

Approximately
15 feet x 75 feet.

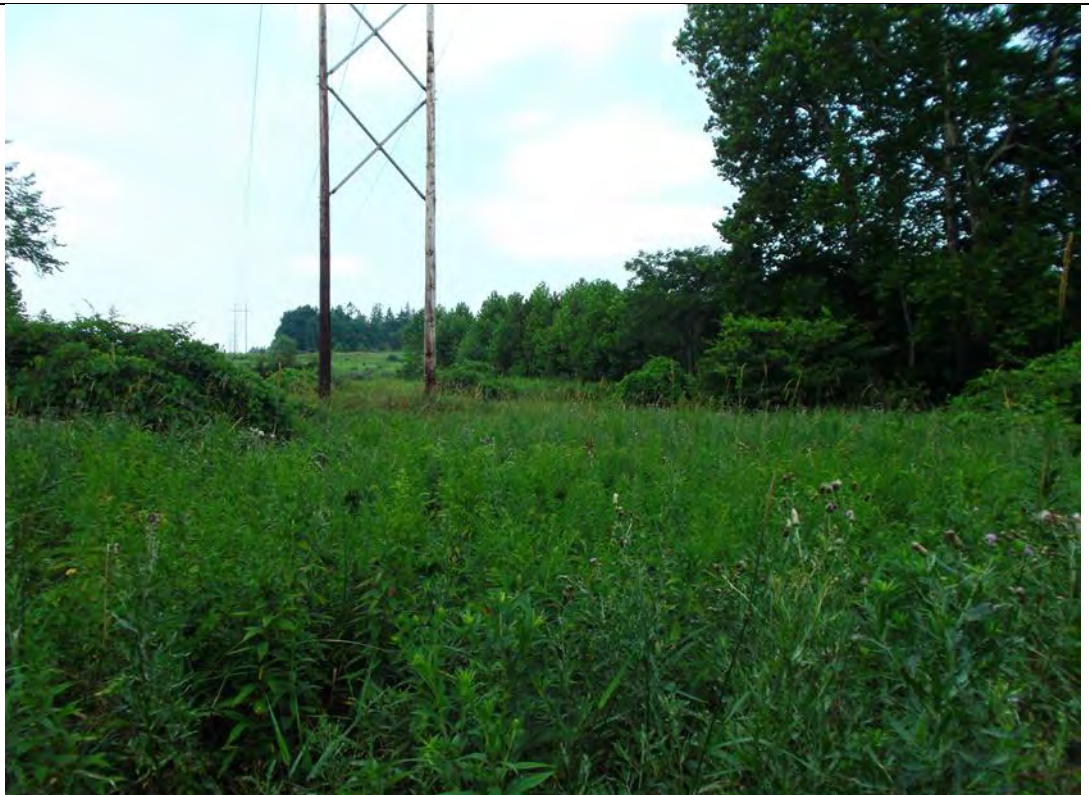
Photo No.
4

Area 3

Reed canary grass (mixed with and behind goldenrod) within ROW between County Road 21 and Kline Kill Creek.

Approximately
50 feet x 75 feet.

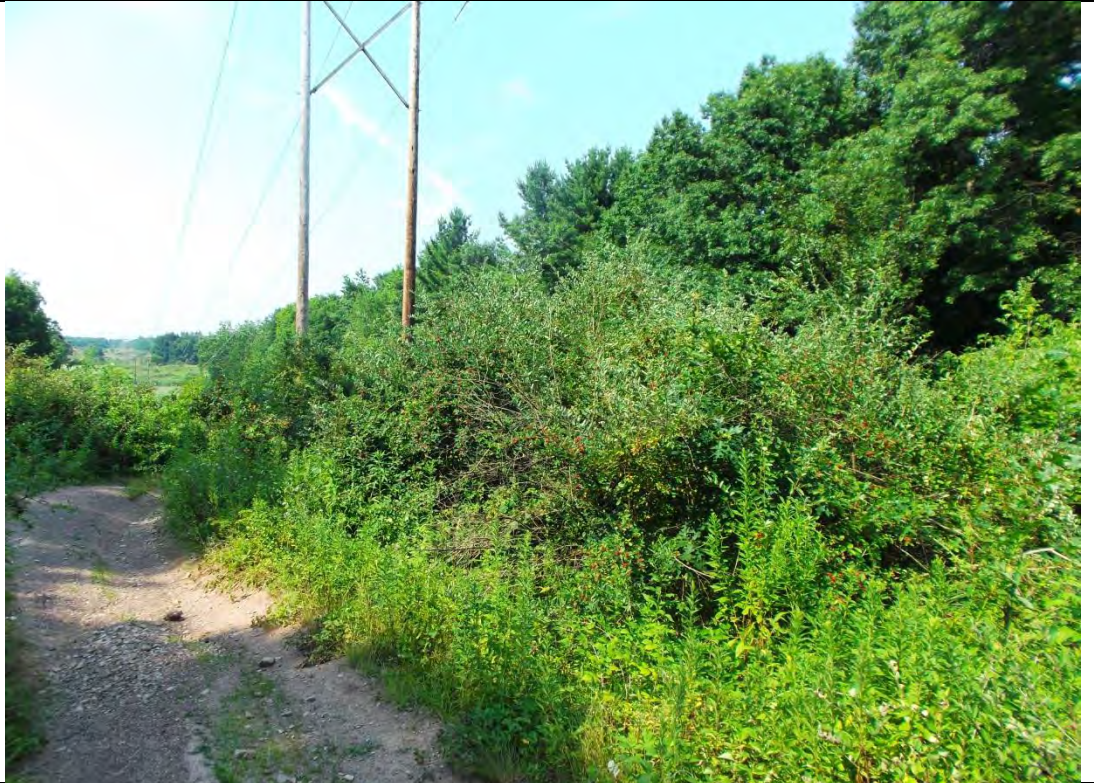
Photo No.
5

Representative view
of shrub honeysuckle
within entire length of
ROW between Kline
Kill Substation and
County Road 21.

Shrub honeysuckle is
distributed relatively
evenly throughout
ROW, more than any
other invasive
species identified.

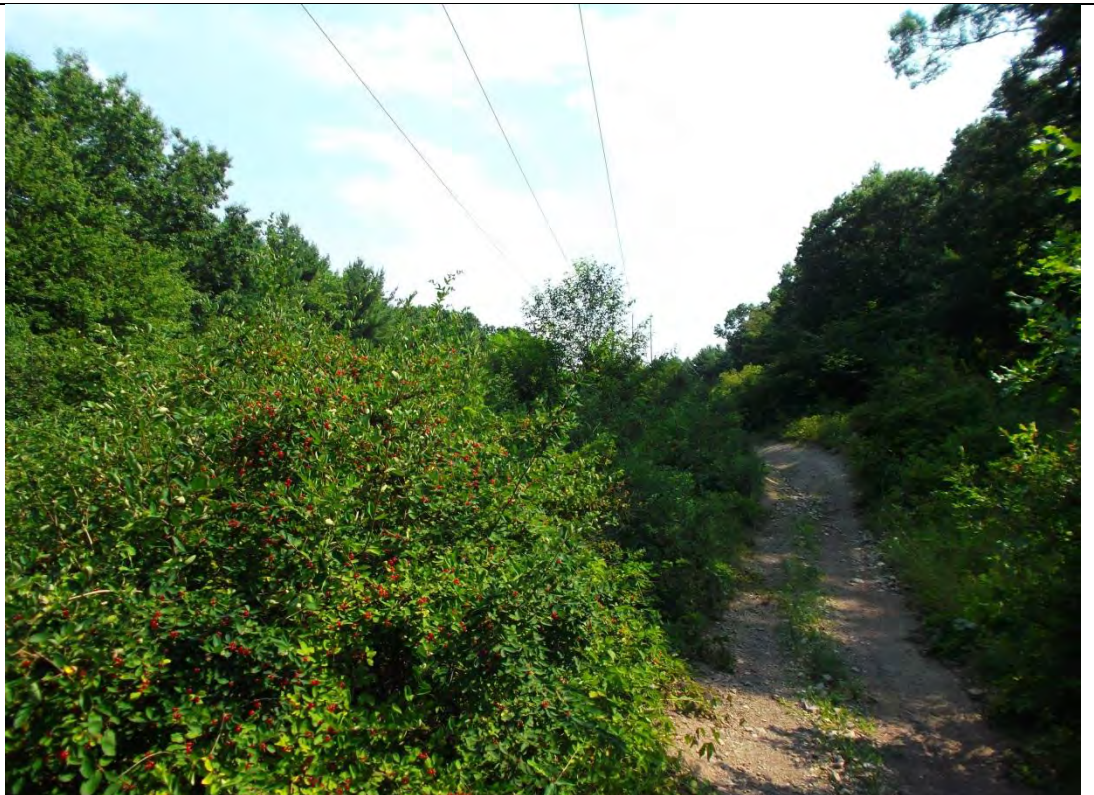
Photo No.
6

Representative view
of shrub honeysuckle
within entire length of
ROW between Kline
Kill Substation and
County Road 21.

Shrub honeysuckle is
distributed relatively
evenly throughout
ROW, more than any
other invasive
species identified.

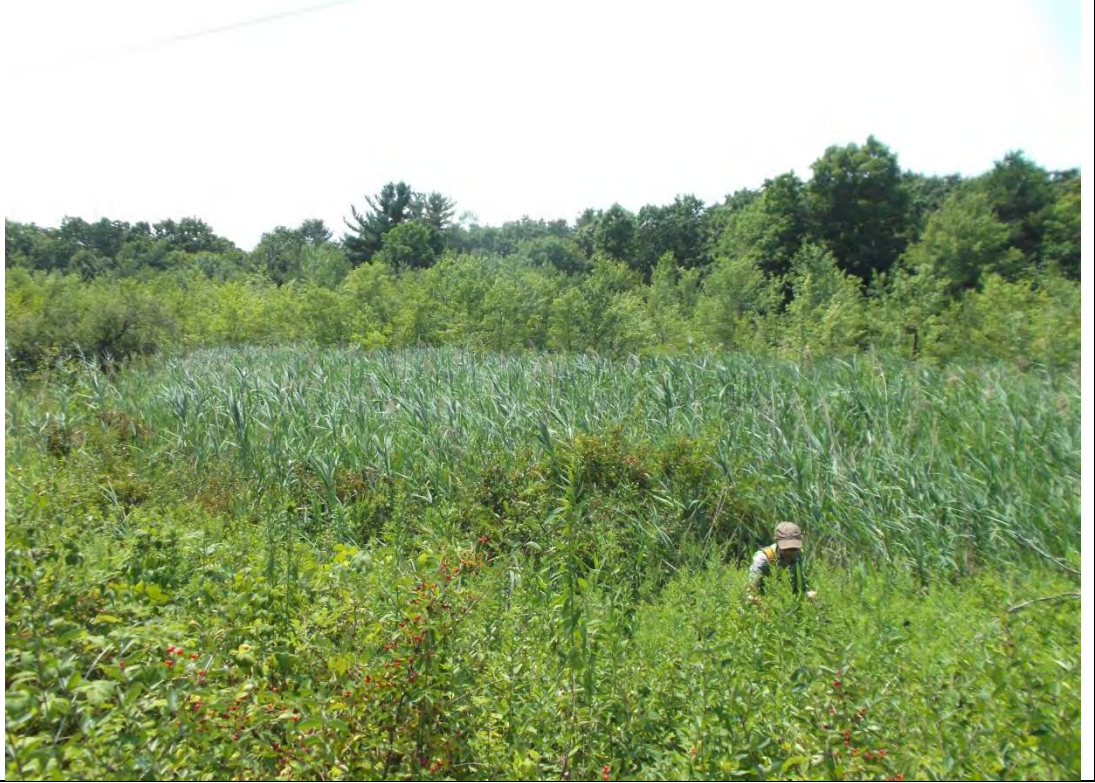
Photo No.
7

Area 4:

Common reed in west
portion of ROW.

Approximately
25 feet x 50 feet.

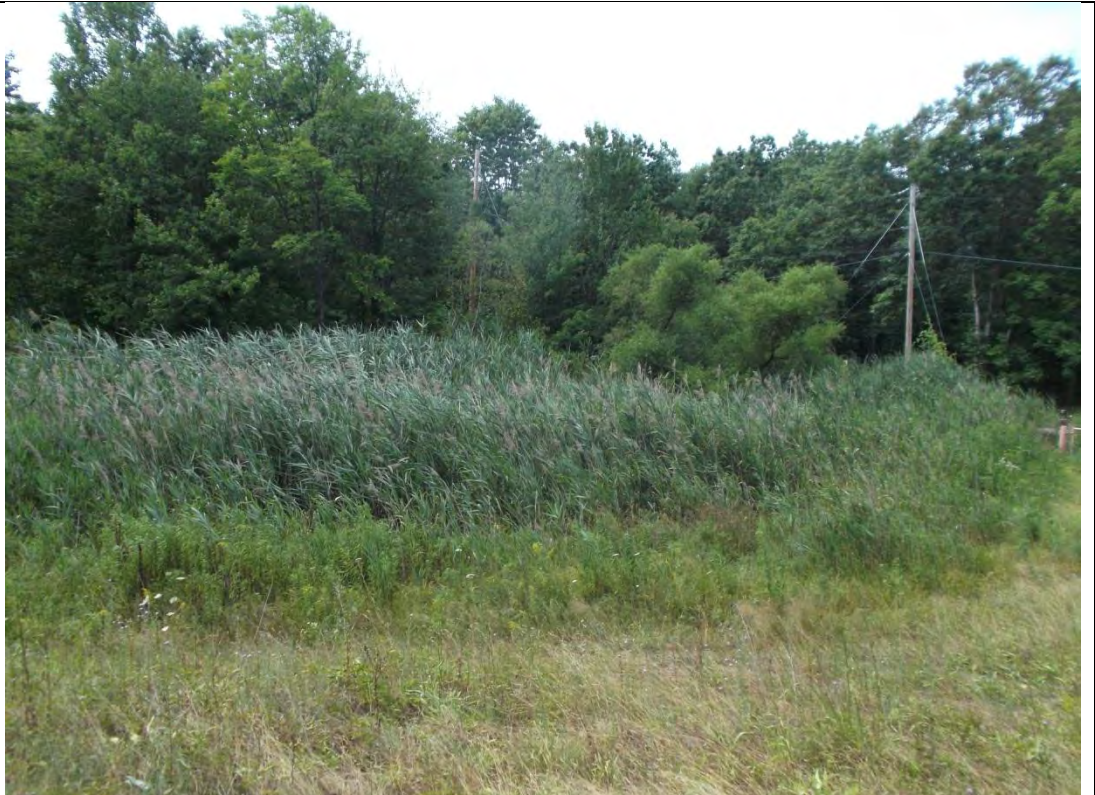
Photo No.
8

Area 5:

Common reed on
west side of ROW,
adjacent to and south
of Shufelt Road
crossing.

Approximately
15 feet x 30 feet.

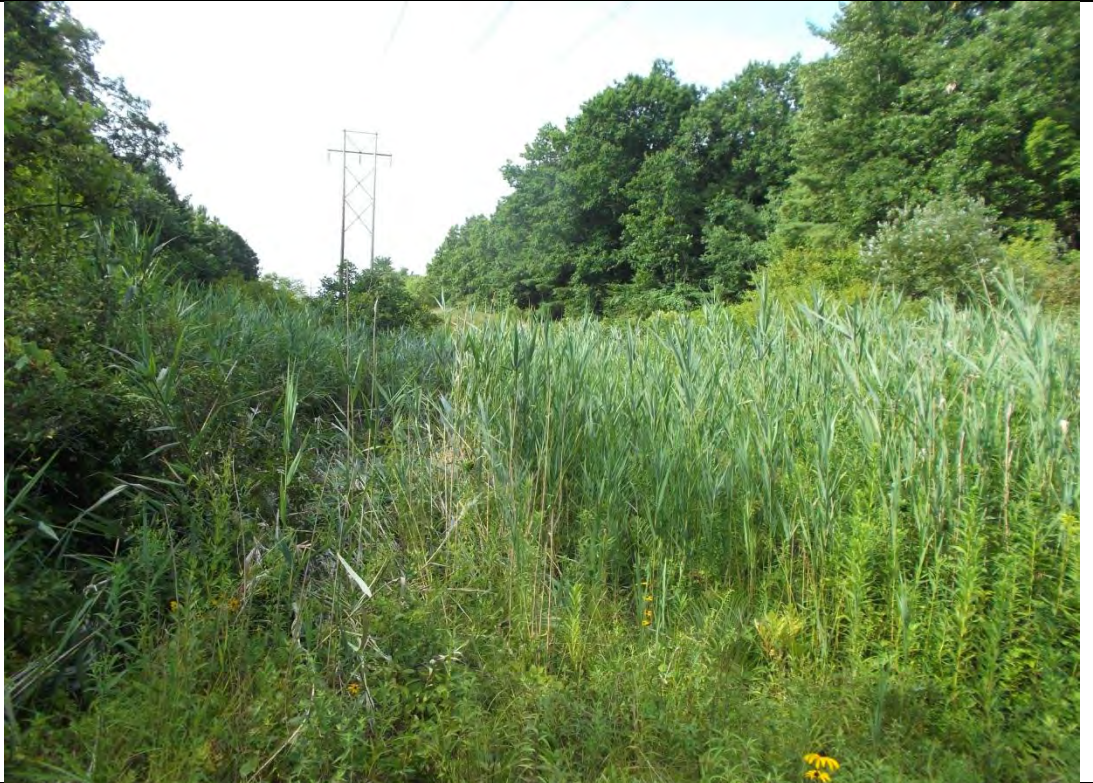
Photo No.
9

Area 6:

Largest stand of
common reed
observed in ROW,
between Shufelt Road
and New York State
Road 203.

Approximately
75 feet x 100 feet.

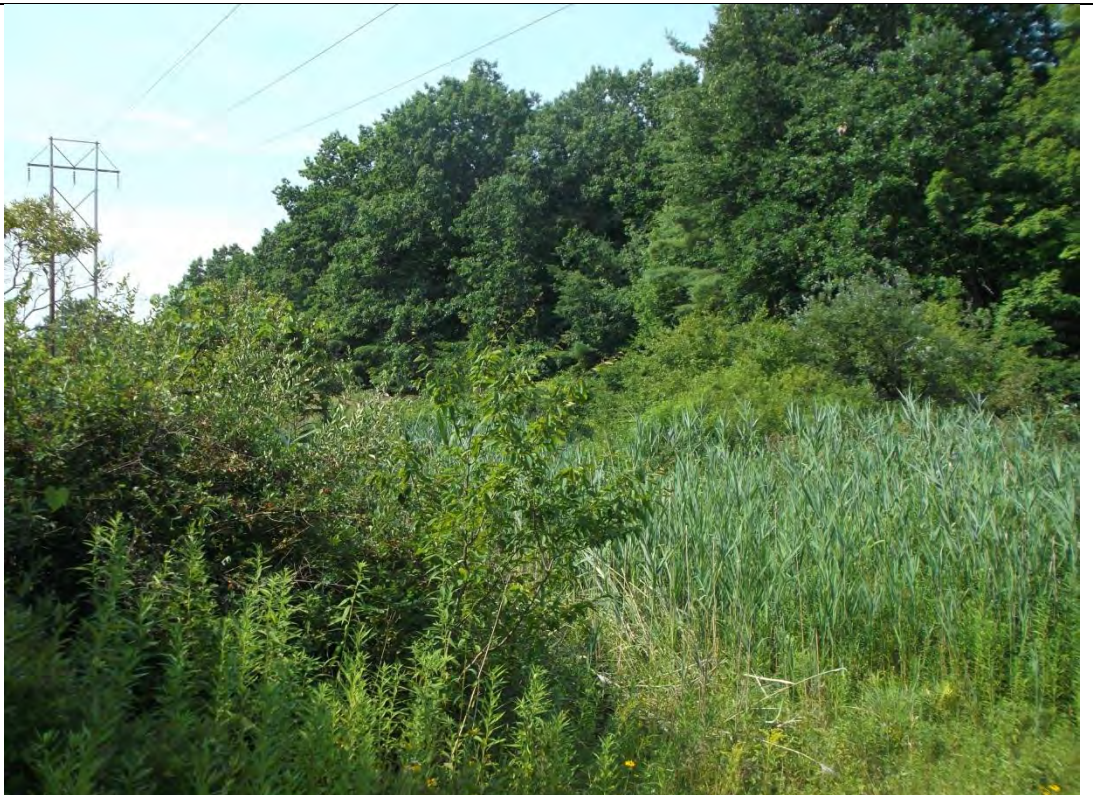
Photo No.
10

Area 7:

Common reed on
west side of ROW
between Shufelt Road
and New York State
Road 203.

Approximately
10 feet x 15 feet.

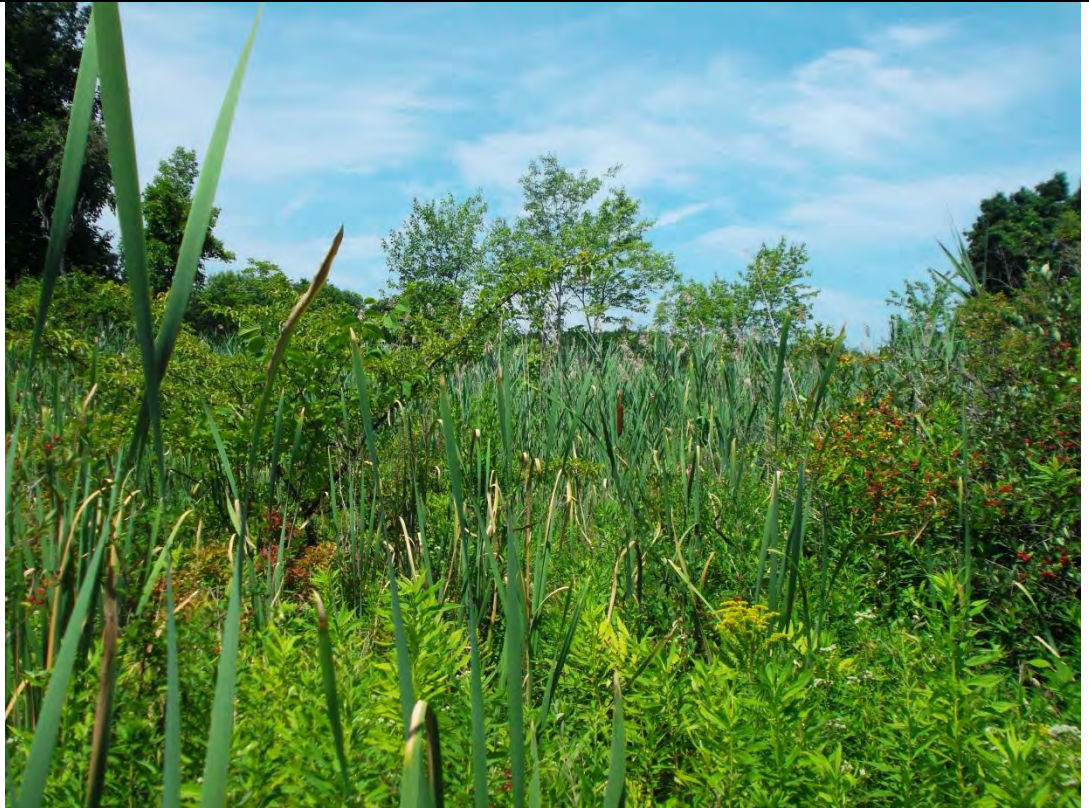
Photo No.
11

Area 8:

Common reed (behind
cat-tails) in ROW
adjacent to and south
of New York State
Road 203. (Mucky
conditions prevented
closer access.)

Approximately
25 feet x 25 feet.

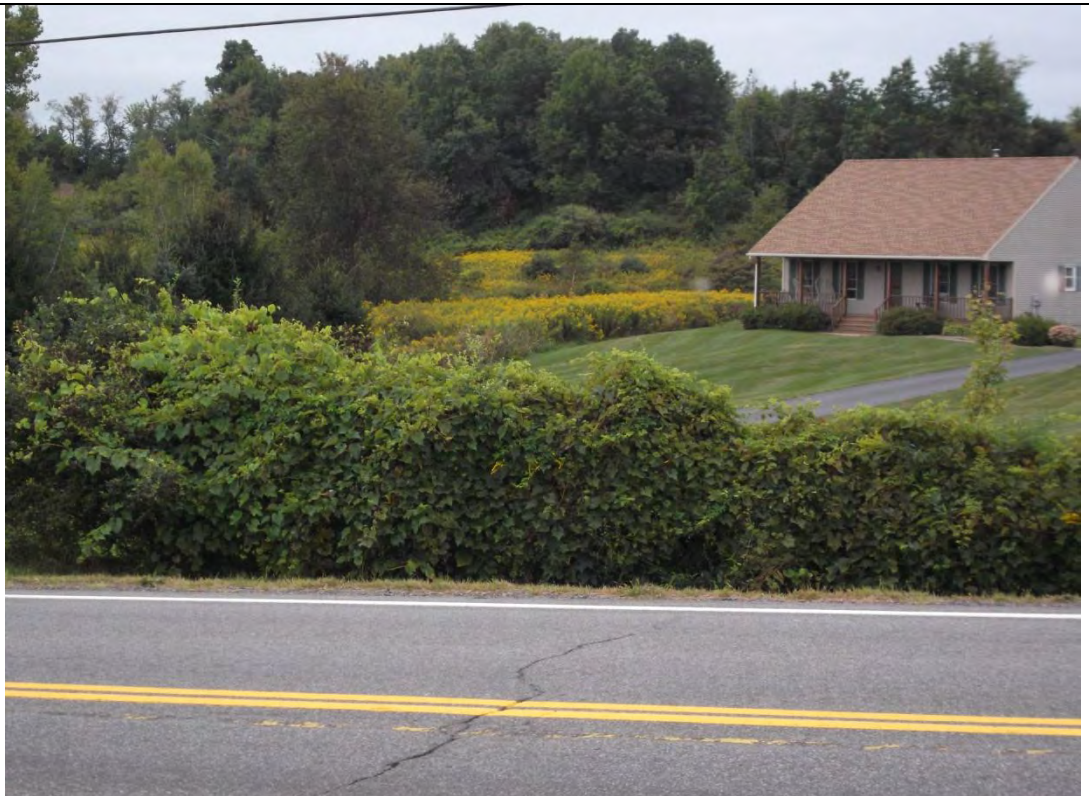
Photo No.
12

Area 9:

Porcelain Berry in
ROW on south side of
County Road 21.

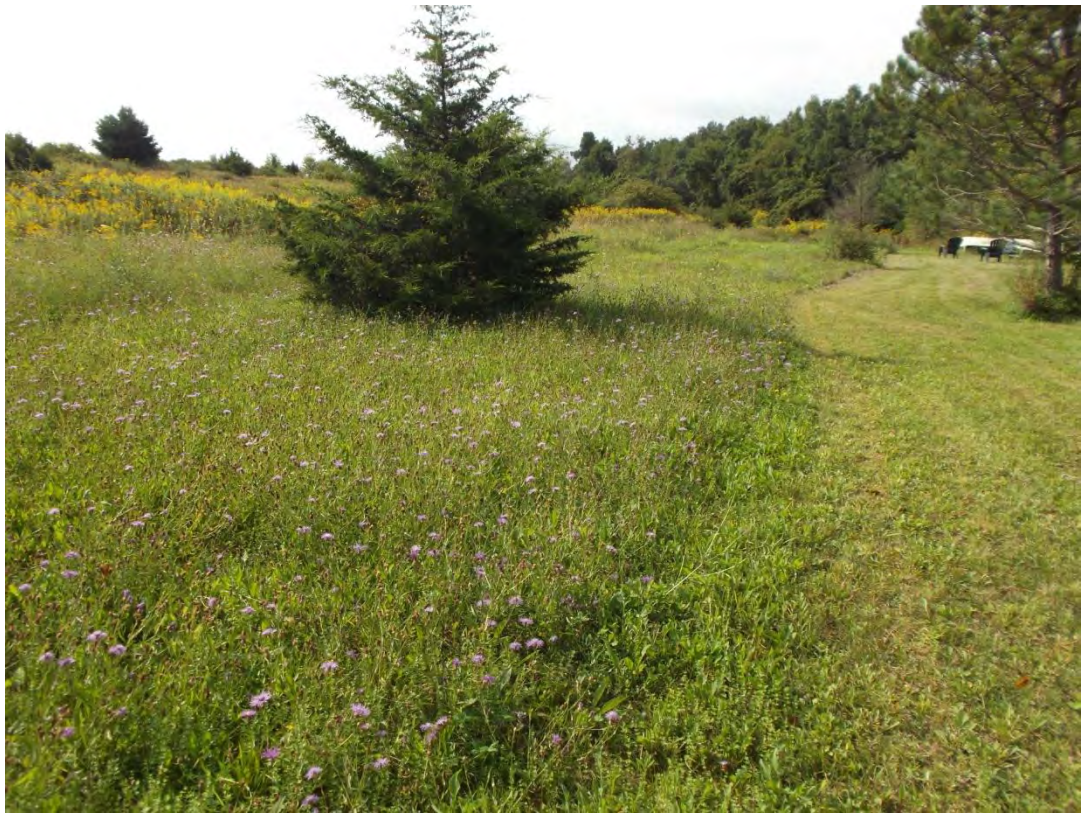
Photo No.
13

Area 10:

Spotted Knapweed in
ROW. Abundant
throughout residential
property crossed by
ROW south
of/adjacent to County
Road 21.

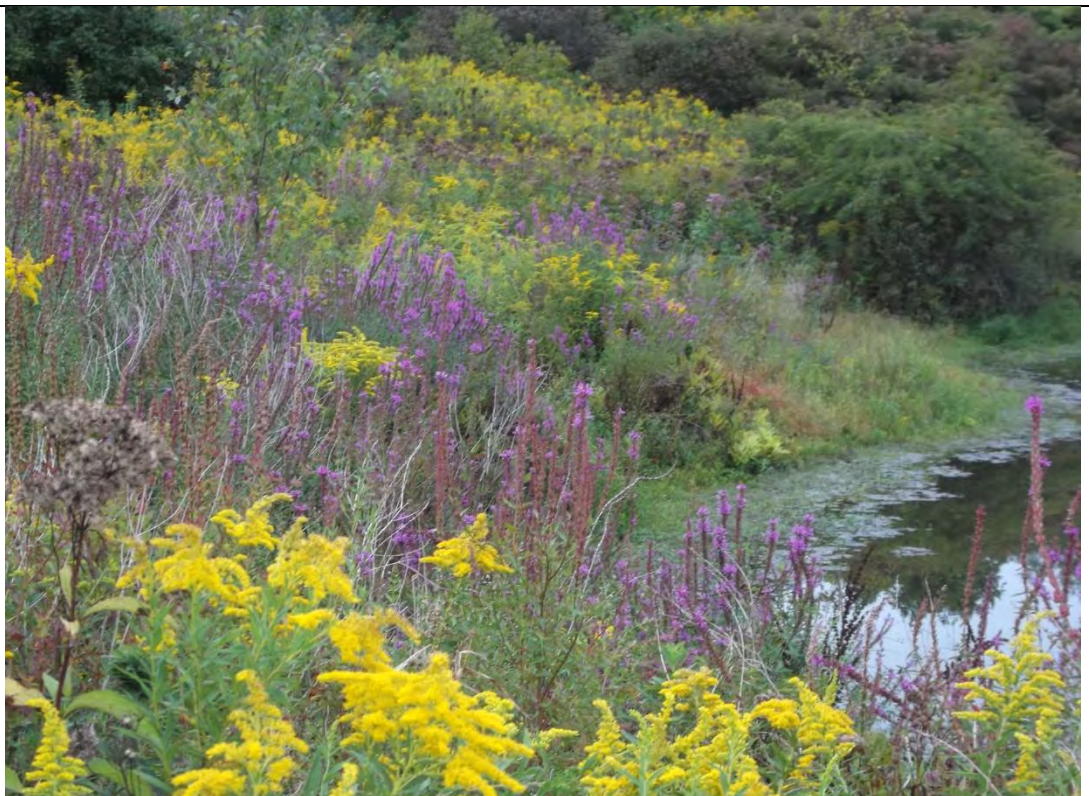
Photo No.
14

Area 11:

Purple Loosestrife on
periphery of
recreational/scenic
residential pond
south of County Road
21. Abundant around
pond.

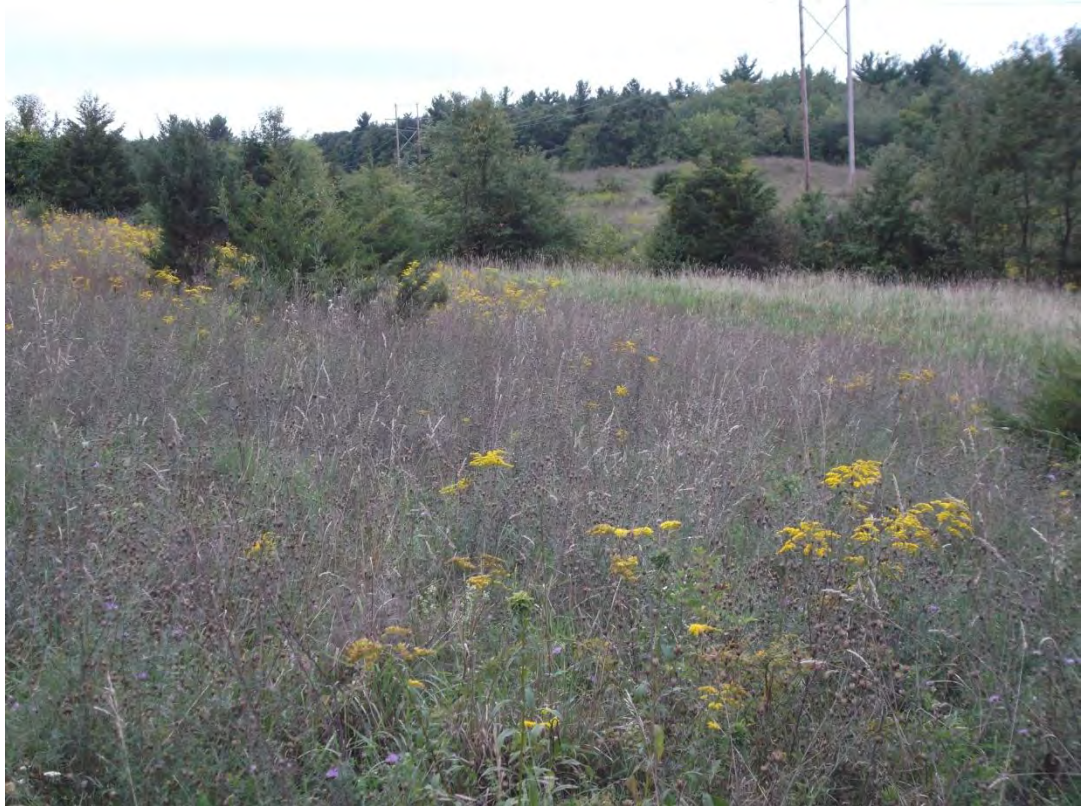
Photo No.
15

Area 12:

Field in ROW with abundant knapweed (not in bloom; brown/gray herbaceous vegetation in foreground).

Area 13 with reed canary grass visible in distance.

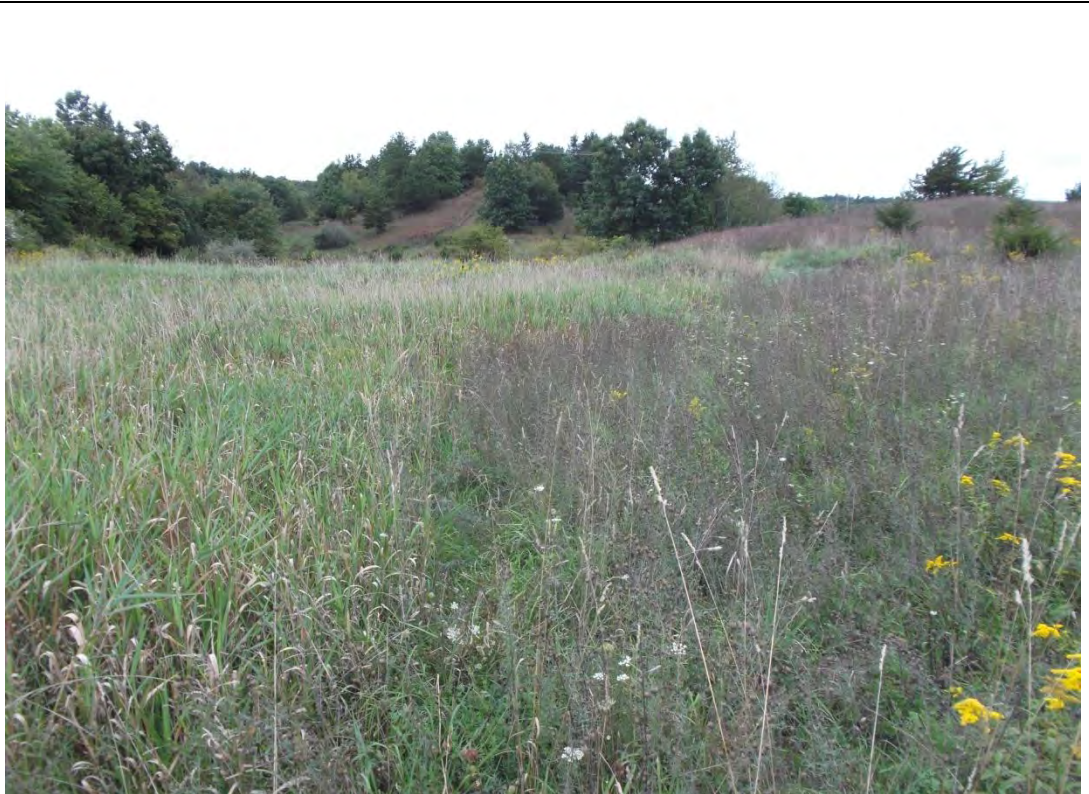
Photo No.
16

Areas 12, 13:

Field in ROW with abundant knapweed (right side photo), and reed canary grass (left side). Both span full width of ROW. South of County Road 21.

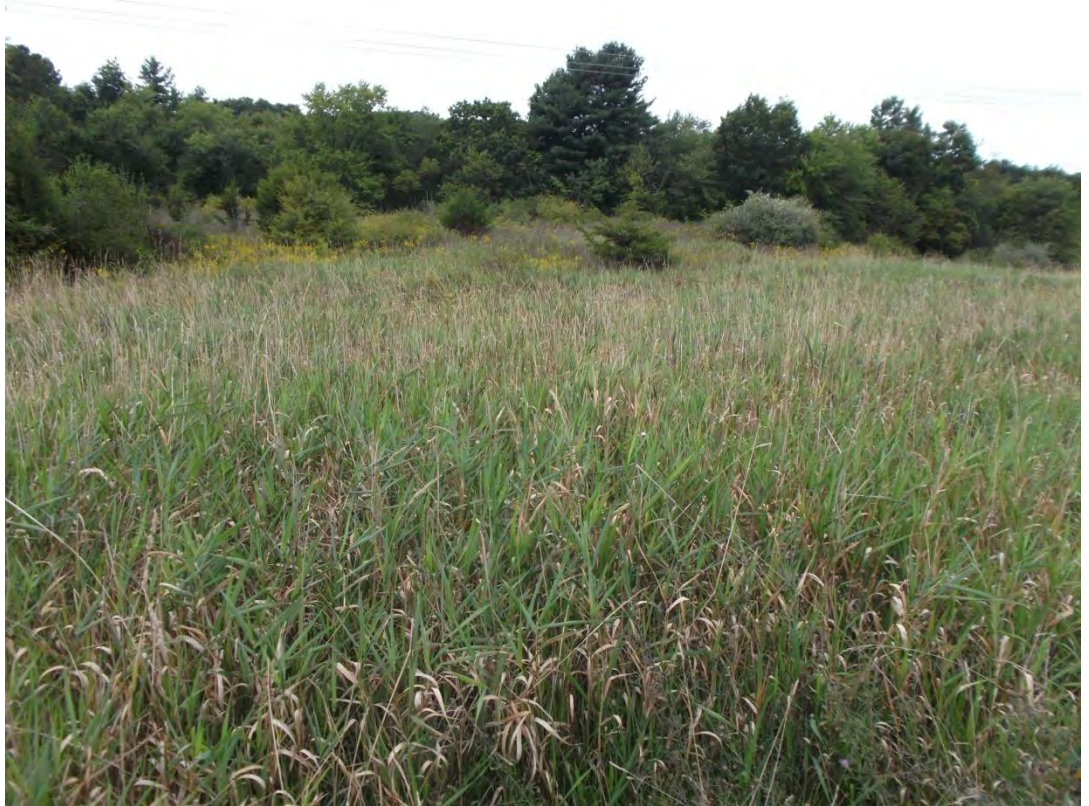
Photo No.
17

Area 13:

Reed canary grass
abundant in ROW
south of County Road
21. Spans entire
width of ROW.

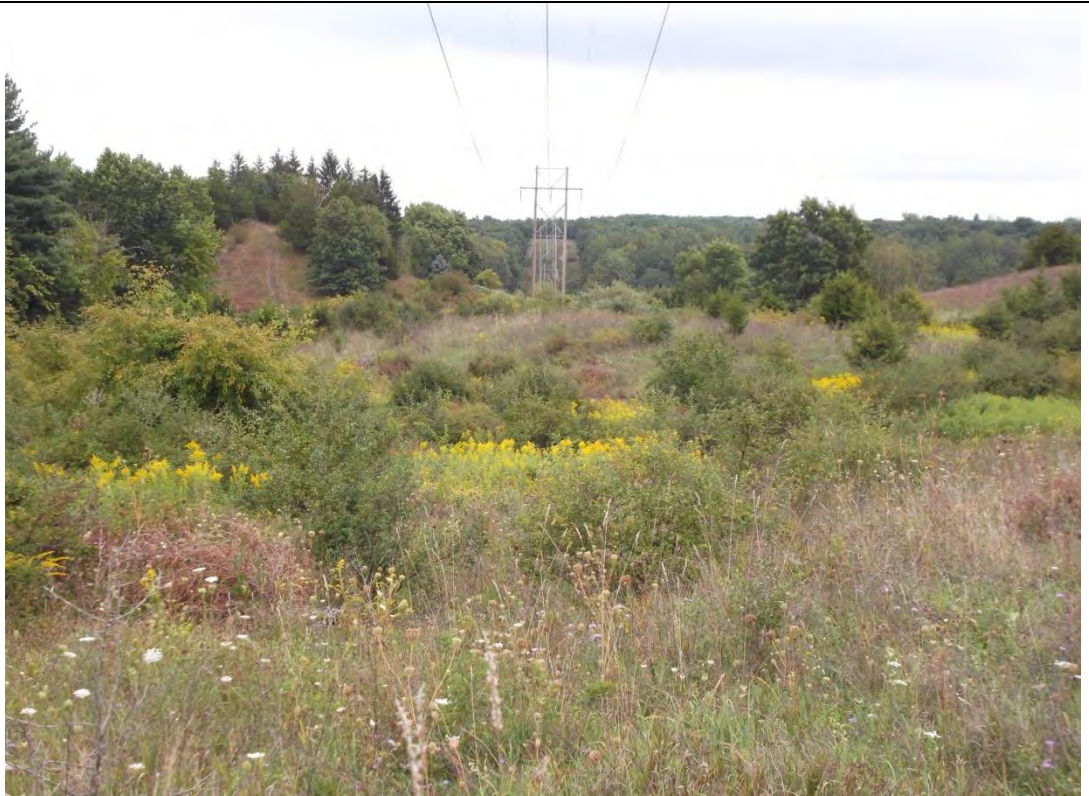
Photo No.
18

Representative view
of existing ROW
south of County Road
21, showing scattered
shrub honeysuckle
and multiflora rose.
These species are
abundant and
scattered throughout
ROW, but not in
discrete stands.
