Columbia County Transmission Line

Resource Location Map: B7

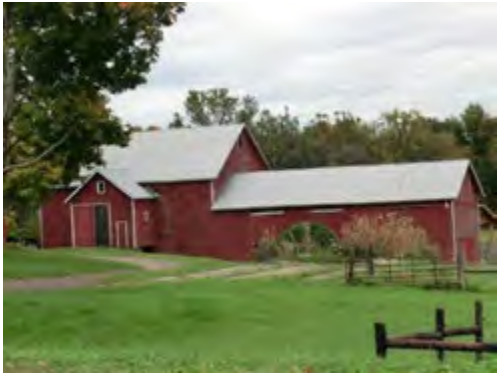
| <p>URS Survey No.: 39 Route 21, Ghent, NY Resource Type: Farm (dairy) Tax Parcel ID: 65.-1-1.1 Date: Ca. 1958 NR status: Not eligible Justification: Lacks architectural significance and integrity</p> | <p>Map No.: D7</p> | <p>Style/Type: Ranch Stories: 1 Roof: Hipped Ext. Siding: Aluminum Foundation: Not visible Windows: Aluminum, one-over-one, double-hung sash; large picture window flanked by one-over-one, double-hung sash Alterations: Side deck; replacement windows Outbuildings: Late 19th to early 20th century barn and 2 sheds</p> |

| <p>URS Survey No.: 39 (continued)</p> | <p>Map No.: D7</p> | <p>Barn</p> |

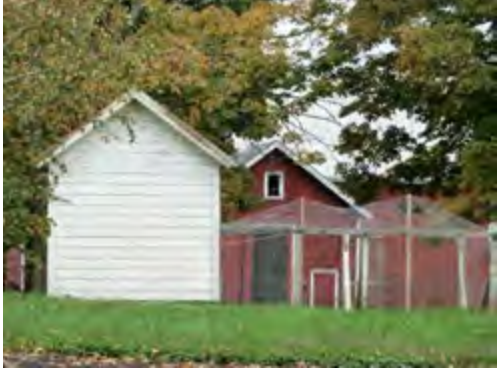
| <p>URS Survey No.: 39 (continued)</p> | <p>Map No.: D7</p> | <p>Sheds</p> |

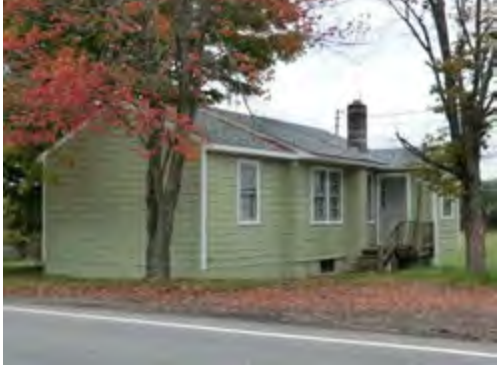
| <p>URS Survey No.: 40 1778 Route 21, Ghent, NY Resource Type: Residential Tax Parcel ID: 65.-1-30 Date: Ca. 1948 NR status: Not eligible Justification: Lacks architectural significance and integrity</p> | <p>Map No.: D7</p> | <p>Style/Type: Minimal Traditional Stories: 1.5 Roof: Side gable Ext. Siding: Wood clapboard Foundation: Concrete Windows: Wood, one-over-one, double-hung sash Alterations: Front porch addition Outbuildings: N/A</p> |

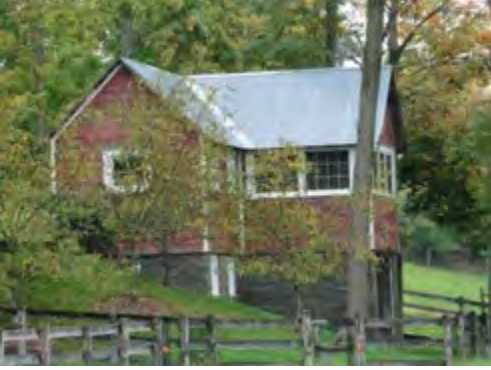
| <p>URS Survey No.: 189 52 Garner Road, Ghent, NY Resource Type: Residential (former farm) Tax Parcel ID: 75.-1-1.2 Date: Ca. 1790 NR status: Not eligible Justification: Lacks integrity</p> | <p>Map No.: E6</p> | <p>Style/Type: Georgian Stories: 2 Roof: Side gable Ext. Siding: Wood clapboard Foundation: Stone Windows: Wood, twelve-over-twelve, six-over-six, double-hung sash Alterations: Side porch addition; rear additions Outbuildings: Two barns; two sheds; secondary dwelling</p> |

| <p>URS Survey No.: 189 (continued)</p> | <p>Map No.: E6</p> | <p>Barn</p> |
