**LONG ISLAND POWER AUTHORITY**

**Tropical Storm Irene Storm Report  
August 28 – September 5, 2011**

**Submitted to the New York State Public Service Commission**

**November 18, 2011**

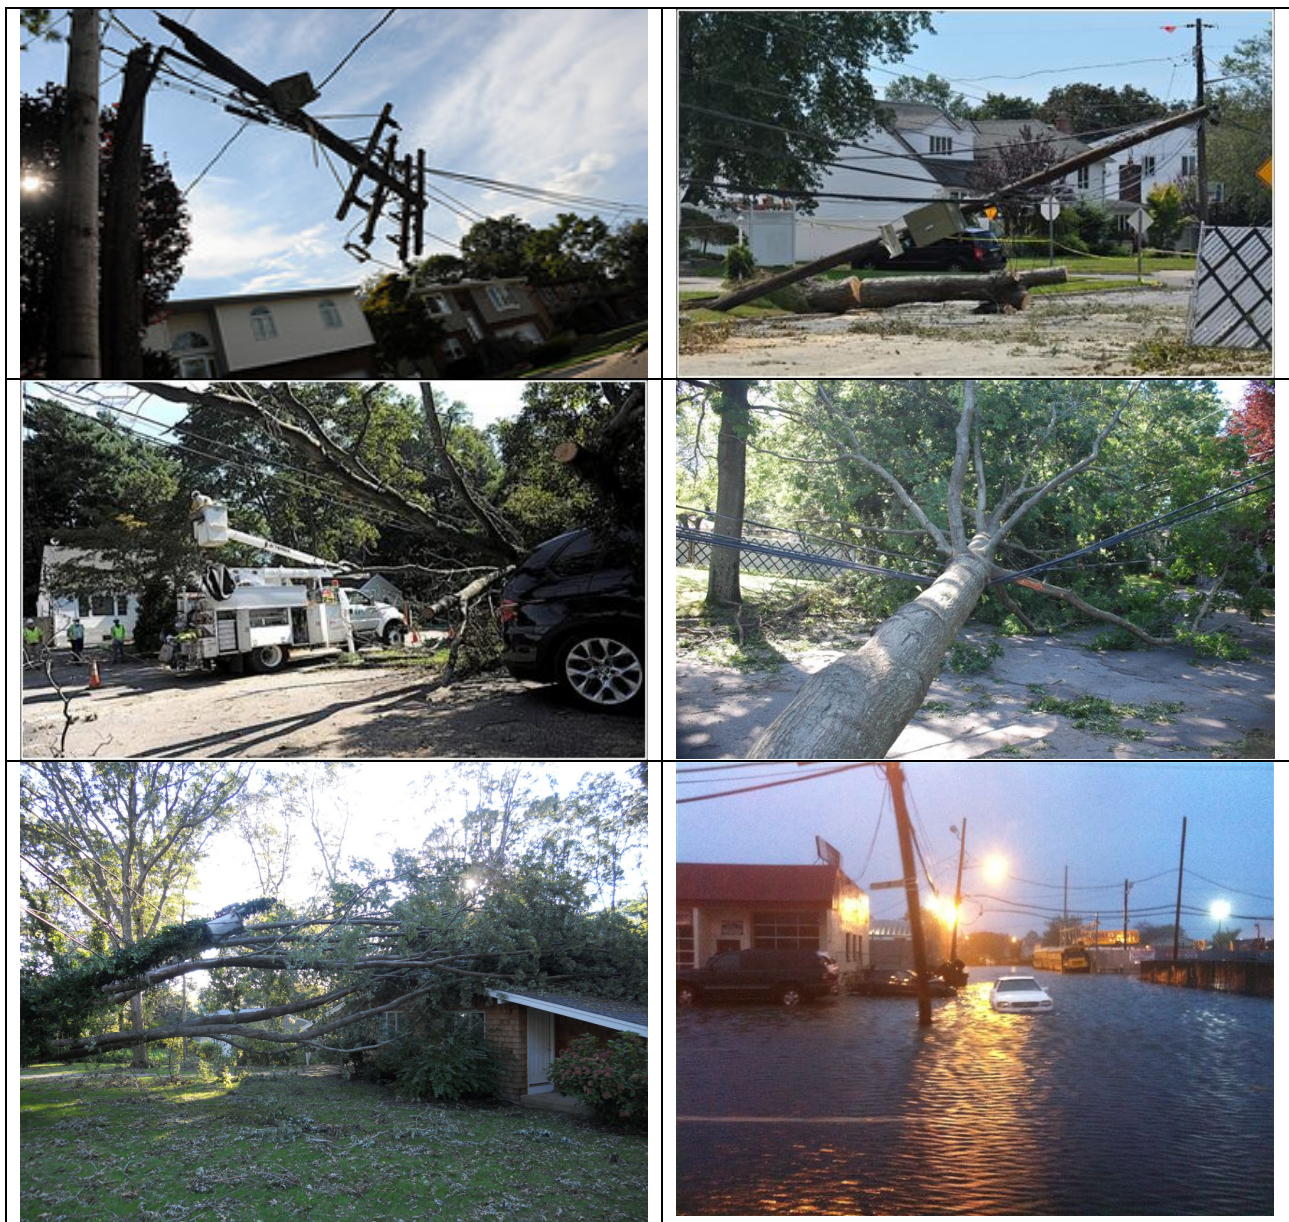
The photographs below illustrate the magnitude of the storm's damage and its devastating impact on Long Island.
