City of Buffalo - Underground Street Light Circuit Infrastructure Replacement Program

Case 12-E-0201

April 15, 2013

Niagara Mohawk Power Corporation 300 Erie Boulevard West Syracuse New York 13202

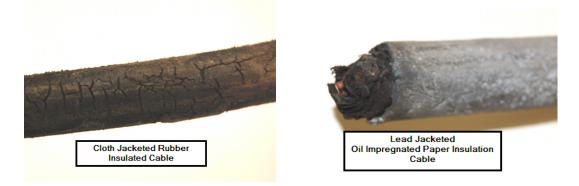
Aged cable infrastructure estimated to have originated during the 1940s through the 1970s is believed to be a significant contributing factor to the high rate of elevated voltage incidents. A considerable portion of this circuit infrastructure is comprised of original series circuit conductor. These conductors are either woven cloth jacketed rubber insulated wire or lead covered oil impregnated paper insulated cable.

The most common failure modes of these cables are water intrusion or insulation breakdown resulting in faults with the metallic protective jacket.

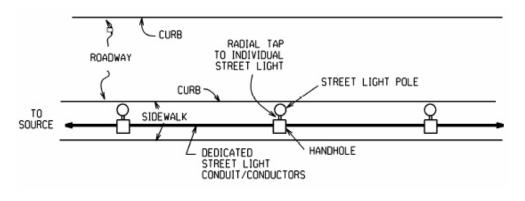
Figure 1 – New Conduit Installation Configuration

In recognition of the City's ownership of the majority of street light standards, the proposed underground circuit configuration shall utilize a linear design which incorporates handholes located at individual street light locations as shown in Figure 1.

These handholes will provide the means to install appropriate grounding equipment and ample space to facilitate radial taps and circuit protection devices to source the adjacent

street light facility. This circuit configuration supports an unimpeded cable pull, the ability to easily remedy conductor load balance issues and promotes a safer electrical termination condition when the customer's standard is not in-service.

The planned design eliminates the current circuit configuration approach which often requires the need to remove the city owned street light standard to facilitate the feed or pulling of cable through the conduit entrance at the top of a foundation. This proposed design layout will be utilized for new or complete rebuild situations. Existing street lighting installations shall require the circuit design alignment to be modified to meet existing foundation conduit entrances.

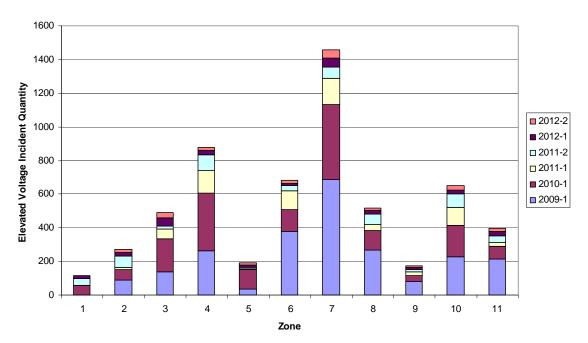
Figure 2 – Historical Elevated Voltage Incidents by Zone

Test results within the City have identified an incident rate above a minimal threshold, therefore requiring that testing be performed on a semi-annual basis. The test results indicate the number of elevated voltage incidents recorded per year in a zone. The greater the cumulative number of incidents in a zone, the higher priority assigned to that zone in the circuit replacement priority plan. Figure 2 below illustrates the accumulated

elevated voltage test results which have been recorded since 2009. The test results identify a significant reduction of incidents per test cycle since the beginning of the testing program. However, the illustration of this data in Exhibit E highlights the reoccurrence condition within individual circuits even though timely repairs are made to remedy the identified incident condition.

City of Buffalo - Historical Elevated Voltage Incidents By Zone

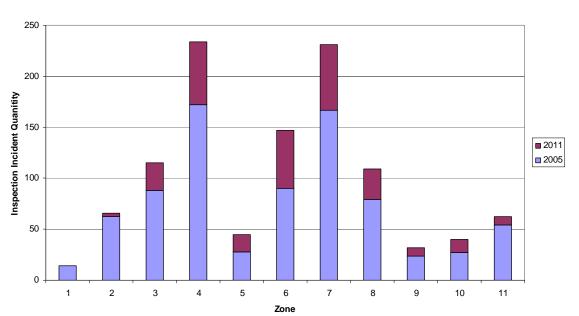
The Company inspects street lighting infrastructure in compliance with Commission Order in Case 04-M-0159 and subsequent revisions. The street lighting infrastructure within the City is visually inspected once every five (5) years. Since the inception of the program and based upon the cyclical schedule, all lighting facilities accessible to public contact within the City have been inspected twice (2005, 2011). The inspection program follows National Grid's Electric Operating Procedure (EOP) G017 – Street Light Standard Inspection Program (Appendix 2). The Company also will consider specific inspection criteria related to circuit wiring, circuit grounding or TOH applications in the prioritization plan. These criteria are presented in Exhibit A. The historical inspection incident data are presented in Figure 3 by zone designation. In all designated zones within the City, inspection incidents have declined since the initial inspection.

City of Buffalo - Historical Inspection Incidents By Zone

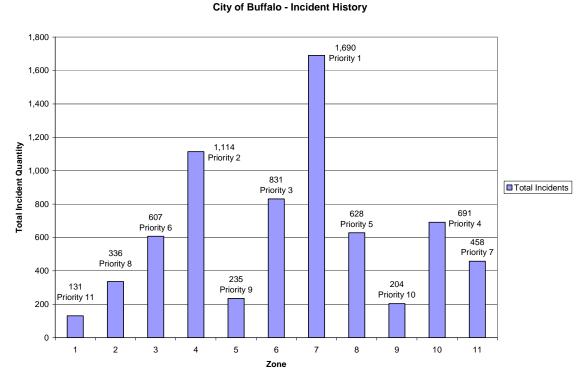
Figure 4 – Total Incident History by Zone

Zone	Total Inspection	Total Testing	Total Incidents	Incident Priority
1	14	117	131	11
2	66	270	336	8
3	115	492	607	6
4	234	880	1,114	2
5	45	190	235	9
6	147	684	831	3
7	231	1,459	1,690	1
8	109	519	628	5
9	32	172	204	10
10	40	651	691	4
11	62	396	458	7
Total	1,095	5,830	6,925

All data will be assembled by designated location information. Prioritization will be based on gross incident quantities of elevated voltage and specific inspection results within the established geographical zones, with the higher priority going to the zone with the greatest number of incidents.

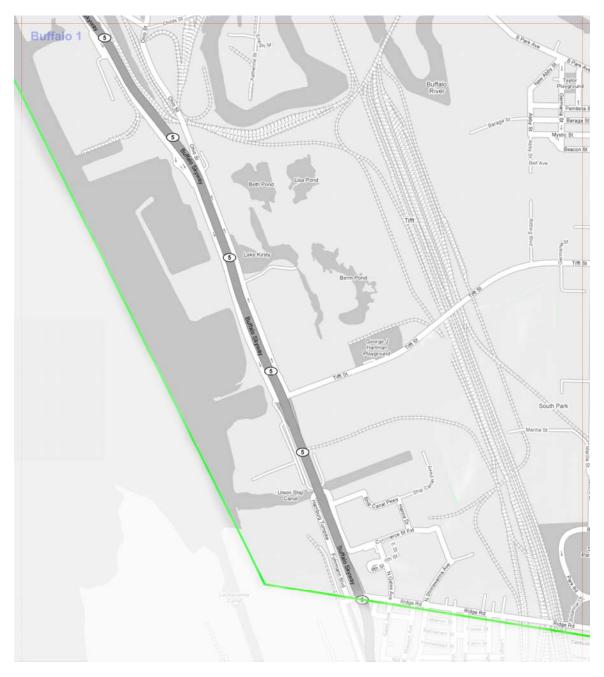
General Locations of UG Street Lights to be Removed

Safety Condition – Clearance								
Steel Street Light Standards Pr	Steel Street Light Standards Proximity to Overhead Distribution Conductors							
[Underground Street Light Ser	vice to be Relocated to Over	head Street Light Service]						
Street	Cross Street	Cross Street	Zone					
Spring	Clinton	Swan	4					
Hickory	Clinton	South Division	4					
Hickory	William	Clinton	4					
South Division	Pine	Spring	4

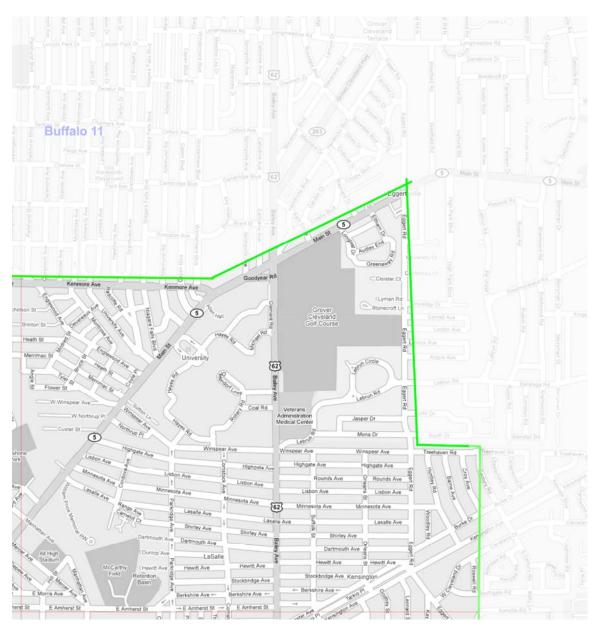
City of Buffalo Zone Maps with Incidents - Complete

City of Buffalo SL Cable Replacement Program All Incidents

Other physical conditions seen by local operation crews and supervision while responding to outages will be considered as secondary and applied based upon local knowledge as appropriate. The recognition of all available data and knowledge will be used to determine priority ranking by geographic zone for the purpose of establishing a scheduled target area for budget purposes, scheduling, engineering design and construction planning. A summary table of the accumulated testing and inspection incidents used to determine priority ranking of each zone is provided in Figure 4. The locations of these incidents are presented within the designated geographical zones in Exhibits E, 2-11.
