Case 19-E-0730

**REPLY COMMENTS OF JOINT PETITIONERS IN RESPONSE TO COMMISSION
JANUARY 17, 2020 NOTICE SEEKING COMMENTS**

Historical Site Assessment for Indian Point Energy Center

Technical Support Document (TSD) No. 19-002 Rev 02

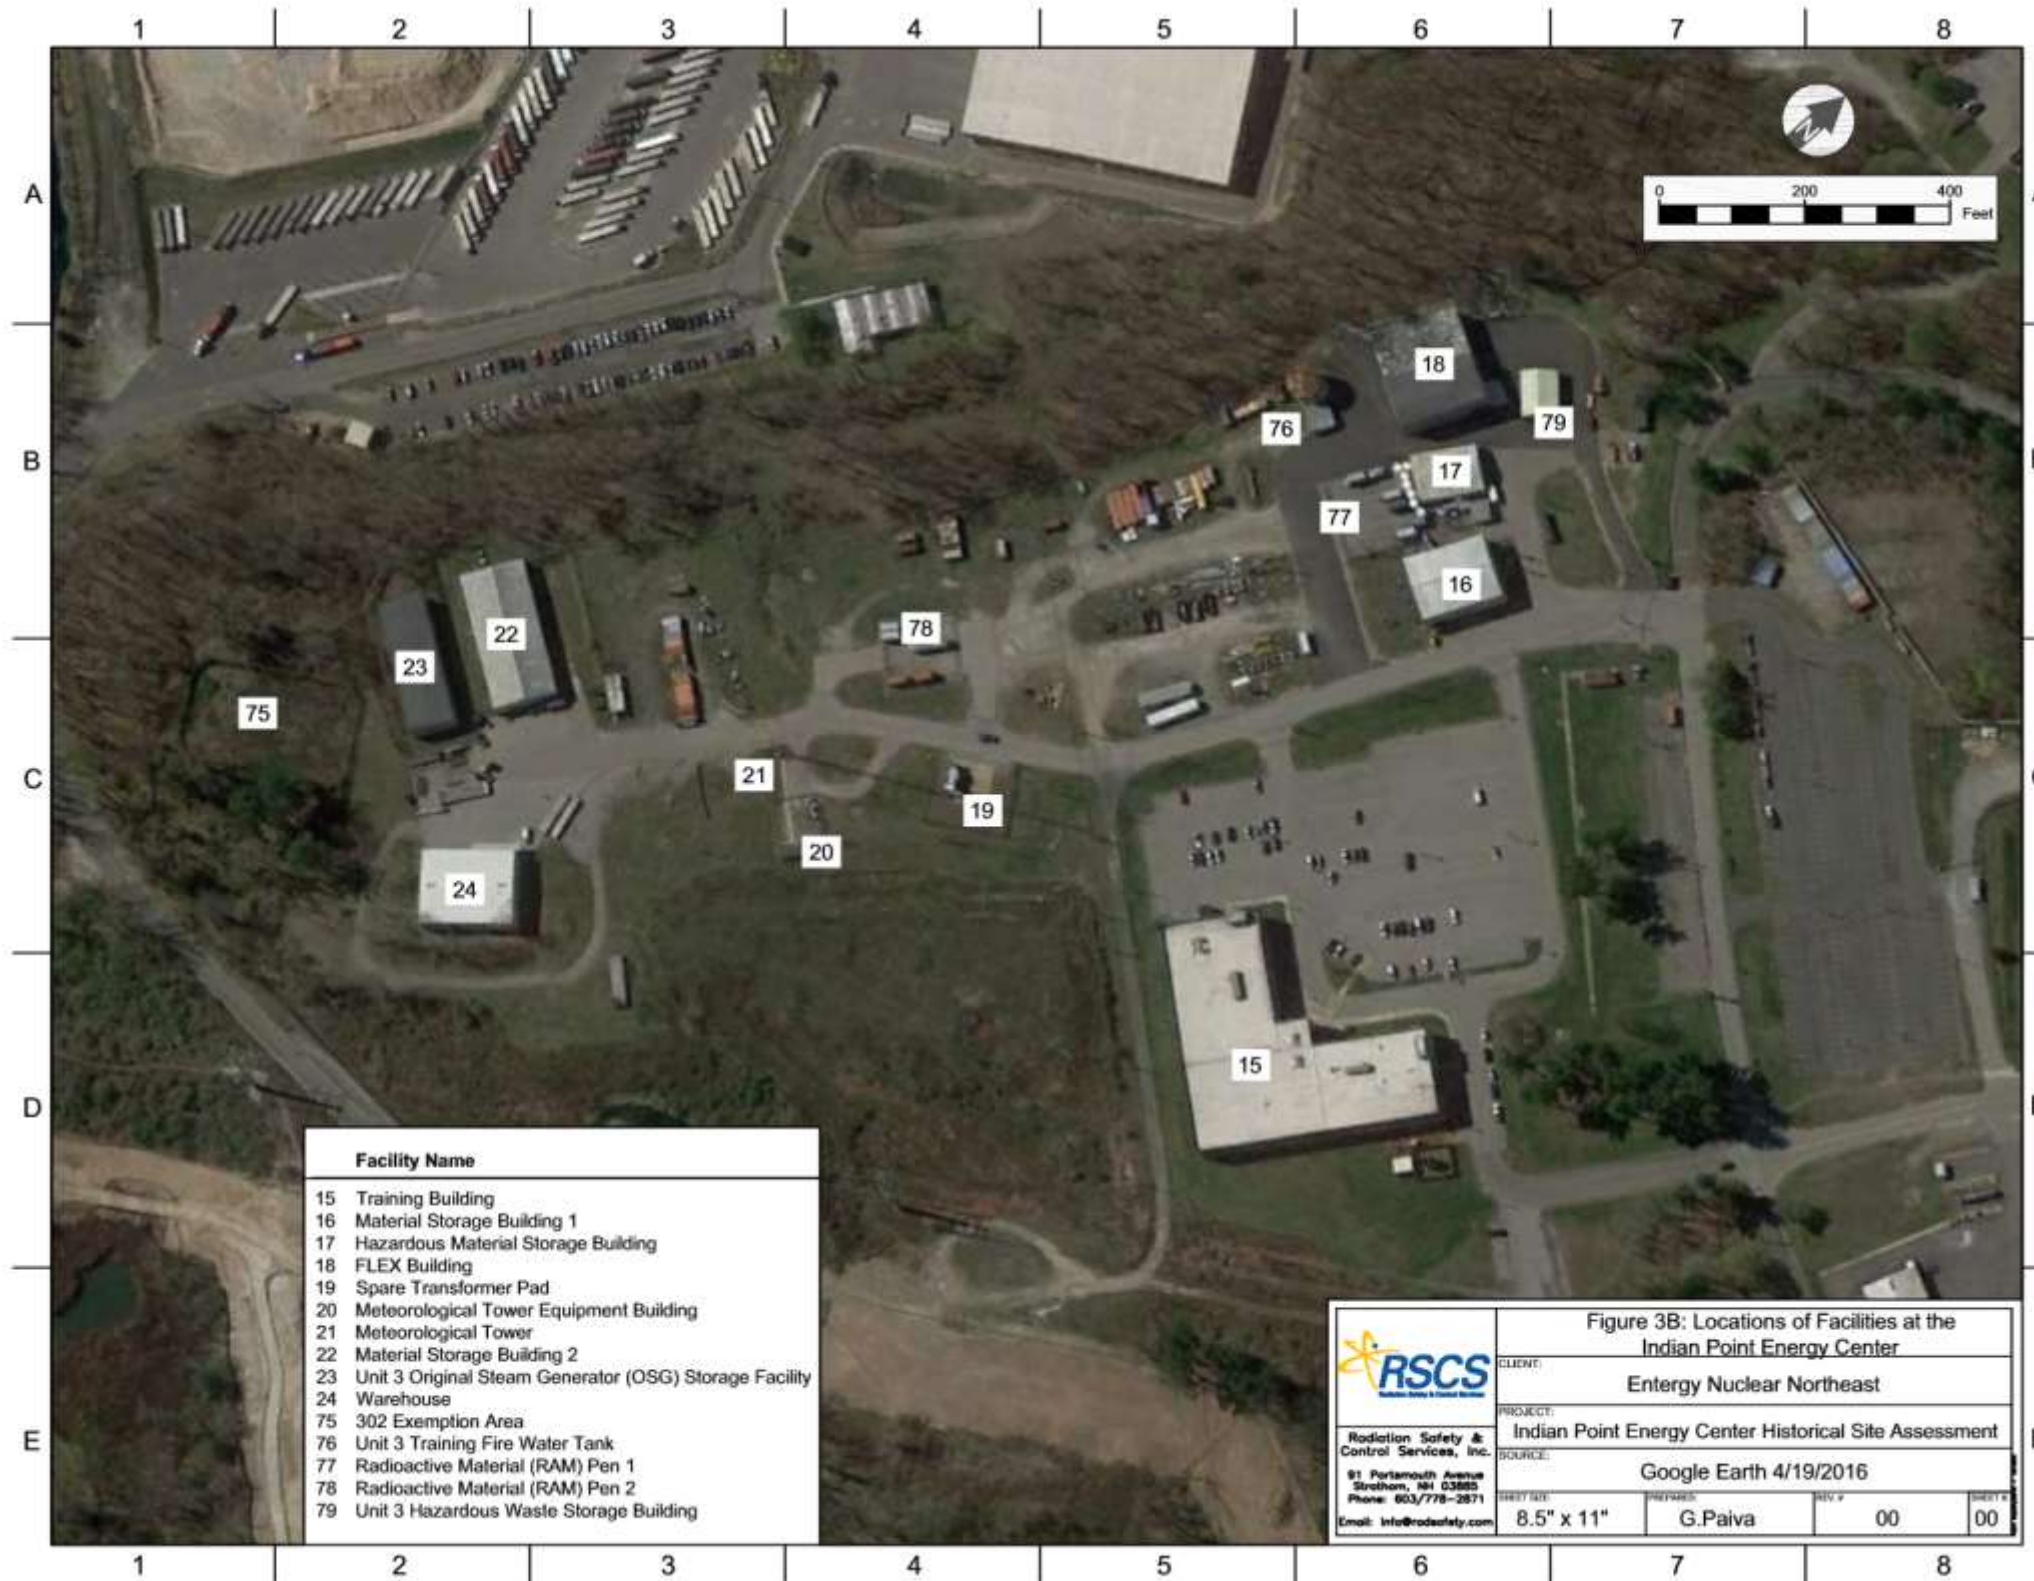
Figure 3B: Locations of Facilities at the Indian Point Energy Center

In 2000 an approximately six-foot high pile of soil posted as a lead hazard was identified in a lay-down area southwest of the Training Center and north of the Unit 3 Original Steam Generator Storage Facility (Figure 3B, Cell C4) [20]. Unit 3 staff identified the area as one where sandblasting of equipment presumably coated with lead-based paint occurred. The soil pile has been removed from the site.
