Figure 2. Danger Trees to be Removed for the Lockport Mortimer Line 111 Rebuild Project, Niagara, Orleans and Monroe Counties, New York.

Figure 4.
Wetland Mitigation Site for
the Lockport Mortimer
Line 111 Rebuild Project,
Town of Barre, Orleans
County, New York

Company: National Grid
Project: Lockport Mortimer Line 111 Rebuild Project
Wetland Mitigation Plan – Danger Trees

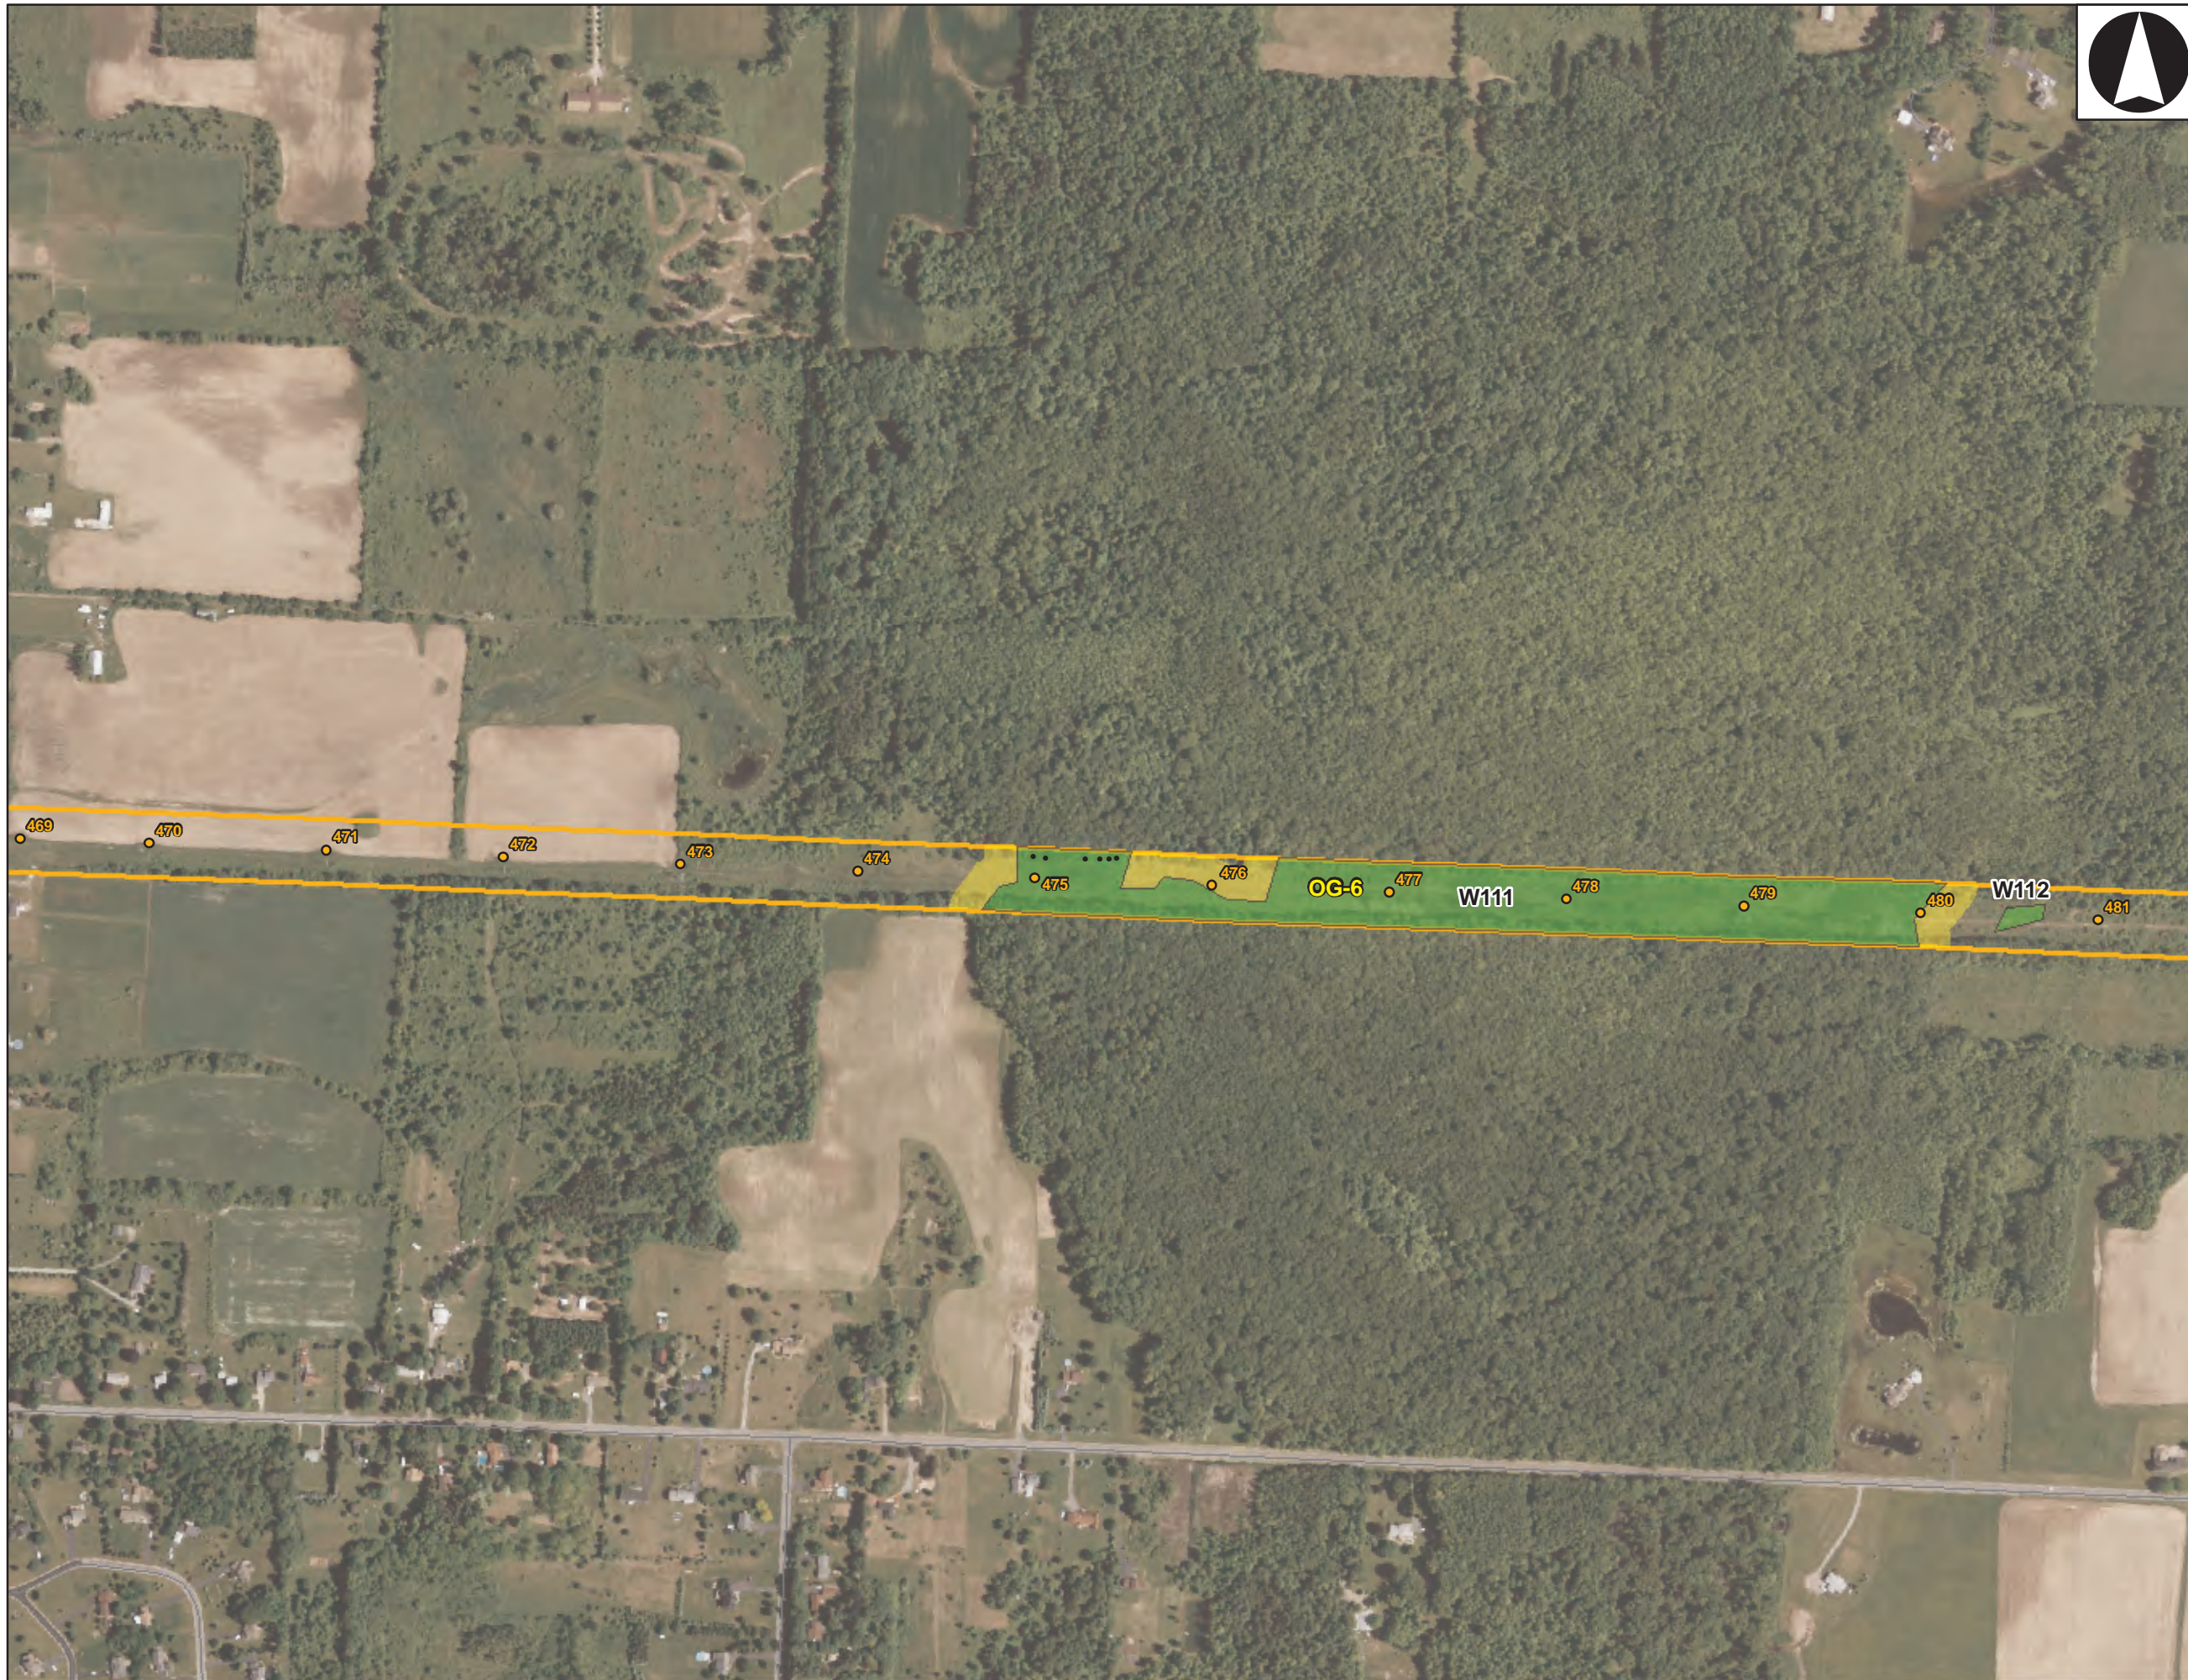
SHEET 14

Figure 2. Danger Trees to be Removed for the Lockport Mortimer Line 111 Rebuild Project, Niagara, Orleans and Monroe Counties, New York.

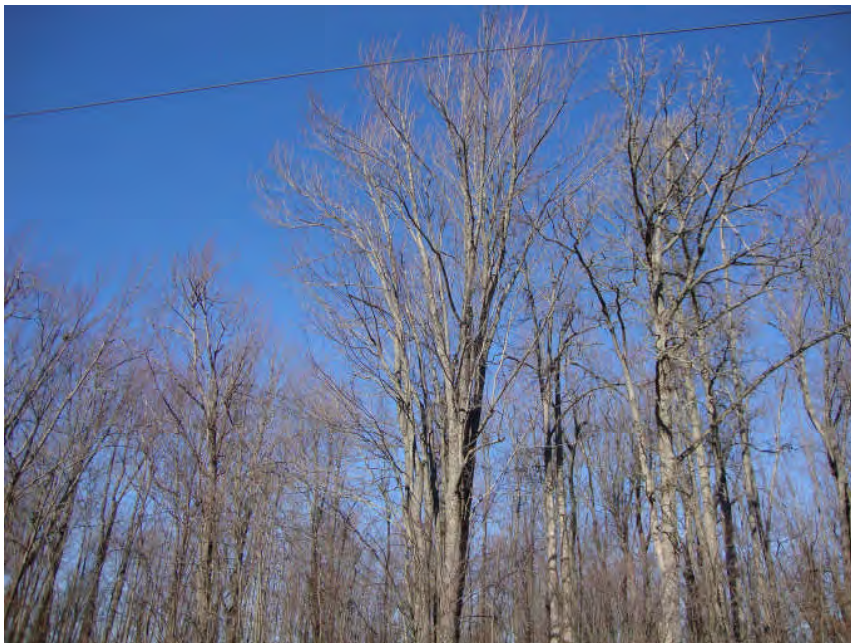
Photographer: B. Eckwahl
Date: 02/09/12
Photo No.: 8
Direction: North
Comments: W58-24
Wildlife tree with a denning cavity at the base of the trunk, will be topped to preserve habitat

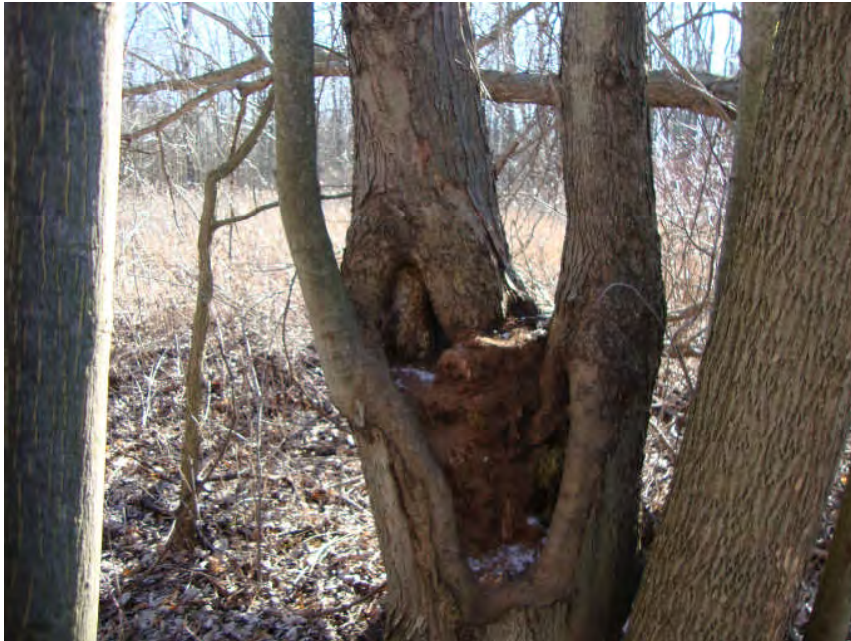
Photographer: B. Eckwahl
Date: 02/09/12
Photo No.: 9
Direction: South
Comments: W58-24
Wildlife tree with a denning cavity at the base of the trunk, will be topped to preserve habitat

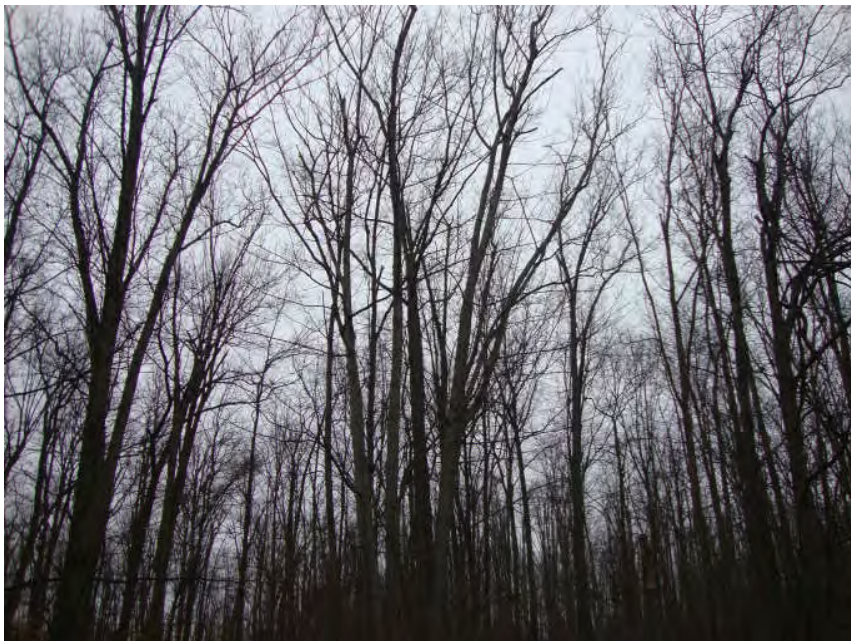
Photographer: B. Eckwahl
Date: 01/26/12
Photo No.: 10
Direction: North
Comments: W59-2
Wildlife tree with hollow stems and nesting habitat, will be topped to preserve habitat

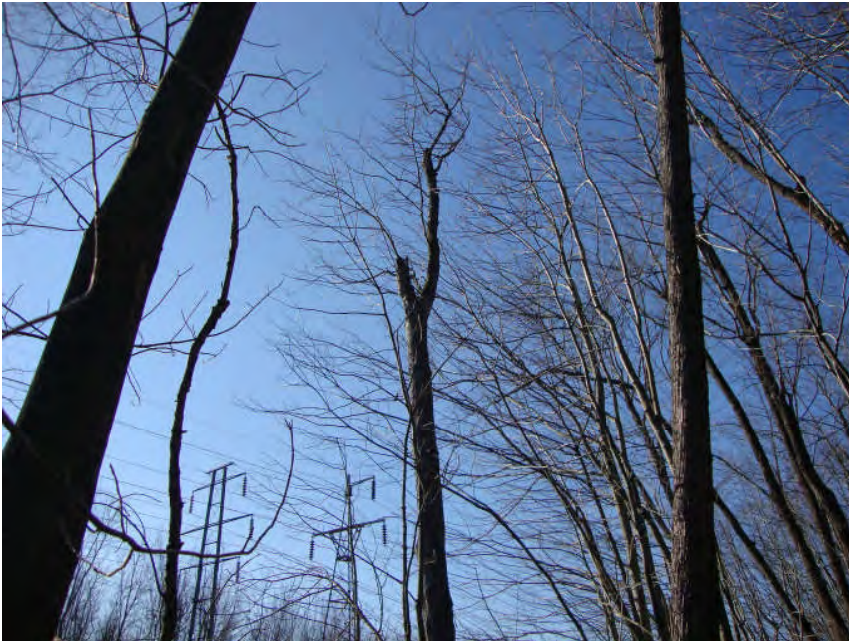
Photographer: B. Eckwahl
Date: 02/06/12
Photo No.: 11
Direction: Southwest
Comments: W59-10
Wildlife tree, dead snag, will be topped to preserve habitat

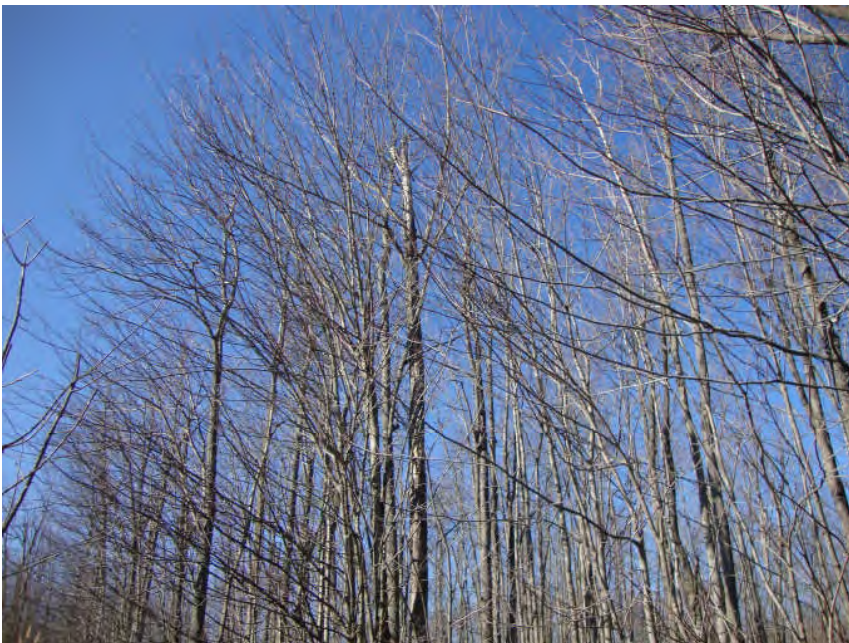
Photographer: B. Eckwahl
Date: 02/06/12
Photo No.: 12
Direction: Northwest
Comments: W59-19
Wildlife snag with denning cavity, will be topped to preserve habitat

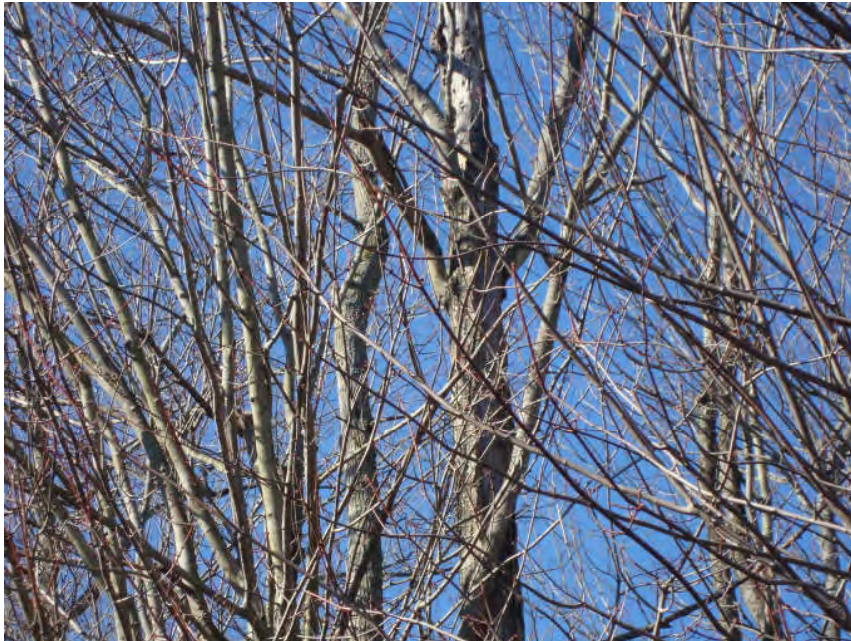
Photographer: B. Eckwahl
Date: 02/06/12
Photo No.: 13
Direction: Northwest
Comments: W59-19
Wildlife snag with denning cavity, will be topped to preserve habitat

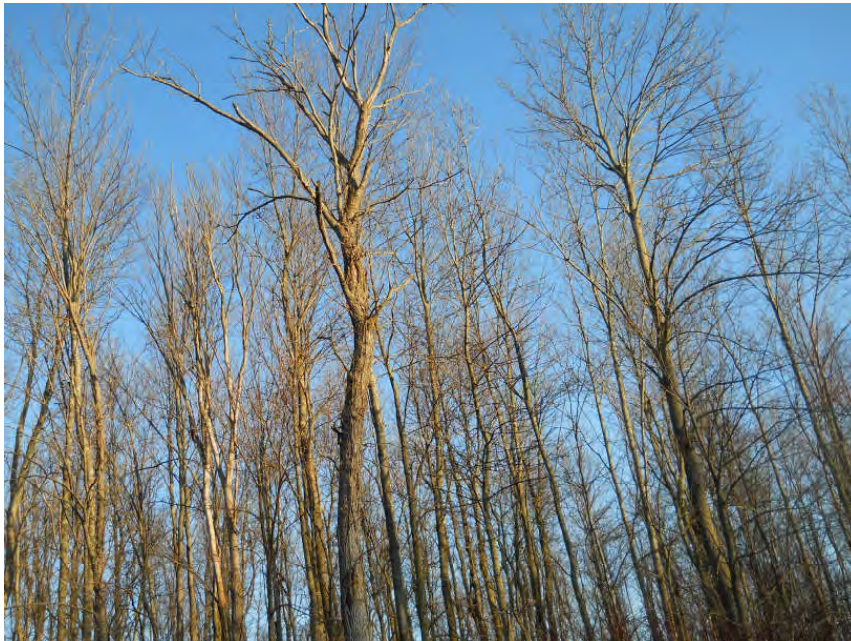
Photographer: B. Eckwahl
Date: 01/11/12
Photo No.: 17
Direction: North
Comments: W60-8
Wildlife snag with roosting
habitat, will be topped to
preserve wildlife value

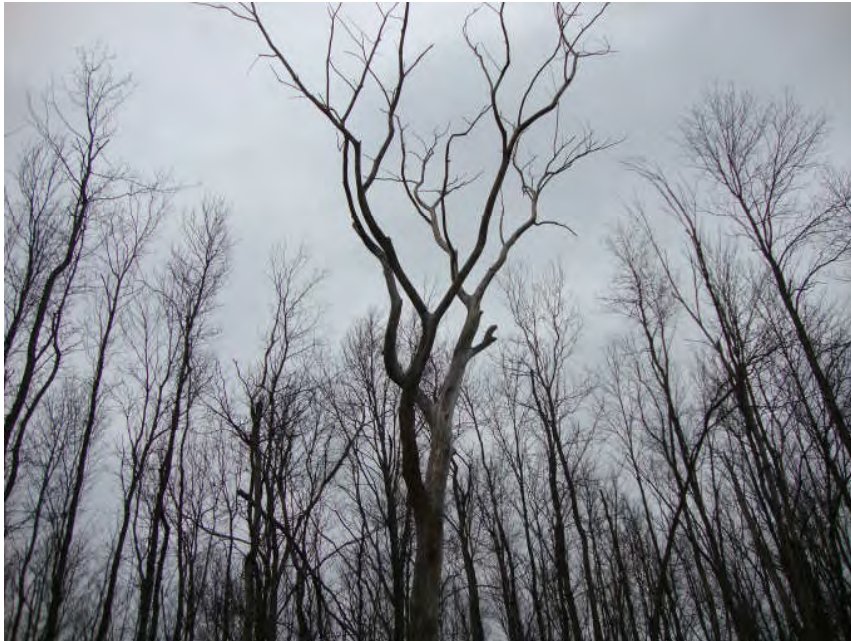
Photographer: B. Eckwahl
Date: 01/24/12
Photo No.: 19
Direction: North
Comments: W60-57
Wildlife roost snag with
woodpecker activity, will be
topped to preserve habitat value

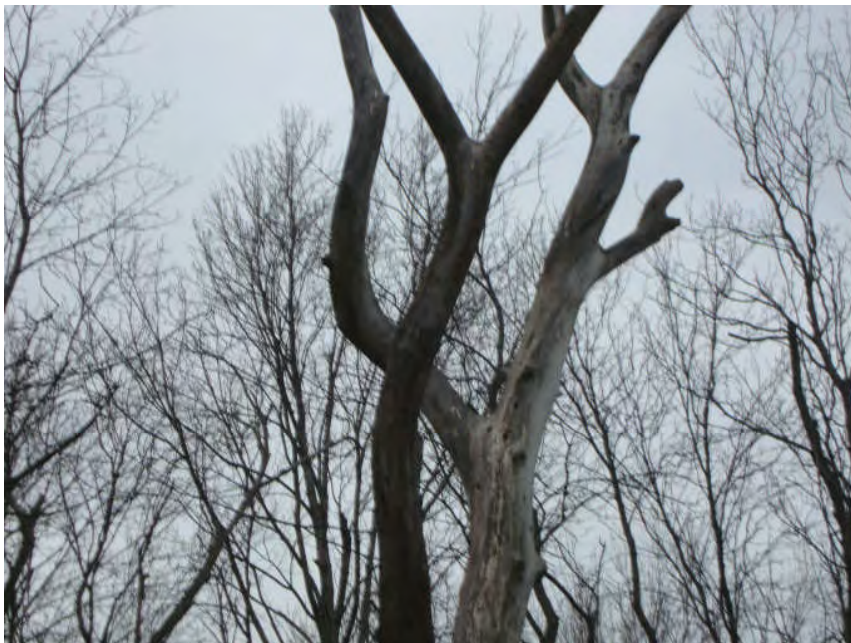
Photographer: B. Eckwahl
Date: 01/24/12
Photo No.: 20
Direction: North
Comments: W60-57
Wildlife roost snag with
woodpecker activity, will be
topped to preserve habitat value

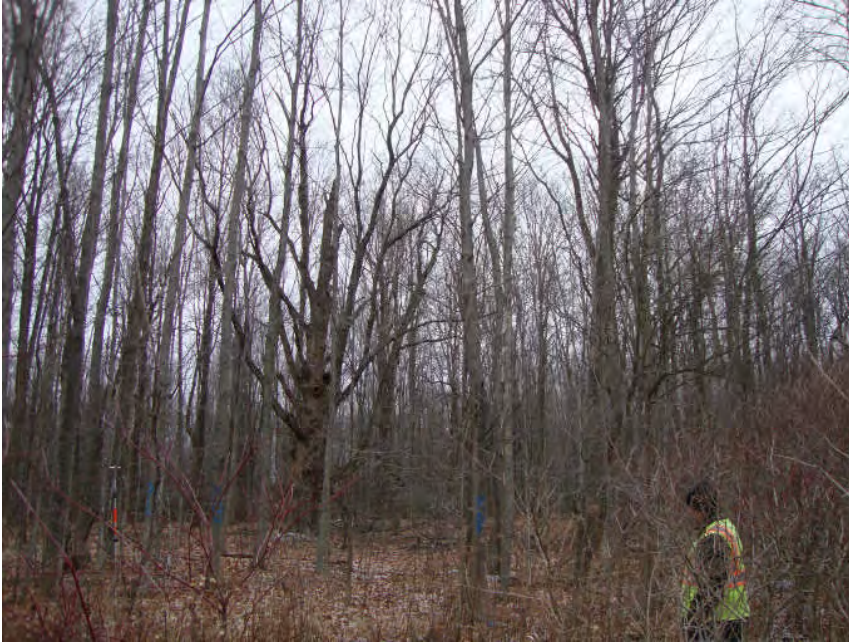
Photographer: B. Eckwahl
Date: 01/25/12
Photo No.: 23
Direction: North
Comments: W83-14
Note the superior wildlife tree
beyond the danger tree removal
area

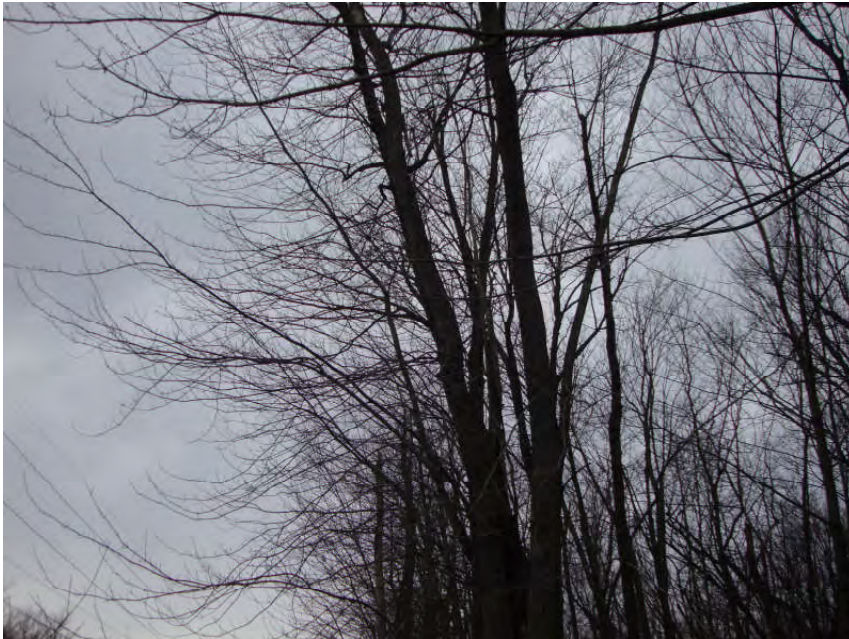
Photographer: B. Eckwahl
Date: 02/21/12
Photo No.: 27
Direction: West
Comments: W94-56
Wildlife tree with potential bat roosting habitat: cracks and crevices, will be topped to preserve habitat

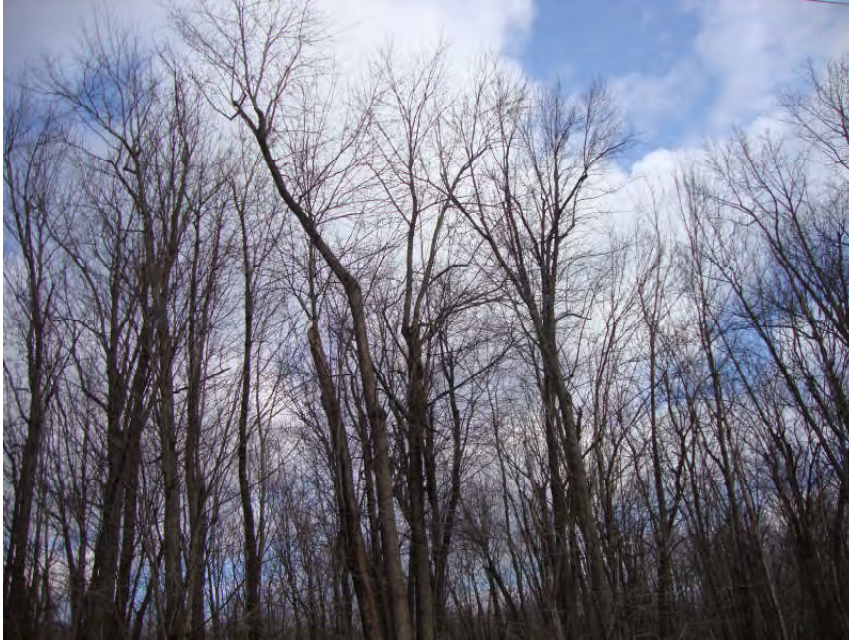
Photographer: B. Eckwahl
Date: 02/22/12
Photo No.: 29
Direction: North
Comments: W94-101
Wildlife tree with potential summer or maternity bat roosting potential habitat, will be topped to preserve habitat

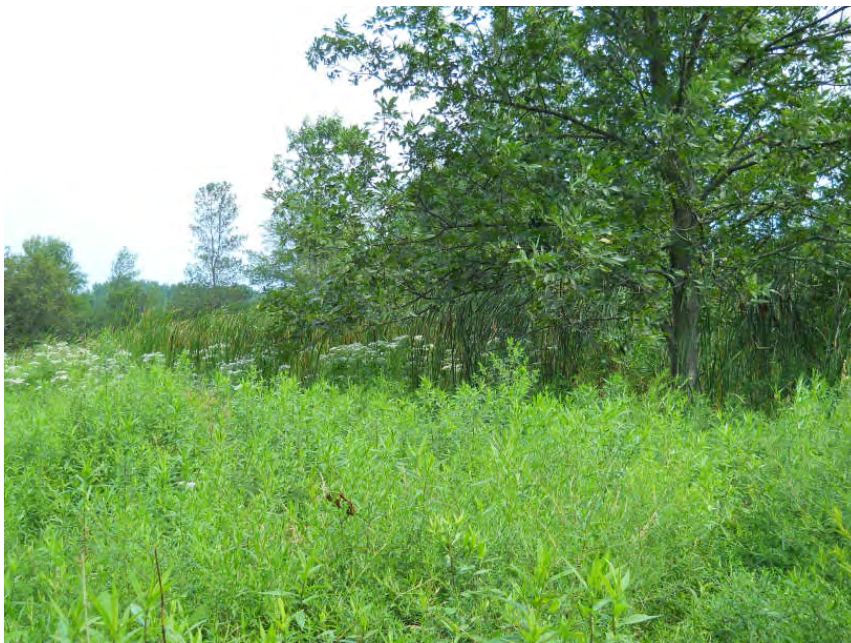
Photographer: P. Green
Date: 8/18/11
Photo No.: 2
Direction: East
Comments: Taken from southwest corner of wetland mitigation site. Note the common buckthorn (*Rhamnus cathartica*) present within the palustrine scrub shrub (PSS) portion of the site on the left side of the photograph.

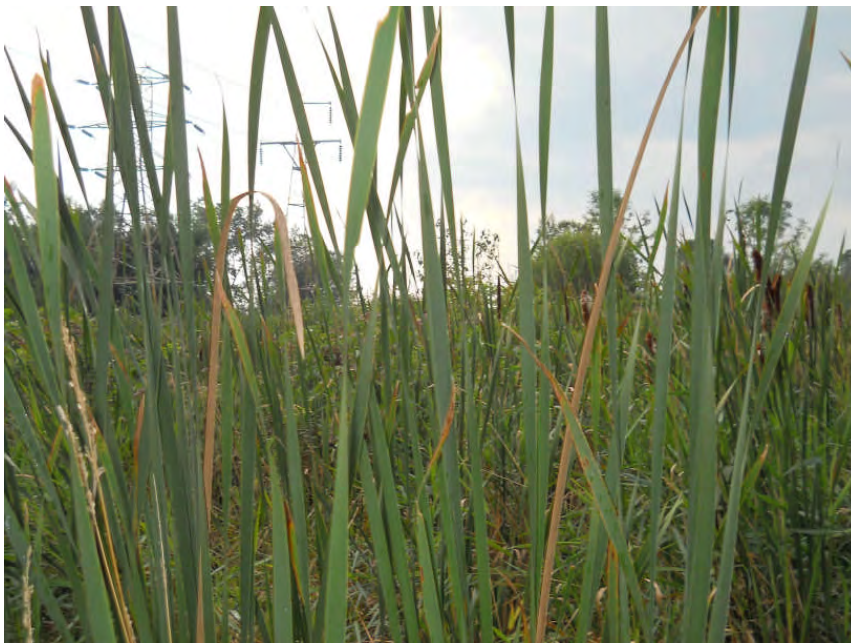
Photographer: P. Green
Date: 8/18/11
Photo No.: 18
Direction: West
Comments: Taken from southeast corner of wetland mitigation site

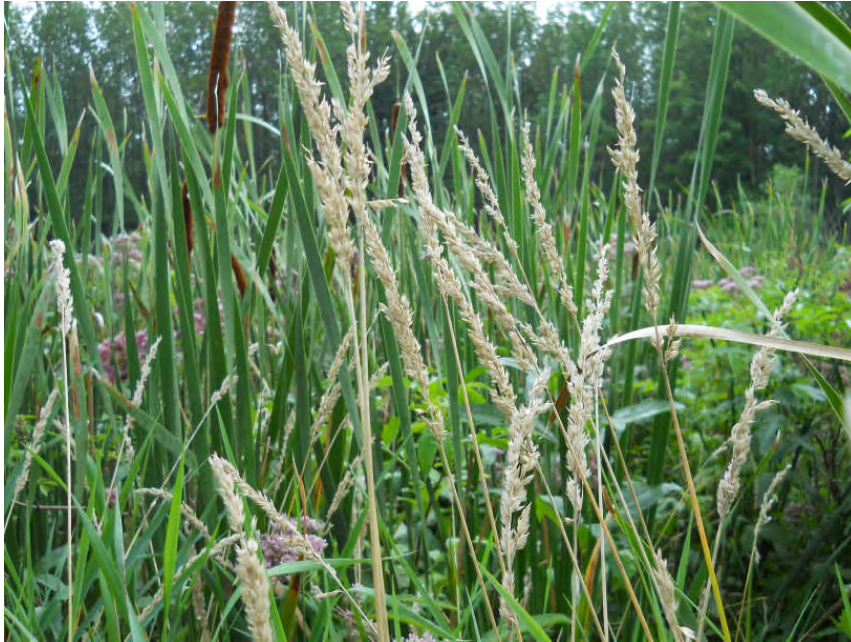
Photographer: P. Green
Date: 8/18/11
Photo No.: 19
Direction: N/A
Comments: Close up of reed canarygrass (*Phalaris arundinacea*), which is present through the wetland mitigation area (See Figure 2 in Appendix A for mapped locations).

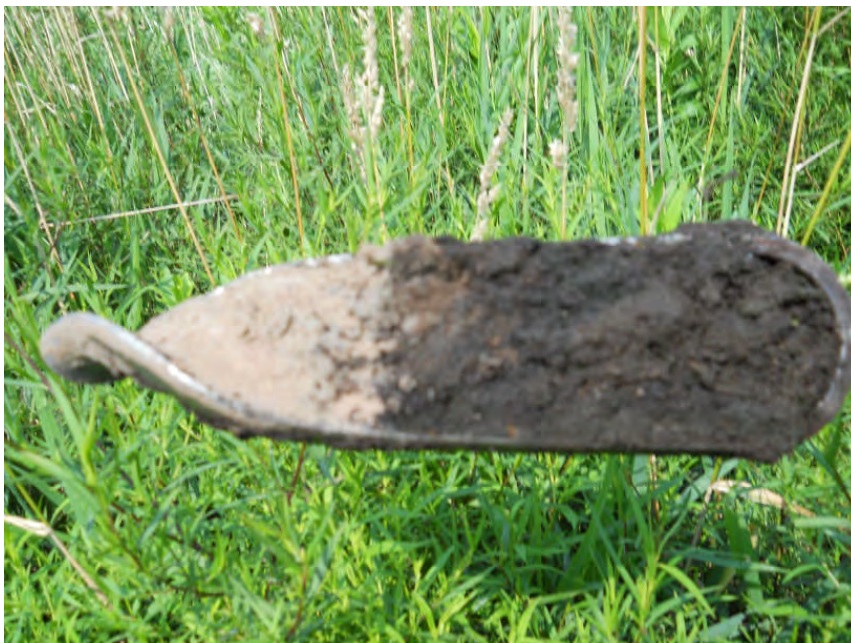
Photographer: P. Green
Date: 8/18/11
Photo No.: 20
Direction: N/A
Comments: Soil sample taken from wetland plot in palustrine emergent (PEM) wetland type located in the central portion of the mitigation site.

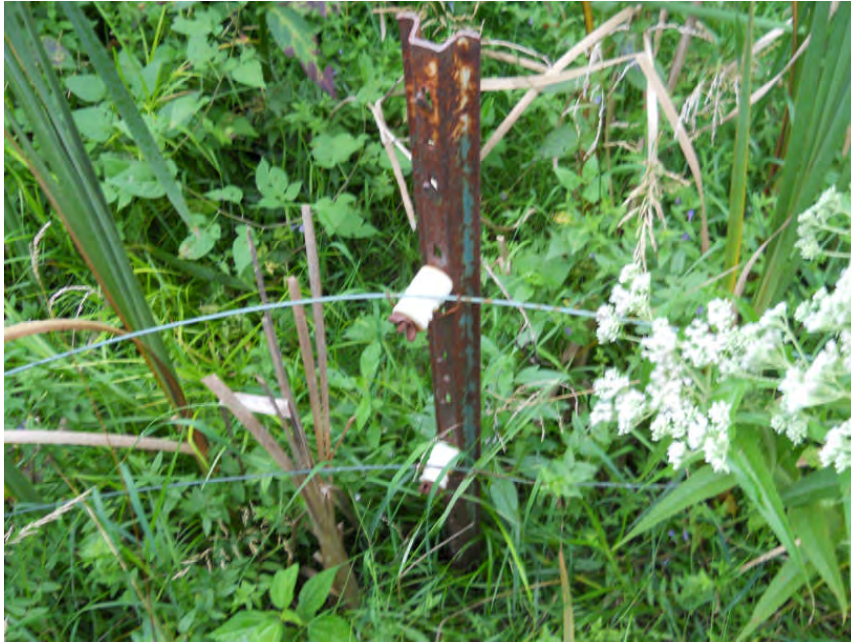
Photographer: P. Green
Date: 8/18/11
Photo No.: 21
Direction: N/A
Comments: An abandoned electric fence is present along the southern boundary and western portion of the wetland mitigation site.

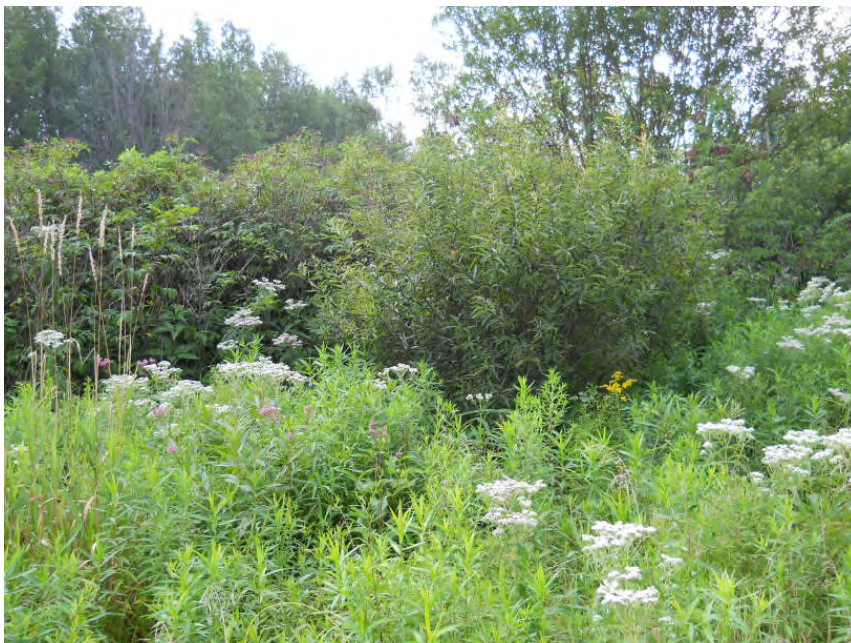
Photographer: B. Eckwahl
Date: 8/18/11
Photo No.: 22
Direction: Southwest
Comments: Taken from southern central boundary of wetland mitigation site (looking outside of the wetland mitigation site into Wetland W61 (DEC AL-9) and the Line 111 Right-of-Way (ROW))

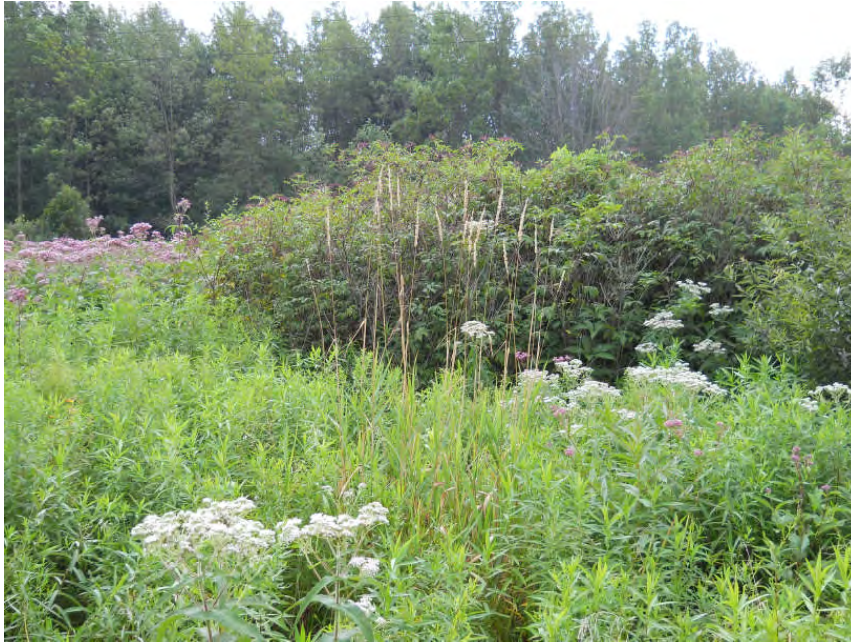
Photographer: B. Eckwahl
Date: 8/18/11
Photo No.: 23
Direction: South
Comments: Taken from southern central boundary of wetland mitigation site (looking outside of the wetland mitigation site into Wetland W61 (DEC AL-9) and the Line 111 Right-of-Way (ROW))

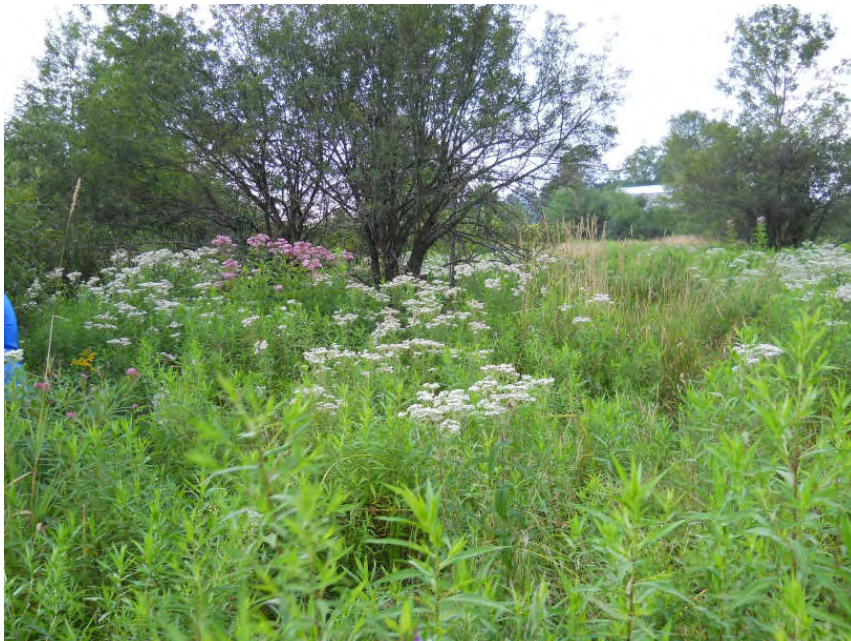
Photographer: B. Eckwahl
Date: 8/18/11
Photo No.: 24
Direction: West
Comments: Taken from southern central boundary of wetland mitigation site

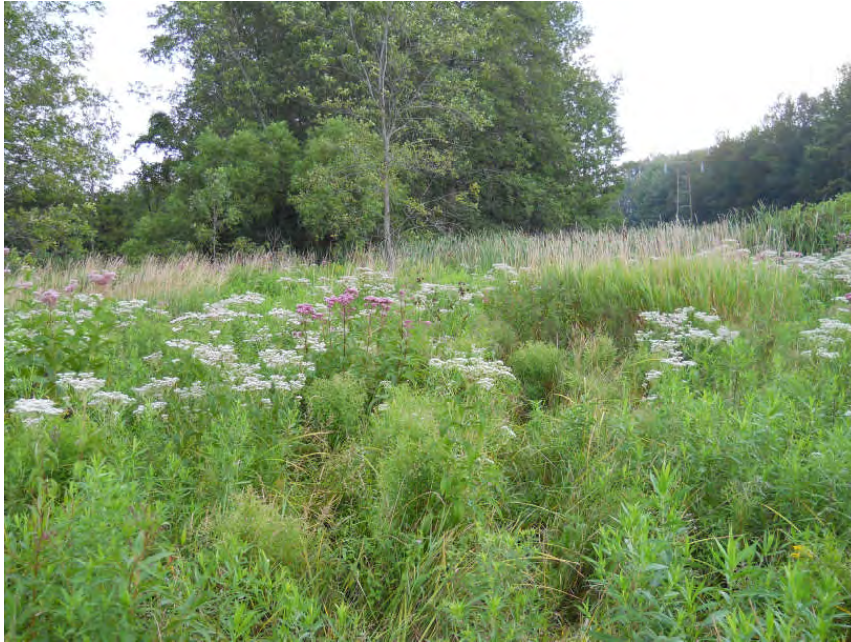
Photographer: B. Eckwahl
Date: 8/18/11
Photo No.: 25
Direction: East
Comments: Taken from southern central boundary of wetland mitigation site
