**CENTRAL HUDSON GAS & ELECTRIC
CORPORATION**

CONTACT (STRAY) VOLTAGE TESTING

FACILITY INSPECTIONS

2016 Contact (Stray) Voltage Testing and Facility Inspections

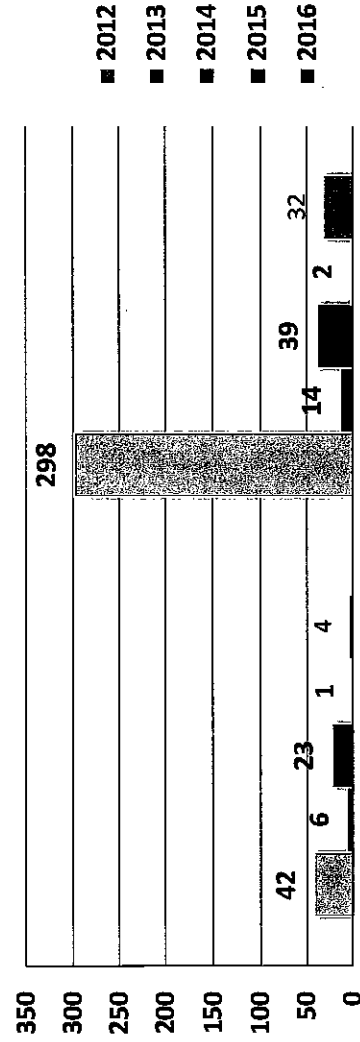
Summary of Harmonics Analysis 2012 - 2016

Asset Class	Total Findings (2012 - 2016)		
	Cat. 1	Cat. 2	Cat. 3
Overhead Distribution	60	355	1
Underground (Non-URD)	0	0	0
URD (Pads)	3	3	0
Street and Traffic Lights	13	1	0
Transmission Overhead	0	26	0
Substation Fences	0	0	0
Total	76	385	1
