Orange & Rockland

**Preparation and Restoration Performance Report
Tropical Storm Isaias
(Matter 20-01633)**

August 4 – August 11, 2020

October 13, 2020
Pearl River, New York

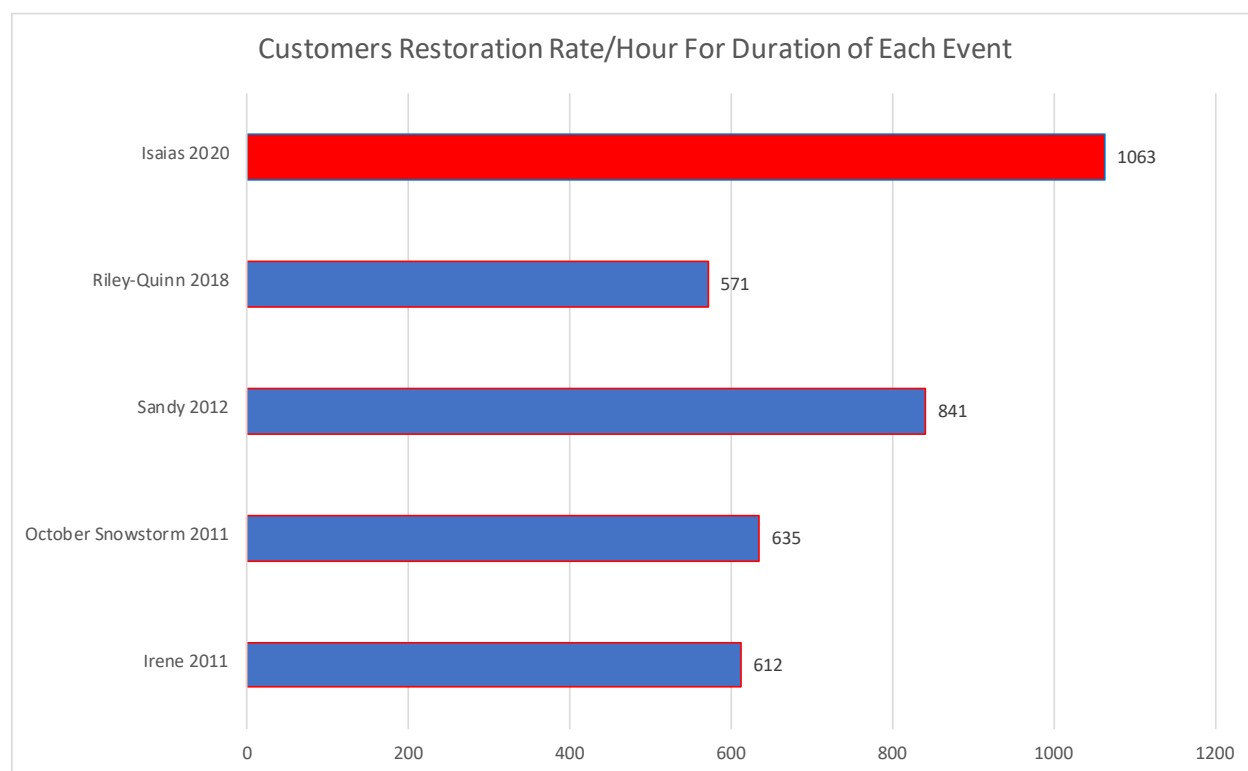
Figure 1 - Hourly Restoration Rates – Major Events Affecting Greater Than 100,000 Customers

Despite the significant damage to the O&R distribution system resulting from Isaias, improvements such as ongoing infrastructure investments; the integration of Automated Metering Infrastructure (“AMI”) into the Company’s outage management system (“OMS”); lessons learned from previous major events; and organizational enhancements to its Incident Command System (“ICS”) allowed the Company to achieve its best customer restoration rate of any major event affecting greater than 100,000 customer in the past 20 years. The 1,063 customers restored/hour for Isaias exceeded the Company’s next best performance (Superstorm Sandy in 2012) by 26% and exceed its performance during last major event to hit the O&R service territory (Winter Storms Riley and Quinn in 2018) by 86% (see Figure 1 below).

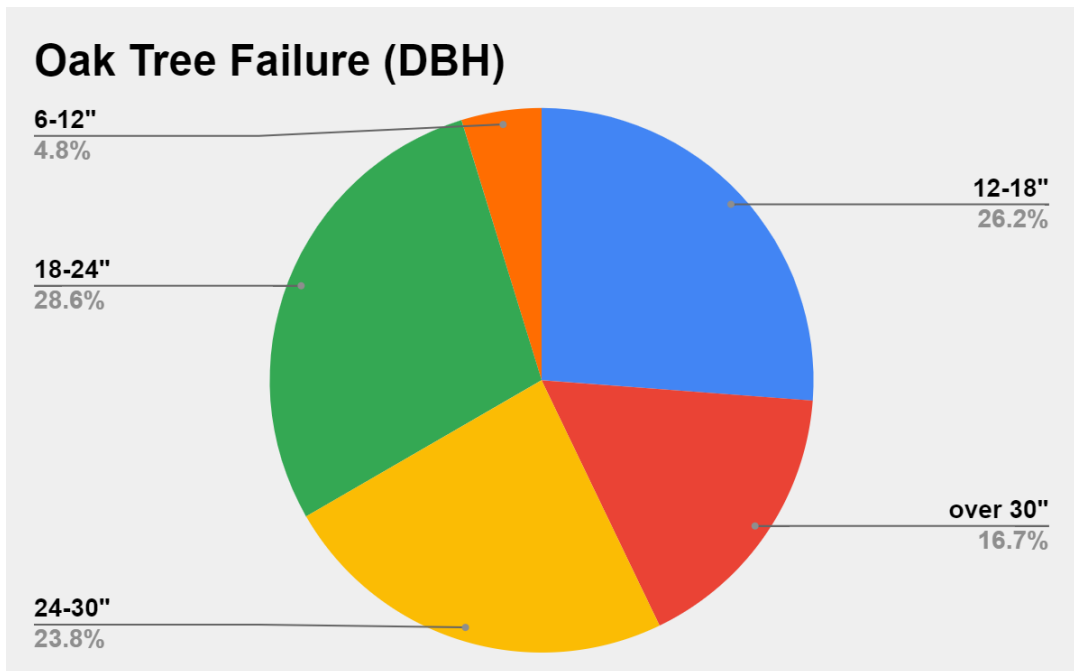
Figure 6 – Oak tree failures (70% > than 24" DBH indicating mature trees)

According to this investigation, the species identified most often with tree failures was oak, with root failure being the primary cause. It is important to note that the oaks with a diameter

between 18 inches and 24 inches accounted for only 30% percent of oak failures (see Figure 6 below). Mature oak trees close to their full growth potential made up about 70% of the failure type, which helps to explain the large amount of damage caused by Isaias. The various oak tree failures by type are set forth in Figure 7 below.

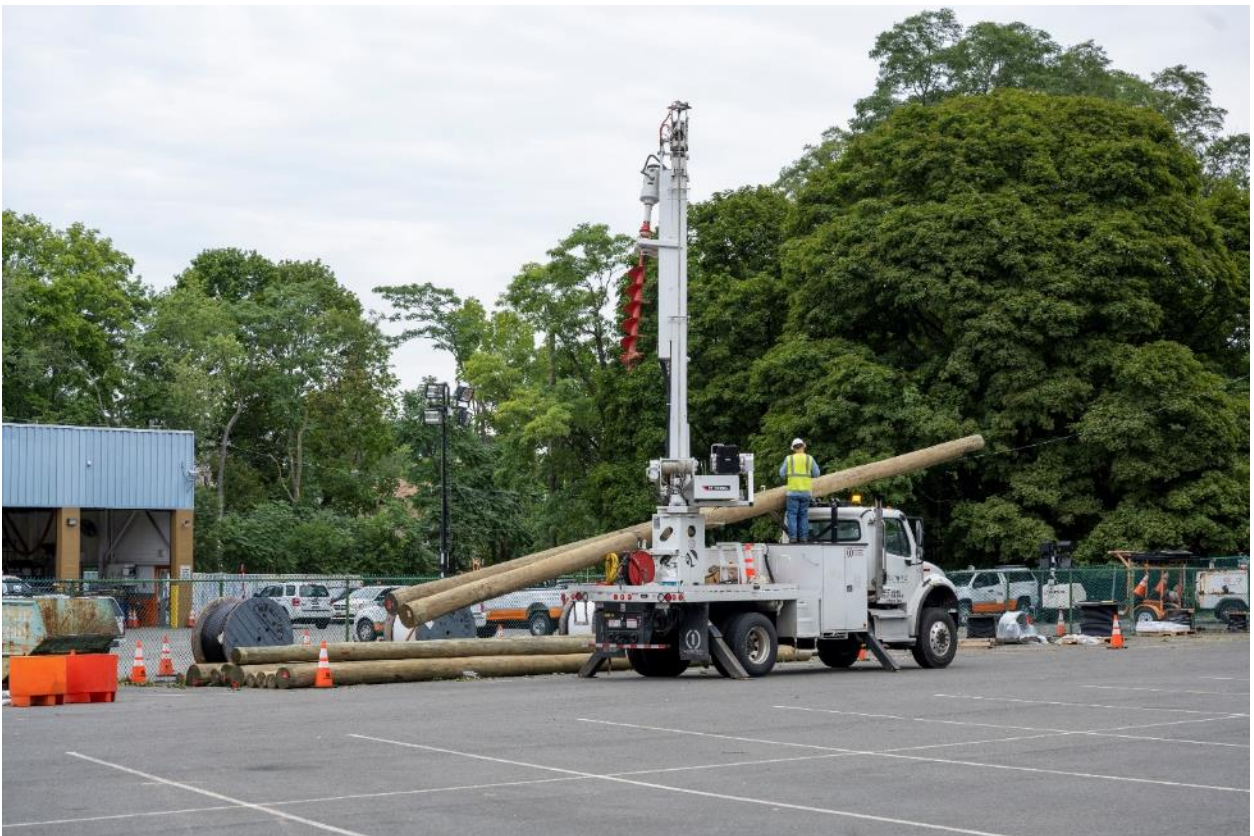
Photo 11 - Materials Staging Area – Spring Valley Operations Center

The Company established material laydown areas at its Spring Valley Operations Center and at the Sheraton Crossroads Hotel in Mahwah, New Jersey to support its restoration efforts. Both locations had similar materials on hand for the work crews including:

- Poles (45' and 50');
- Transformers (various sizes);
- Cross-arms;
- Wire (various sizes);
- Guy wire;
- Insulators;
- Sleeves;
- Anchors, pins, rods, braces; and
- Minor items (*e.g.*, bolts, pole hardware).

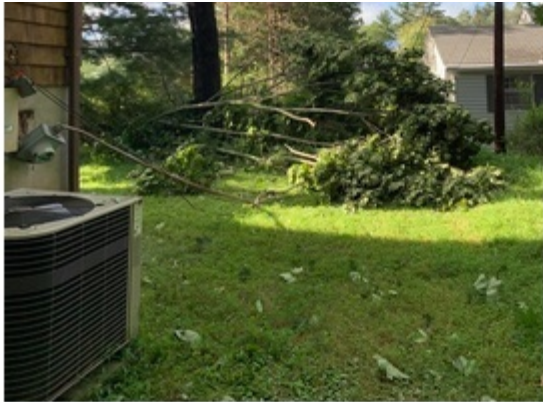
Hi ORU We have power but a branch fell on our service drop from the line to our house and so a live wire is on the ground. It ripped our meter halfway off the house. I need to know if it is dangerous to remain on the property. We know not to go near the wire. We obviously need someone to remedy this. Here's an image:
