THE FISHERS ISLAND WATER WORKS CORPORATION'S SHARED SERVICES WORK PLAN

Case 24-W-0146 Order issued 10/17/2024 follow
up filing

**FISHERS ISLAND
WATER DISTRICT
Fishers Island, New York
WATER CONSERVATION
ANNUAL REPORT**

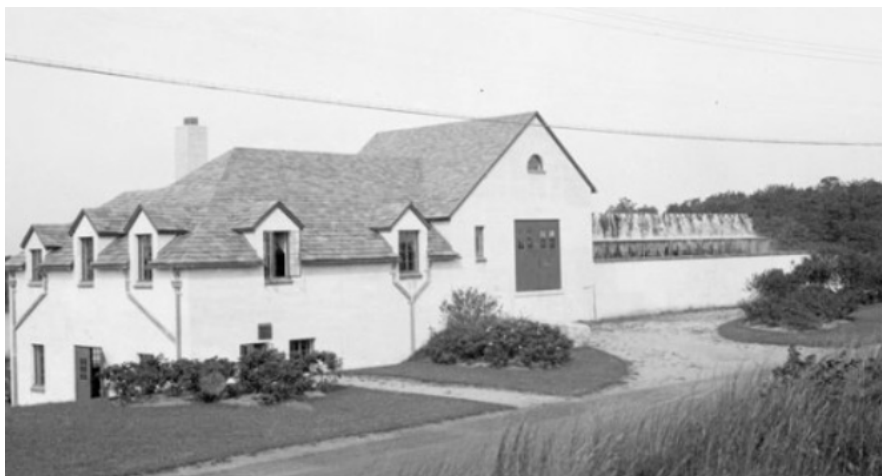
Completed Water Filtration Plant circa 1927

As part of the development of the east end, a Filtration Plant was built in 1927 to treat, filter and chlorinate the Island’s lake-based water supply. The Filtration Plant remains on “stand by” status, but is still used in July,, August and September to augment the well system.

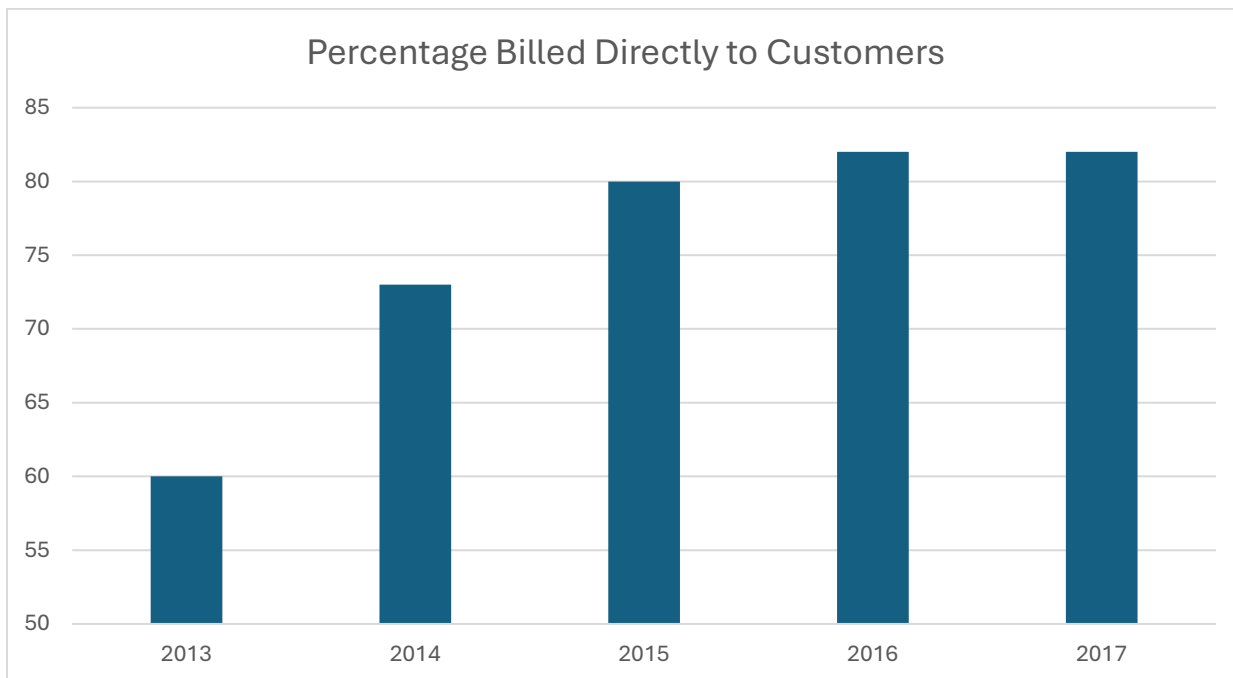
Year over year, Fishers Island WaterWorks has consistently improved its efficiency in delivering water to our customer base. Below is a chart illustrating this improvement by exhibiting over a 20% improvement in water distribution over a 5-year span. As a point of interest, this improvement reflects our historic water conservation successes even before the customers gets the water distribution.

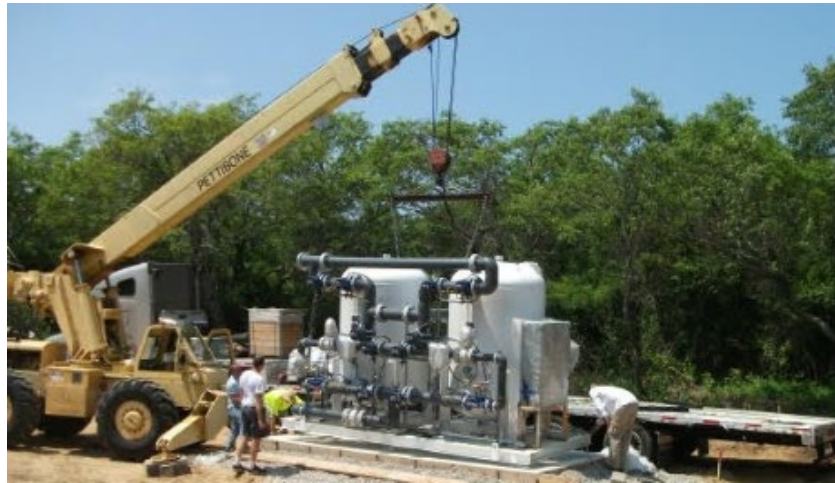
Fishers Island Water Works' new filtration machine, arrived on July 17, 2018. After installation is completed, the filtration system will process all of the island's water producing incredibly clean and pure drinking water while concurrently improve overall well output. Ultimately a building will be built around the system to adequately protect it.

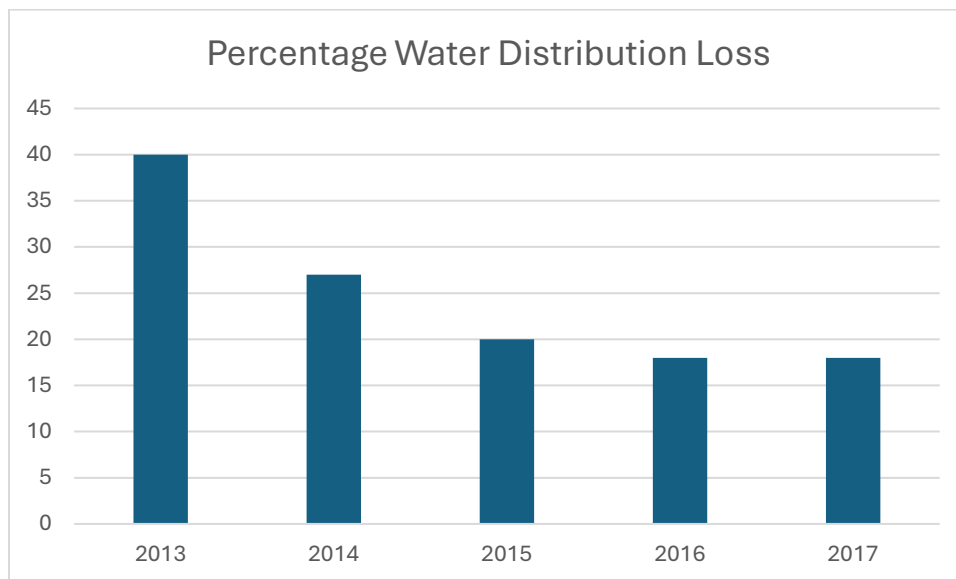
Unbilled water loss in 2013 was 40%, 2014 was 27%, 2015 was 20% and for 2016 and 2017 was 18%.
