Re: Case 04-M-0159 – Proceeding on Motion of the Commission to Examine the Safety of Electric Transmission and Distribution Systems – 2014 ANNUAL REPORT

Niagara Mohawk Power Corporation
d/b/a National Grid

Stray Voltage Testing and Facility Inspection

2014 Annual Report

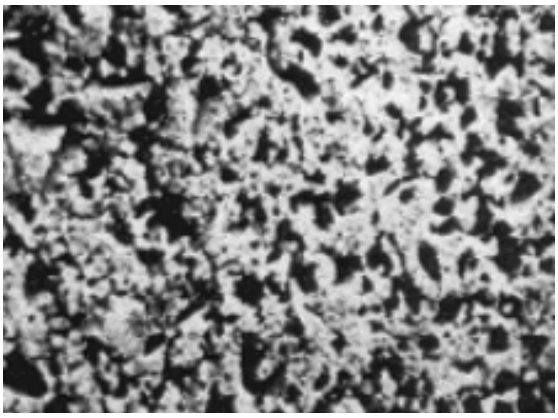
Pattern Cracking

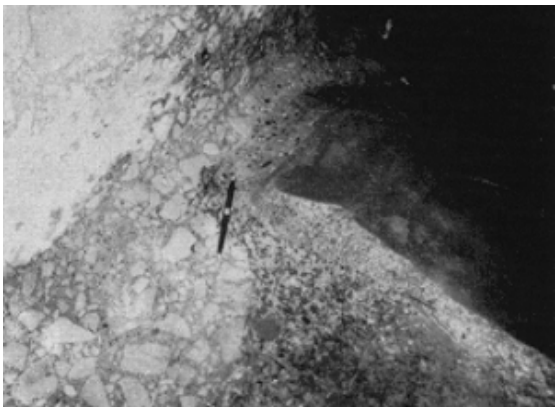
Disintegration
Deterioration of concrete into small fragments

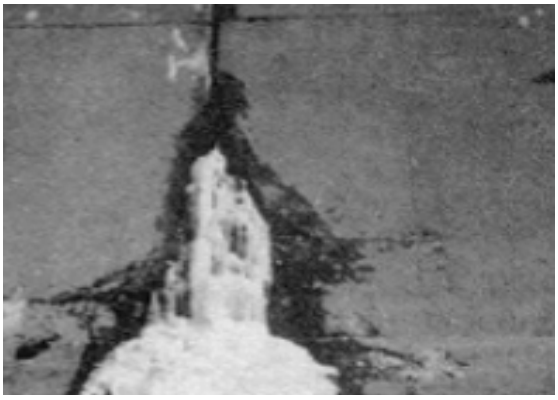
Erosion/Abrasion

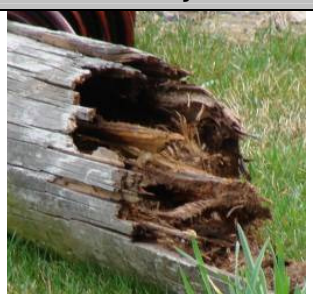
Typical Pole Defects		
Bark Inclusion	**Checking (Solitary)**	**Checking (Around Periphery of Pole)**

The growth of the main stem around a dead branch	The separation of fibers parallel to the grain and extending towards the center of the pole	Multiple checks around entire pole circumference
Cross Break	**Mechanical Damage**	**Split**

The separation of fibers perpendicular or at an angle to the grain	Transportation and erection damage due to machinery such as chainsaws or cranes	The cracking of a pole due to mechanical connections or the intersection of checks
Dead Streak	**Decay**	**Decay Knot**
The growth of the main stem around the dead wood

The softening of the pole due to fungal growth	Knots which have decayed and can extend towards the center of the pole
Pocket		
A Solitary Check, a series of checks at one location, or area of decay at the surface of the wood pole

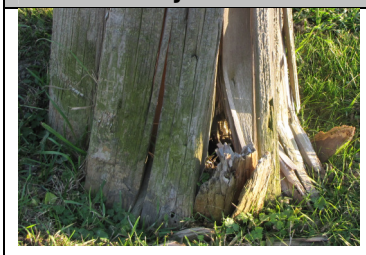
- Used for physical damage which compromises the strength and/or integrity of the pole (checking, dead streak, bark inclusion, cross break, decay, burning, hollow sounding pole)

Damage poses significant risk of imminent failure	N/A	N/A	 All Others

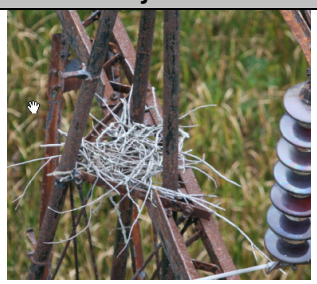
- Used when bird nests are found on line

Bird nest in Inspector's judgment poses and immediate and substantial risk to public safety and/or system reliability	N/A	 Limited risk of bird contact but nest should be removed	No risk of contact such as very small nests or those at bottom of structure
