Re: Case 04-M-0159 – Proceeding on Motion of the Commission to Examine of the Safety of Electric Transmission and Distribution Systems – 2019 ANNUAL REPORT

Stray Voltage Testing and Facility Inspection

2019 Annual Report

Report on the results of stray voltage testing and facility inspections
for the 12-month period ended December 31, 2019

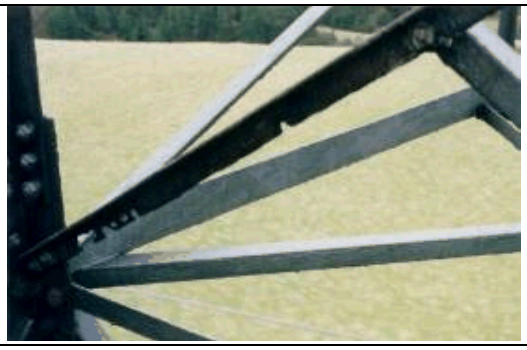
Rating 6 – "Very Severe Deterioration" Perforated Element – severe physical damage	Rating 5 – "Significant Pitting" Significant pitting – loss of section clearly visible, edges feathered/thinned

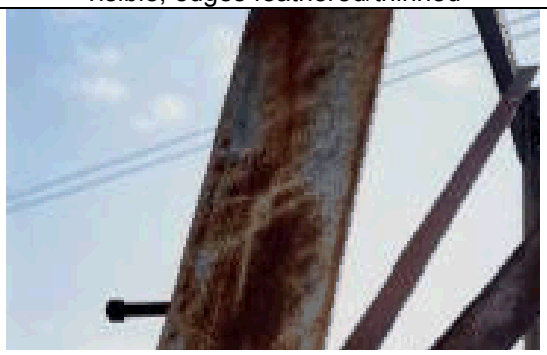
Rating 4 – "Light Pitting" Some very light edge roughening. Loss of greater majority of coating and zinc layers. Corroded surface would dominate surface preparation – remedial action using wire brush, scraper and brushed paint not sufficient to give greatly increase life	Rating 3 – "Light Corrosion" Very light surface corrosion, majority of coating intact

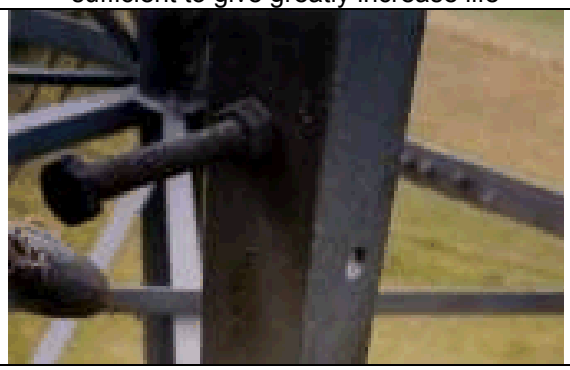
Rating 2 – "Intact" Paint coating over all surface – overcoat may not be intact and some very small areas (<1%) of light corrosion may be present. Galvanizing intact except for some very small areas (<1%) of light corrosion	Rating 1 – "Serviceable" Fully painted – overcoat and undercoat intact Fully galvanized – coating intact

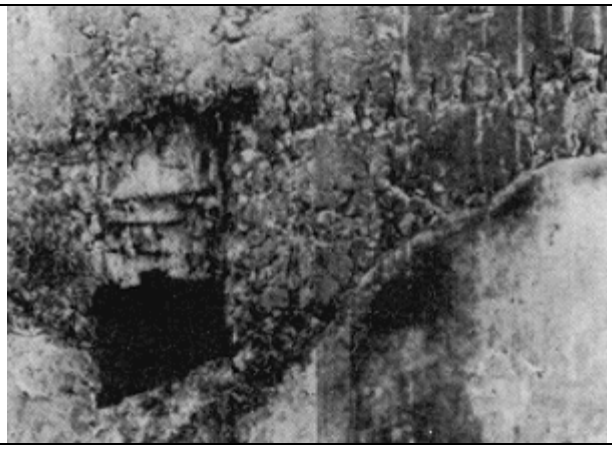
Honeycombing Construction faults, poor workmanship	Pattern Cracking

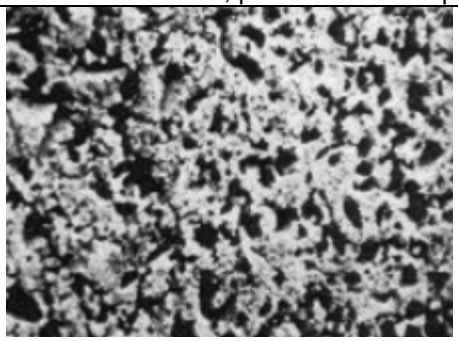
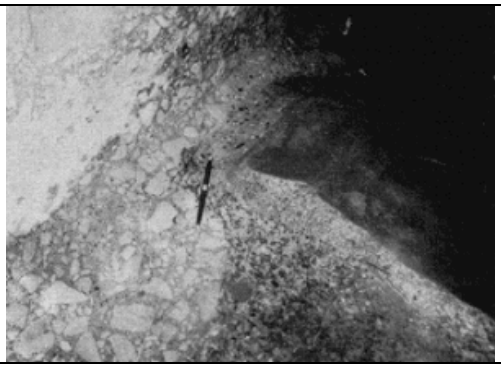
Disintegration Deterioration of concrete into small fragments	Erosion/Abrasion

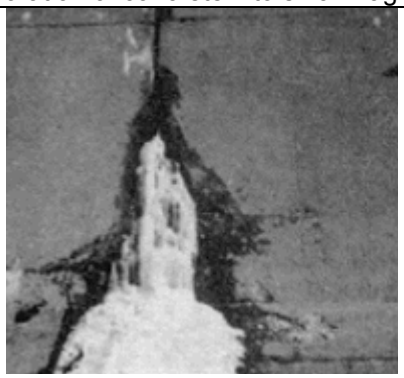
Seepage Movement of water or other fluids through pores	Spalling Development of fragments
Distortion or Movement Change in alignment of the components of a structure	Delamination Degradation of steel/concrete interface

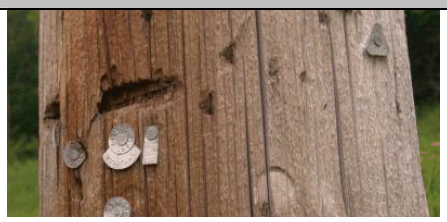
Typical Pole Defects		
Bark Inclusion	**Checking (Solitary)**	**Checking (Around Periphery of Pole)**

The growth of the main stem around a dead branch	The separation of fibers parallel to the grain and extending towards the center of the pole	Multiple checks around entire pole circumference
Cross Break	**Mechanical Damage**	**Split**

The separation of fibers perpendicular or at an angle to the grain	Transportation and erection damage due to machinery such as chainsaws or cranes	The cracking of a pole due to mechanical connections or the intersection of checks
Dead Streak	**Decay**	**Decay Knot**
The growth of the main stem around the dead wood	The softening of the pole due to fungal growth	Knots which have decayed and can extend towards the center of the pole
Pocket		
A Solitary Check, a series of checks at one location, or area of decay at the surface of the wood pole
