STATE OF NEW YORK
DEPARTMENT OF PUBLIC SERVICE

Case 14-G-0201

Investigation of
Natural Gas Explosion and Collapse of the Buildings
1644 and 1646 Park Avenue, New York, NY
March 12, 2014
Consolidated Edison Company of New York, Inc.

Safety Section
Office of Electric, Gas & Water
Final Report November 12, 2015

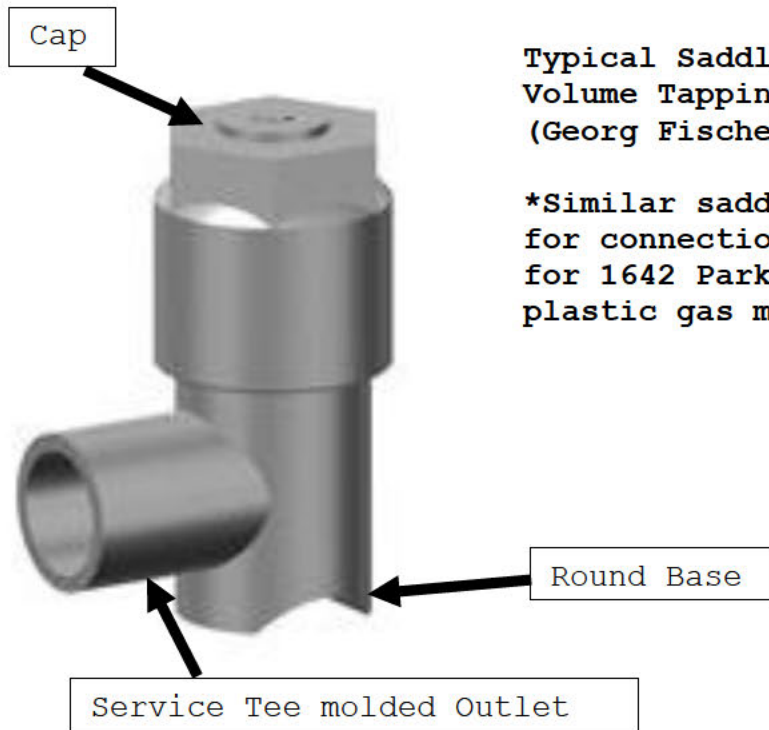
Typical Saddle Fusion Fitting: High Volume Tapping Tee with Large Round Base (Georg Fischer HVTT2LRB) .

*Similar saddle fusion fitting was used for connection of the gas service line for 1642 Park Avenue onto the 8-inch plastic gas main.

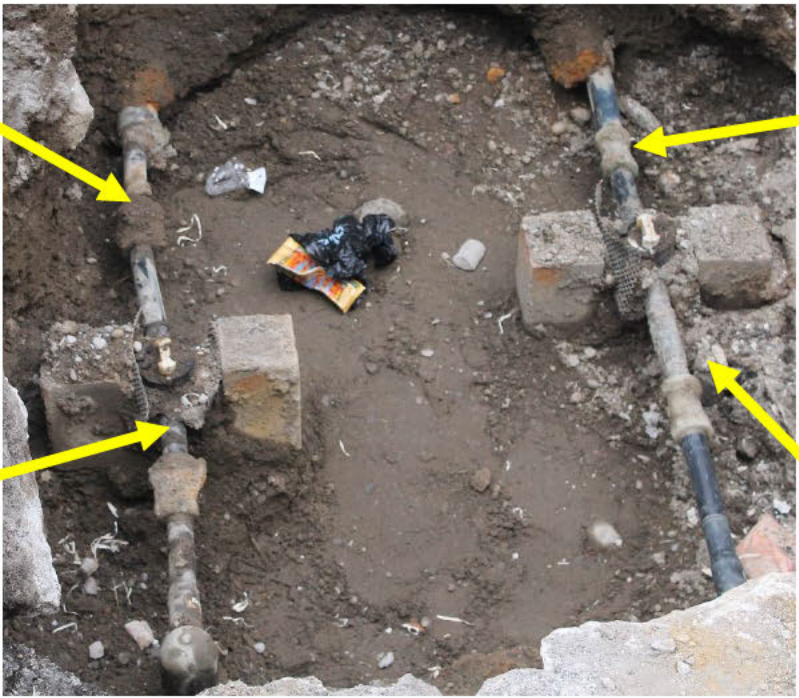
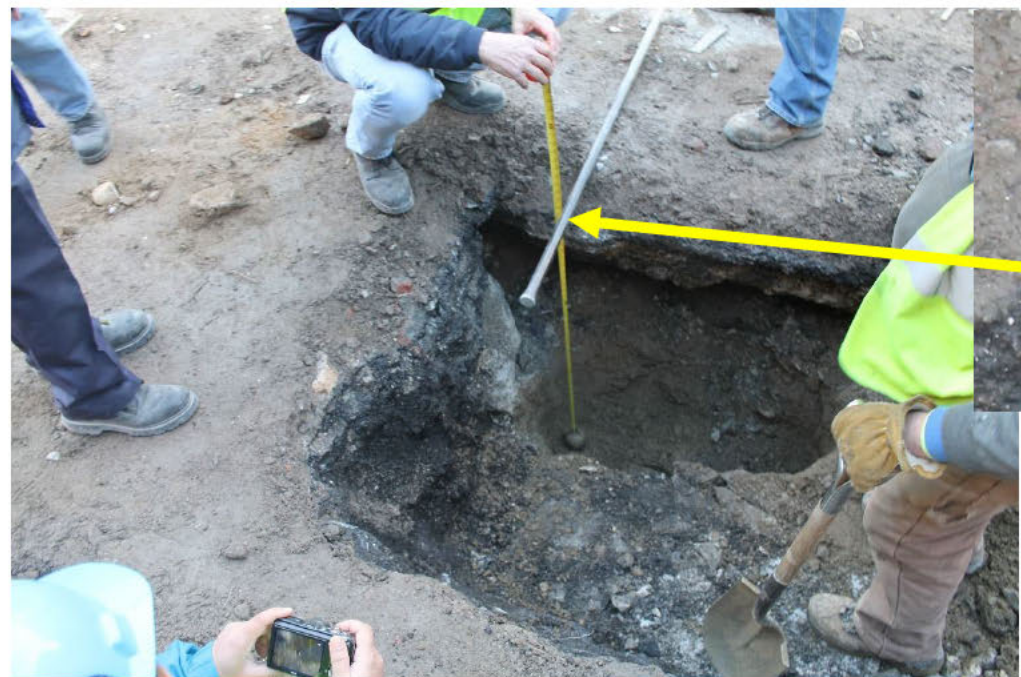
Figure 2a: 1644 and 1646 Park Avenue gas services

The gas service lines to the buildings at 1644 and 1646 Park Avenue, next door to 1642, were comprised of 1-1/4 inch copper tubing with short sections of plastic tubing at the connection to the 8 inch cast iron gas main (See Figure 2a below). At the time of the incident, the average operating pressure of those gas main and service lines was 7.7 inches of W.C., which is typical for Manhattan's low pressure distribution system.

1646 Park Avenue copper gas service from plastic to Head of Service Valve

1646 Park Avenue plastic gas service from gas main to copper

¹⁹ This is when DPS Staff first observed that both service lines for 1644 and 1646 Park Avenue consisted of approximately 4 feet of 1-1/4 -inch plastic pipe with a plastic tap to the main and a plastic curb valve which then transitions to 1-1/4 -inch copper service up to the head of service valves. This is inconsistent with CECONY's maps. See Figure 2a.

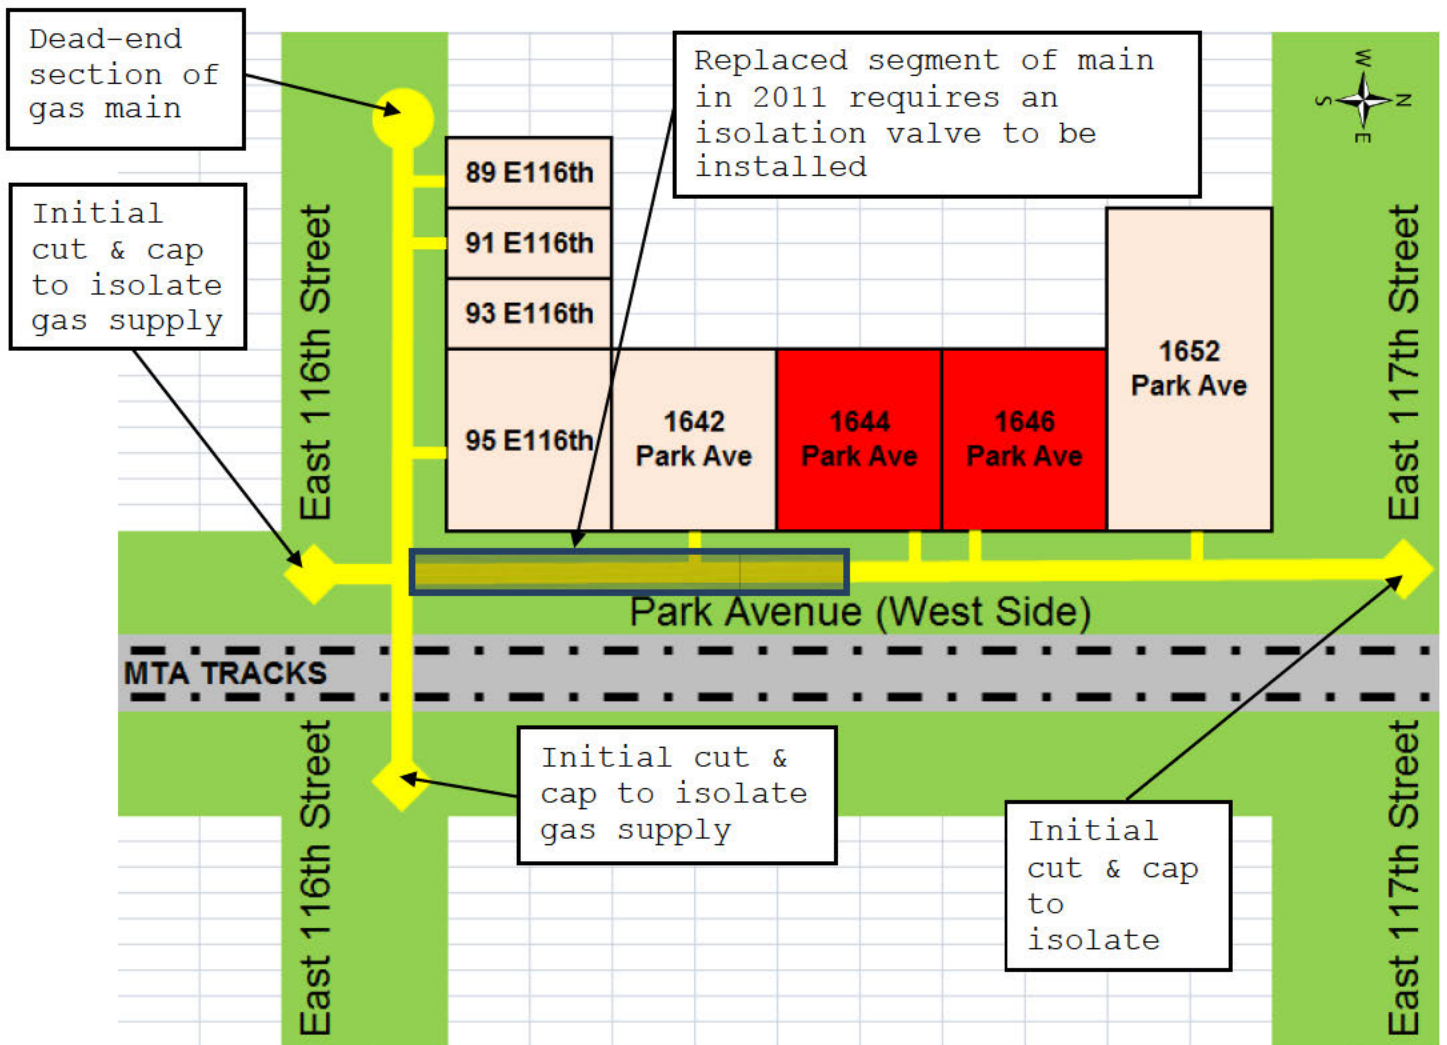
Figure 3 - Gas main isolation to the incident site¹²

¹² This diagram was generated by DPS Staff and, while it illustrates the locations of the cut and cap operations and the gas service at the site of the explosion, it is not drawn to scale.

gas main and services supplying the incident area.¹⁸ The pipeline system tested was limited to the main and services shown in yellow in Figure 3, with isolation points at initial cut and cap excavations and at the individual meter outlets or head of service connections. The initial test of the gas main in the incident area failed, meaning that it was unable to maintain pressure at 8 inches of W.C. After the failure, a tracer gas was introduced into the system in order to identify and locate any leaks. A few indications of tracer gas over the gas main were identified on Park Avenue between East 116th and East 117th Streets, indicating the presence of leaks. A collaboration of parties (NTSB, PHMSA, NYSDPS, FDNY, NYPD, OEM and CECONY) developed a plan to segment the system into smaller sections and conduct individual pressure tests of each section with priority given to sections of gas main that had tracer gas indications. A full list of pressure tests and test details are listed in Appendix B.

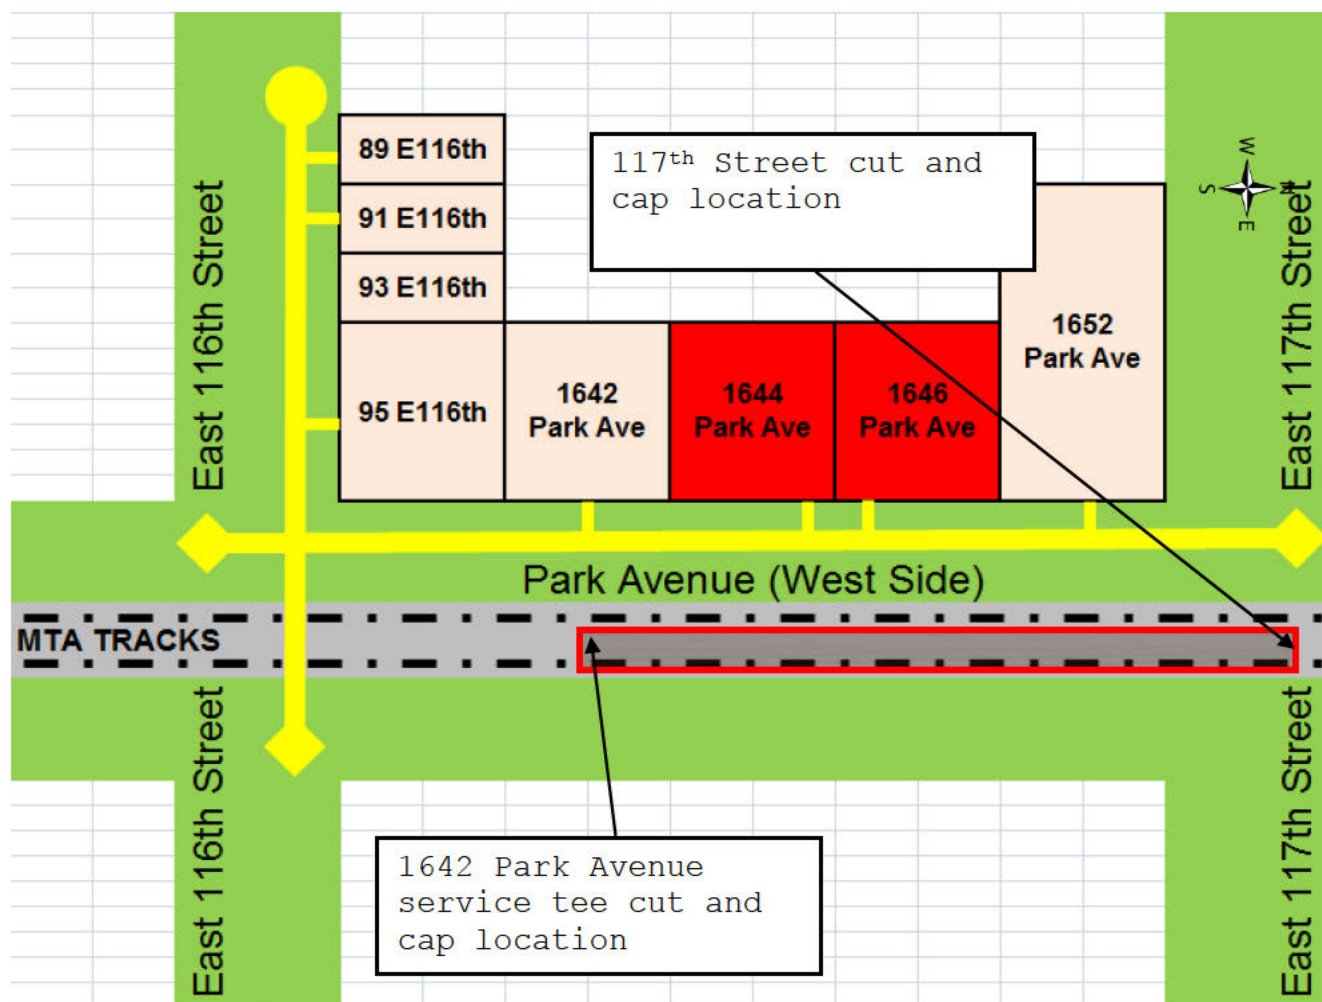
Figure 8 - Segment of main (red lined) pressure tested from 1642 Park Avenue service tee cut and cap location to the initial cut and cap location at 117th Street and Park Avenue.

Because the segment of main spanning from the 1642 Park Avenue building service tee cut and cap location to the corner of East 117th Street (See Figure 8 below) failed the post-incident pressure test, investigators decided to excavate all of the services between East 116th and East 117th Streets, including the transition coupling between the 8-inch plastic and cast iron gas main (see Figure 22).

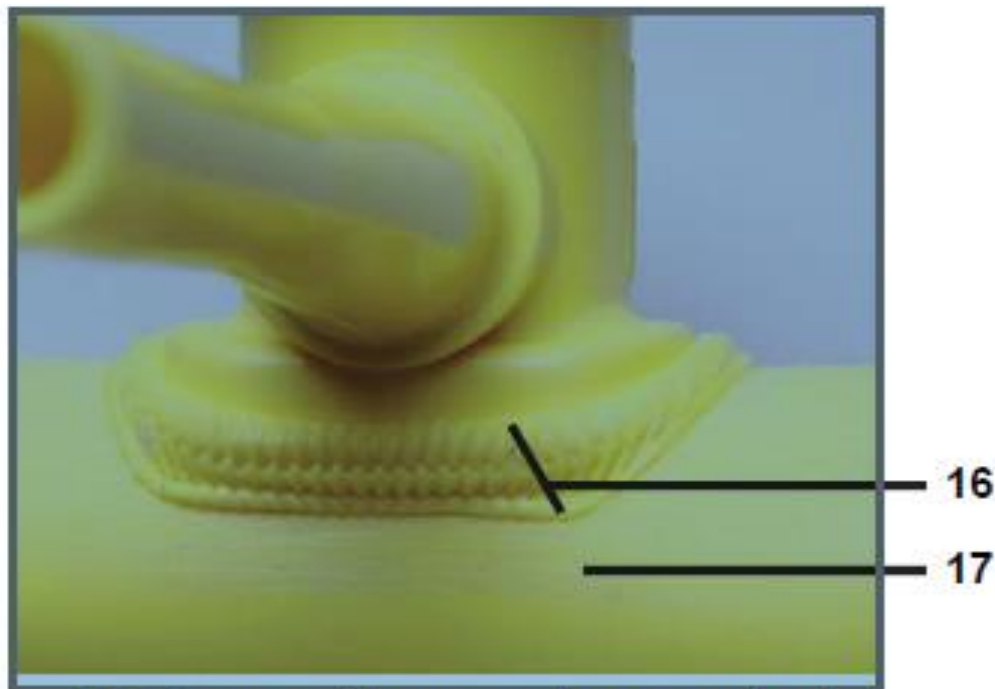
**Figure 12 - Acceptable fusion criteria per Plastics Pipe Institute
- TR-41/2002. Shown using MDPE example for visual effects.**

The manufacturer of this type of plastic tee assembly, Plastics Pipe Institute, provides guidelines for correct installation. The guidelines reference TR-41/2002 in G-8123-12 as the standard for evaluating acceptable saddle fusion joints during a visual inspection.²¹ As shown in the photographic image of an acceptable saddle fusion, three uniform and distinct melting beads should be formed at the base of the service tee and around the entire joint (see Figure 12 below).

16. Proper alignment, force and melt
17. Proper pipe surface preparation

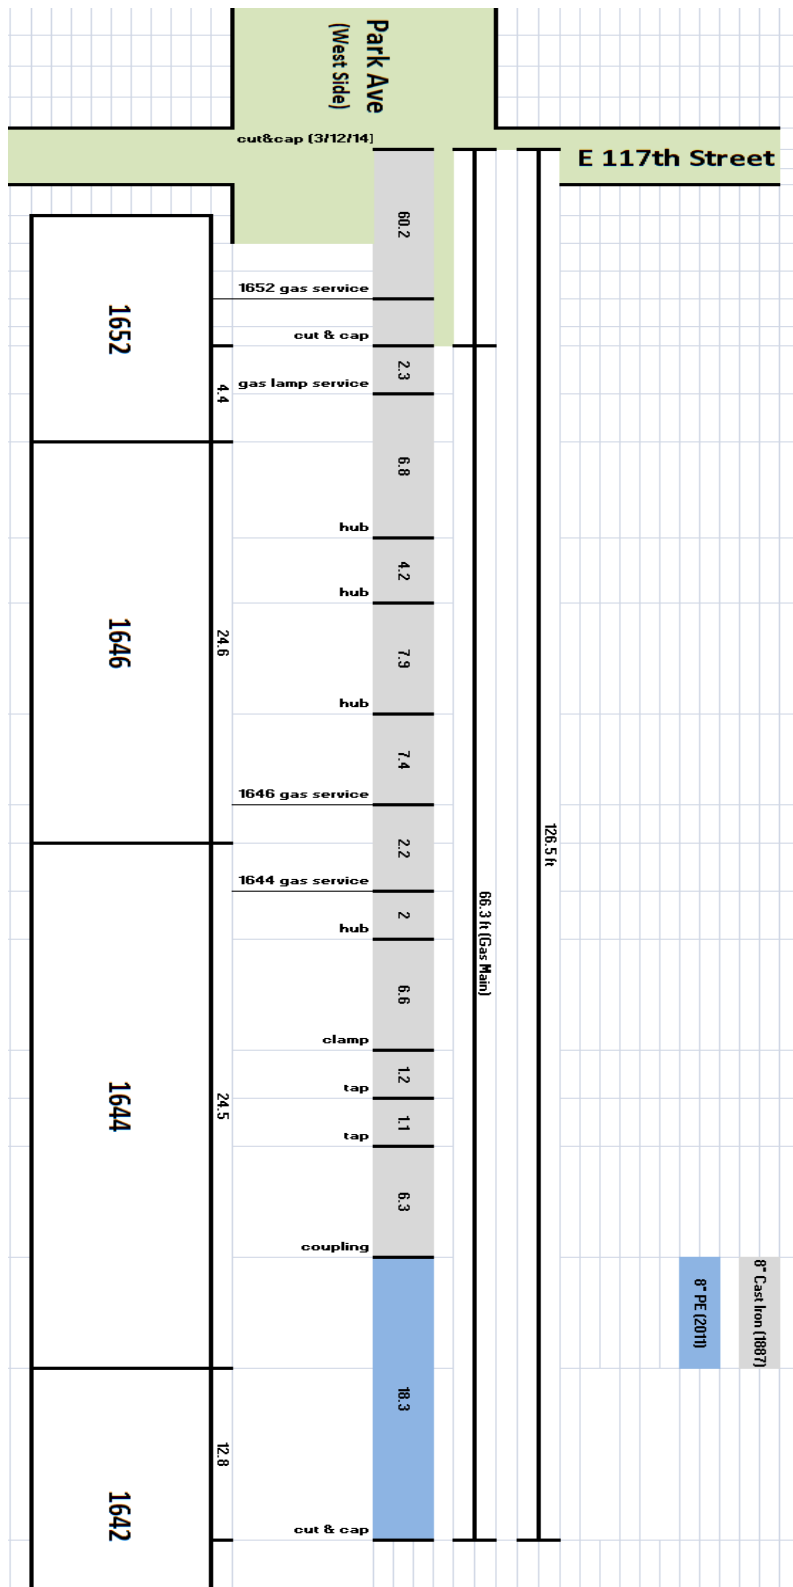
Figure 22 - Natural gas main pressure test layout (not to scale).

- 1) Pressure tested from East 117th Street and Park Avenue initial cut and cap to cut and cap in front 1642 Park Avenue, including both services for 1644 and 1646 Park Avenue, as well as cut and capped segment of service line for 1652 Park Ave. Pressure was introduced from East 117th Street; pressure chart recorders were placed in front of 1642 Park Avenue.
