# Eight Point Wind Feasibility Assessment

Performed on December 1<sup>st</sup>, 2016 by:

## EIGHT POINT WIND FEASIBILITY ASSESSMENT

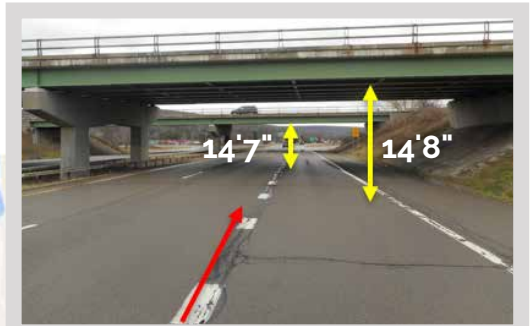
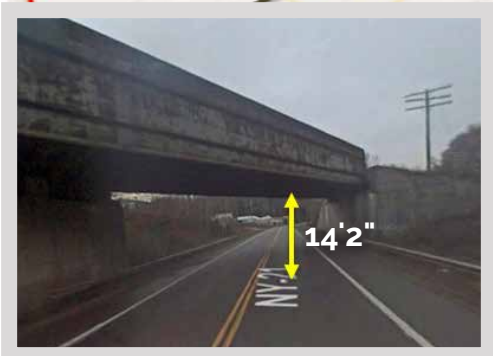
NY21 rail overpass in Alfred Station

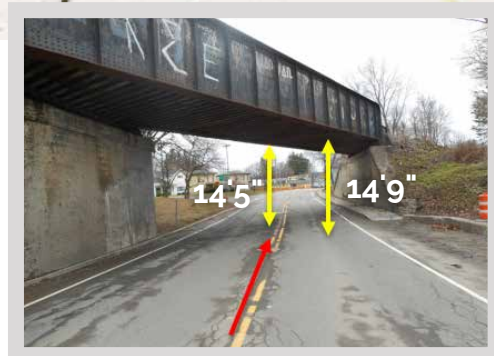
NY417 train overpass in Wellsville

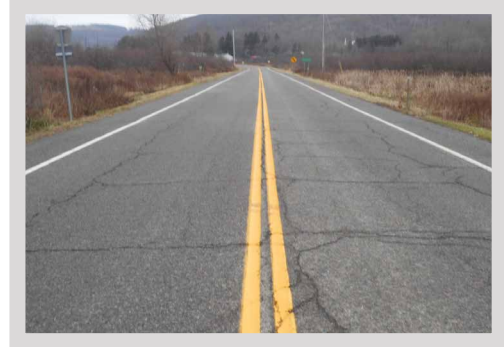
Width – Two lane State Highway, approx. 40ft wide

Material – Asphalt in good condition

Risk Level – grades up to 10%

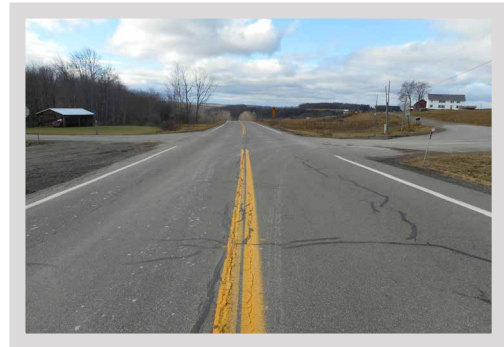
Width – Two lane Steuben County, approx. 25ft wide

Material – Asphalt in good condition

Risk Level – grades up to 8%, line of sight poor

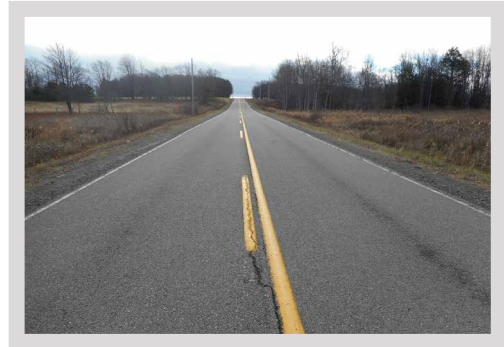
Width – Two lane Steuben County, approx. 21ft wide

Material – Asphalt in decent condition

Risk Level – grades up to 8%, line of sight poor

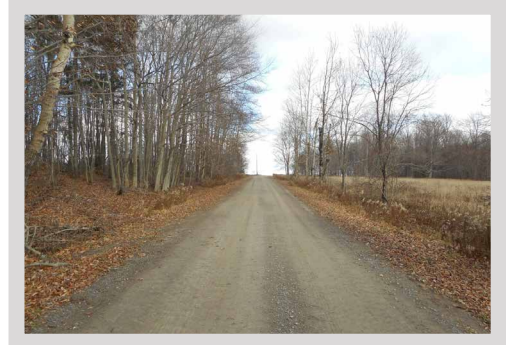
Width – Single Lane County Road, approx. 22ft wide

Material – Dirt/Gravel mix (seasonal road)

Risk Level – Soft Road and Shoulders

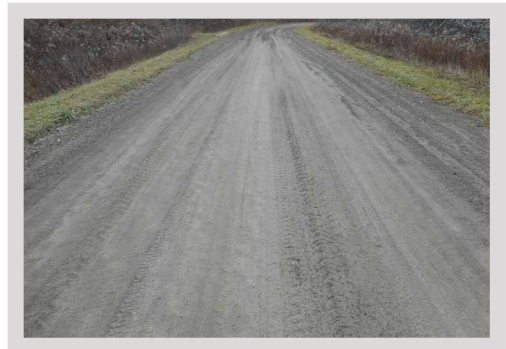
Material – Compacted Gravel/Dirt

Risk Level – Soft Road/Shoulders, grades up to 6%

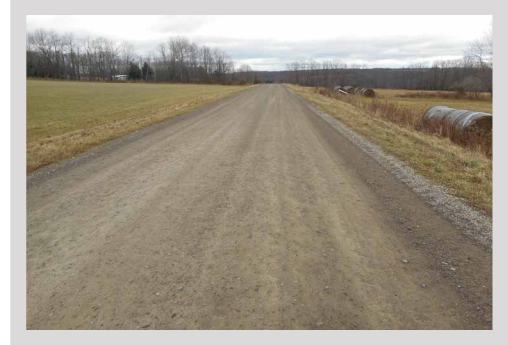
### SECONDARY ROAD - IRISH HILL ROAD

Width – Single Lane County Road, approx. 20ft wide

Material – Compacted Gravel/Dirt

Risk Level – Soft Road/Shoulders

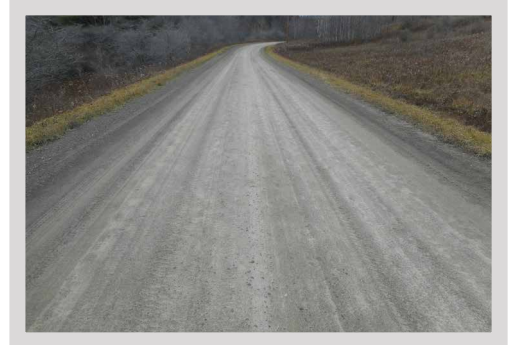
### SECONDARY ROAD - SHAMROCK ROAD

Width – Single Lane County Road, approx. 28ft wide

Material – Compacted Gravel

Risk Level – Soft Road/Shoulders

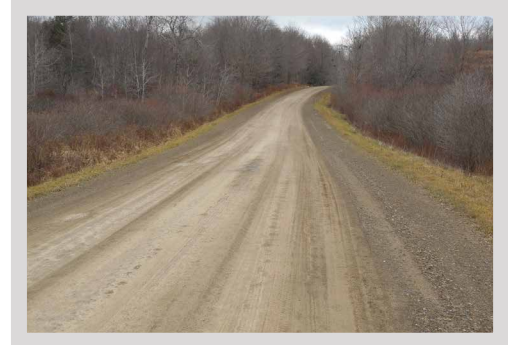
### SECONDARY ROAD - SANDERS ROAD

Width – Single Lane County Road, approx. 21ft wide

Material – Compacted Gravel/Dirt

Risk Level – Soft Road/Shoulders

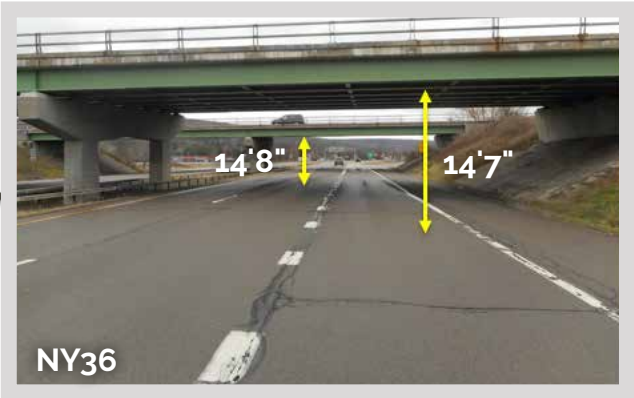
Intersection of NY36 and NY248 in Canisteo measured 135ft, however has limitation. 67.2m Blade CANNOT travel through here.

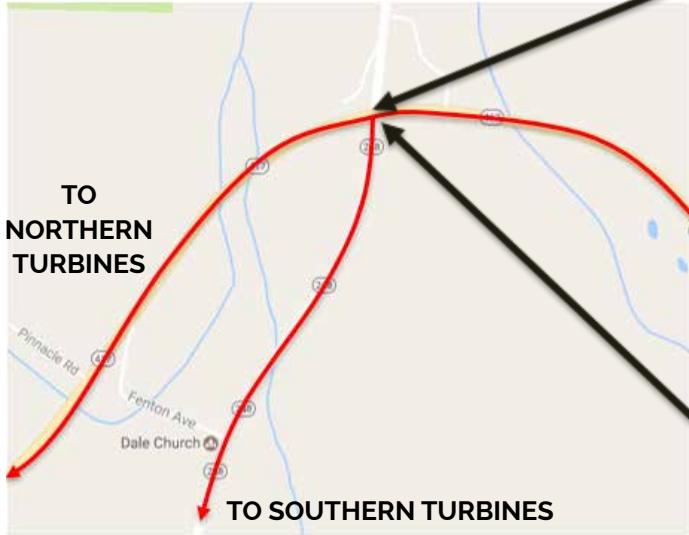
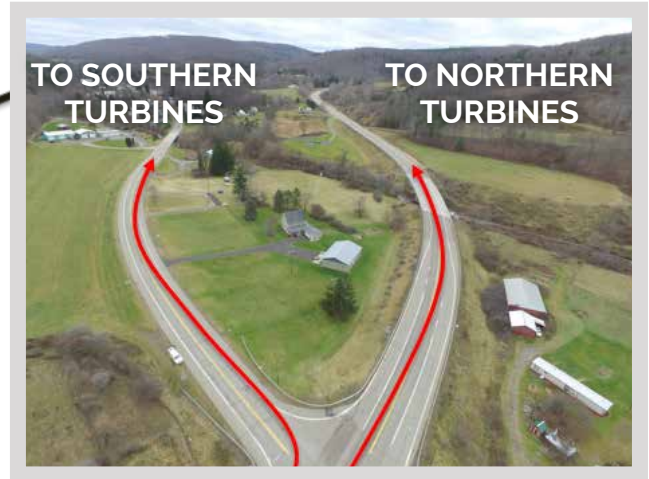
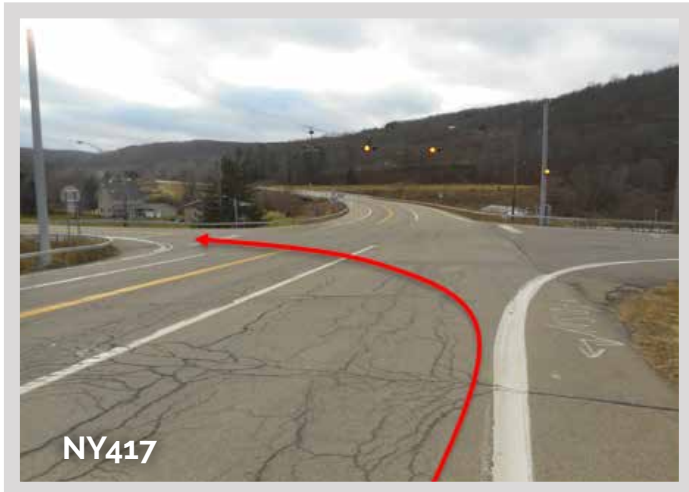
Split in Greenwood of NY417 and NY248.

Intersection of NY417 and NY248, measured 135ft  
- signage will need to be removed

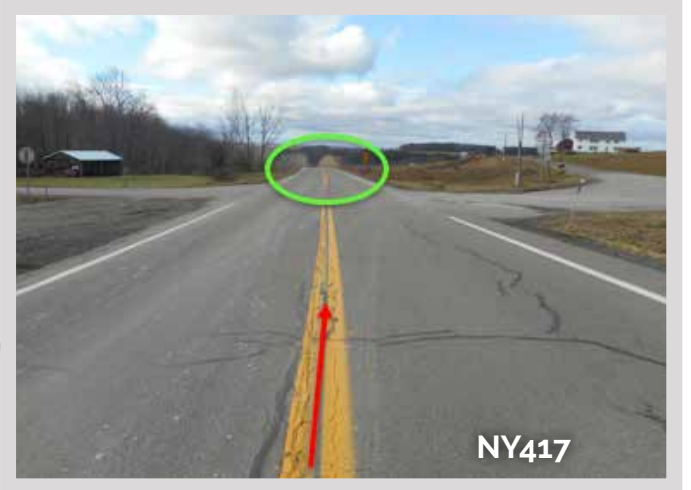
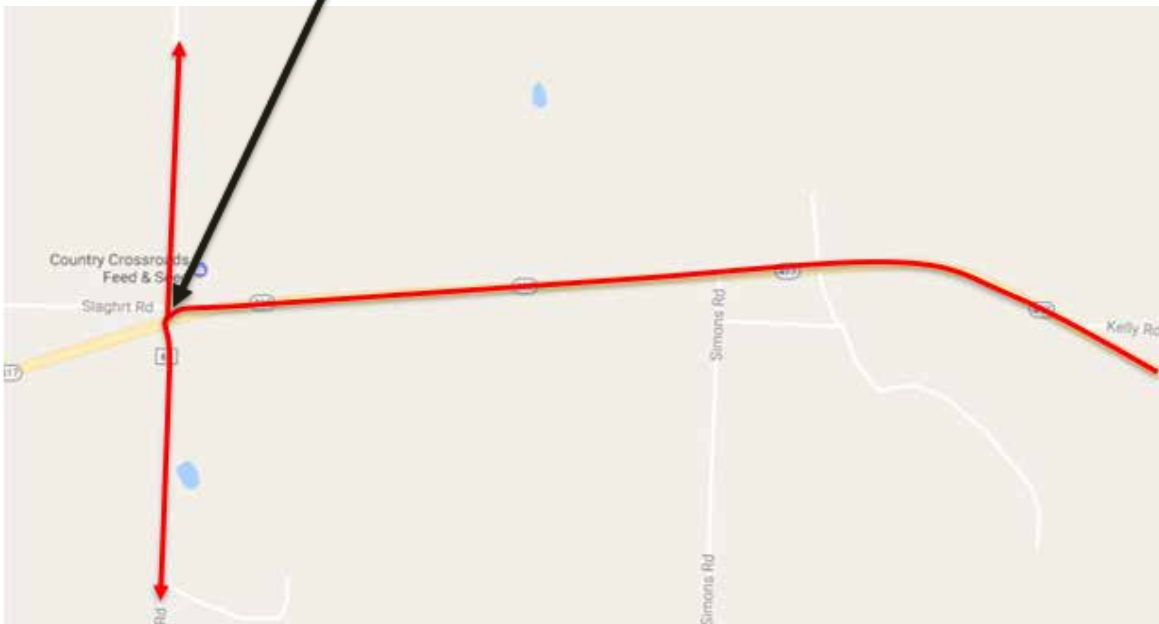
Intersection of NY417 and CR61, measured 135ft to the south and 115ft to the north. Northeast area needs to be modified along with removal of signage. Poor line of sight to the west on NY417 – traffic control needed

Intersection of NY417 and CR61Northeast area needs to be modified along with removal of signage. Poor line of sight to the west on NY417 – traffic control needed

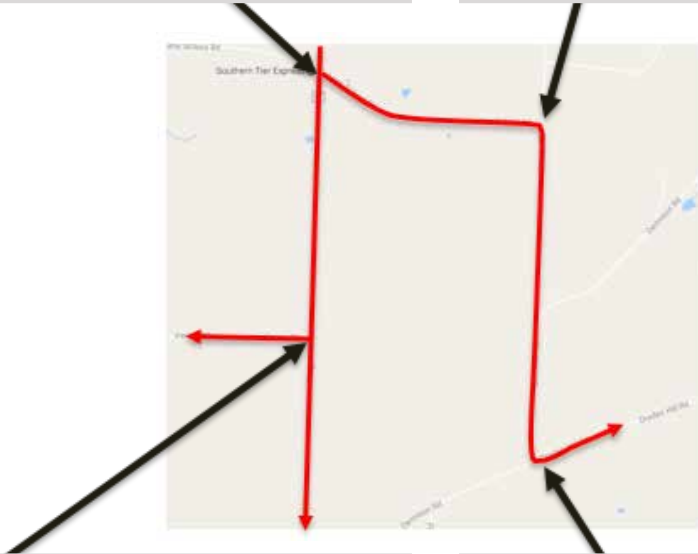
Intersection of Lane School Road and Simmons Road measured 120ft, southwest corner needs to be modified.

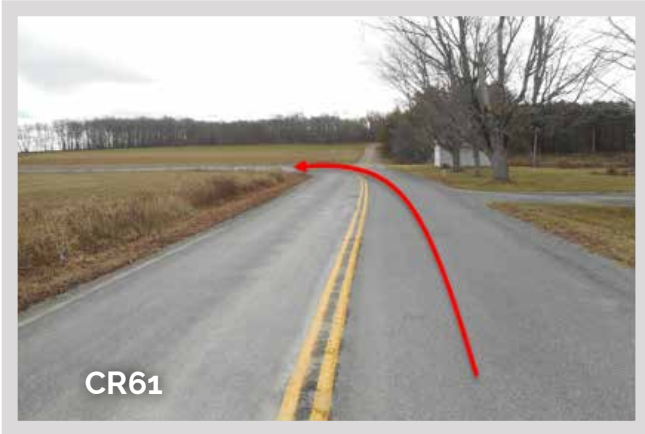
Bend in County Road 61, no issues

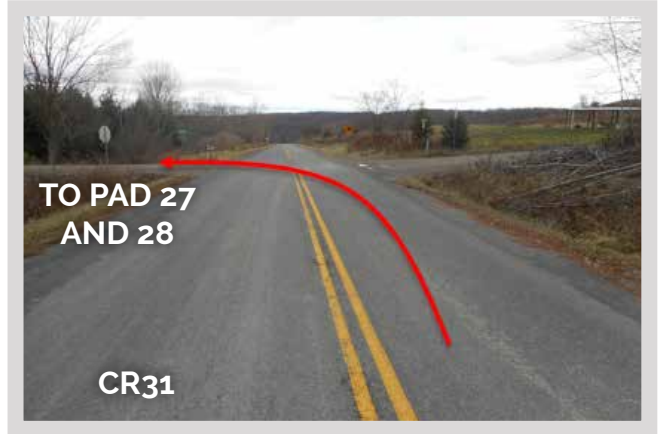
Intersection of County Road 31 and Friar Road, measured 90ft

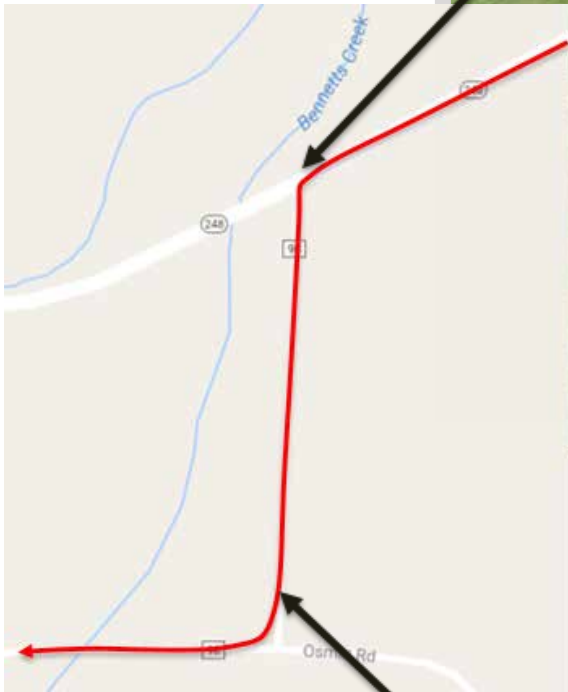
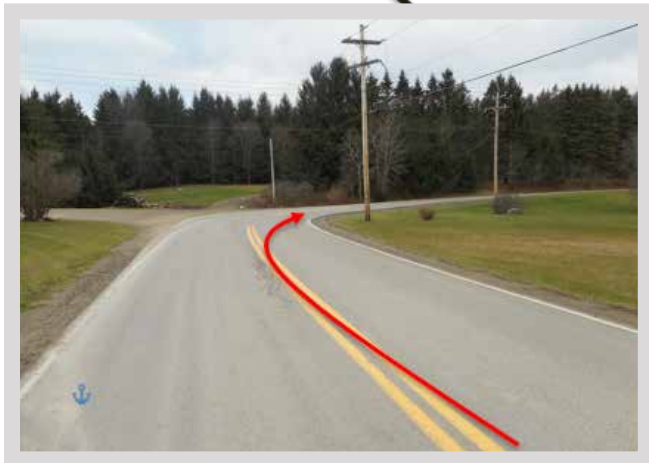
Intersection of NY248 and CR98, measured 120ft – southeast corner needs to be modified with signage removed

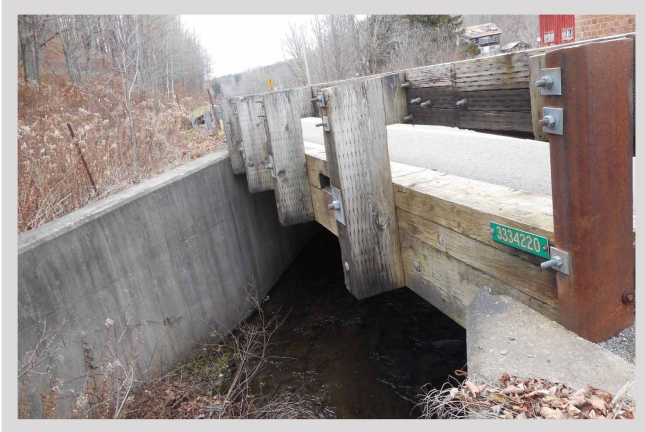
Bridge 1 of 3 on County Road 98 – Tiber Deck

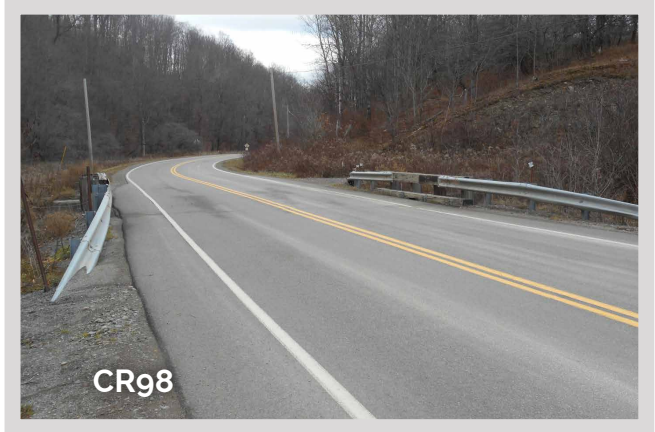
- f. Steuben County has voiced concerns with three structures along CR98 south of NY248 (all are timber deck bridges with asphalt or concrete tops).
  - a. County Road 98 Bridge Locations:

Bridge 1 of 3 on County Road 98 – needs 3rd party review

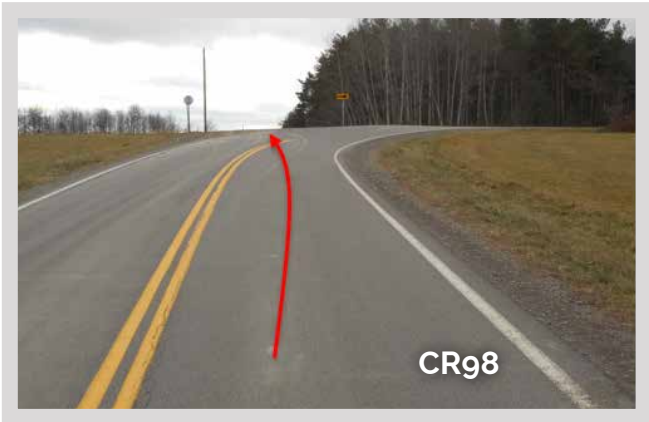
Intersection of CR98 and Downey Road, no turn  
CR98 becomes Downey Road. No concern with  
the transition as of this Assessment

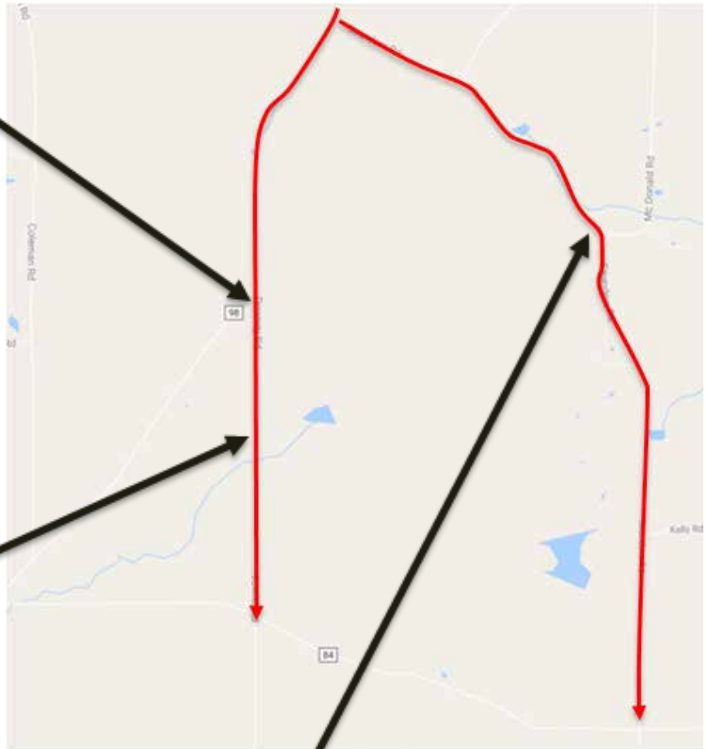
Downey Road, 7% grades
