Niagara Mohawk Power Corporation
d/b/a National Grid

Report on the Condition of Physical Elements of Transmission and Distribution Systems
Submitted September 30, 2011

REPORT ON THE CONDITION OF PHYSICAL ELEMENTS OF TRANSMISSION AND DISTRIBUTION SYSTEMS

OCTOBER 1, 2011

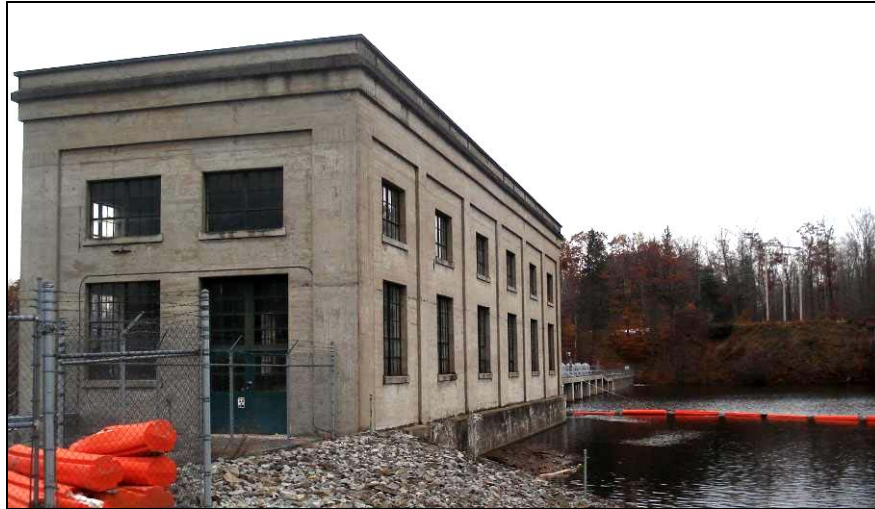
Photo II-8
Brookfield's Generating Station at the Lighthouse Hill Site

The condition of the station is fair to poor depending on the specific assets being considered. An integrated plan has never been developed for the station since numerous relay upgrades have been performed without any improvements to the station itself. The disconnect switches are in very poor and hazardous condition with failed insulators and repairs appear to work only temporarily due to the design configuration. Most of the oil circuit breakers (OCBs) are in fair condition, but several are obsolete and would pose a challenge to significantly repair.

The seven OCBs are located 200ft from the Salmon River located about 70ft below the grade elevation. The station is located a mile up stream of the NY State wildlife fish hatchery. Although the risk is low, any significant oil spill in the station would have a significant environmental impact. There is also the risk of a flooding event at the station given its elevation and proximity to the river.

See Photo II-8 illustrating the proximity of the site to the Salmon River.

Conceptual engineering for a new substation, relocated to a greenfield site along an adjacent road in the clearing near the transmission right-of-way and away from any flooding risk, was completed June 2010.

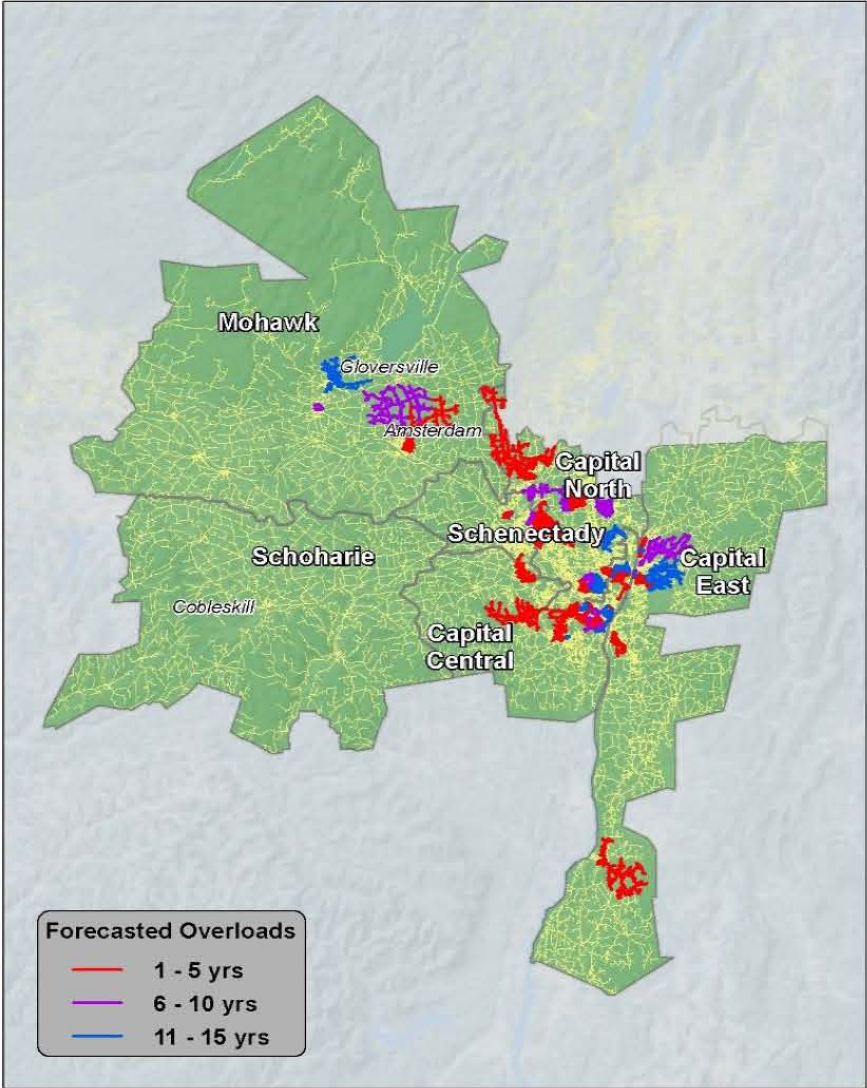
Forecasted Overloaded Distribution Feeder Map

The following map shows the Distribution feeders which are forecasted to be overloaded in the next 1-5, 6-10 and 11-15 year timeframe. The forecast overload is based on 100% of summer normal rating.

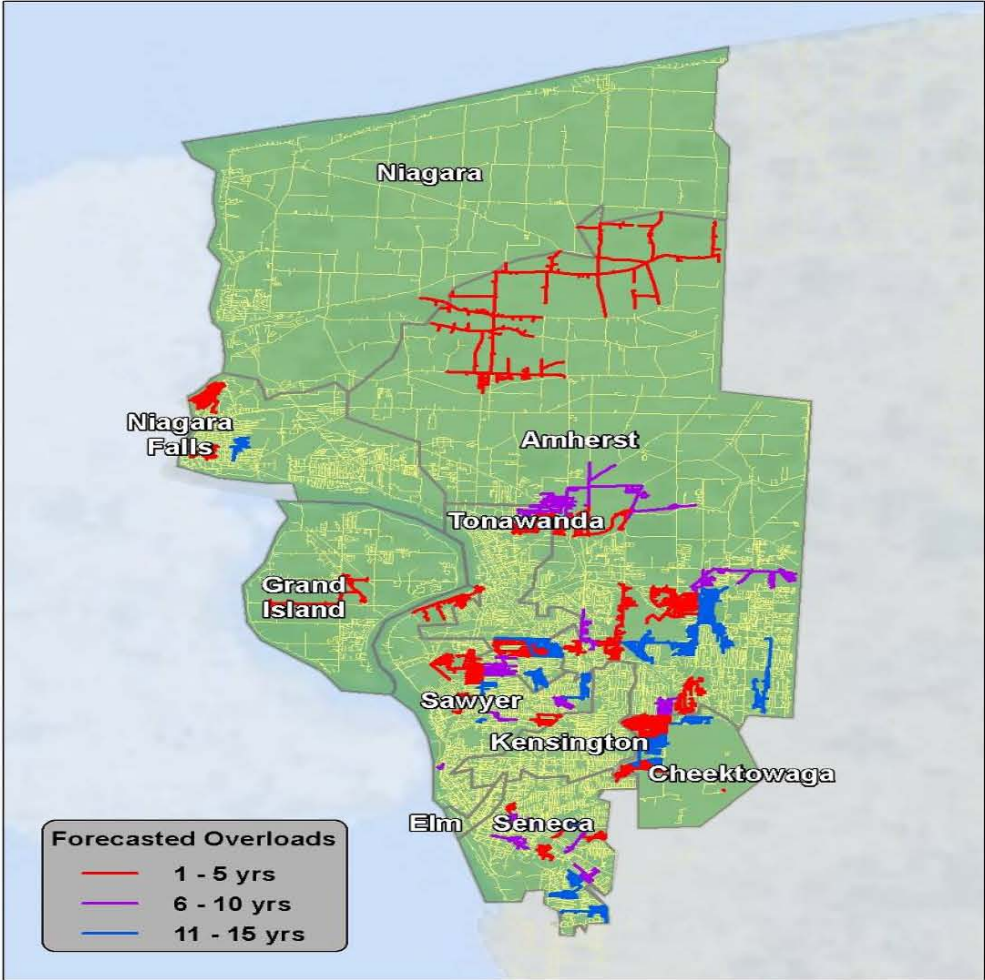
Forecasted Overloaded Distribution Feeder Map

The following table shows the distribution feeders which are forecasted to be overloaded in the next 1-5, 6-10 and 11-15 year timeframe. The forecast overload is based on 100% summer normal rating.

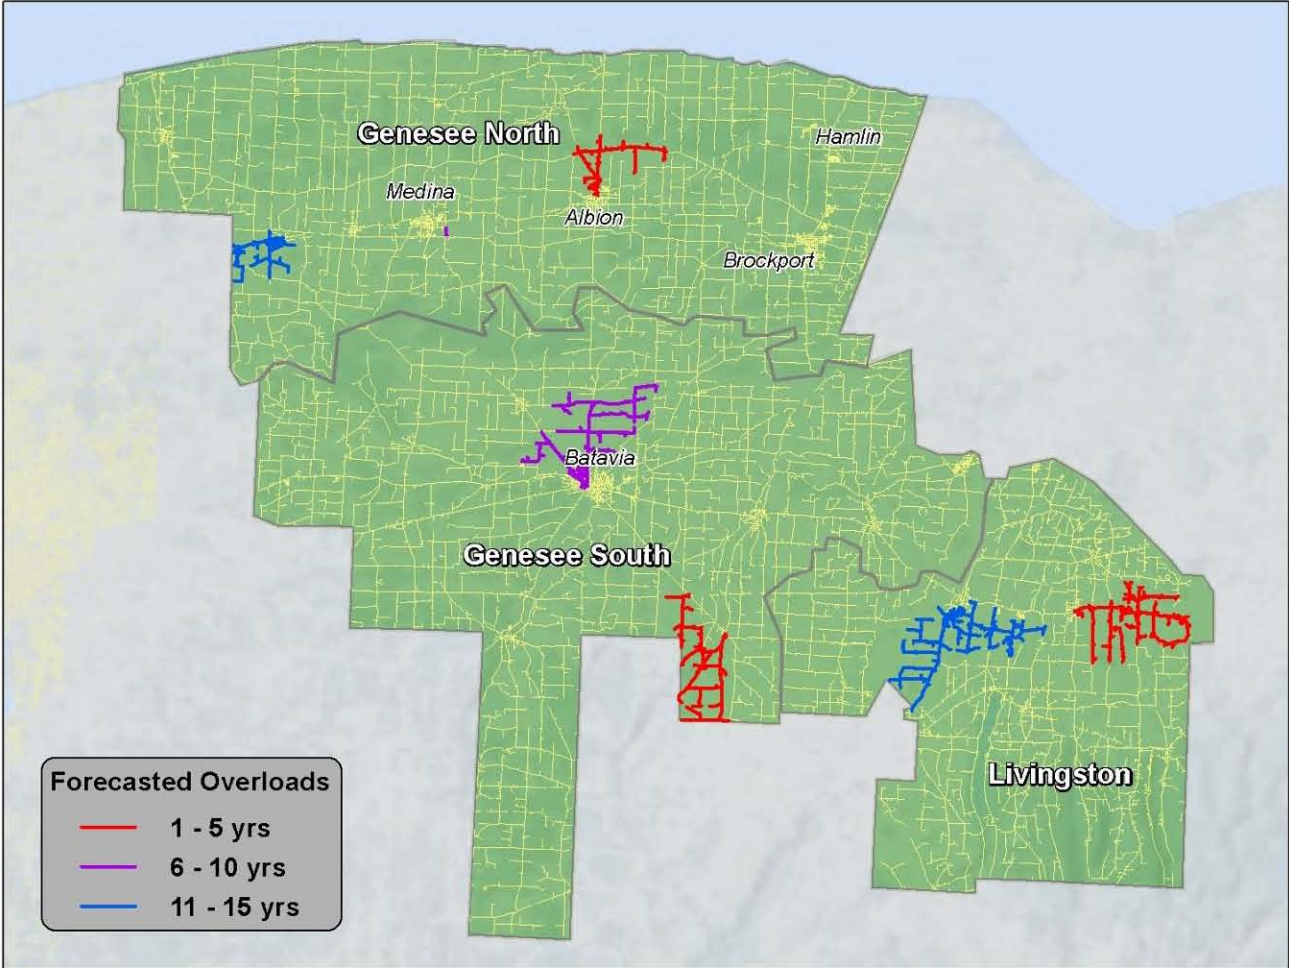
Forecasted Overloaded Distribution Feeder Map

The following map shows the distribution feeders which are forecasted to be overloaded in the next 1-5, 6-10 and 11-15 year timeframe. The forecast overload is based on 100% of summer normal rating.

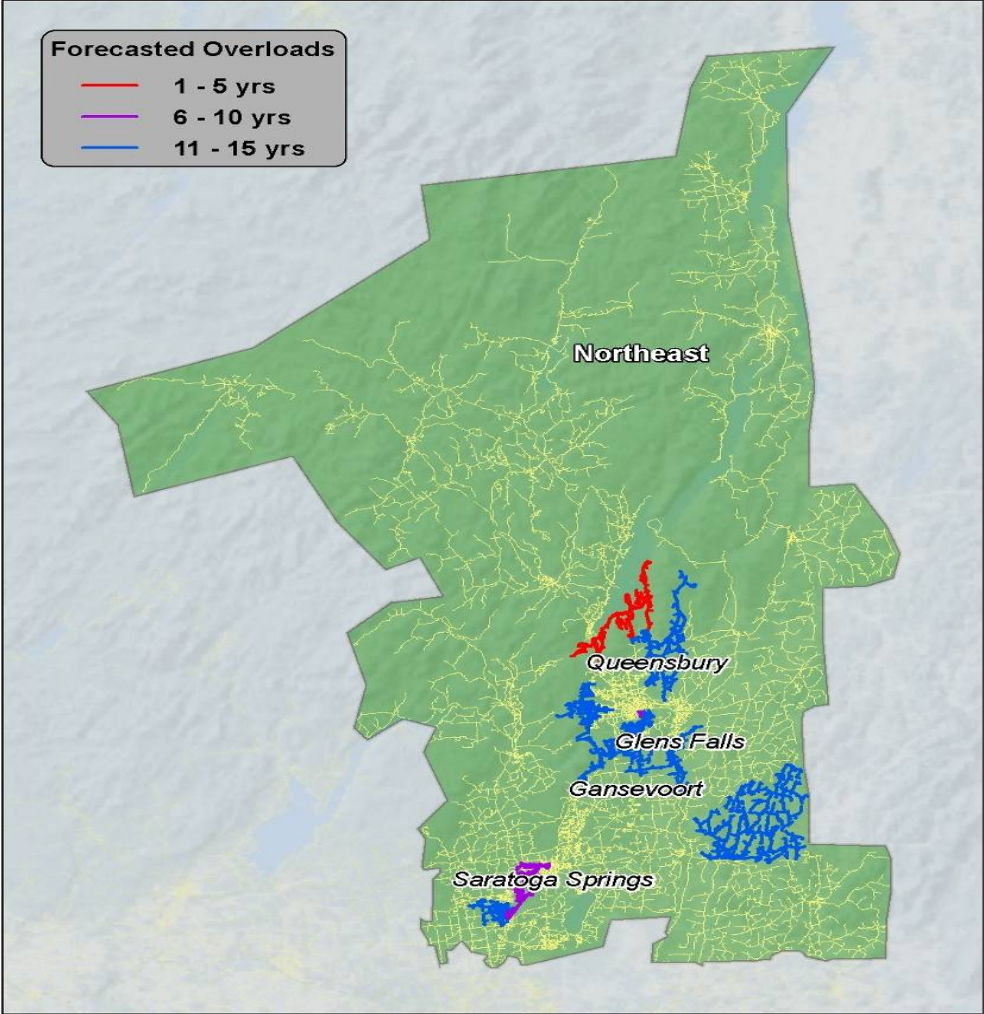
Forecasted Overloaded Distribution Feeder Map

The following map shows the distribution feeders which are forecasted to be overloaded in the next 1-5, 6-10 and 11-15 year timeframe. The forecast overload is based on 100% summer normal rating.

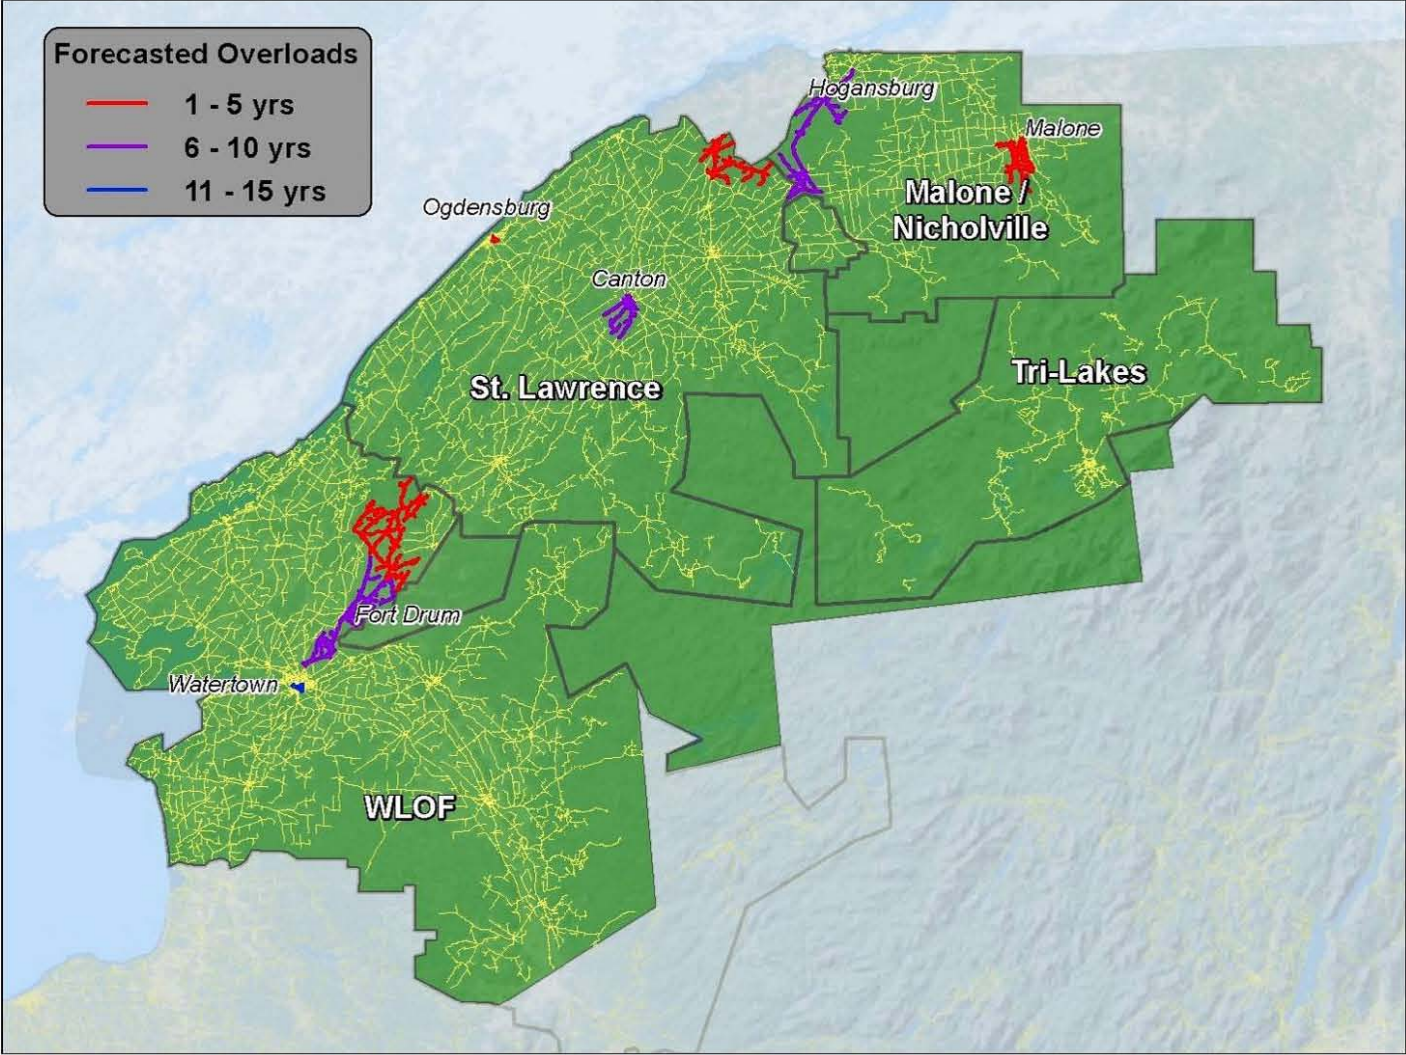
Forecasted Overloaded Distribution Feeder Map

The following map shows the Distribution feeders which are forecasted to be overloaded in the next 1-5, 6-10 and 11-15 year timeframe. The forecast overload is based on 100% summer normal rating.

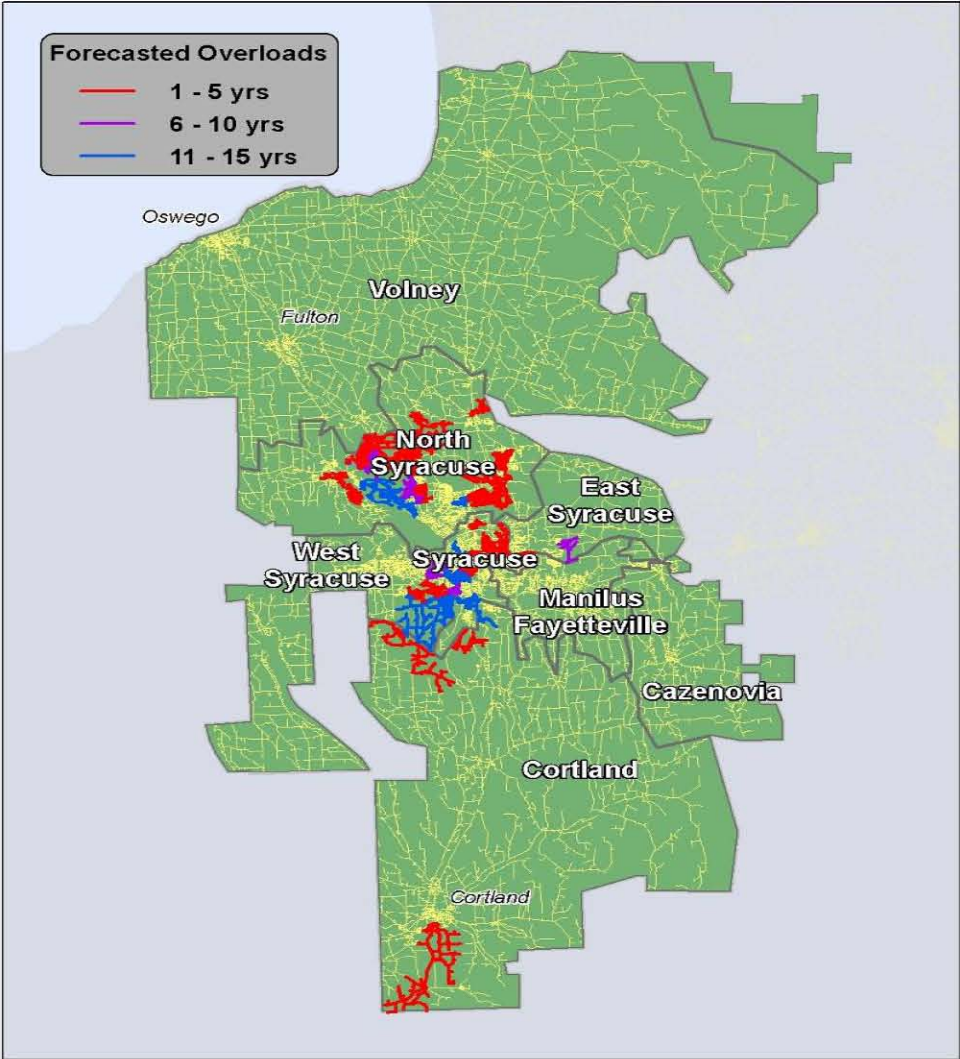
Forecasted Overloaded Distribution Feeder Map

The following map shows the Distribution feeders which are forecasted to be overloaded in the next 1-5, 6-10 and 11-15 year timeframe. The forecast overload is based on 100% of summer normal rating.

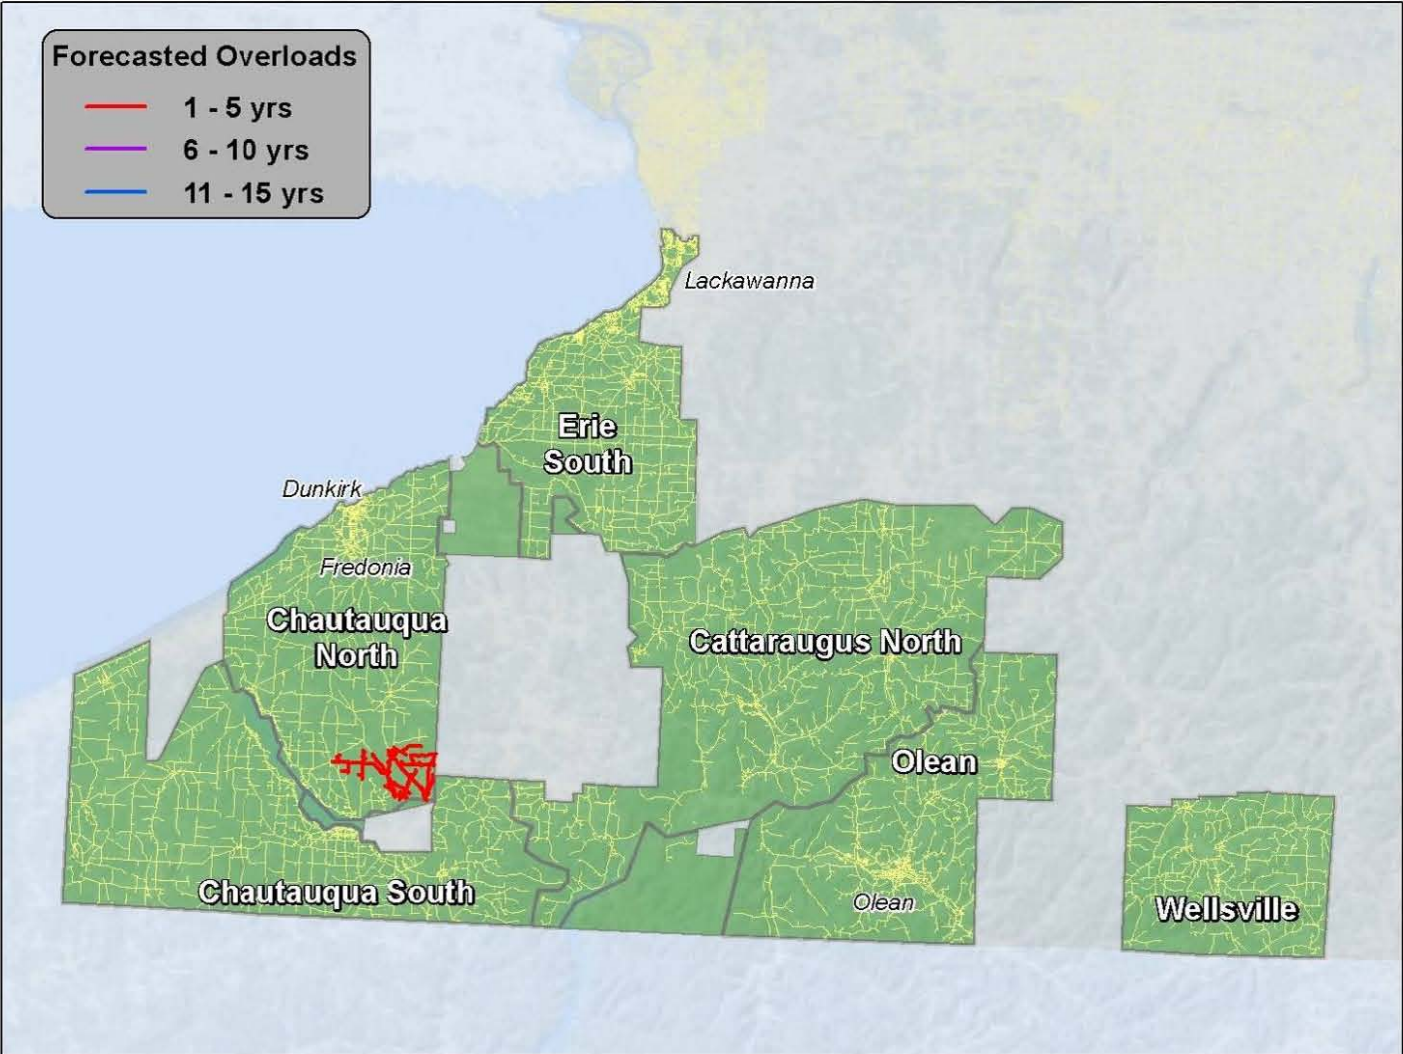
Forecasted Overloaded Distribution Feeder Map

The following map shows the Distribution feeders which are forecasted to be overloaded in the next 1-5, 6-10 and 11-15 year timeframe. The forecast overload is based on 100% of summer normal rating.

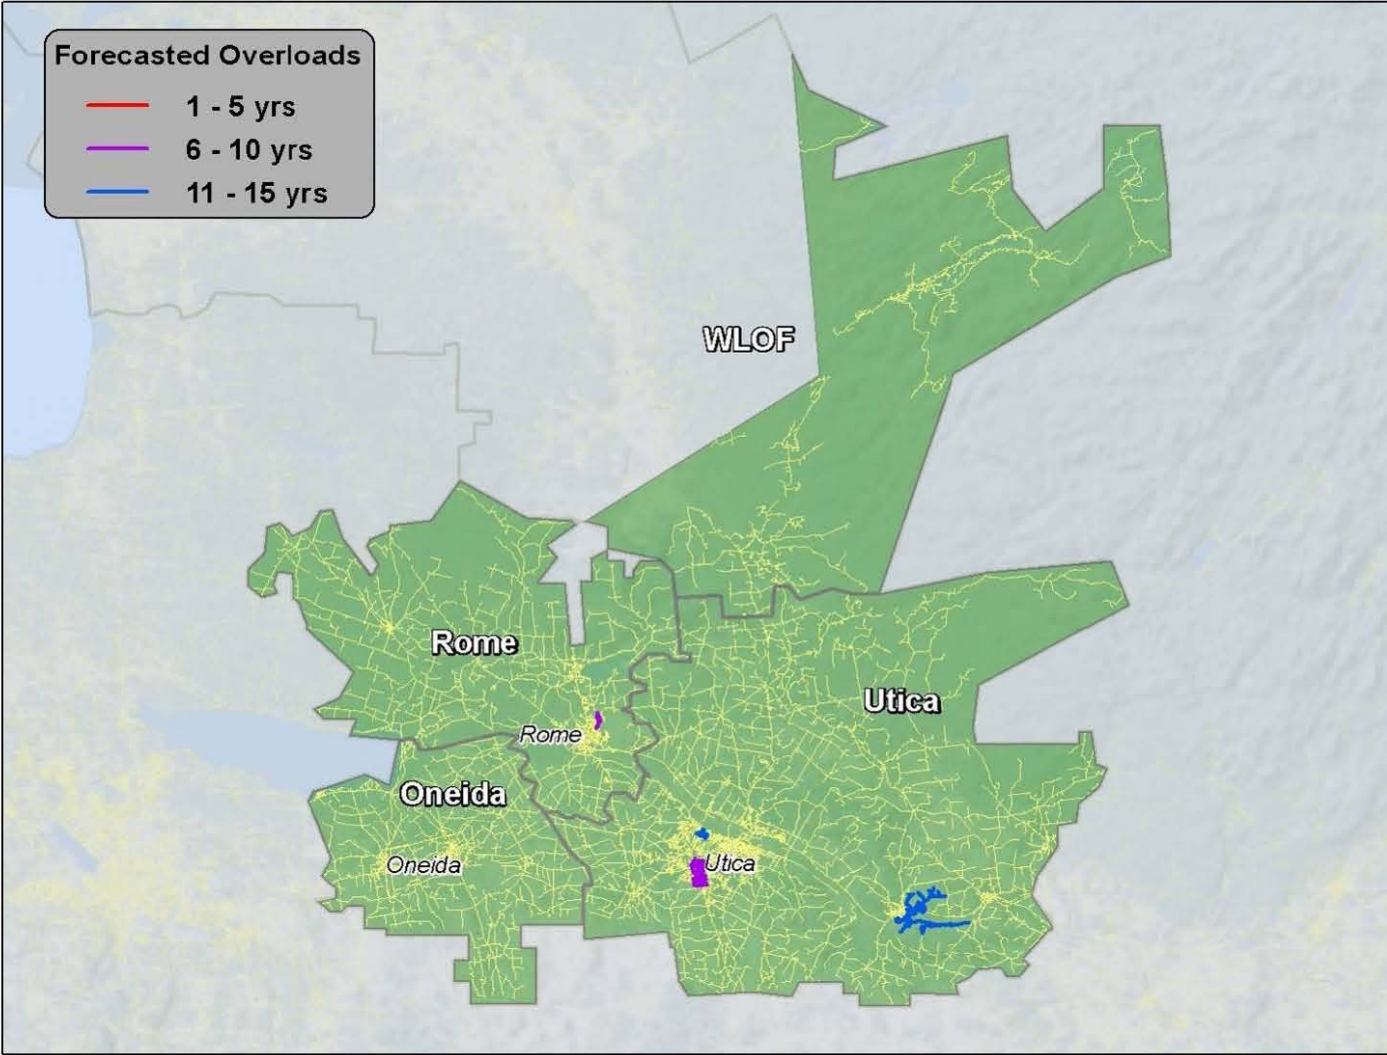
Forecasted Overloaded Distribution Feeders

The following map shows the Distribution feeders which are forecasted to be overloaded in the next 1-5, 6-10 and 11-15 year timeframe. The forecast overload is based on 100% of summer normal rating.
