STATE OF NEW YORK  
DEPARTMENT OF PUBLIC SERVICE

Case 09-G-0380

80-50 260<sup>th</sup> Street, Queens  
Natural Gas Explosion  
April 24, 2009

Consolidated Edison Company of New York, Inc.

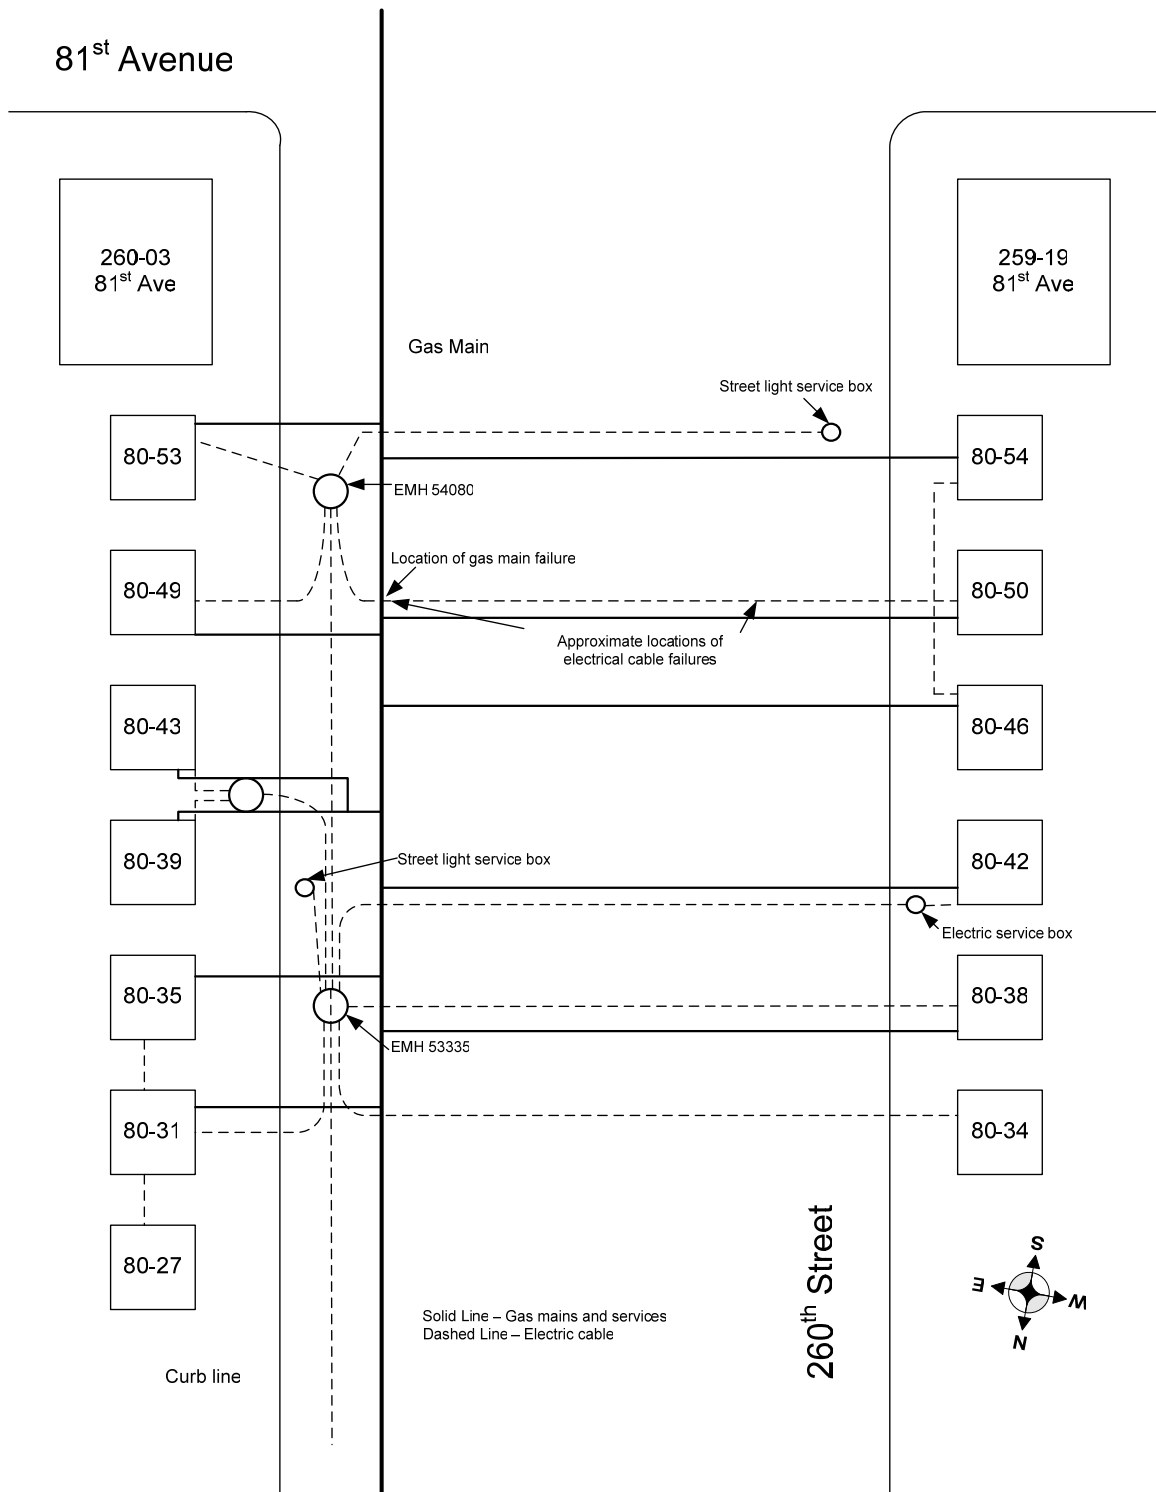
Figure 1 - Gas & Electric Facilities on 260<sup>th</sup> Street  
Note: This diagram is not to scale and is intended only to show the relative position of facilities

The buildings located at 80-46, 80-50, and 80-54 260<sup>th</sup> Street were each supplied electric service via a common two-inch steel conduit, installed in 1951 (see Figure 1). The conduit originated in a service box (identified as EMH-54080) located in the street in front of 80-53 260<sup>th</sup> Street. The service conduit extended north from the service box for approximately 20 feet, turned west and entered house 80-50. The conduit also branched in front of house 80-46 to serve the adjacent homes on each side - houses 80-46 and 80-54 260<sup>th</sup> Street.<sup>1</sup> Electric power was supplied through three individual lengths of #2 copper cables.
